Drone Inspection

Property: 123 Example Road, London N1 5QQ

Date of Report: 30th April 2025

Scope: Main roof and rainwater goods

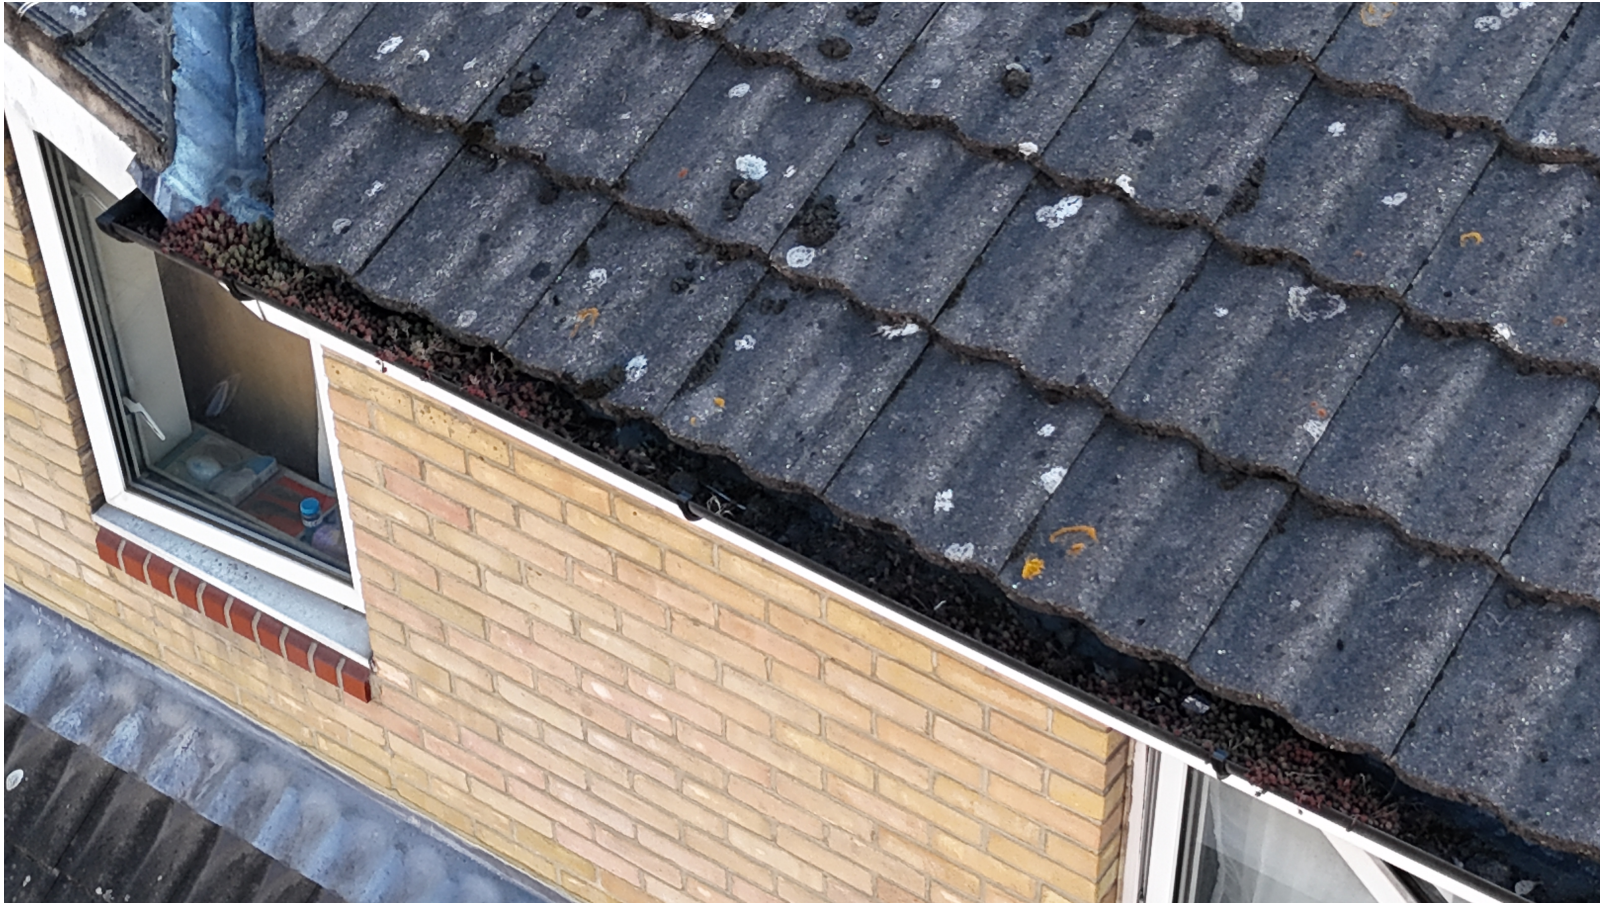
Roof condition in keeping with normal wear. Moss, lichen and debris noted to roof slopes and rainwater goods.

Figure 1: Moss and lichen to front roof slope and gutter

- Clearing moss, lichen and debris from roof slopes and gutters.
- Clear downpipes and gulleys which may be congested as entirety of drainage route is hidden from view.
- Assess rainwater goods further for worn joints that require re-sealing and monitor during rainfall.

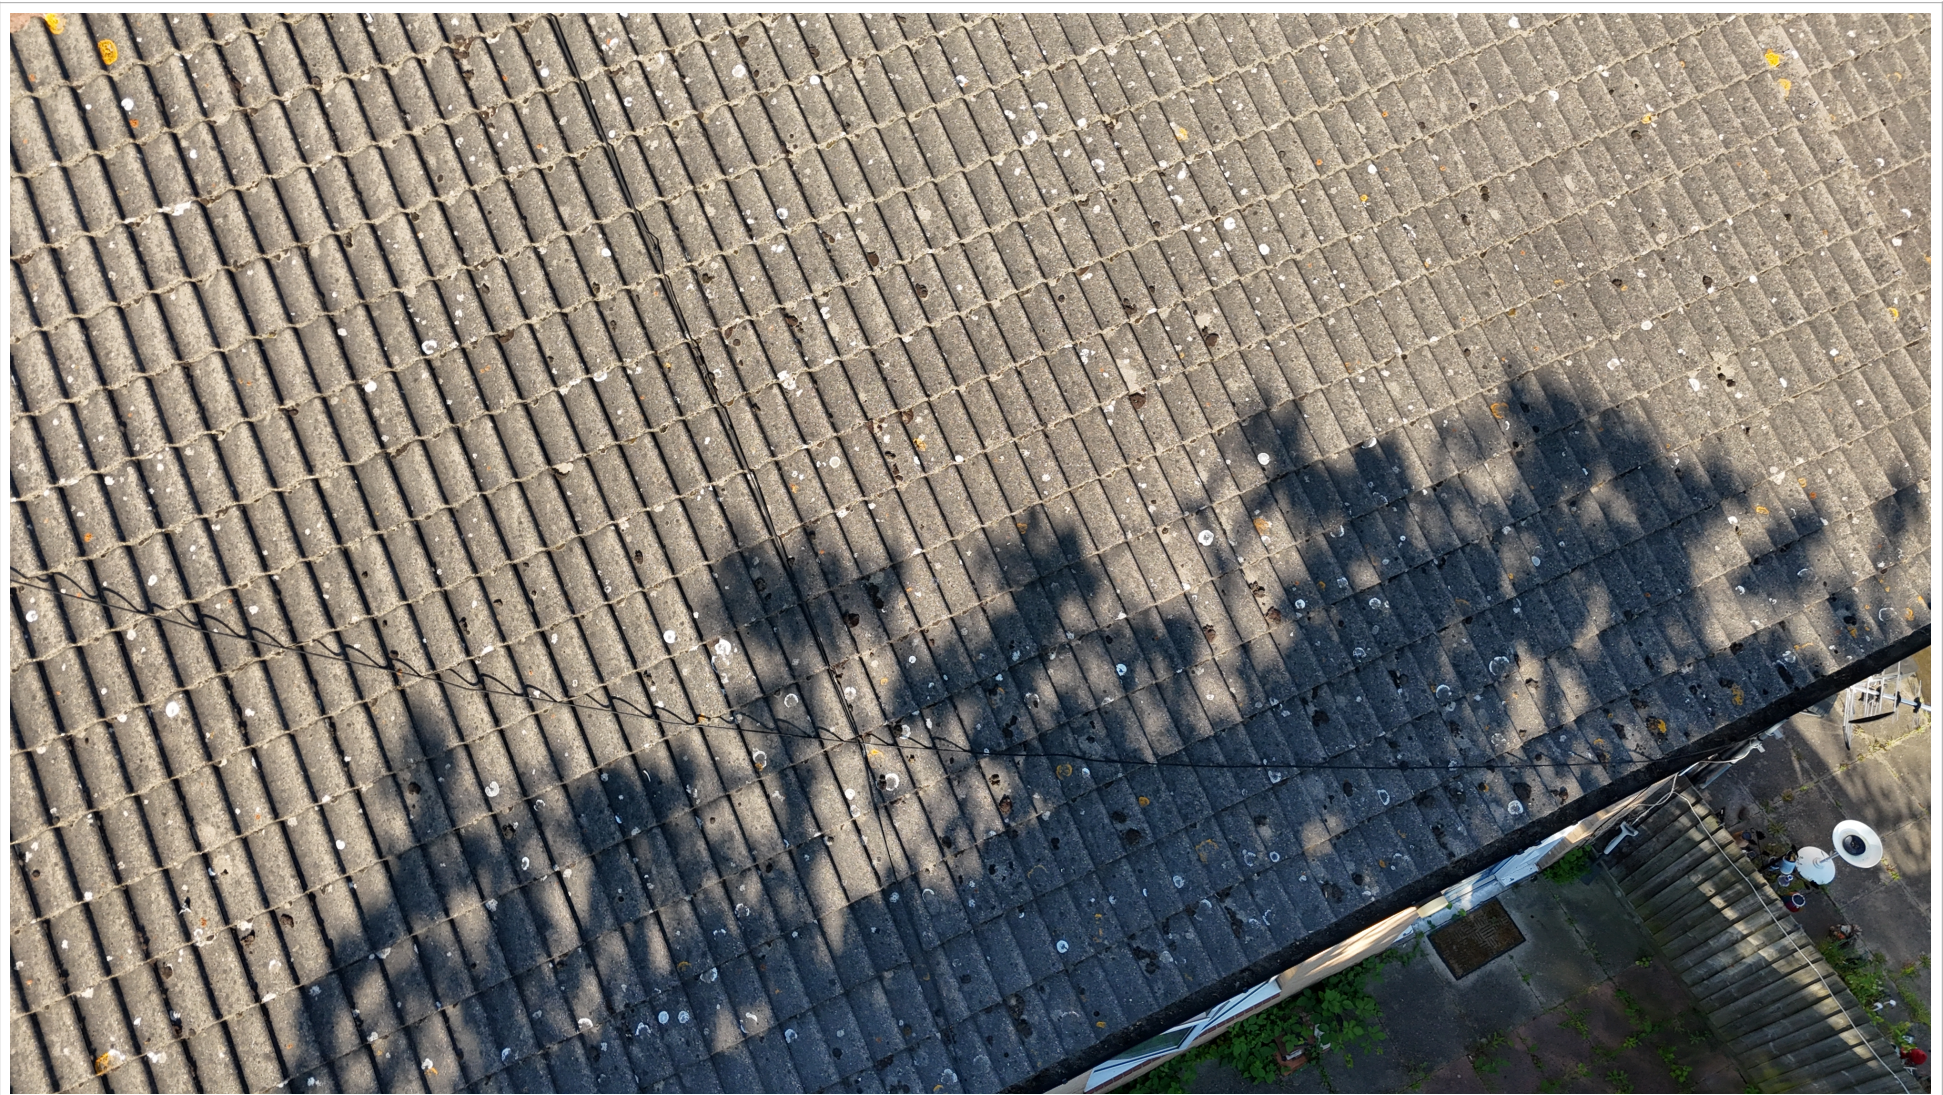
Figure 2: Moss and lichen to rear roof slope

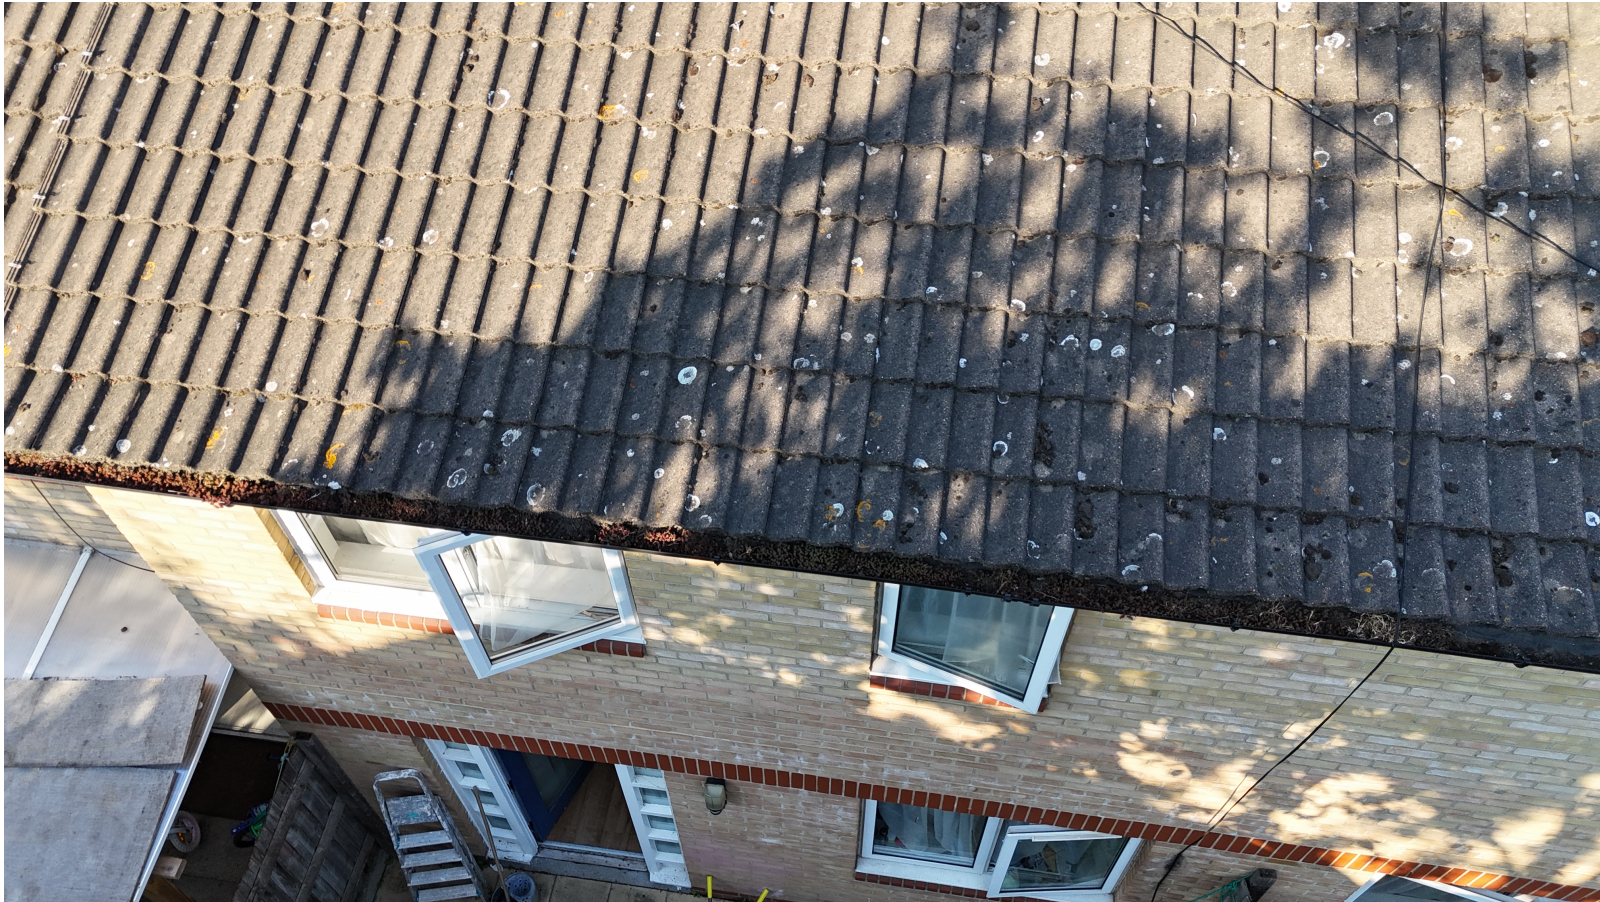
Rainwater Elements	Y/N	Condition		Rating
Gutter	Y	View blocked due to being congested with moss etc but staining noted to underside of joints		2
Downpipe	Y	Staining noted to joints and possibly congested with moss		2
Discharge point	Y	No visible blockage to gulley		1
General		Heavy moss accumulation to gutters	< 3 months	2

Figure 3: Moss to rear gutter

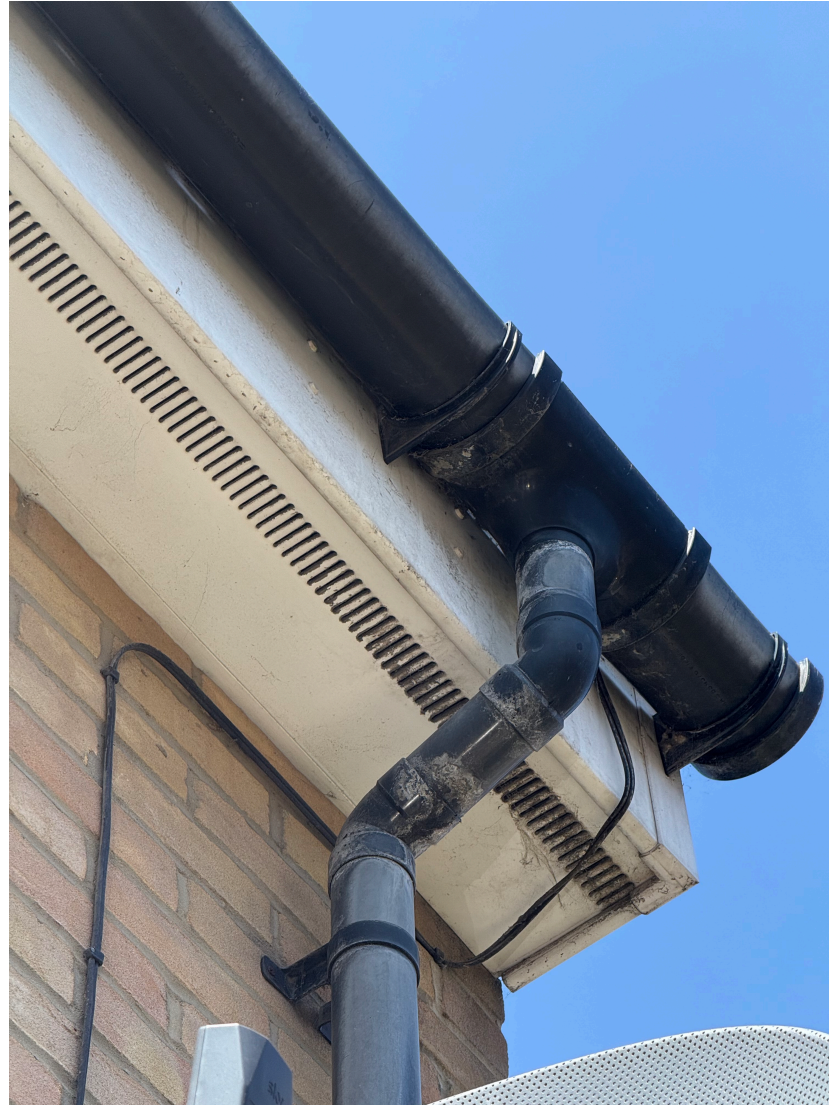
Figure 4: Staining to front downpipe
