# Your survey report

21 Sample Road, London E14

**Inspection Date**

4th November 2025

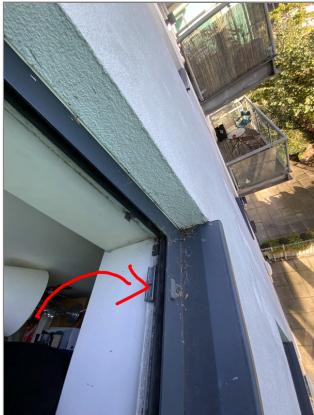
The uPVC windows are dated, with some difficult to open. In addition, the rubberised gaskets are worn which will ultimately lead to vapour entering the void causing mould and draughts in and around the frame. The mastic to the perimeter of the frames is in a similar condition. These should be regarded as having limited life and will require replacement within the short term. Some of the double glazed units have also failed which is common due to a limited lifespan. We recommend a

*Photo - 2 Gasket (black rubber seal) worn*

reputable window contractor attends to clarify the extent of window repairs required so you may budget for this in the short to medium term. The work can prove relatively expensive. Condition Rating 2.

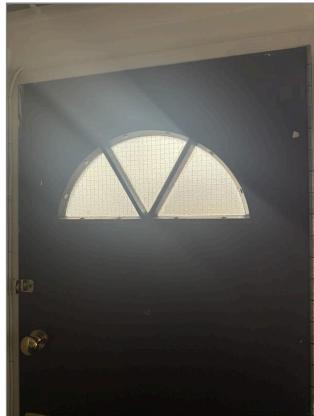
*Photo - 3*

The door set is missing a door closer. This is required to close the door unaided in the event of an emergency, to contain fire, heat and smoke. The requirement for older buildings with such doors however varies based on a risk based approach. The same applies when considering the glazed pane which is set 1.1m above ground level. Typically, the Freeholders may decide that the door closer is not required on the basis of the subject flat being located at the end of the open walkway. The risk of fire reaching the glazing is also considered to be low. Therefore, the risk of causing harm or preventing escape in the event of a fire may be considered as low given the fire escape staircase is located away from the door, and smoke will pass out into the open air. Nonetheless, the guidance for existing blocks is due to be revised this year (2025) which may change or enforce new requirements impacting the suitability of the current configuration. We therefore suggest you budget for replacing the door set with a new fire rated alternative as a worst-case scenario. Our condition rating is based on the risk posed and revision of guidance that is due. Condition Rating 3.

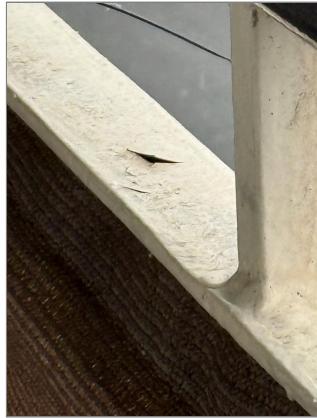
Photo - 4

We noted flaking paint and spots of corrosion to the metal handrail caused by a lack of maintenance. The exposed areas should be treated with a rust inhibitor and redecorated to avoid the same. In significant circumstances, this can weaken the railing structural integrity. Condition Rating 2.

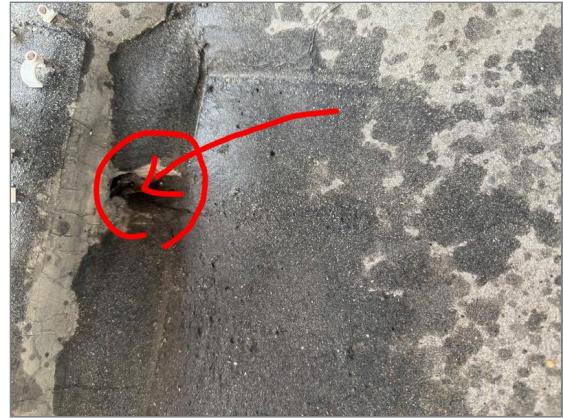
The balcony drain is of a small circumference and is blocked easily. This could allow blockages causing dampness. You should clear this soon and regularly. Condition Rating 2.

Photo - 5 *Balcony drainage slightly congested and of a smaller size requiring regular clearing.*

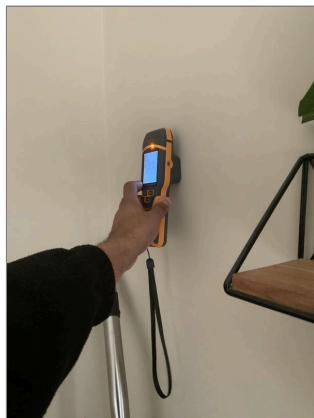
Photo - 6

We noted staining indicative of water escape to the external facing living room wall. This appears to be caused by defective rainwater goods concealed within the wall. The moisture readings to the patch and immediate area was moderate. We therefore believe the matter is historic with the area drying out. The vendor should confirm any remedial work and further investigation undertaken to resolve the source/cause of the issue prior to exchange. The affected area will require 'stain blocking' and redecorating once fully dry. Where stains re-emerge, the plaster will require renewing as it is contaminated with salts. Condition Rating 2.

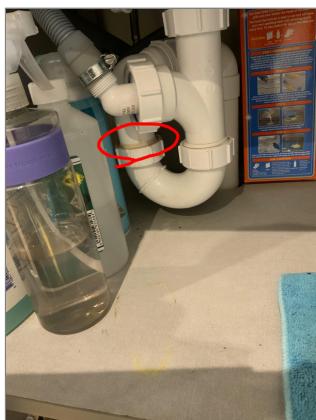
*Photo - 7 Historic staining but monitor*

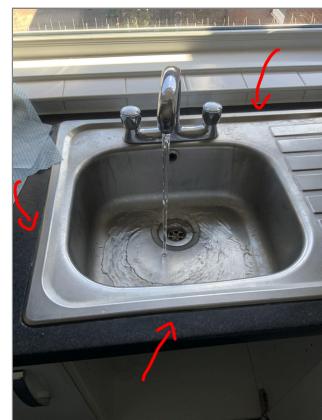
The mastic to the abutment of the countertop and wall and perimeter of the sink was partially missing. We therefore recommend the mastic is renewed promptly to prevent water ingress which can cause decay, rot or even insect infestation over time. Condition Rating 2.

*Photo - 8 Mastic to perimeter of sink missing or worn*

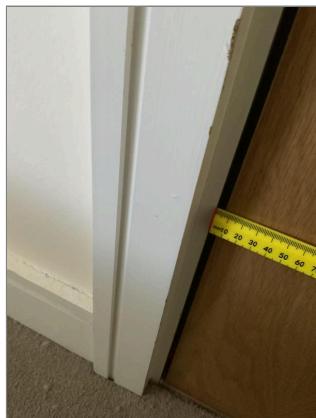
- The potential change in fire door regulations to older buildings that may result in repairs or renewal being required. On a related note, the internal fire doors have excess gaps that sit outside the tolerances typically prescribed by manufacturers and as such will require repair. We expect these matters to be common and due to the building's age and general wear. Nonetheless, its commonality should not be confused with the severity.
- As the kitchen has been recently installed, mechanical ventilation must have been allowed for to comply with regulations.

*Photo - 9 Example of excess gap*
