LEVEL 3

# Your survey report

Sample address NW2

10th November 2025

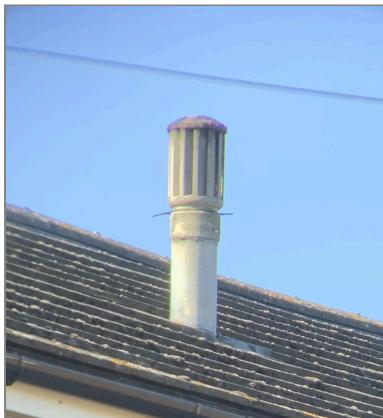
It appears an asbestos type flue is present to the rear stack(s). Whilst we cannot guarantee its condition, it appears undisturbed and therefore is at less of a risk to release fibres. Nonetheless, any contractor working at high level must be notified of this prior to commencing work so they may take the necessary precautions. You may still wish to remove this, if so, a Licensed Asbestos Contractor can assist further. See section I3 for related commentary. Condition Rating 2.

*Photo - 2 Asbestos based flue*
