INSPECTION REPORT

For the Property at:
123 MAIN STREET
WESTLAKE, OH 44145

Prepared for: JOHN SMITH
Inspection Date: Wednesday, May 11, 2022
Prepared by: Joseph Grady

Report No. 1003

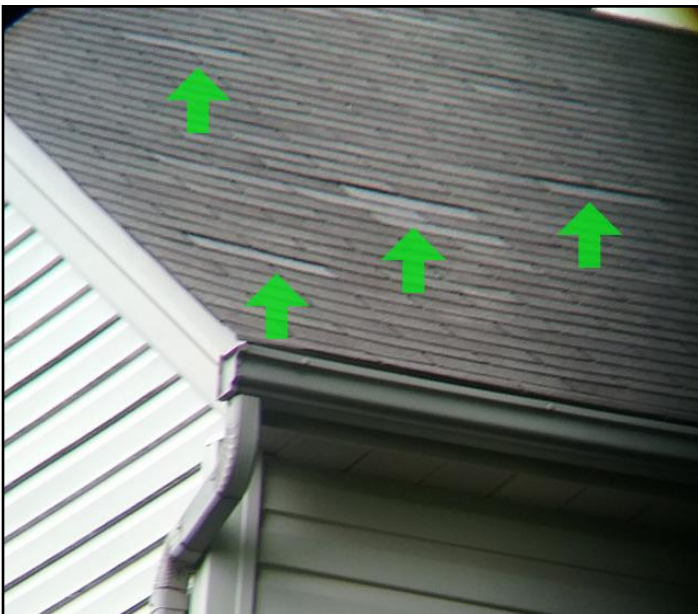
missing shingles on Northwest and Southeast facing roof

1. missing shingles: NW roof

Task: Repair or replace

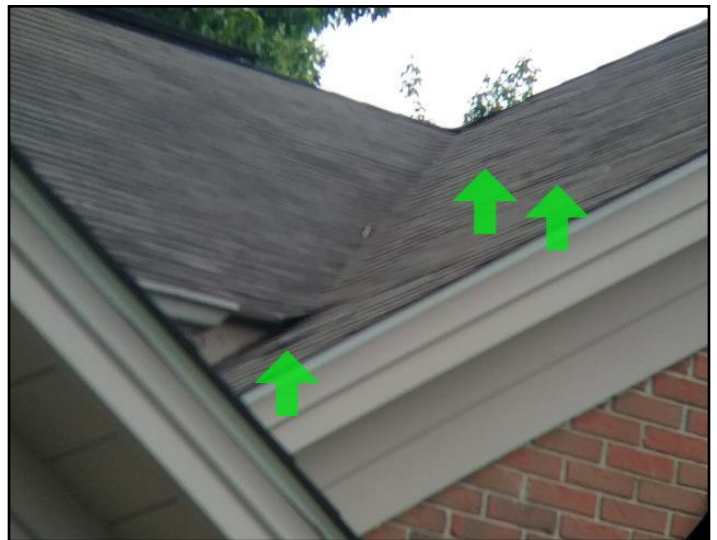
2. missing shingles: SE roof

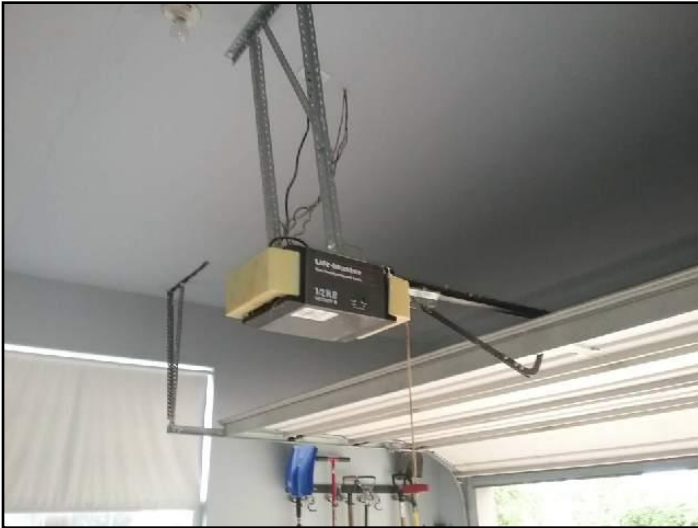
3. door opener is functioning fine

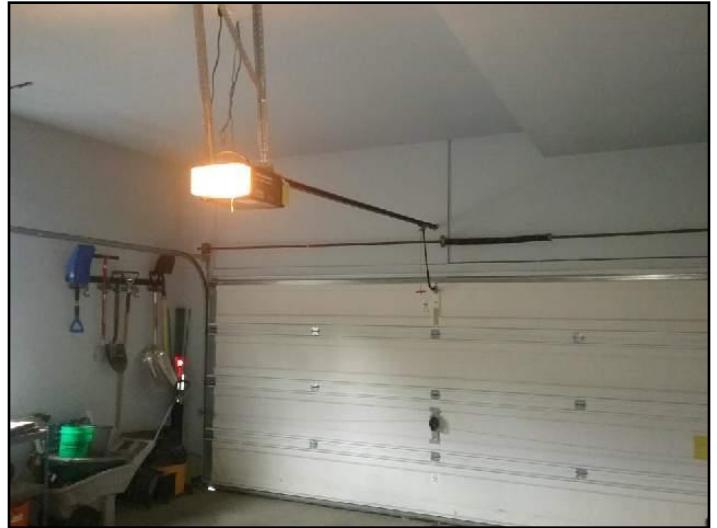
4. safety stop feature operated correctly

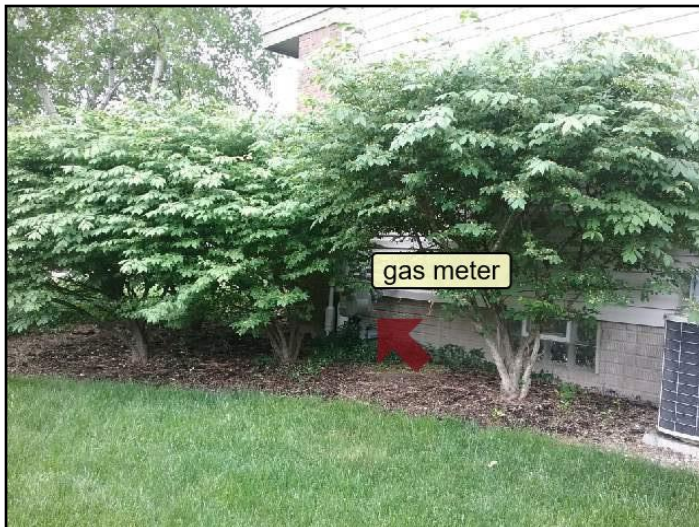
Over-grown trees and shrubs are too close to the house, restricting air flow near A/C compressor and limiting access and visibility of gas meter / safety shutoff

5. access to gas meter is limited by bushes

Task: Prune bushes and trees

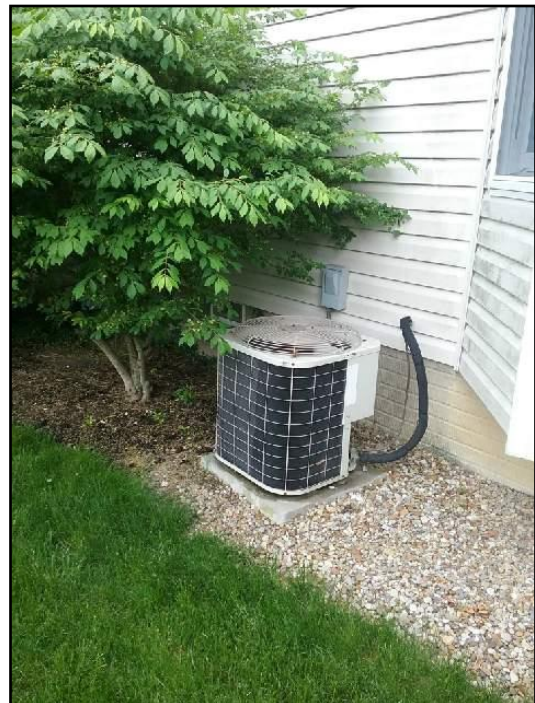
6. bush restricts air flow

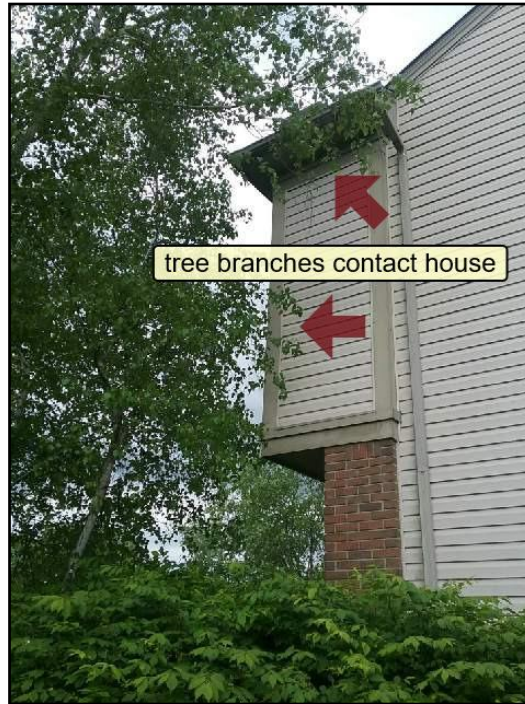
7. birch tree contacts house and gutter

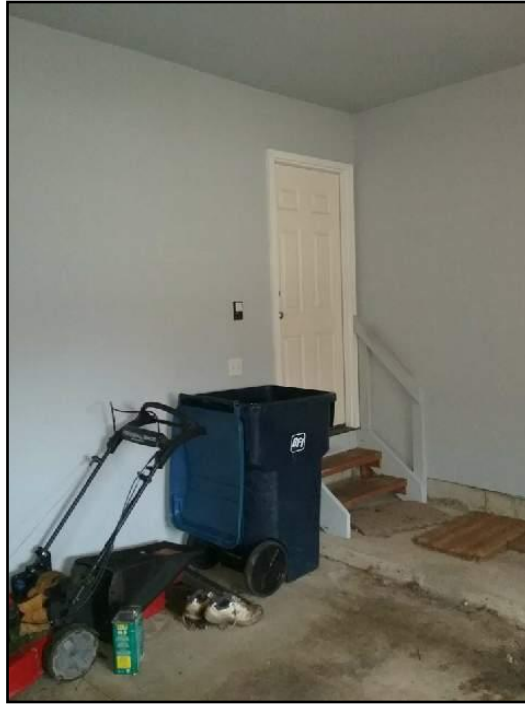
door closing mechanism needs adjustment to close fully for fire safety

8. *garage man-door should close fully*

Task: Repair

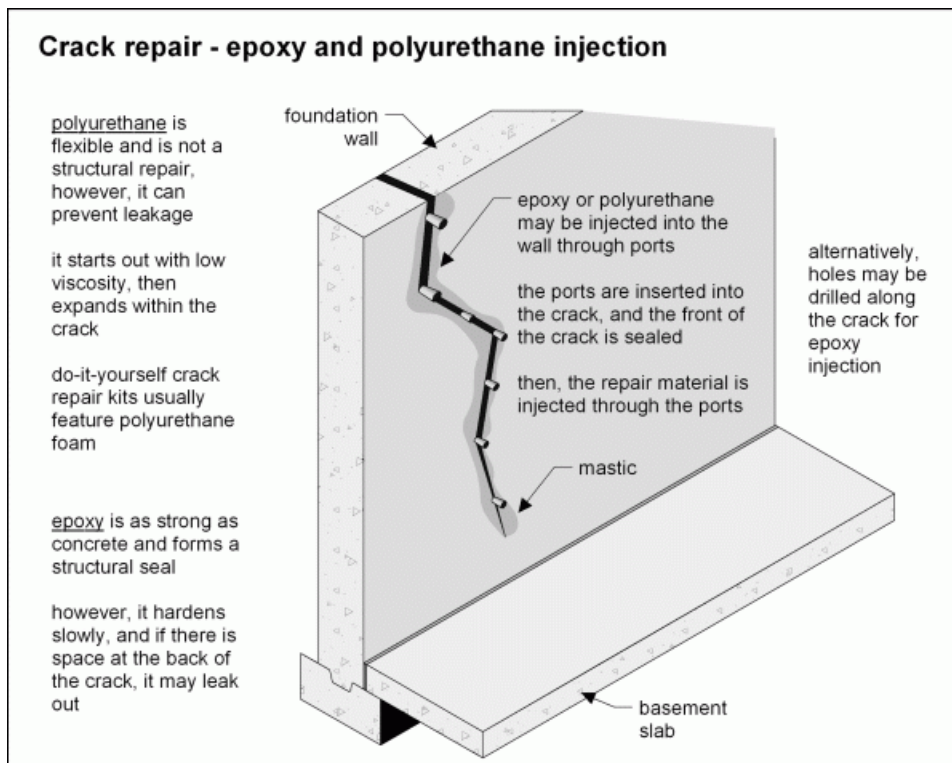
5. Condition: • Typical minor cracks

Task: Monitor

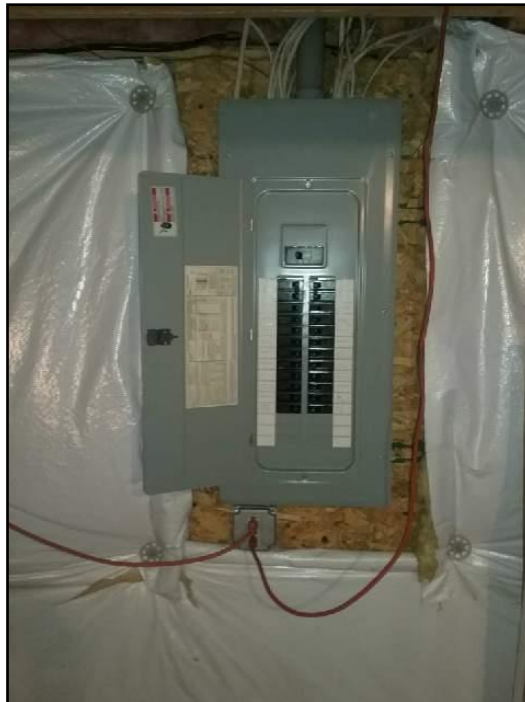
9. 150-amp panel

150-amp service panel is on south wall of basement

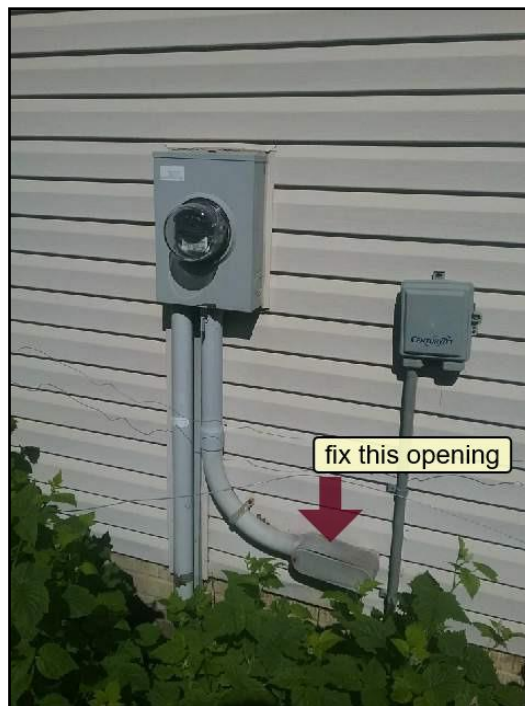
damaged service entrance hardware can allow water access

Implication(s): Shock hazard or interruption of electrical service | Electric shock

10. damaged hardware at service entrance

Task: Repair

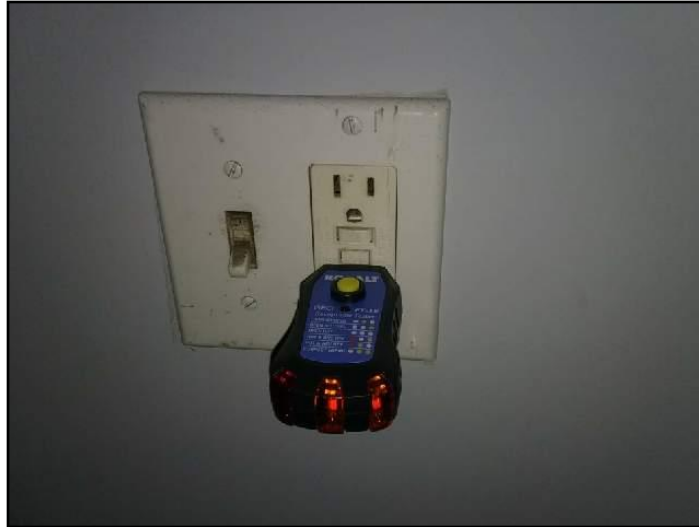
11. GFCI in garage operable

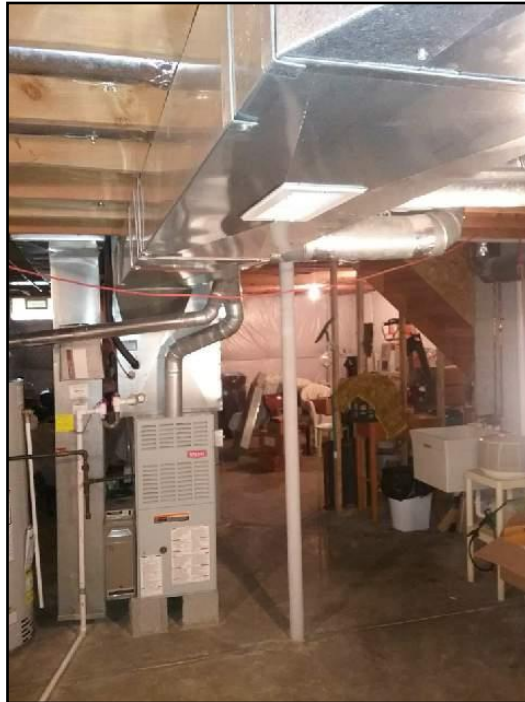
12. Forced warm-air heating with extended plenum

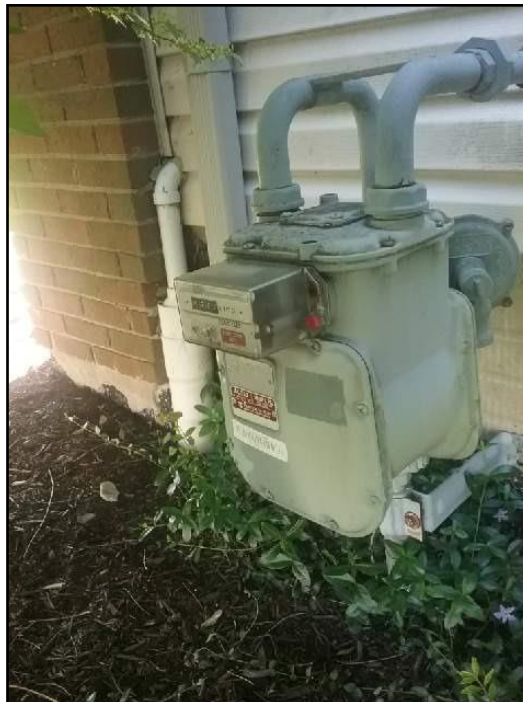
Gas supply and emergency shut-off located behind bushes at NE corner of house

14. Gas supply and emergency shut off

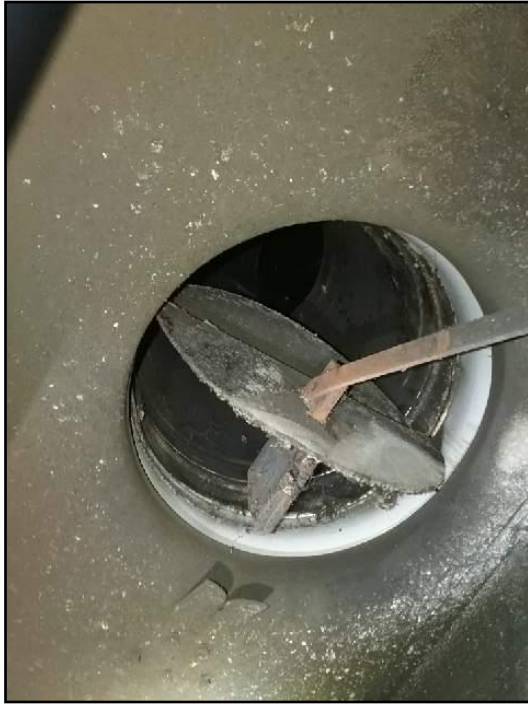
15. damper door functioning as needed

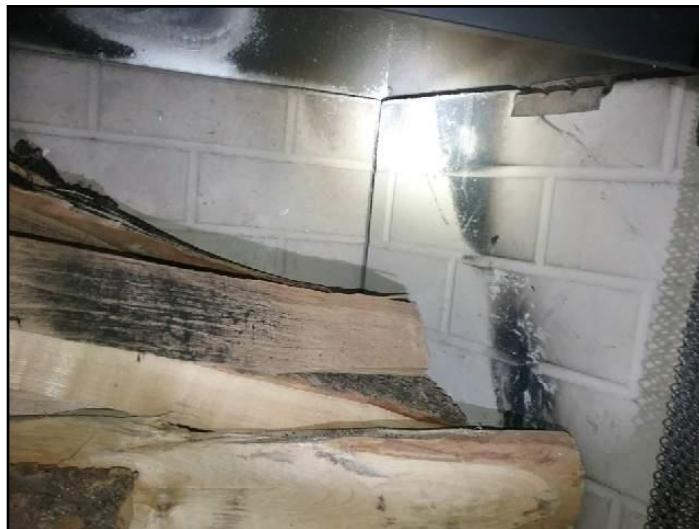
17. fire-brick lines firebox

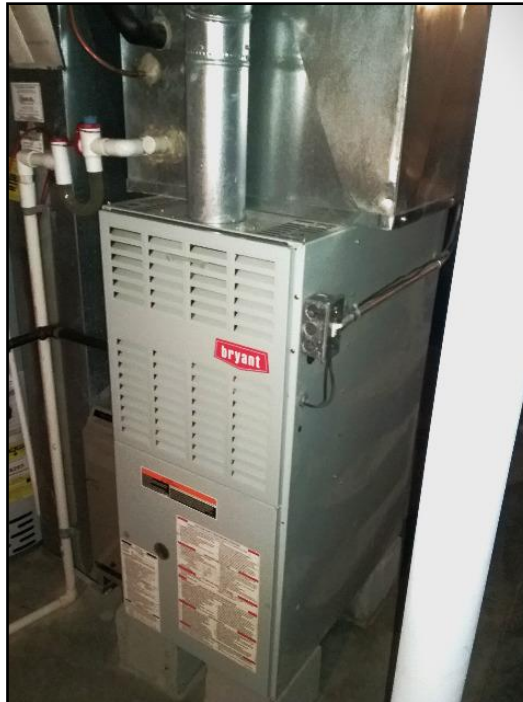
replace dirty air filter

18. furnace has dirty air filter

Task: Replace air filter, inspect & service annually

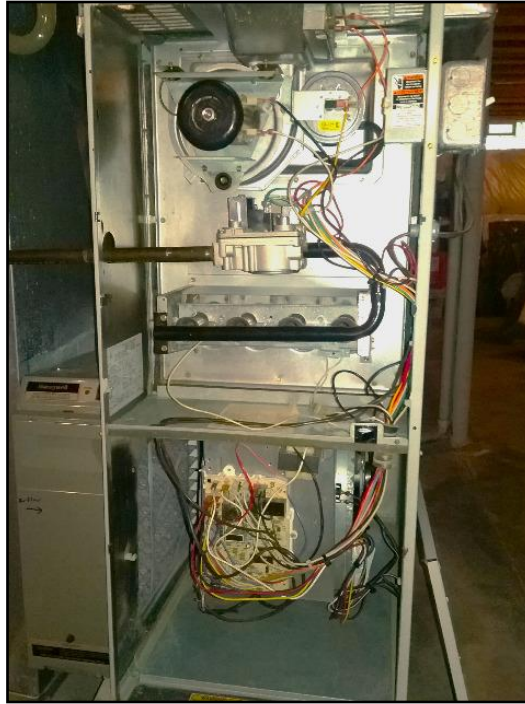
10. Condition: • Aging

19. Monitor & service aging furnace

Task: Monitor furnace: inspect & service annually

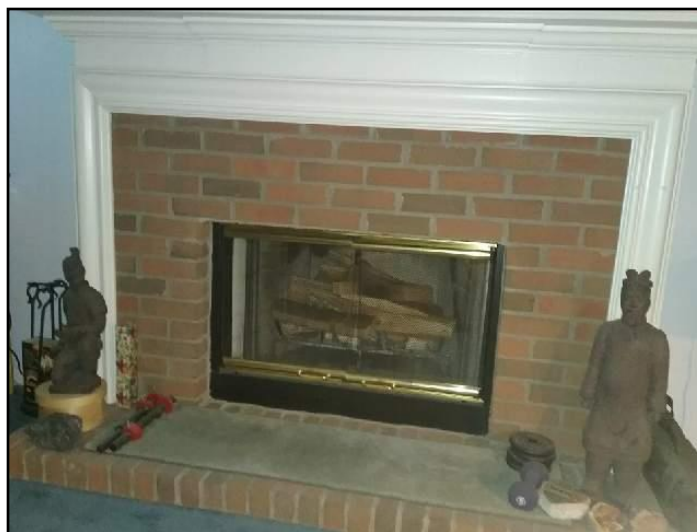
Carpet remnant should be removed from fireplace hearth for fire safety

Implication(s): Fire hazard

21. masonry fireplace with carpet on hearth

Task: Remove

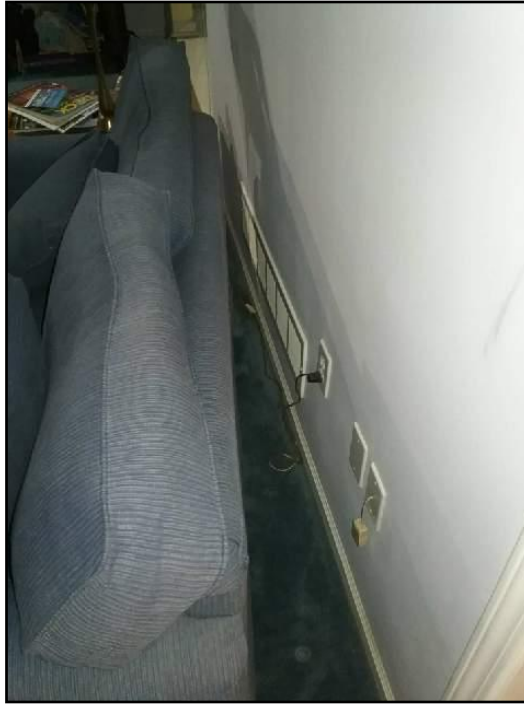
24. cold air return is blocked by furnitiure

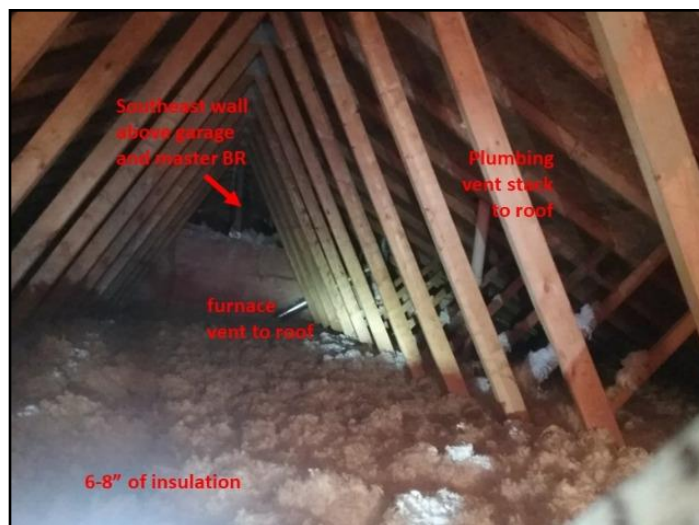
14. Condition: • [Amount less than current standards](#)

25. Add attic insulation to reduce heat loss

Task: Upgrade

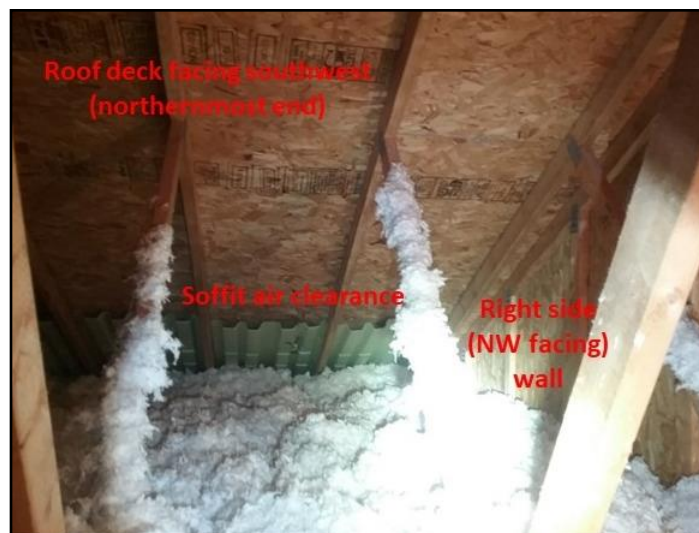
Inspection of roof deck from attic showed no indication of any active leaks

26. NW facing roof section: no active leaks detected

Task: Monitor & inspect roof annually

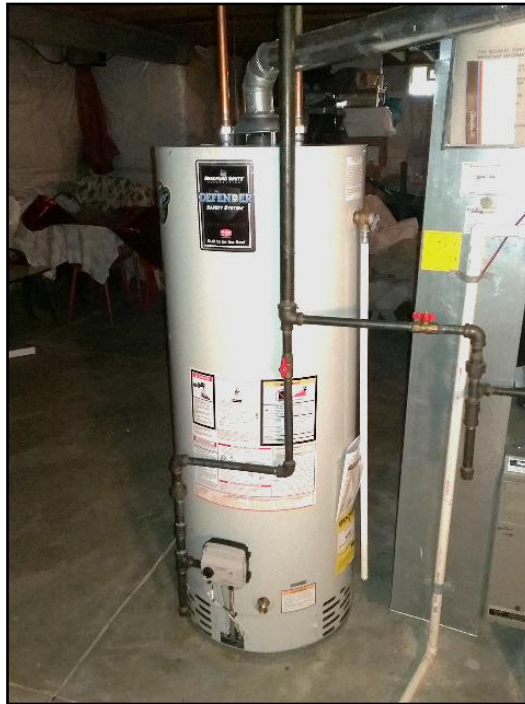
17. **Condition:** • Safety pan and drain defect

30. 50-gallon hot water tank

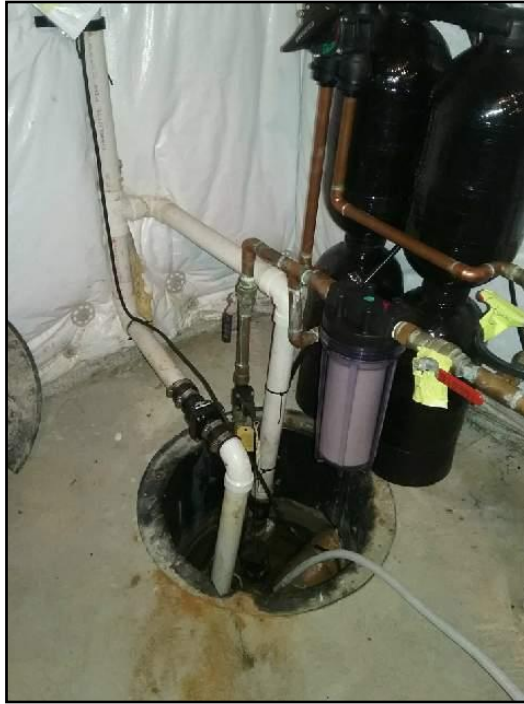
18. Condition: • Sump pump is near water supply inlet / shutoff in basement, and was verified to be operating properly. Pit cover should be in place for safety.

31. *sump pump should be covered*

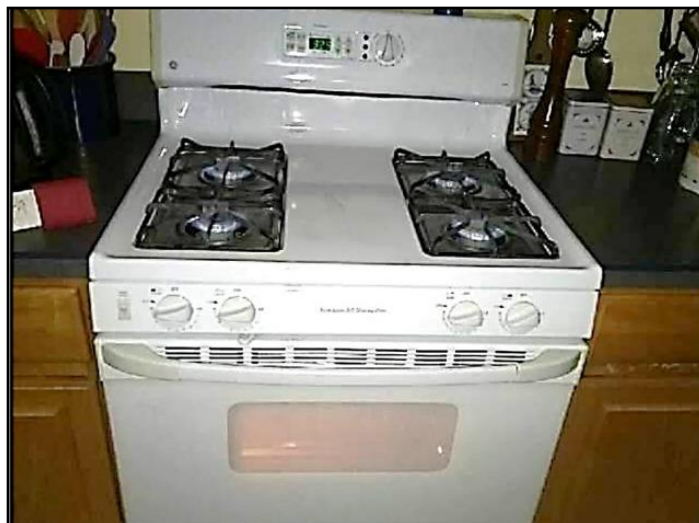
32. Four gas burners and oven were operable

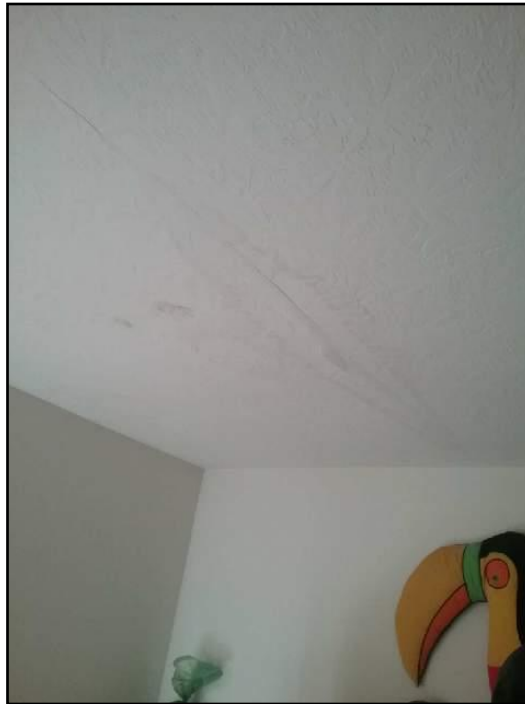
Ceiling water stains indicate prior or ongoing roof leak above Northwest second floor bedroom

33. Water stains on bedroom ceiling

Task: Repair Monitor

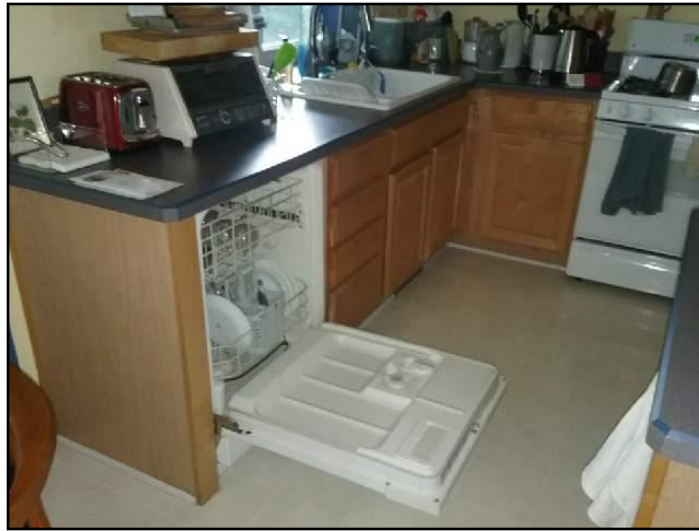
22. Condition: • Springs defective

34. dishwasher door spring needs repair

Task: Repair

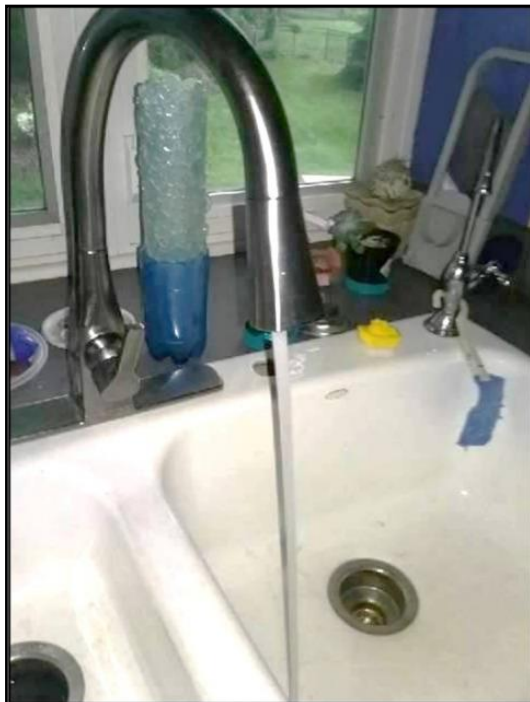
35. kitchen sink water faucet is functional

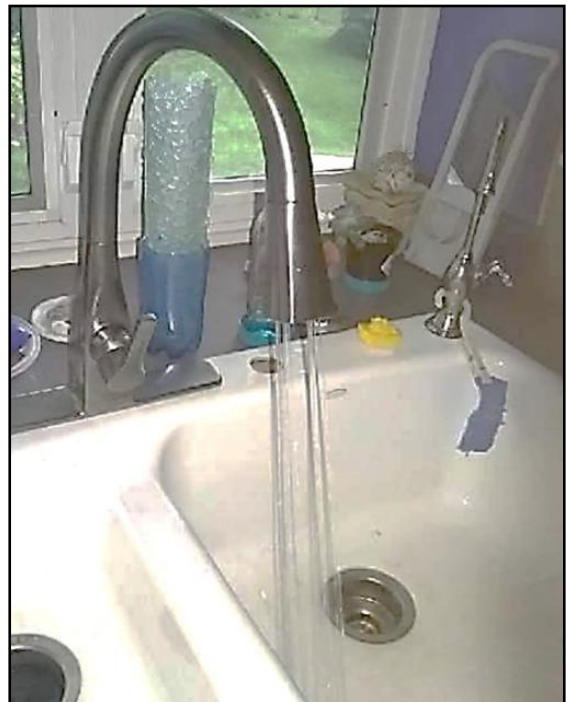
36. sink faucet flow diverter is functional
