# How Dr. Heater<sup>®</sup> Reveals Design Flaw

## Case #1- Serious Erosion in VDU Heater

### Introduction

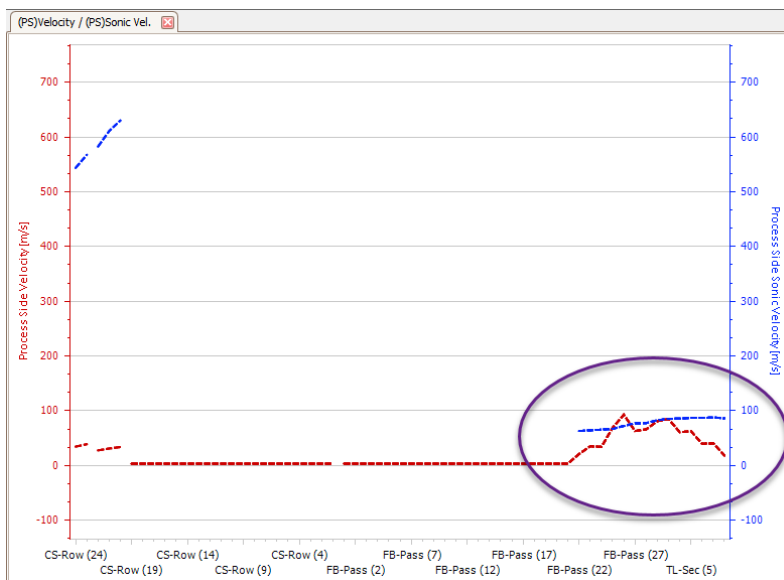
### Velocity / Sonic Velocity Curve:

- 12- In some local point of heater, the process side velocity has exceeded 80% of Sonic velocity. This can cause vibration due to shock waves in the heater, as well as erosion of the heater tubes or transfer line and fluid fogging / entrainment, which can upset fractionation in the vacuum tower (if any).**

**This explains the repeated erosion at the outlet header, a flaw hidden in conventional thermal analysis.**

Erosion wasn't due to poor operation, it was a design-level flaw:
