Case #1- Serious Erosion in VDU Heater

A VDU heater experienced repeated tube failures due to severe erosion near the outlet, despite normal tube wall temperatures and no operational alarms. Traditional analysis couldn't explain the root cause until we applied **Dr. Heater[©]**, the FHinfinity's built-in diagnostic tool.

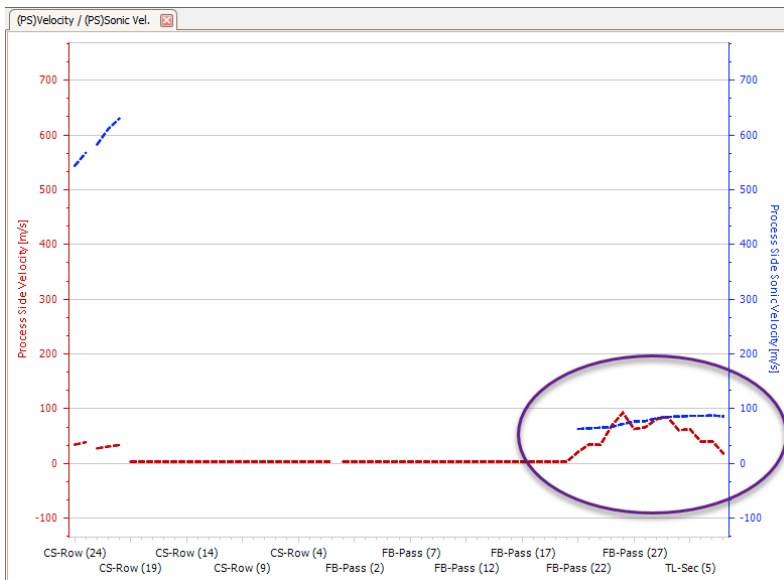
Velocity / Sonic Velocity Curve:

- 12- In some local point of heater, the process side velocity has exceeded 80% of Sonic velocity. This can cause vibration due to shock waves in the heater, as well as erosion of the heater tubes or transfer line and fluid fogging / entrainment, which can upset fractionation in the vacuum tower (if any).

This explains the repeated erosion at the outlet header, a flaw hidden in conventional thermal analysis.
