Infrared Thermographic Inspection Report

Service Provider: ConforX – Thermal Imaging & Insulation Solutions

Property Type: Residential apartment with terrace

Location: Valencia, Spain

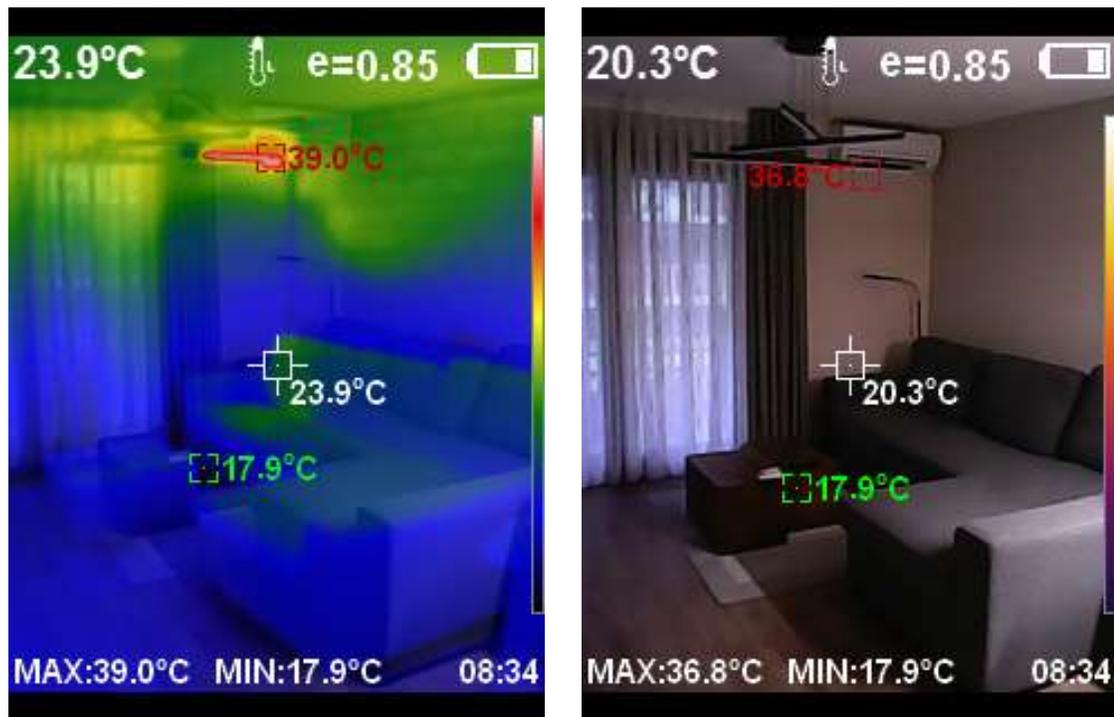
Living / Daily Room – Exterior Wall and Window

The paired images show a gradual temperature reduction toward the exterior wall and window area. This pattern is characteristic of conductive heat transfer through façade-adjacent elements and indicates the presence of thermal bridging at window reveals. Such behavior is common in residential buildings and may contribute to localized thermal discomfort and increased heating demand during colder periods.

The inspection identified moderate envelope-related heat transfer typical of residential construction. No immediate risks or defects requiring urgent intervention were observed. Improvements such as enhanced window sealing, targeted insulation upgrades, and routine monitoring may improve comfort and reduce energy consumption.

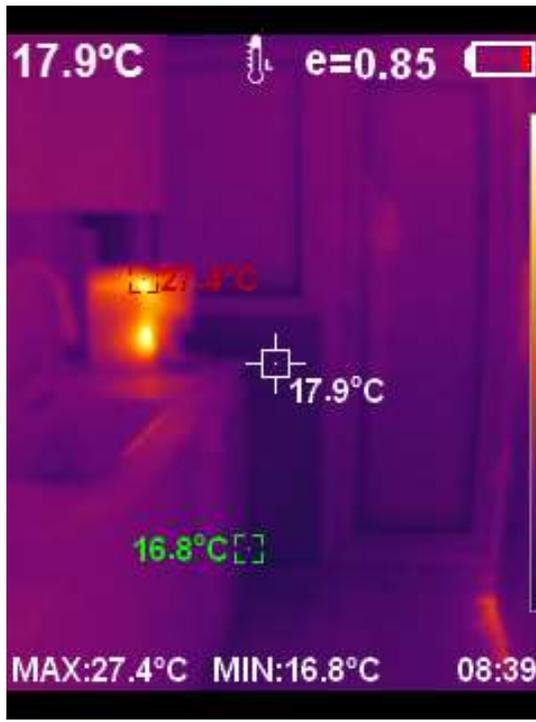
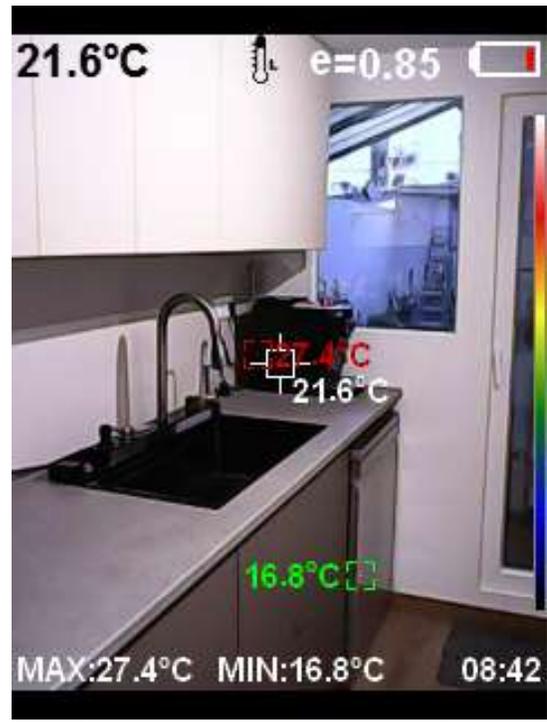
Kitchen – Worktop and Appliance Area

The thermographic image shows a localized high-temperature area corresponding to the coffee machine, which was operating at the time of inspection. This elevated temperature is a normal operational thermal signature and does not indicate any fault or abnormal condition. Surrounding surfaces display expected temperature distribution.

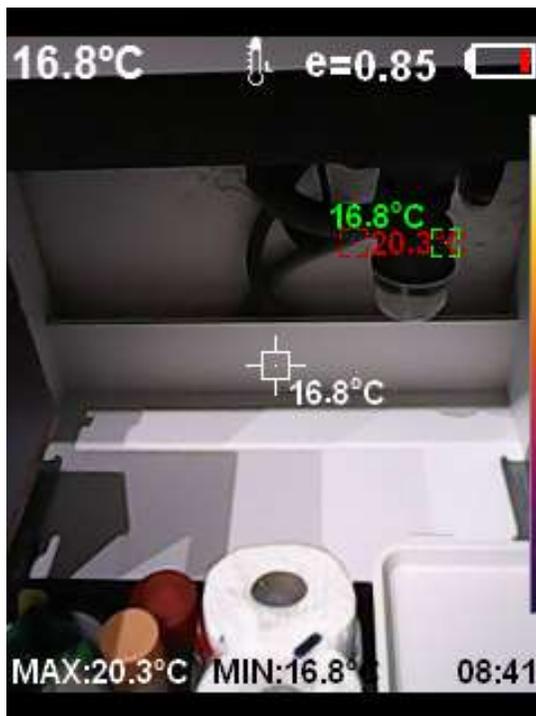
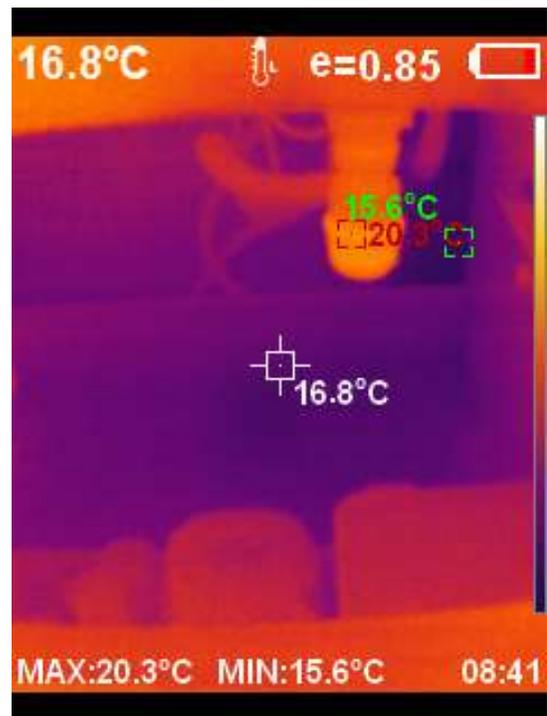
Kitchen – Under-Sink Cabinet

Under-sink thermographic images show surface temperatures slightly lower than adjacent cabinetry. This pattern is typical for plumbing voids due to air circulation and lack of insulation. No thermal patterns indicative of active water leakage were observed at the time of inspection.

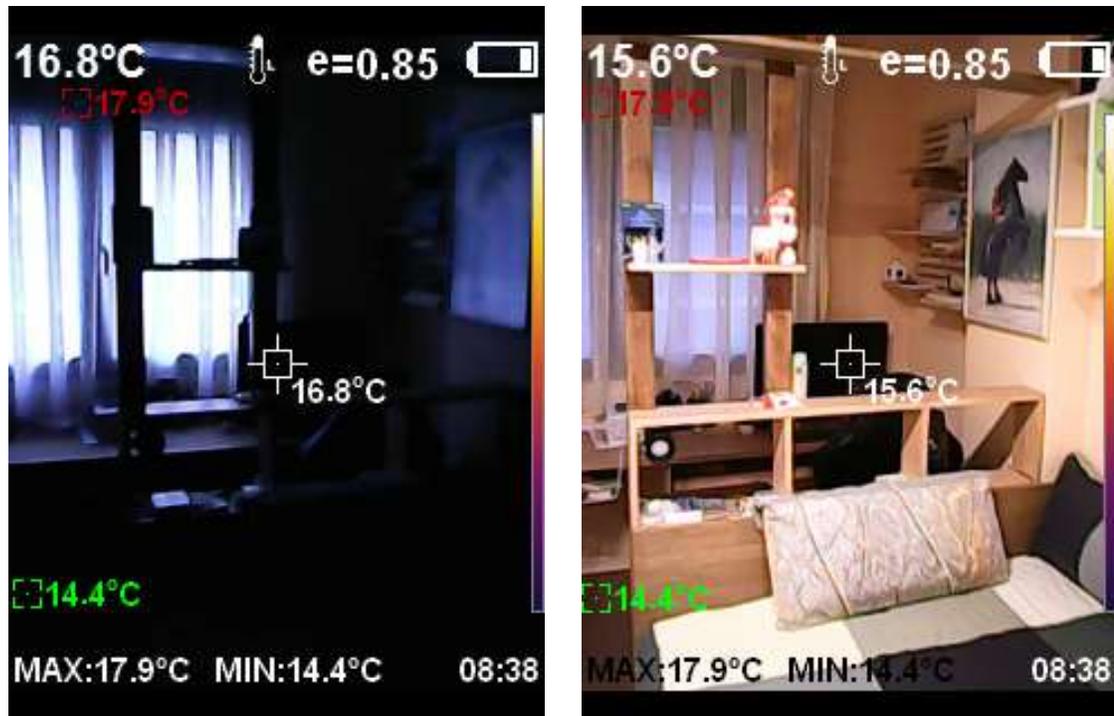
Kids Bedroom – Exterior-Facing Window

The paired images indicate reduced surface temperatures around the window frame and lower wall section. This is consistent with localized heat loss at façade junctions. While not abnormal, such conditions may affect comfort in rooms with prolonged occupancy.

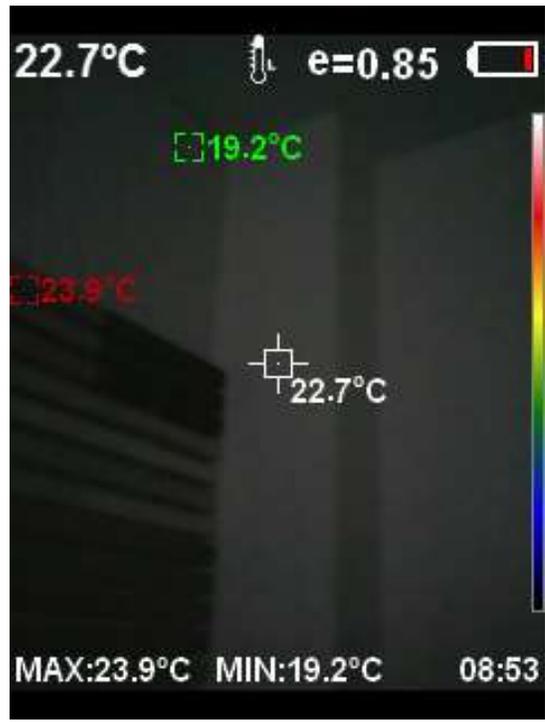
Parents' Bedroom – Exterior Wall

The temperature gradient visible toward the exterior wall reflects normal envelope heat transfer. No localized anomalies suggesting insulation failure or moisture intrusion were detected in this room.

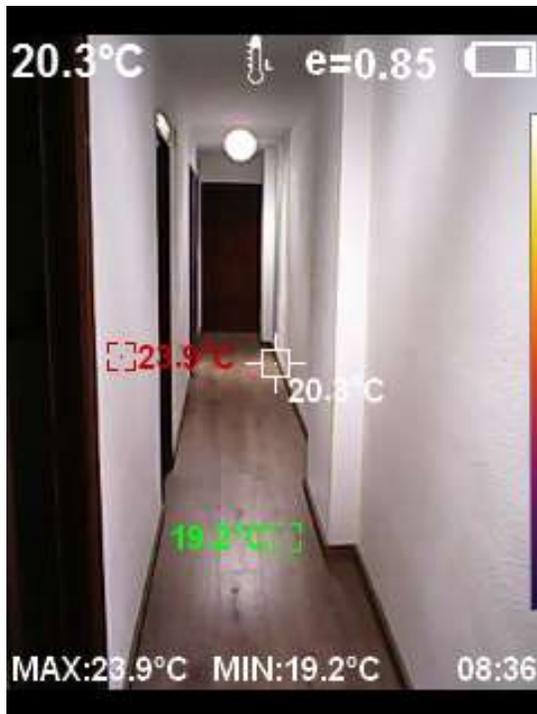
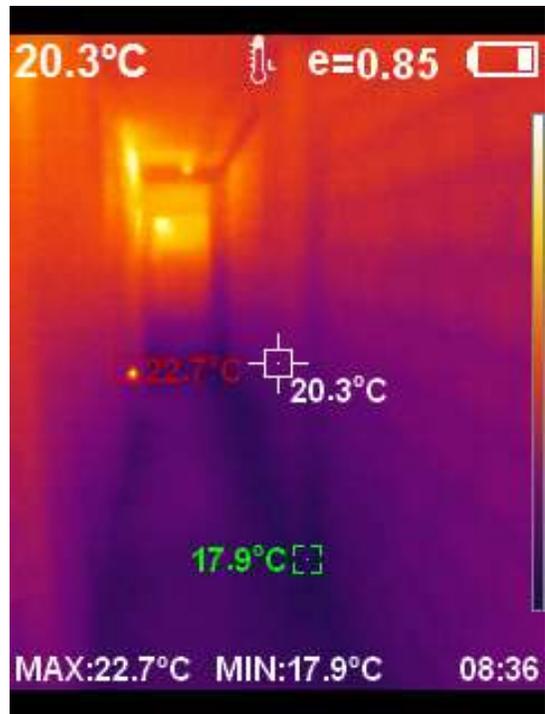
Hallway / Alleyway

Internal circulation areas show stable and uniform surface temperatures. As these spaces are largely surrounded by conditioned rooms, they do not represent significant heat-loss zones.

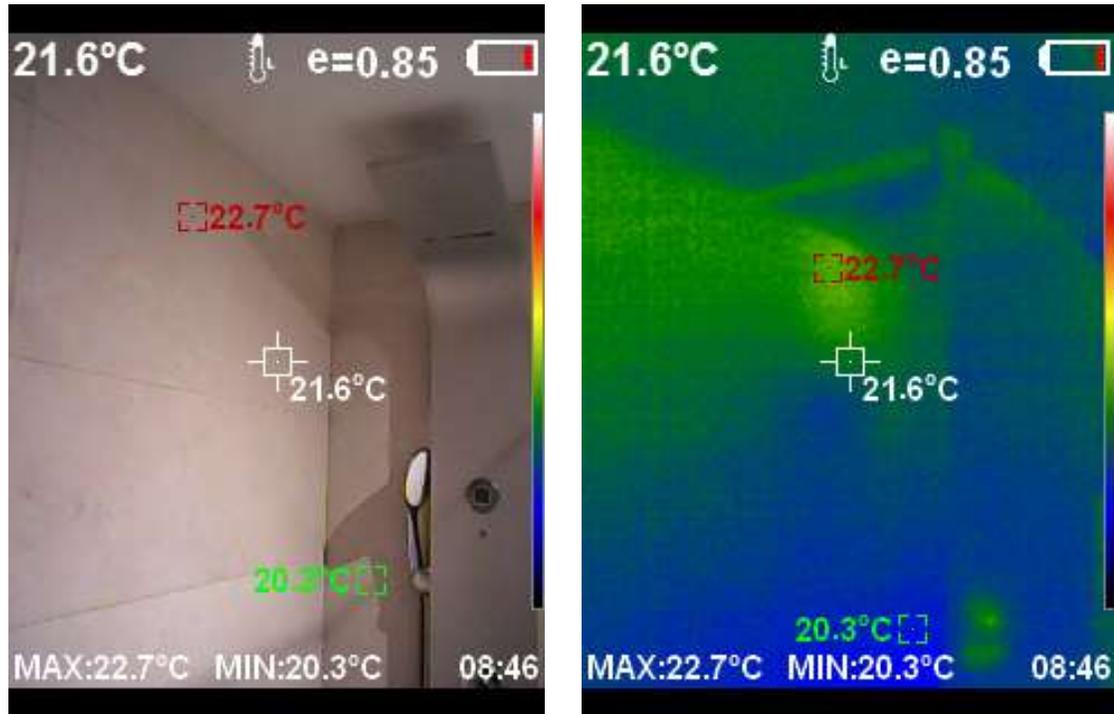
Bathroom walls and ceiling areas display uniform thermal distribution. No thermographic evidence of active moisture intrusion or abnormal heat loss was identified under the conditions present during inspection.

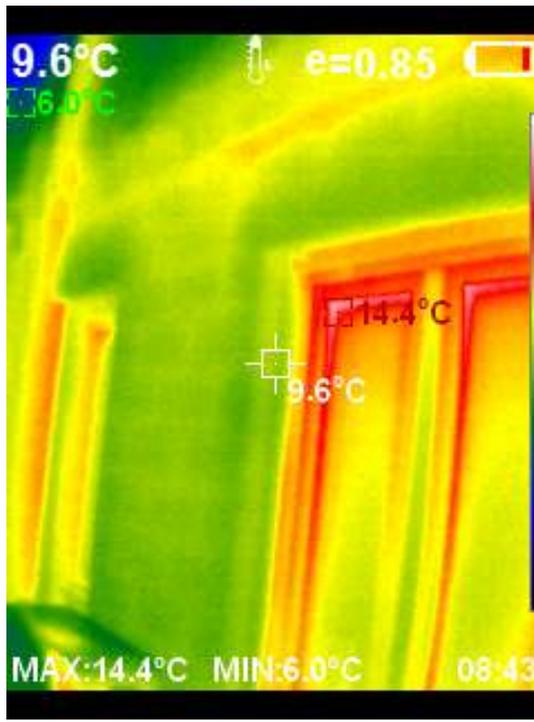
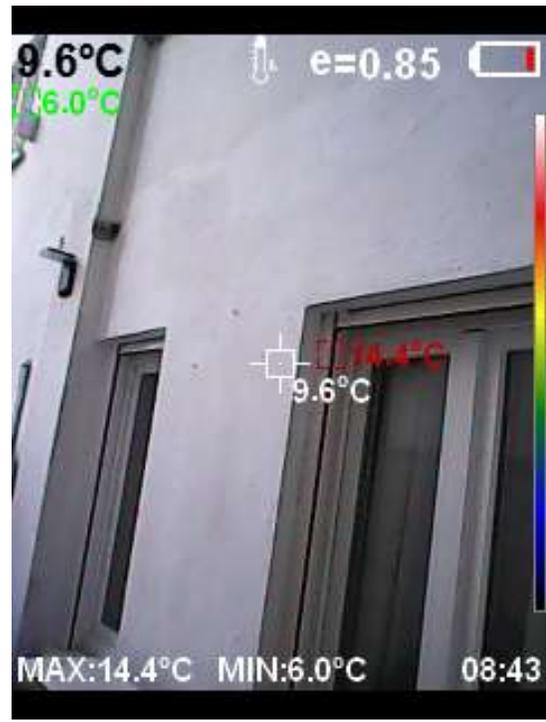
Terrace / Exterior Façade

Exterior thermographic images taken from the terrace provide the reference temperature for the inspection. They illustrate the temperature contrast between interior and exterior surfaces and highlight façade openings as the primary pathways for heat transfer.
