MYM CONSTRUCTION

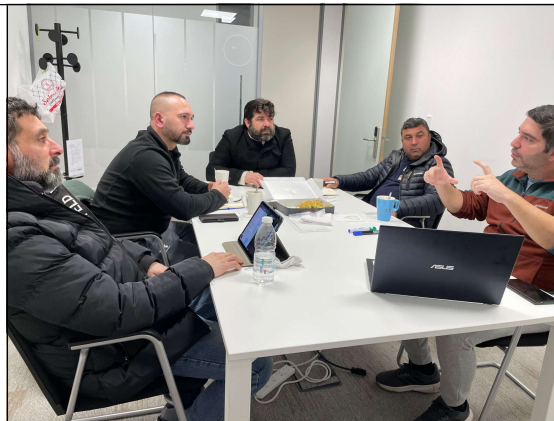
Category	Issue Identified	Regulatory Requirement	Action Plan	Supporting Document / Photo	
Health and Safety Violations	Failure to Plan, Manage, and Monitor Construction Work	CDM 2015 Regulation 13(1)	Develop a Construction Phase Plan and ensure proper supervision.	Our project is <u>less than</u> 500 man.day limit. We adapted CPP and CDM requirements to our Safety Management System. Please check our HSE folder list. We are working with a structural engineer and surveyor.	
	Work was carried out in an unplanned and inadequately supervised manner.	Principal contractor must plan, manage, and monitor construction work.	Assign competent site managers and conduct site inspections.	<p>Our Safety Management System is established and operational. As we reach full operational capacity, we will ensure the full implementation of all system requirements.</p> <p>We have engaged NEBOSH-certified and CSCS-certified professionals under an advisory contract. Before commencing any new type of work, we will seek their guidance, conduct site inspections, and implement the necessary safety measures accordingly.</p> <p>Our HSE training sessions have been successfully completed, and our site supervisor, Mr. Emrah, has gained practical knowledge of the Site Safety Management System. Training session photos are available for review</p>

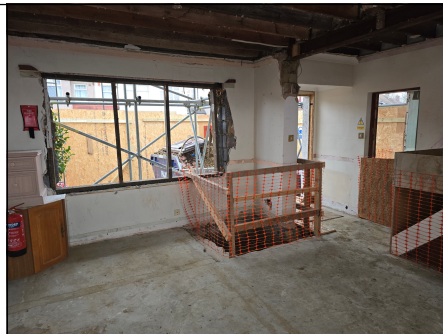
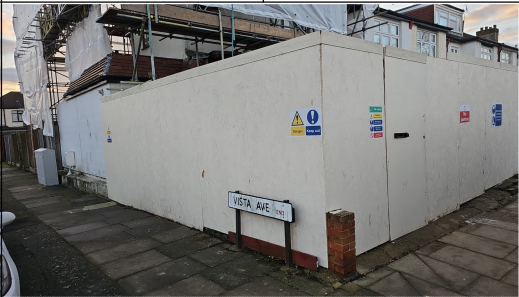
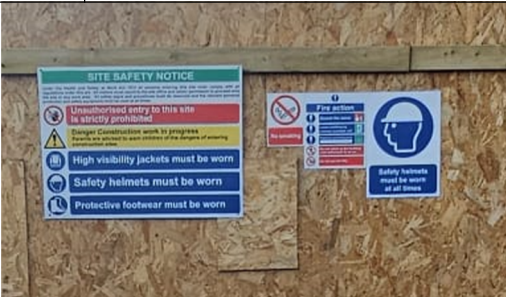
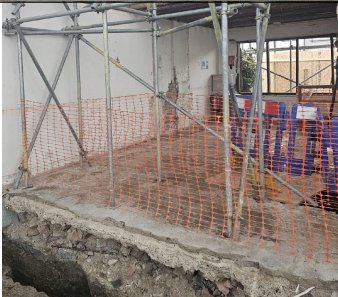
No written arrangements for managing construction activities.	Construction Phase Plan must be developed before resuming work.	Implement a written health and safety management system.	Please check our document lists, HSE folder list. We can upload our system documents if requested.	
	Health and safety precautions not implemented.	Plan must be implemented, reviewed and updated regularly.	Review and update safety plans regularly.	<p>Signs, barriers, fire extinguishers, first aid provisions, PPE, checklists, and required documentation have been placed on-site in accordance with safety regulations. Photos are available on the website.</p> <p>The site has been thoroughly cleaned, with most slip, trip, and fall hazards eliminated. All waste materials have been removed from the site.</p> <p>Please review the site photos for verification.</p>

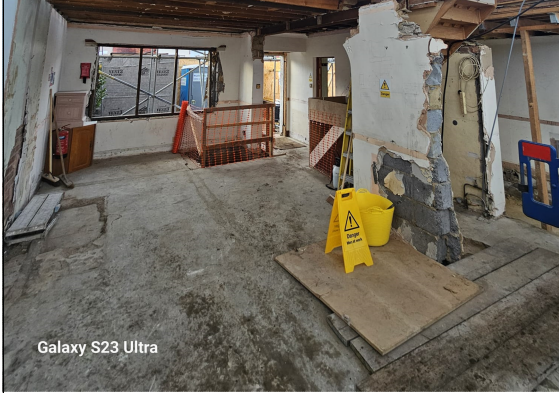
Work at Height Safety	Unprotected floor openings and edges posed fall risks.	Employers must prevent falls from height.	Install fall protection systems such as guardrails and safety nets.	<p>Our risk analysis covers this topic comprehensively. A method statement and toolbox talks have been prepared and implemented accordingly. All necessary PPE and related equipment have been procured. Training sessions have included this topic to ensure full awareness and compliance.</p> <p>We are working with an accredited scaffolding company, and if such work is required again, all equipment will be supplied and installed by them.</p> <p>Relevant documents are available in our document list. On-site, all risks related to this topic have been effectively mitigated.</p> <p>🚫 NO ACCESS TO UPPER FLOOR 🚫</p>

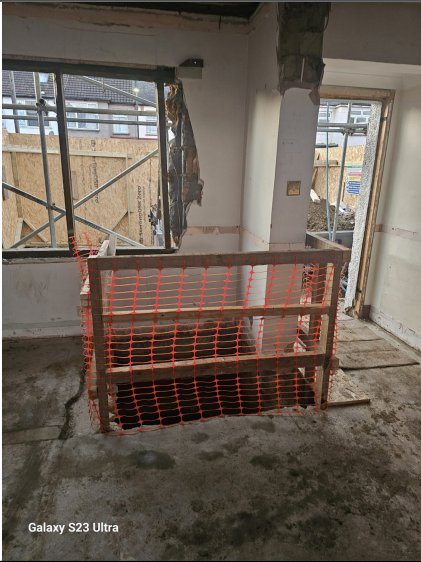
Excavation Safety	Excavation edges were unprotected, posing fall risks.	Install sufficient shoring and safety barriers around excavations.	Install shoring, trench boxes, or other protective systems.	<p>Our risk analysis and method statement documents are in place. Following our risk assessment, we first implemented protective measures by installing barriers and safety signs (as shown in the site photos).</p> <p>According to our previously shared action plan, we decided to eliminate this risk by filling all excavation trenches.</p> <p>All affected areas have been filled with concrete, as outlined in the method statement available in our document list. This work was completed by our subcontractor, ensuring no manual handling risks were introduced.</p>

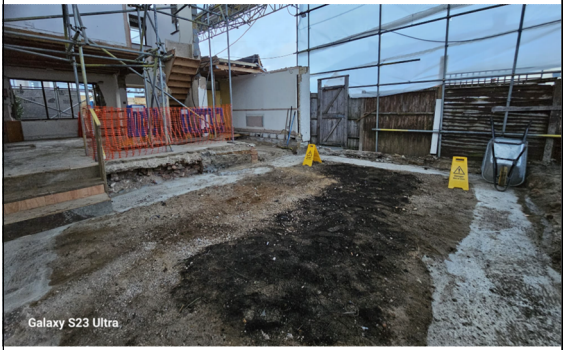
No shoring or support systems to prevent collapse.	Ensure proper excavation support systems are in place.	Ensure proper barriers and controlled access around excavations.	<p>This risk has now been fully mitigated on-site. Additionally, we have conducted a risk analysis, developed method statements, and implemented toolbox talks specific to this task.</p> <p>Please review the site photos and document list for further details.</p>

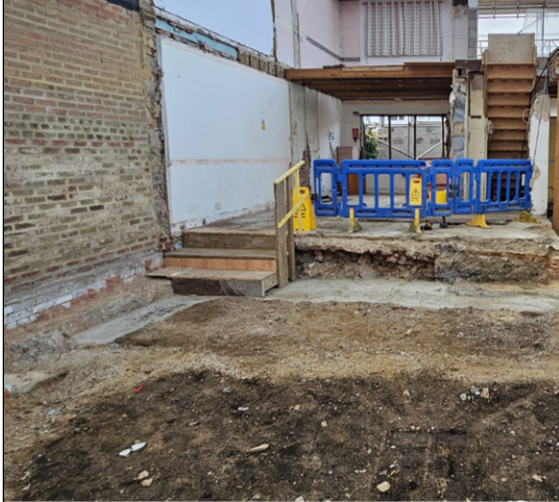
Scaffolding Safety	<p>Scaffolding erected by unqualified personnel.</p>	<p>Scaffolding must be installed and inspected by competent personnel.</p>	<p>Only allow qualified personnel to erect and inspect scaffolding.</p>	<p>We are working with accredited scaffolding companies, ensuring compliance through our subcontractor vetting questionnaire system, which allows us to engage only with competent providers. Their details have already been shared with you.</p> <p>The scaffolding on-site was erected to support wooden structures as per Mr. Murat's request. This scaffolding has now been dismantled and removed by our scaffolding company.</p> <p>Other structures installed by the company have been properly signed, tagged, and are subject to regular inspections conducted by them.</p> <p>Evidence of this can be found in the site photos available on our website.</p> <p>❗ NO ACCESS TO UPPER FLOOR NOW ❗ ❗ SCAFFOLDING REMOVED ❗</p>

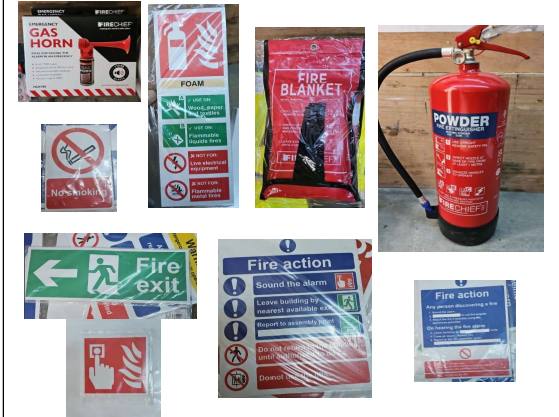
Fire Safety	<p>Burning waste materials on-site posed fire hazards.</p>	<p>All waste disposal must follow fire safety guidelines.</p>	<p>Ensure proper waste disposal procedures and prohibit burning on-site.</p>	<p>Site rules implemented, signs are placed and especially our training includes this topic.</p> <p>This kind of work banned at the site.</p> <p>fire extinguisher, exit signs, warning signs, site rule signs and toolbox talks placed at the site.</p> <p>Fire training is planned on the following month.</p> <p>Please check photos, signs and document list.</p>

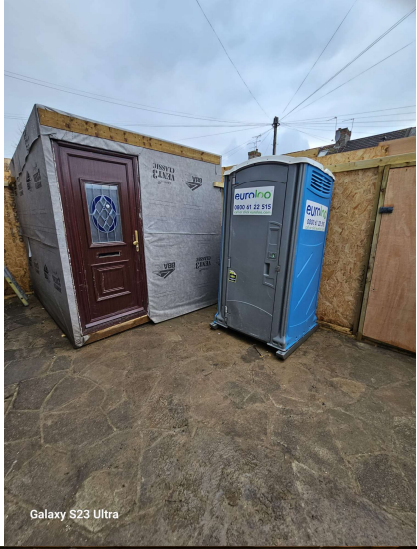
<p>Welfare Facilities</p>	<p>No sanitary conveniences, washing, or rest areas.</p>	<p>Ensure adequate welfare facilities from the start of the project.</p>	<p>Provide adequate sanitary, washing, and rest facilities for workers.</p>	<p>Welfare facility located at the site.</p> <p>Checklist has been put into practice.</p> <p>Toilet is located.</p> <p>Method statements for working in cold temperatures have been put into practice to mitigate associated risks.</p> <p>Contract has been done with a local catering company.</p> <p>Sanitary are with soap, towels etc. is placed.</p> <p>You can find evidence on photos, invoice photos and document list</p>

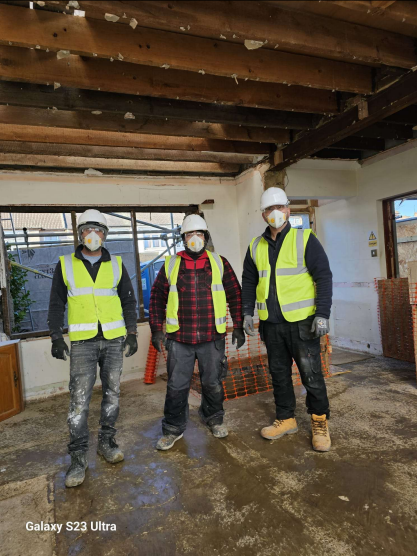
<p>Galaxy S23 Ultra</p>
<p>Personal Protective Equipment (PPE)</p>	<p>Workers were not provided with required PPE.</p>	<p>Employers must provide necessary PPE free of charge.</p>	<p>Ensure workers are equipped with necessary PPE at no cost.</p>	<p>The Risk Analysis outlines the required PPE for the site, and method statements specify the necessary PPE for each task.</p> <p>All required PPE has been procured, distributed to employees, and placed on-site.</p> <p>During HSE training, proper PPE usage was instructed, and toolbox talks have covered PPE-related topics.</p> <p>Please review the site photos, invoice photos, and images of employees using PPE.</p> <p>Our HSE system includes relevant toolbox talks and procedural documents.</p> <p>All PPE invoices and photos can be accessed via our website</p>

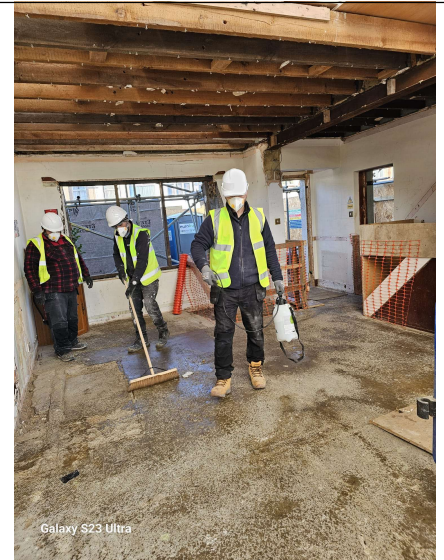
Construction Dust Control	Workers exposed to hazardous Respirable Crystalline Silica (RCS).	Employers must control or prevent exposure to hazardous dust.	Implement dust suppression systems and provide respiratory PPE.	<p>The Risk Analysis outlines the required PPE for the site, and method statements specify the necessary PPE for each task.</p> <p>All required PPE has been procured, distributed to employees, and placed on-site.</p> <p>During HSE training, proper PPE usage was instructed, and toolbox talks have covered this topic.</p> <p>Water spray equipment has been installed on-site to minimize dust exposure.</p> <p>All necessary precautions have been taken to reduce dust exposure, including the removal of most soil and debris from the site.</p> <p>Please review the site photos for verification.</p>
