## RESIDENTIAL PROPERTY INSPECTION

1234 Main Street  
Edwardsville, IL 620\*\*

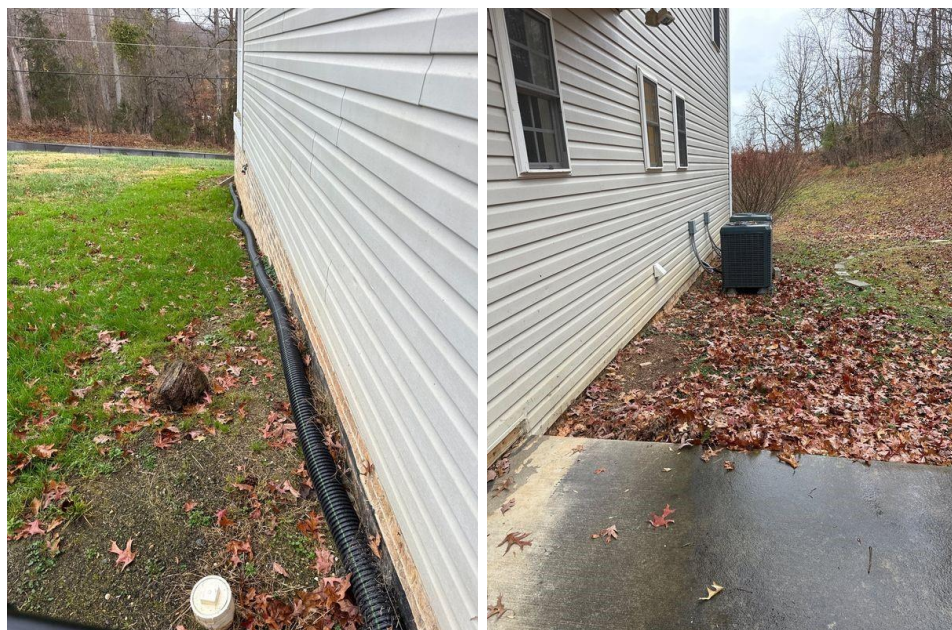
### 3.2.1 Grading/Lot Drainage

## GRADING - NOT DESIGNED TO MANAGE RAINWATER

Recommendation

Contact a Qualified grading contractor.

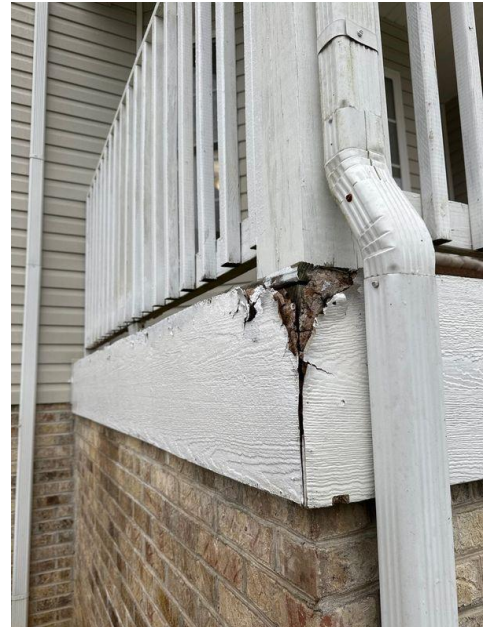
3.4.1 Decks

Marginal Defect

Recommendation

Contact a qualified deck contractor.

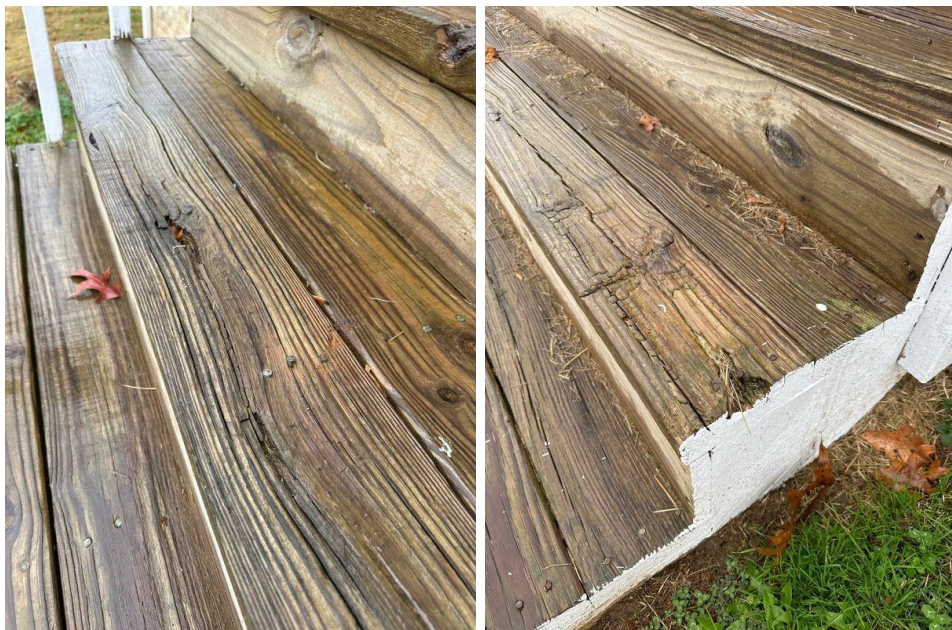
## 3.5.4 Stairs &amp; Steps

**WOOD - WATER DAMAGE**

Recommendation

Contact a Qualified professional.

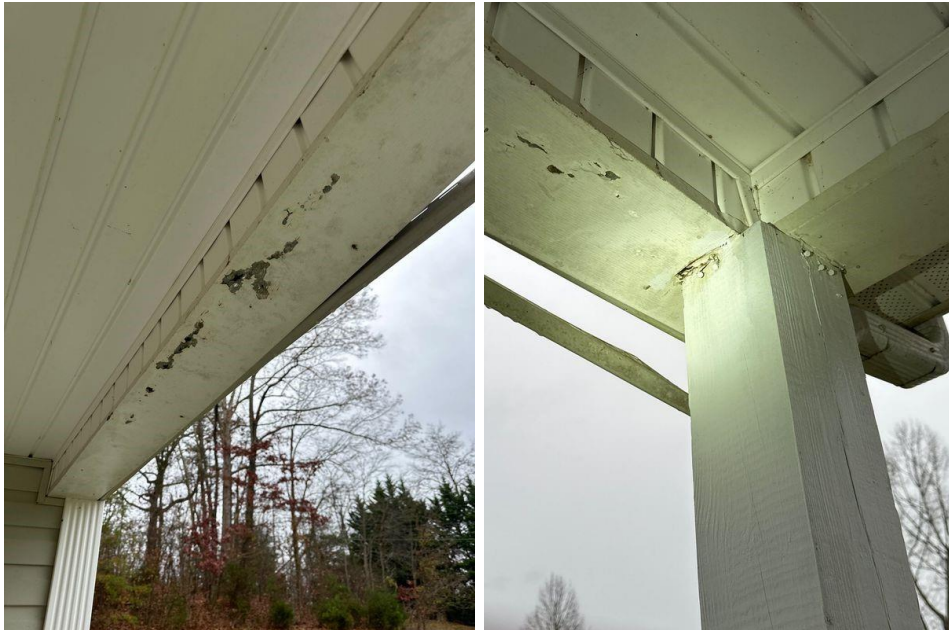
### 3.7.1 Porch/Deck Roof Condition

#### ROOF FRAMING - DAMAGE

Marginal Defect

Contact a Qualified professional.

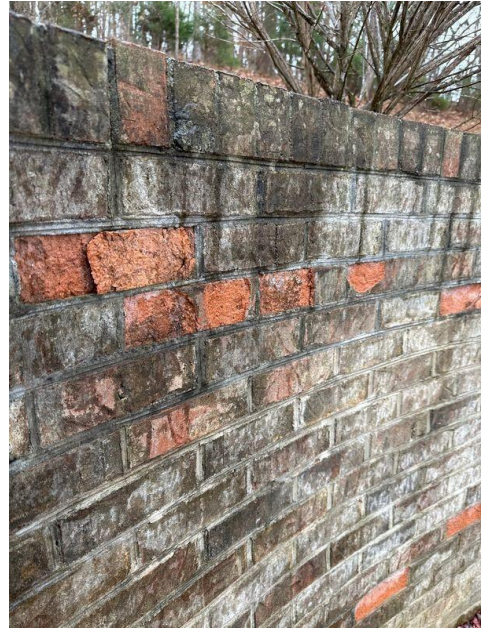
3.10.1 Retaining Wall

WALL - COPING OR CAP FLASHING MISSING

Recommendation

Contact a Qualified masonry professional.

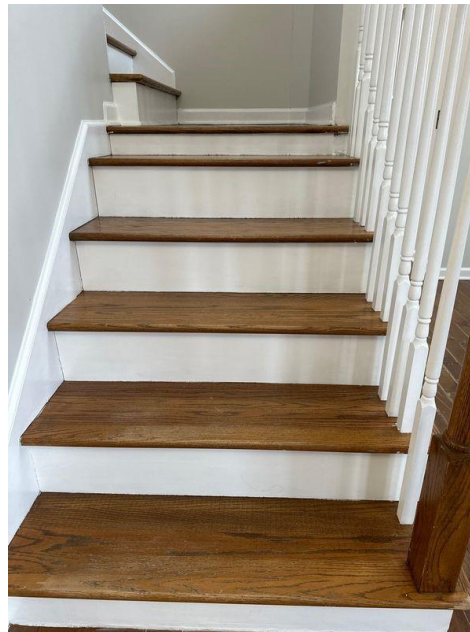
### 8.6.1 Stairs, Handrails, & Guardrails

## STAIRS - RISER, TREAD, AND/OR NOSING DESIGN DEFICIENCIES

Recommendation

Contact a Qualified professional.

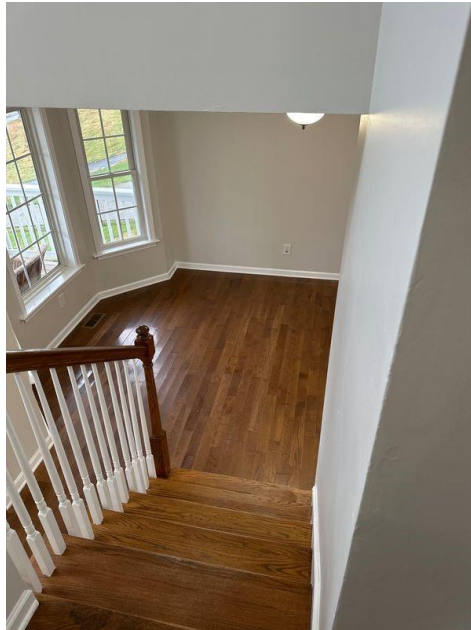
## 8.6.2 Stairs, Handrails, & Guardrails

### STAIRS - INADEQUATE HEIGHT CLEARANCE

Marginal Defect

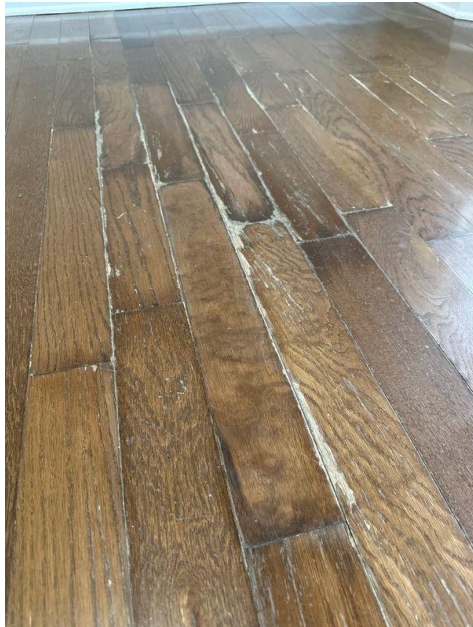
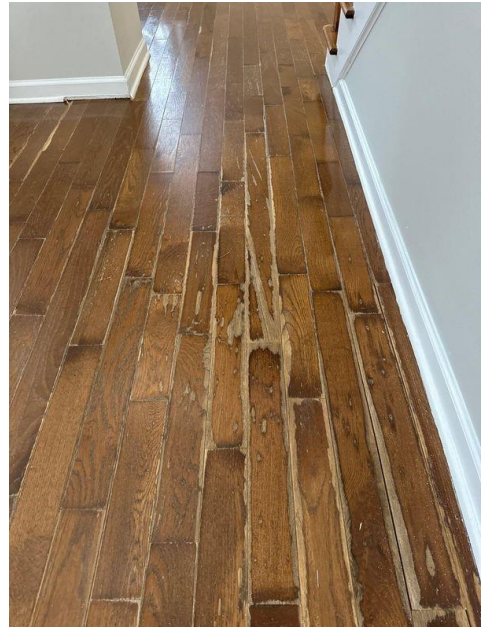
8.8.1 Floor Condition

**HARDWOOD - DAMAGE**

Recommendation

Contact a Qualified flooring contractor

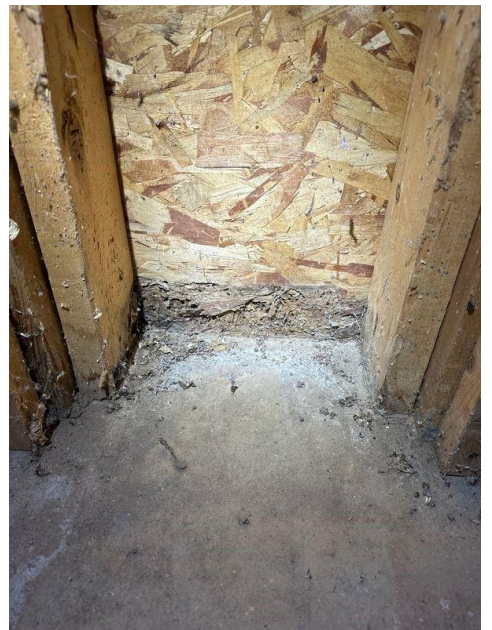
#### 15.4.3 Framing/Floor Structure

##### WALL FRAMING - DAMAGE

Recommendation

Contact a qualified professional.

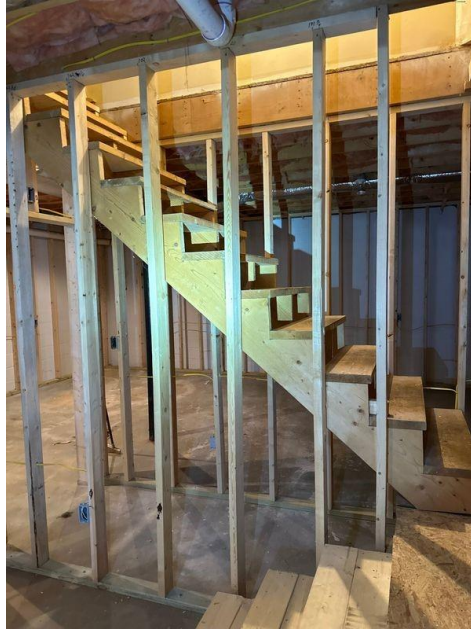
#### 15.9.1 Stairs

##### STAIR RAILING - MISSING

➔ Marginal Defect

Contact a Qualified professional.

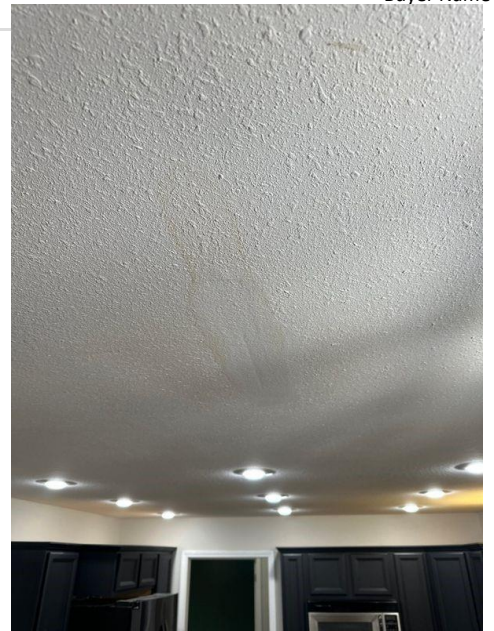
## 16.3.1 Interior Areas - WMC

## CEILING - MOISTURE STAINING

## Recommendation

Contact a Qualified plumbing contractor.

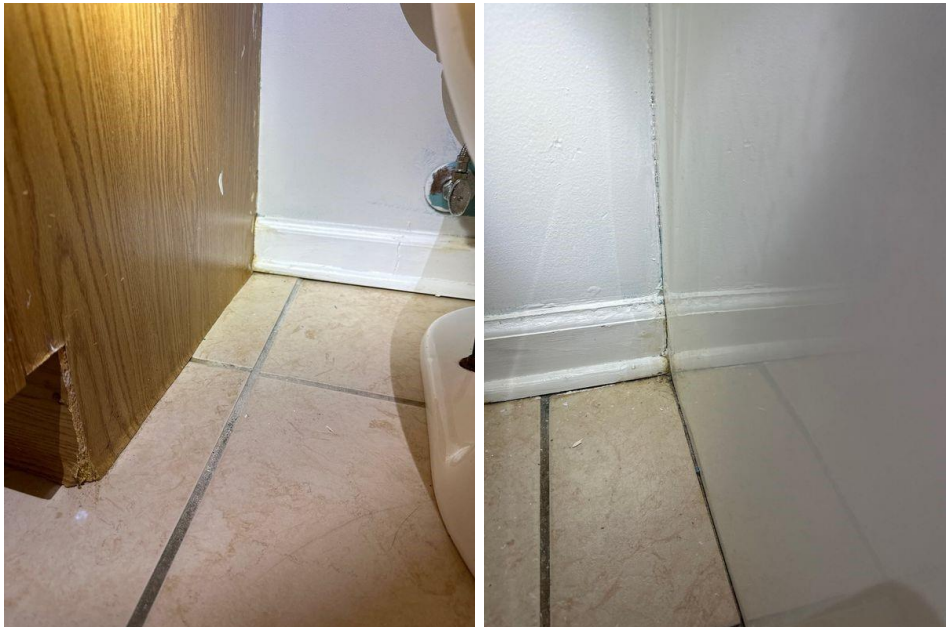
## 16.3.2 Interior Areas - WMC

## BATHROOM - INDICATIONS OF PAST WATER

## Recommendation

Contact the seller for more info
