Preventing Genset Failure: Power Quality Analysis for a Rural Site

The Challenge: Additional Capacity on a Generator

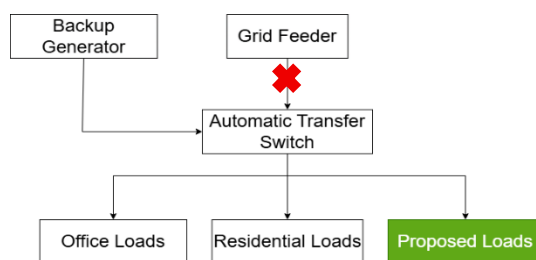
A Power Quality logger (**marked in red**) was installed at the incomer to capture a full load profile over a fortnight.

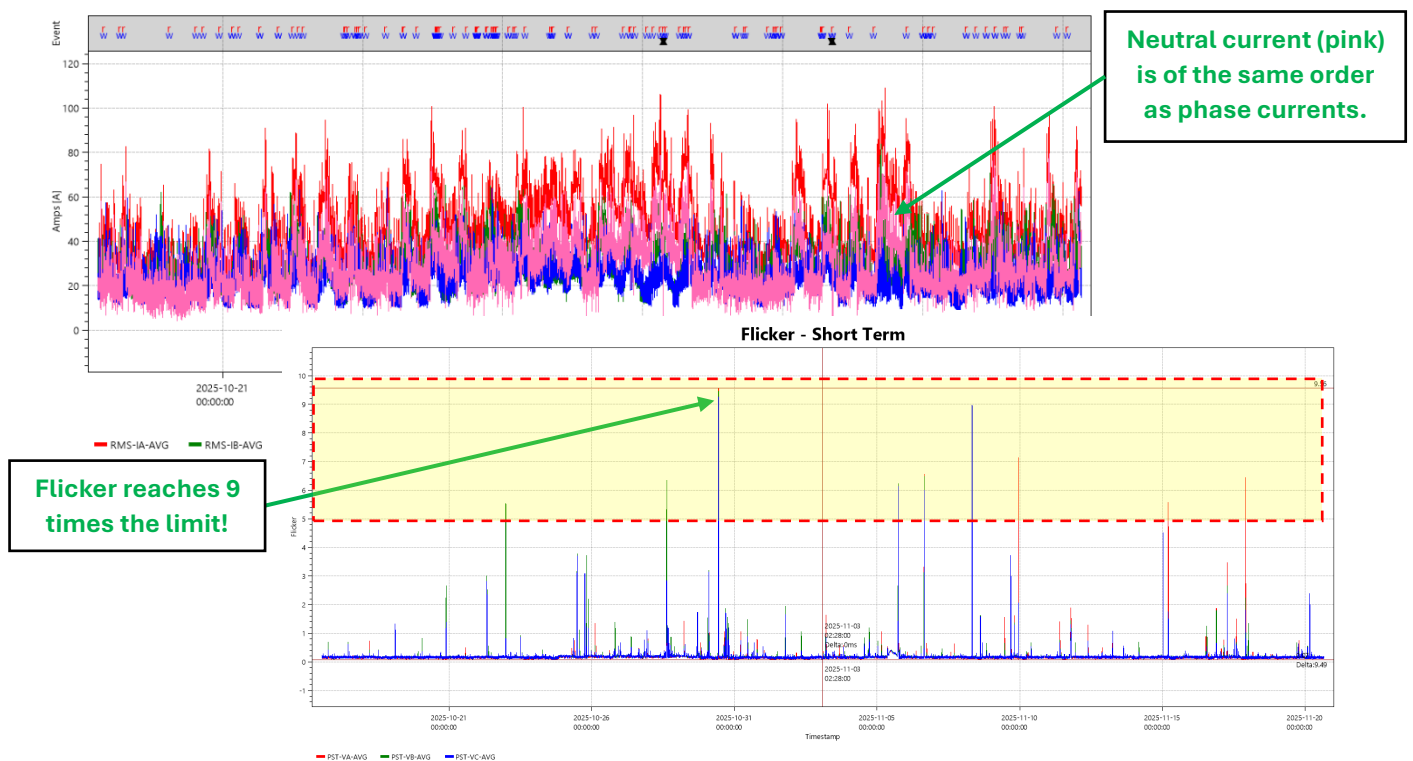
- **High Flicker:** The audit led to the discovery of high voltage flicker ($P_{st} = 9.56$, $P_{lt} = 4.18$) on phase A. It is anticipated Flicker will be higher when the loads are supplied by the generator. High Flicker can lead to stress on electronics, shortening device life and increasing periodic maintenance.
- **High Neutral Current:** There was significant unbalance in the phase currents. This caused a high neutral current (up to 79.3%) compared to phase currents. A high neutral current can cause overheating of cables.
- **Capacity Left on LV Genset:** The remaining capacity of the generator summed to 24A which is less than 10% of the original rated current of the generator.

- Redistributing loads across phases to reduce the neutral current and unbalance.
- Spot logging downstream loads on grid supply to determine the equipment causing high Flicker.
- Only 10% spare capacity on the LV diesel genset identified.
