Residential Solutions
7062545330

Home Inspection Report

Inspected By: Christopher Cooke
Inspected On Sat, Feb 7, 2026 at 9:00 AM

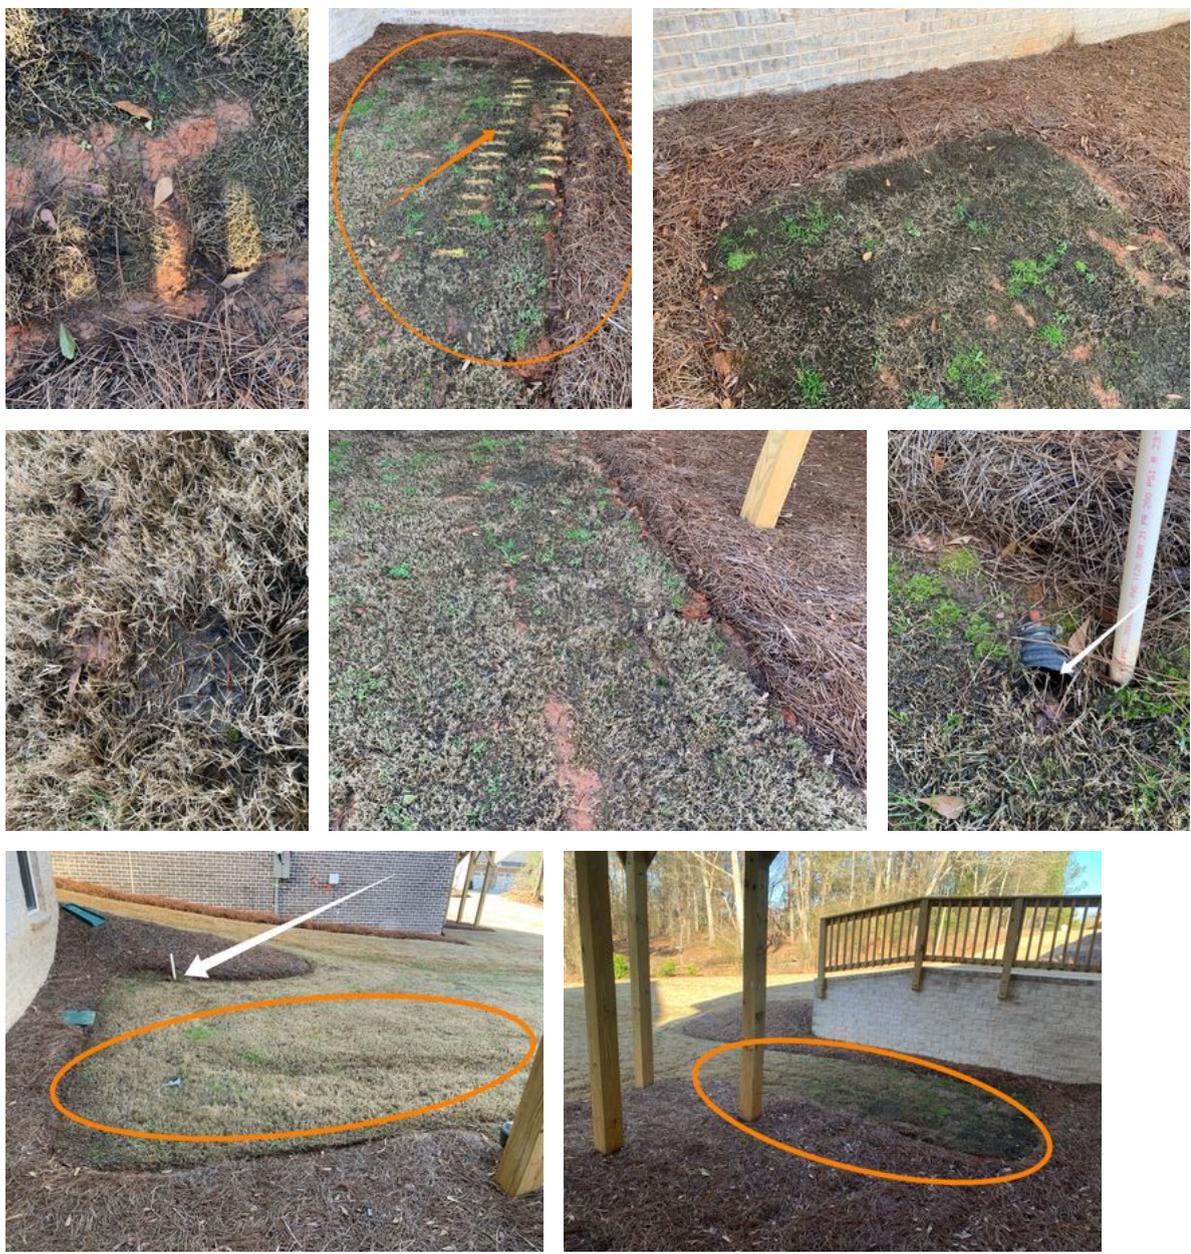
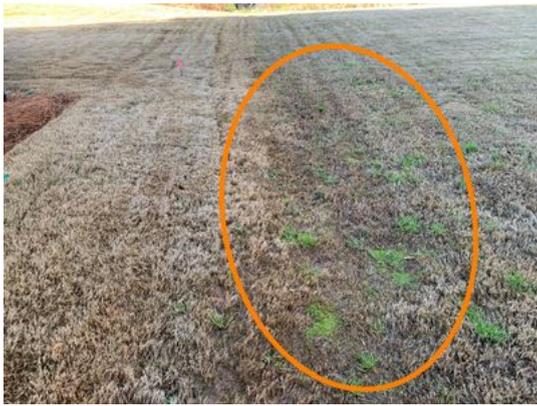
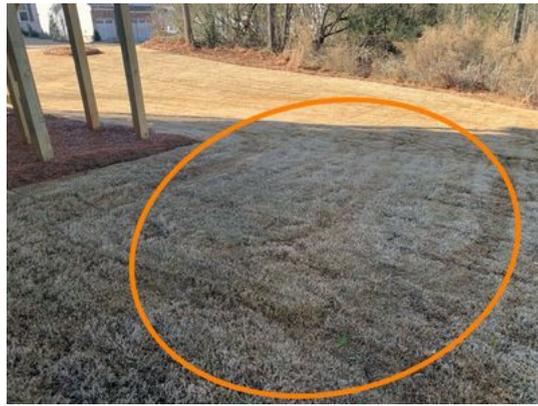
Comment 1

The back section of the grounds was very wet, especially comparison to the grounds of the neighboring yards. Would recommend having the builder assess.

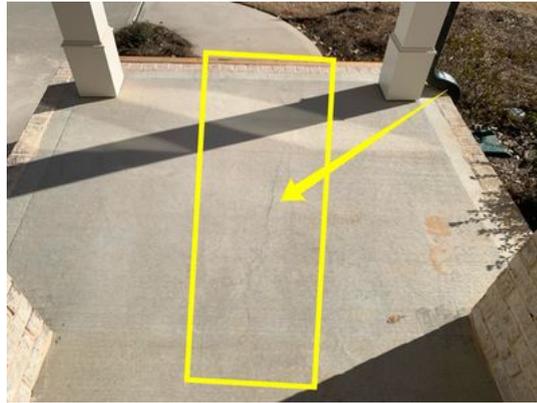
Comment 2

There is some cracking in the front porch slab. At the time of the inspection there was minimal horizontal or vertical displacement. These kind of cracks are not uncommon just from the curing process of the concrete overtime. I would still monitor to see if there's any growth in the crack overtime. Most settling in curing cracks become apparent within the first 5 to 10 years of the life of a structure.

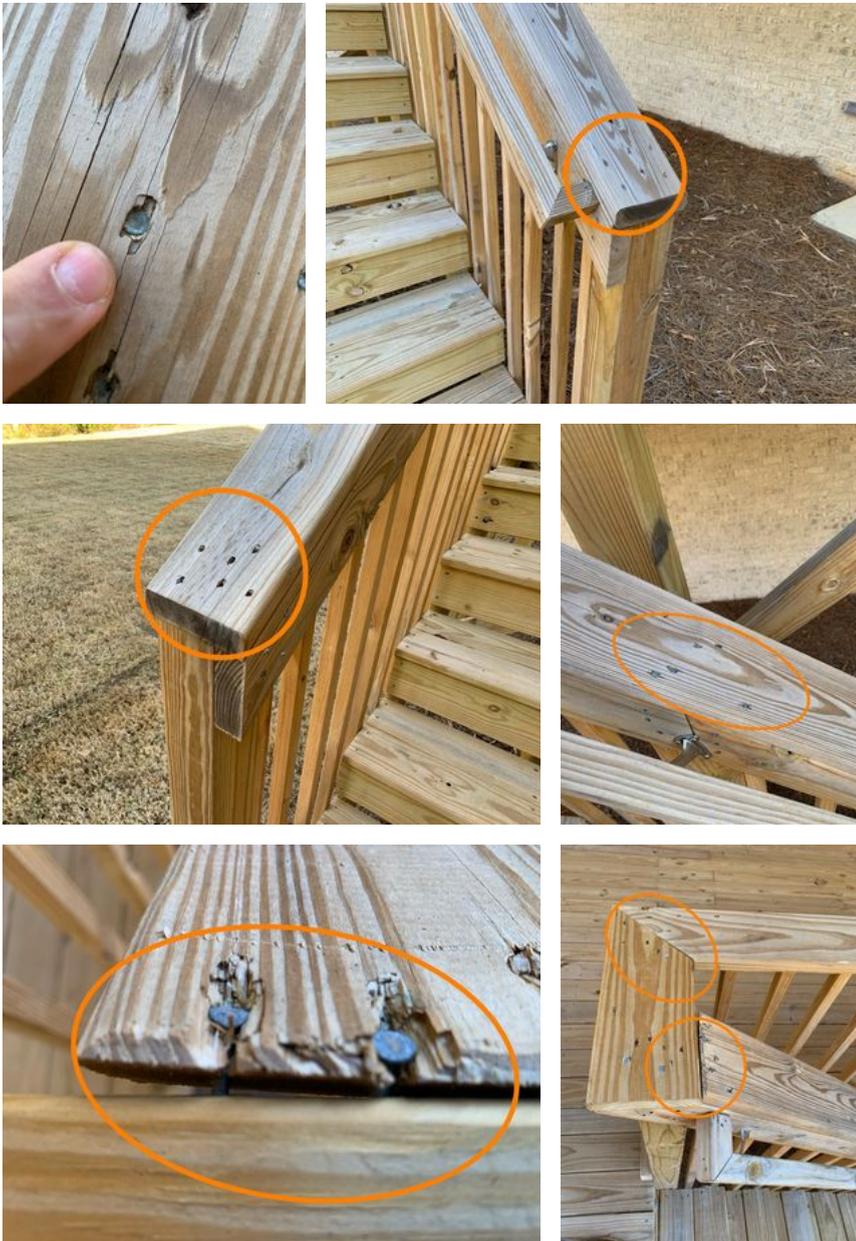
Comment 4

There are a lot of nail holes along the railing. This is just simply poor craftsmanship. These areas can easily cause splinters, but also will catch water and cause rot a lot quicker than any other area.

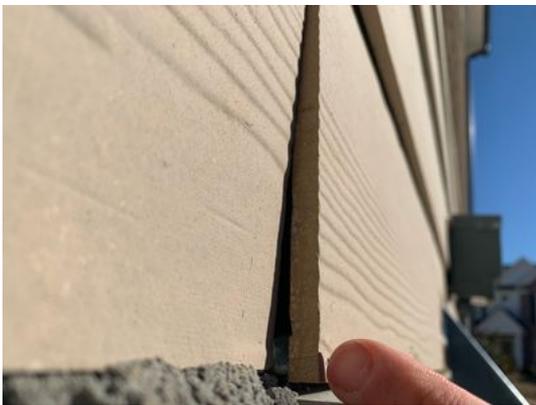
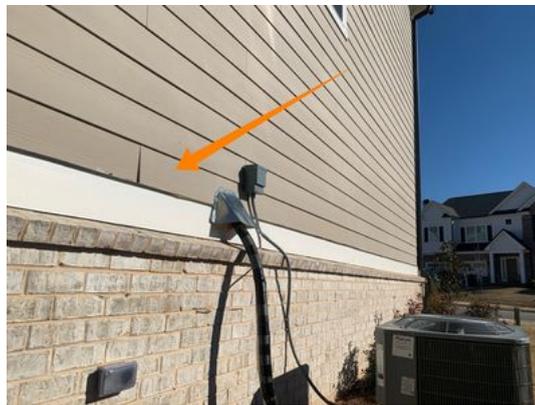
Comment 6

There were a couple places where the hardy type plank was either not properly secured or not sitting flat.

I was not able to get a depiction of the separation of the siding along the back right corner of the structure. The last picture was the most clear depiction I was able to capture at the time of the inspection.

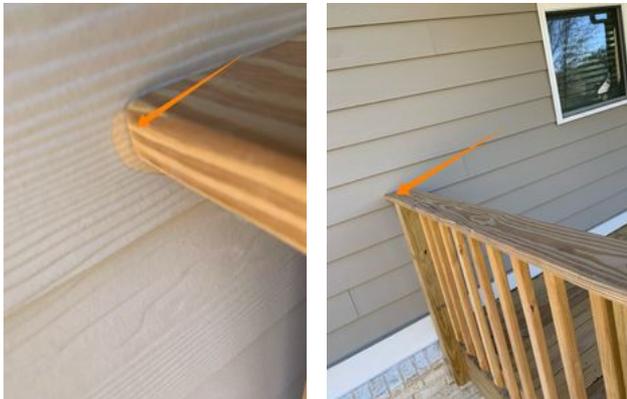
Comment 7

There's a small area of siding that is missing paint around the railing.

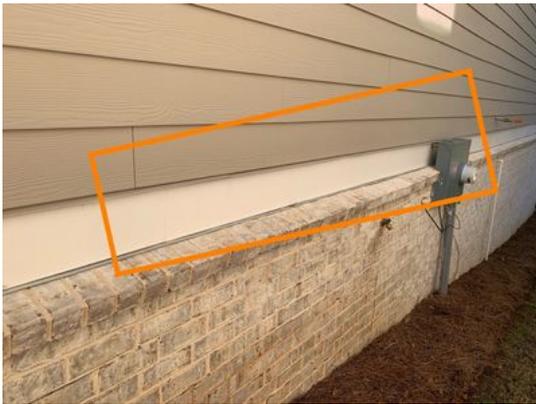
Comment 9

The indicated drip edge is not properly secured.

The indicated trim work along the back porch needs to be properly caulked and repainted.

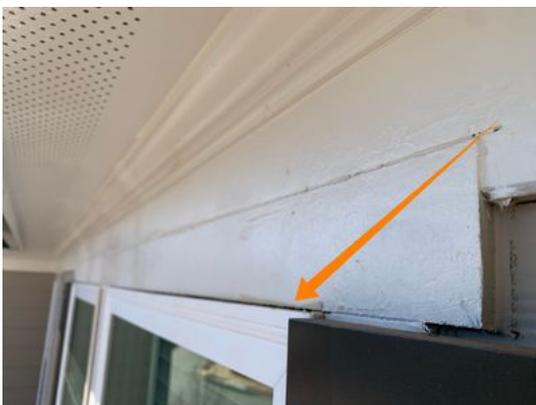
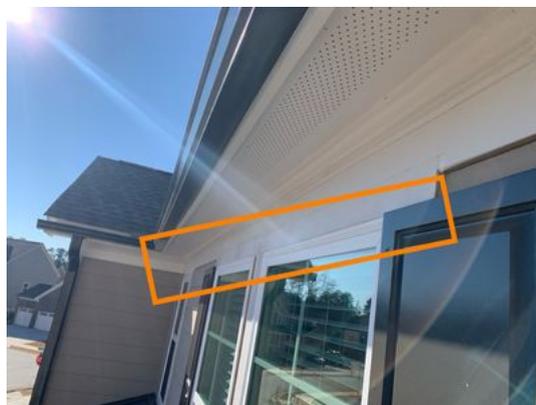
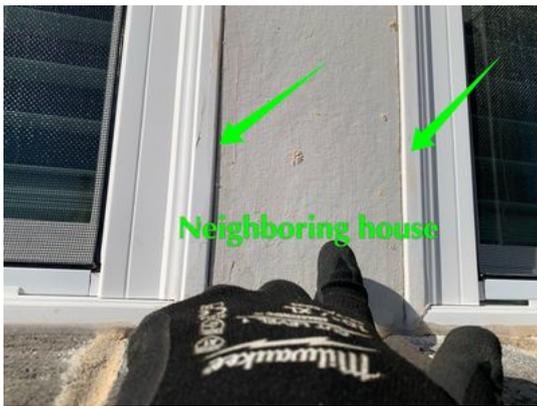
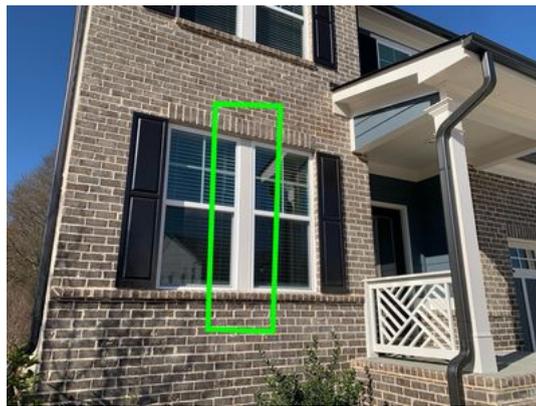
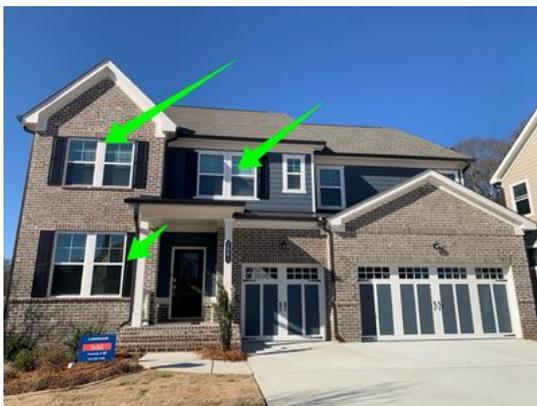
Comment 10

There are consistent gaps around the trim work around ALL of the windows. This can lead to water getting back in behind the trim and damaging the sheathing and even eventually the stud structure and even avoiding the cement board plank warranty.

Neighboring homes have these areas properly attended to.

These pictures are for reference to the areas and types of repairs that may be needed. They are not exhaustive. It was pretty much every exterior window trim that needed to be addressed. Would recommend having the contractor sweep the entire exterior.

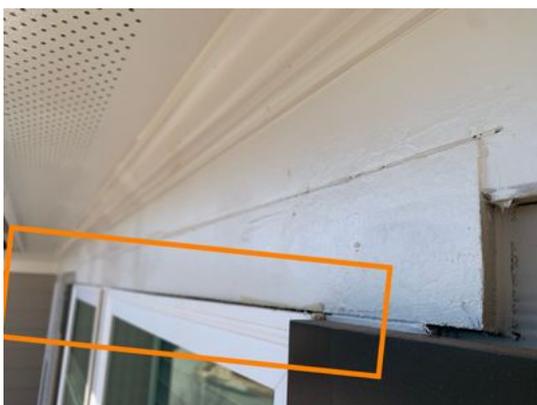
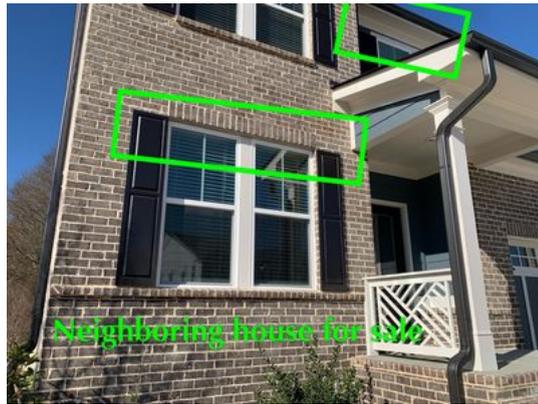
Comment 11

The drip cap or drip edge is missing above the indicated windows. Not only is this an industry standard for new builds, but all other houses in the area built by the same builder have these specific windows, those along the front upstairs area, with drip edge installed along the top of the window.

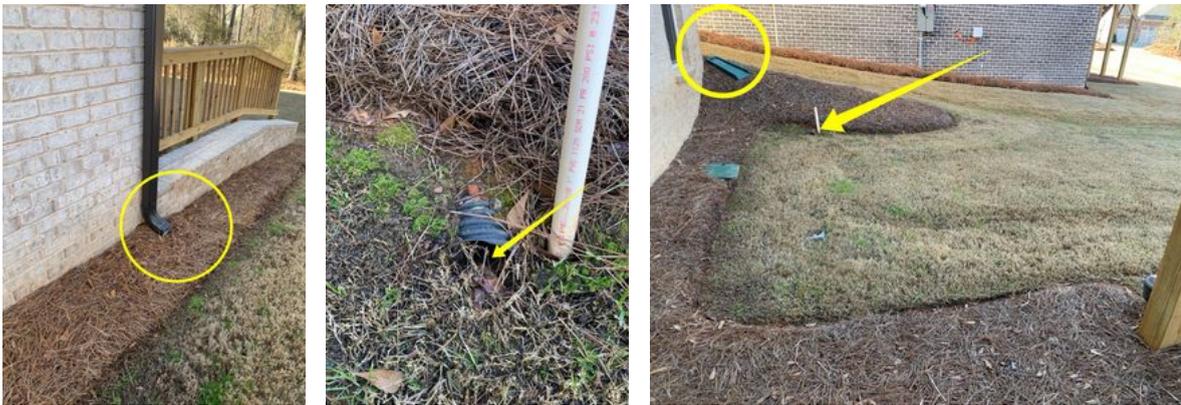
Comment 13

The backyard was very moist and even muddy and many locations. There was no other yards in the area that were even remotely close to as saturated as this area was. There was a landscaping drain line in the indicated location, and the gutters to the left or right of the back of the structure may be adding to the moisture issues. Extending these away from the problem areas may help with the grounds being able to shed moisture more consistently.

The moisture in the grounds may be exacerbated by the sloping around the structure, but there also MAY be a small leak in the irrigation system as noted in the plumbing section.

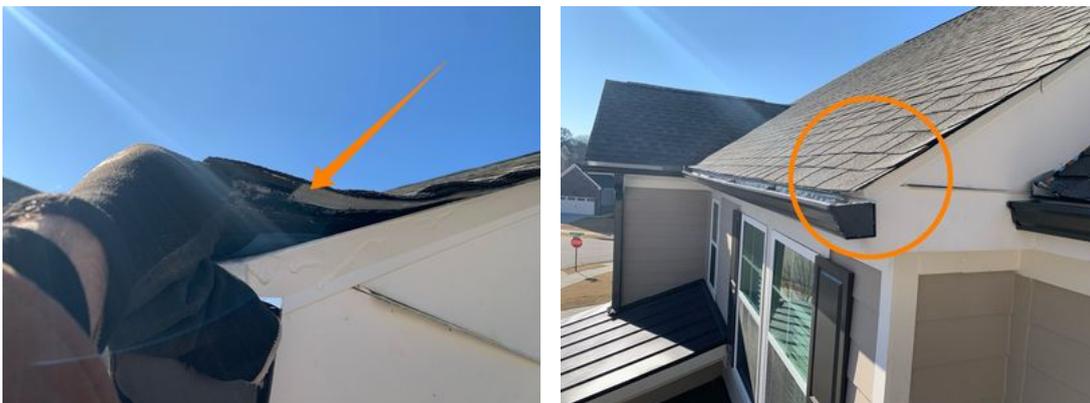
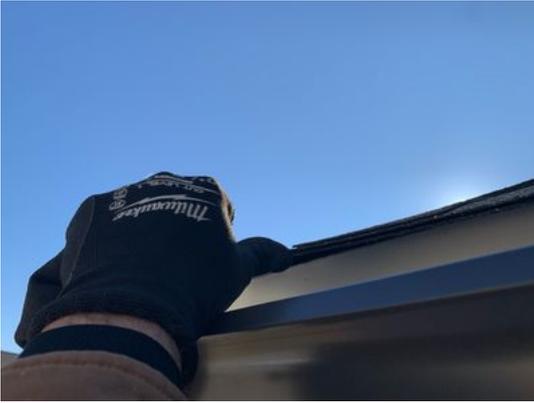
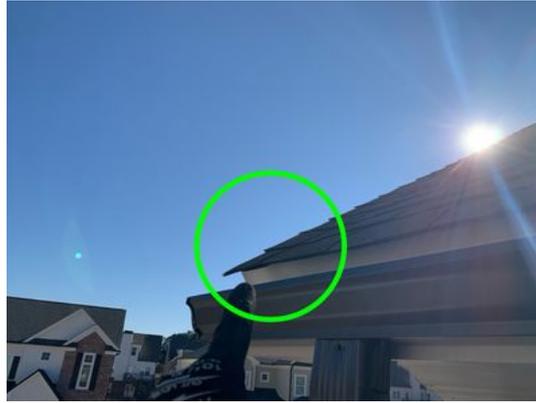
Comment 14

The indicated corner of the roof has shingles that are not properly secured to the decking. The last set of pictures indicates how shingles should be properly adhered so that wind does not come along and damage them.

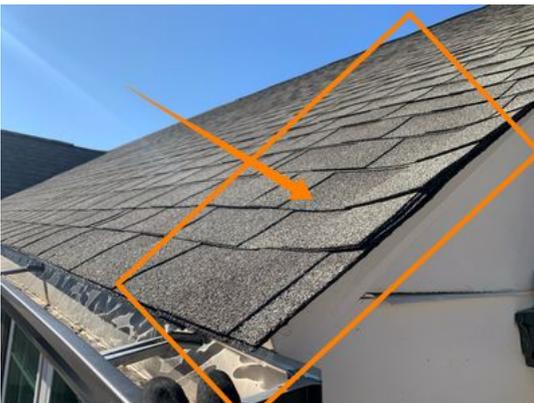
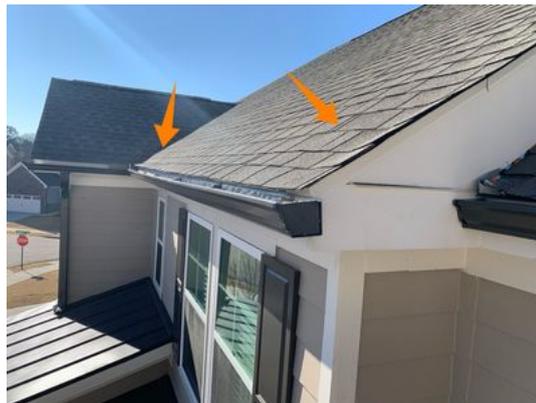
Comment 15

There are two areas where there is some improper sloping and dipping in the roof line. These areas will wear out quicker than the rest of the shingles. Would recommend having the roofer come out and assess for repairs.

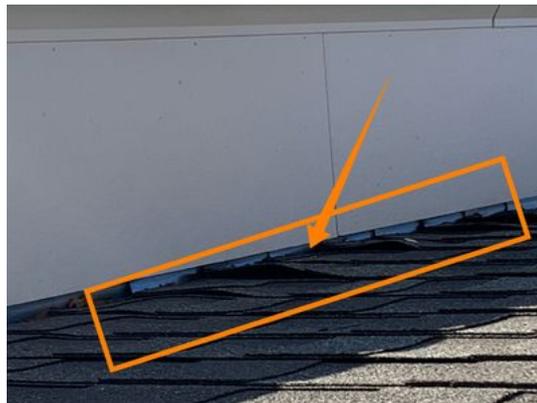
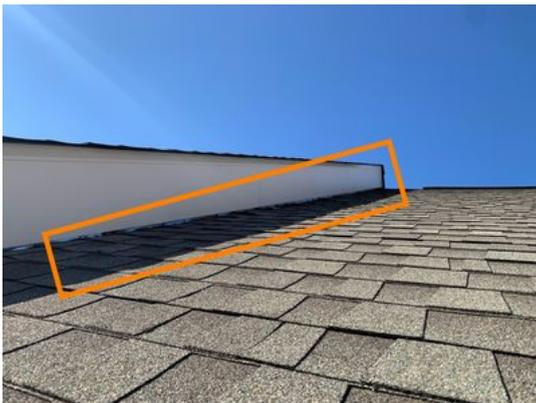
Comment 16

There were quite a few shingles along this side of the house are not laying flat. This may be due to nail pops or improper installation. Would recommend having the roofer come out to assess and repair.

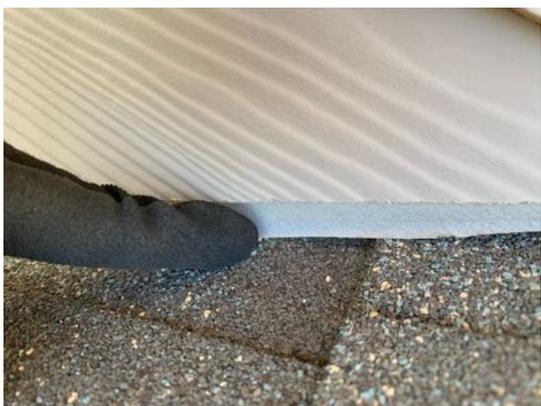
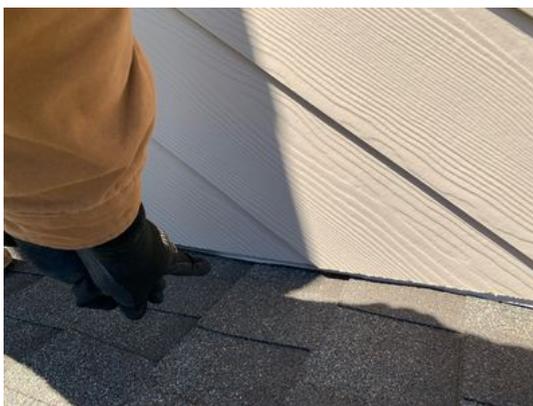
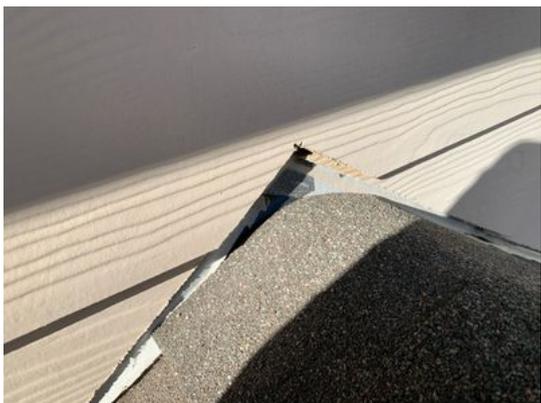
Comment 18

There is some house wrap that is exposed along the bottom of the siding in these areas. Simply running a razor blade along the bottom of the siding should clean up this area.

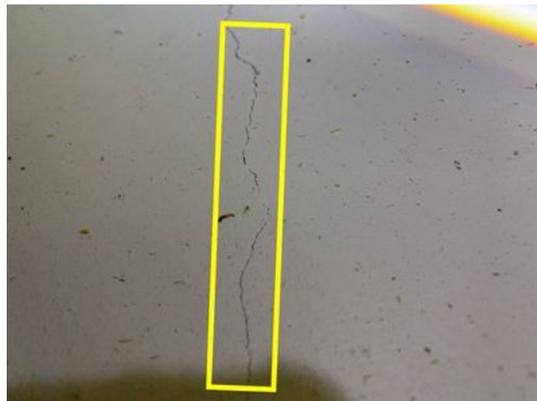
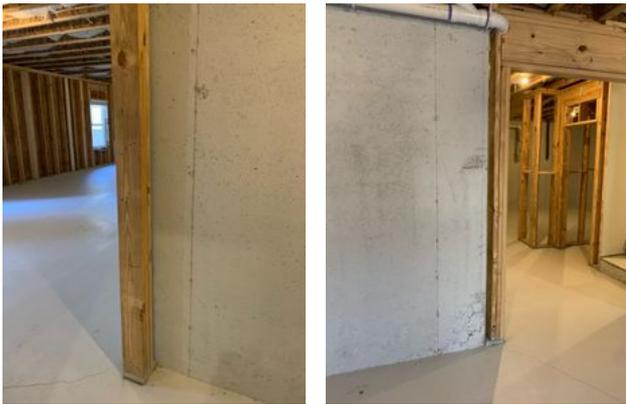
Comment 20

There were minor fractures in the foundation slab. At the time of the inspection both vertical and horizontal displacement was minimal.

Such cracks in newly formed slabs are called shrinkage cracks.

Most shrinkage cracks are of the inconsequential variety usually less than a 16th of an inch wide.

These cracks are often caused by the hardening or curing process.

Most settling and shrinkage cracks appear in the first 5 to 7 years.

There were NO other corresponding cracks in the basement wall at the time of the inspection.

I would recommend keeping an eye on these cracks to see if there's any more shifting overtime beyond a 16th of an inch wide.

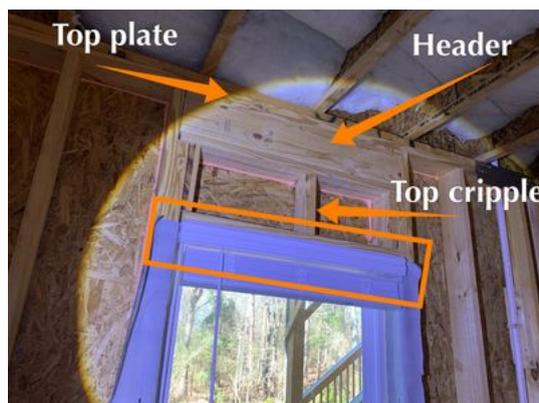
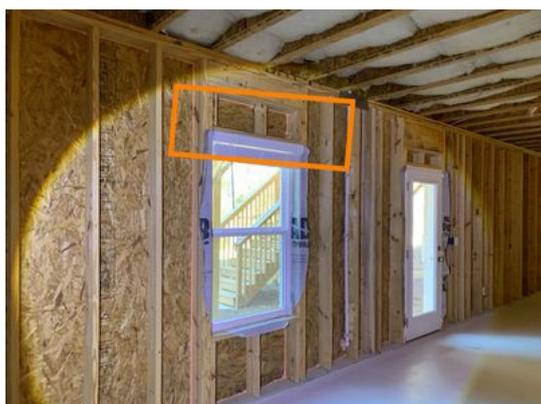
Comment 22

The top cripples are not making any contact with the top sill in this window. ALL other instances in the basement have the cripple making good contact with the top sill.

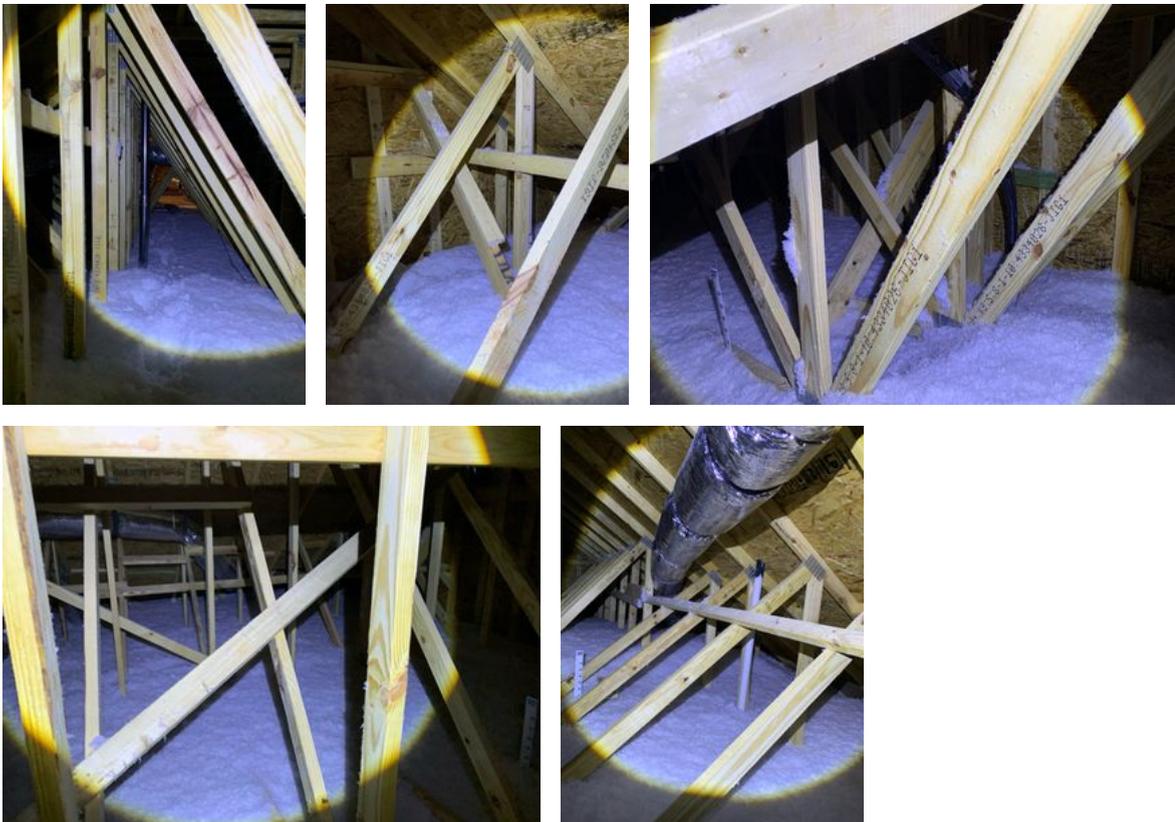
**Comment 24
Information**

The insulation was in good condition and a proper depth for efficiently insulating the house.

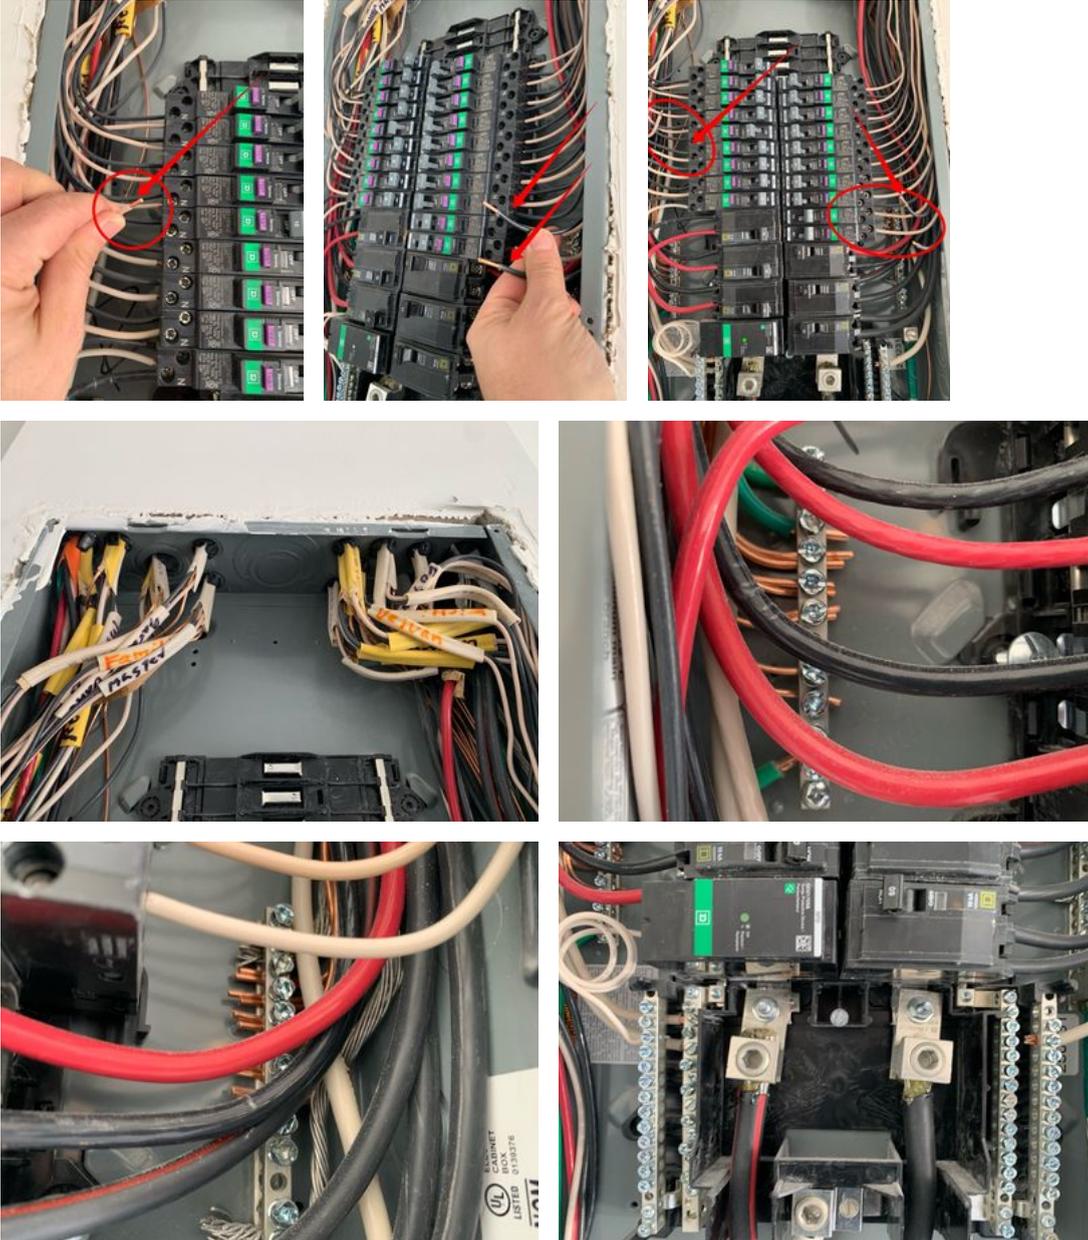
Comment 27
Safety Concern

There were multiple loose wires in the service panel. This may be the issues with the bathrooms and other circuits, but that cannot be verified until the electrician repairs these areas and provides proper proof of testing the circuits in question.

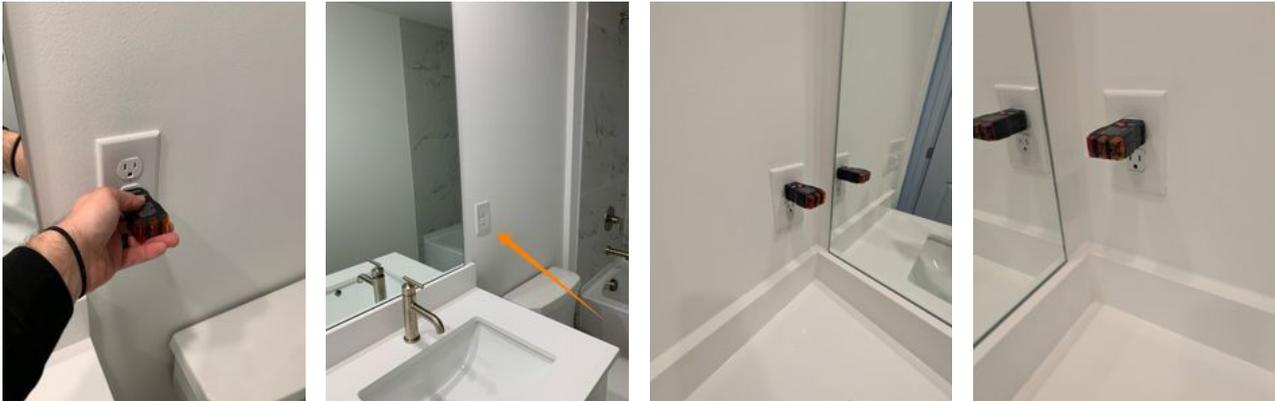
After tripping the bathroom outlets to test the circuit, we were not able to get the bathroom outlets to reset and the actual circuit itself was NOT tripped at the breaker panel. There were no discernible GFCI outlets anywhere in the structure. More than likely, this is due to the loose electrical wiring in the service panel, but would definitely recommend having the electrician double check that the circuit is properly functioning when they come out to make corrections.

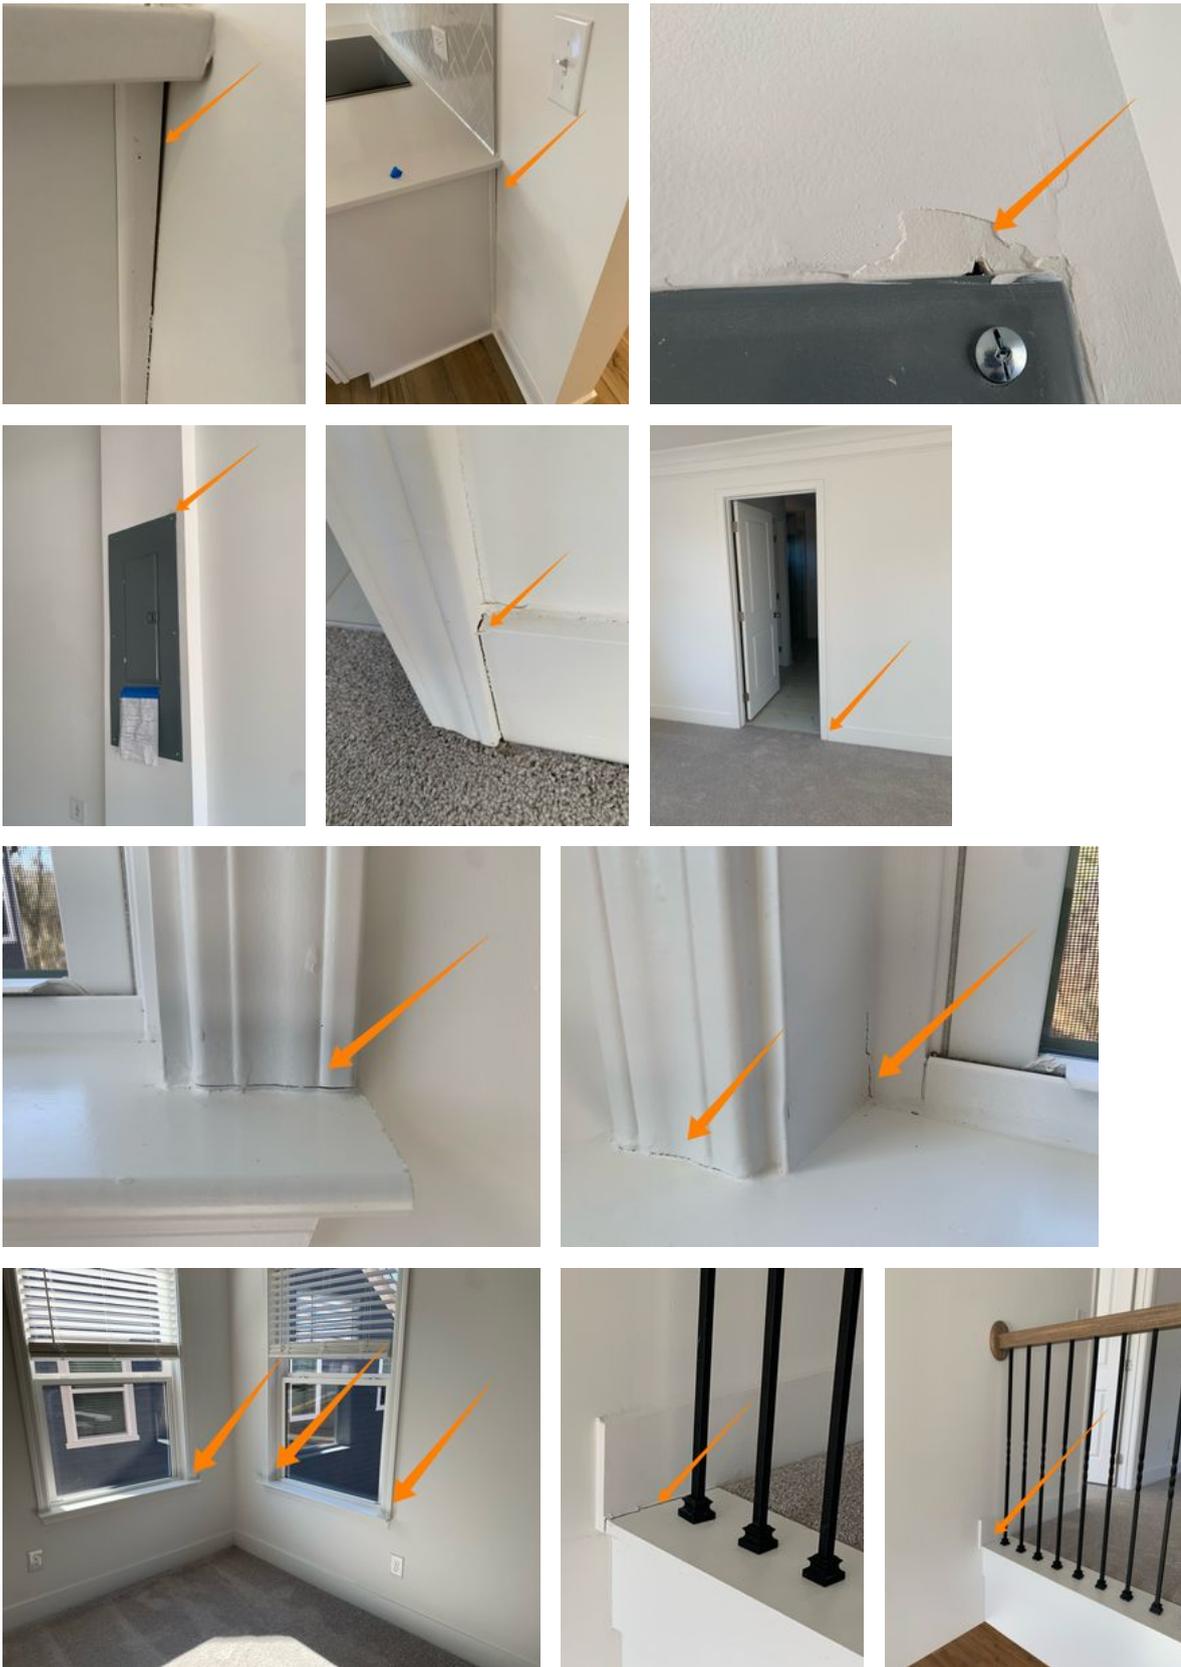
Comment 42 Repair or Replacement Needed

There are multiple areas throughout the house where the trim needs caulking and repainting. These are just a couple of examples of the areas and types of repairs that may be needed. I would make sure to point out these and others to the builder on the final walk-through and ask them to sweep the entire interior. There is one area in the garage around the electrical panel where the drywall needs to be repaired.

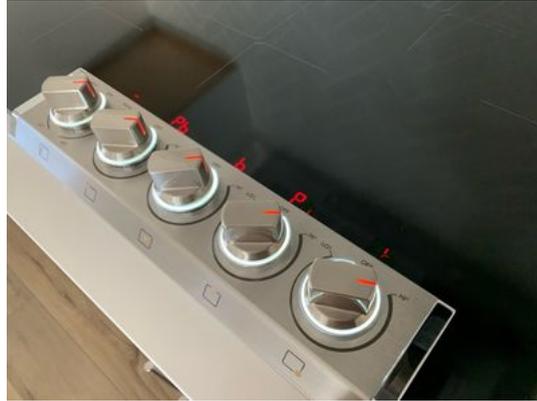
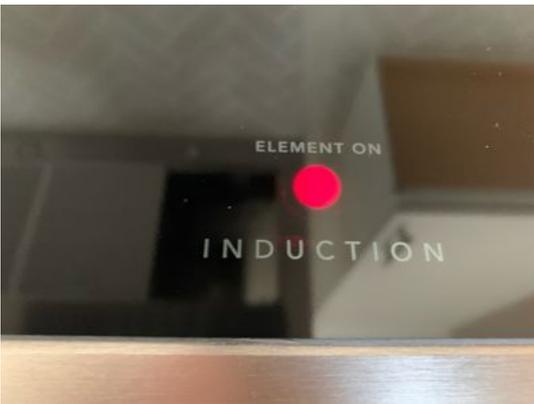
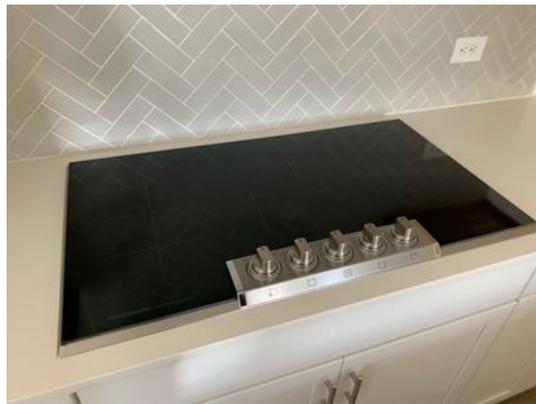
The range was an inductive unit. This means it needs a specific metal in order to interact and heat. You can put your hand on it and it will not heat. It is a protective measure. It appeared to be functioning properly at the time of the inspection, but would want to verify that with some inductive pans.

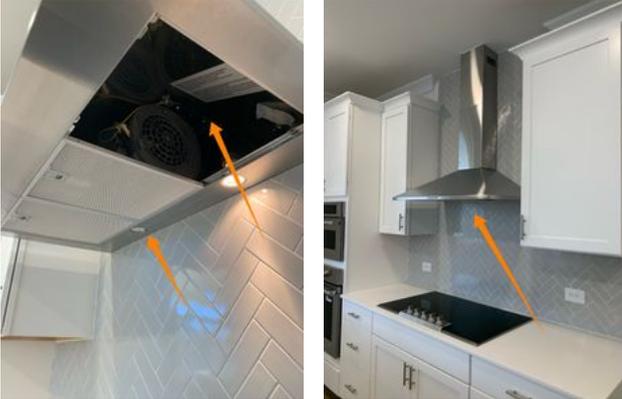
One of the lights was not working on the range hood and one of the protective panels was missing as well.

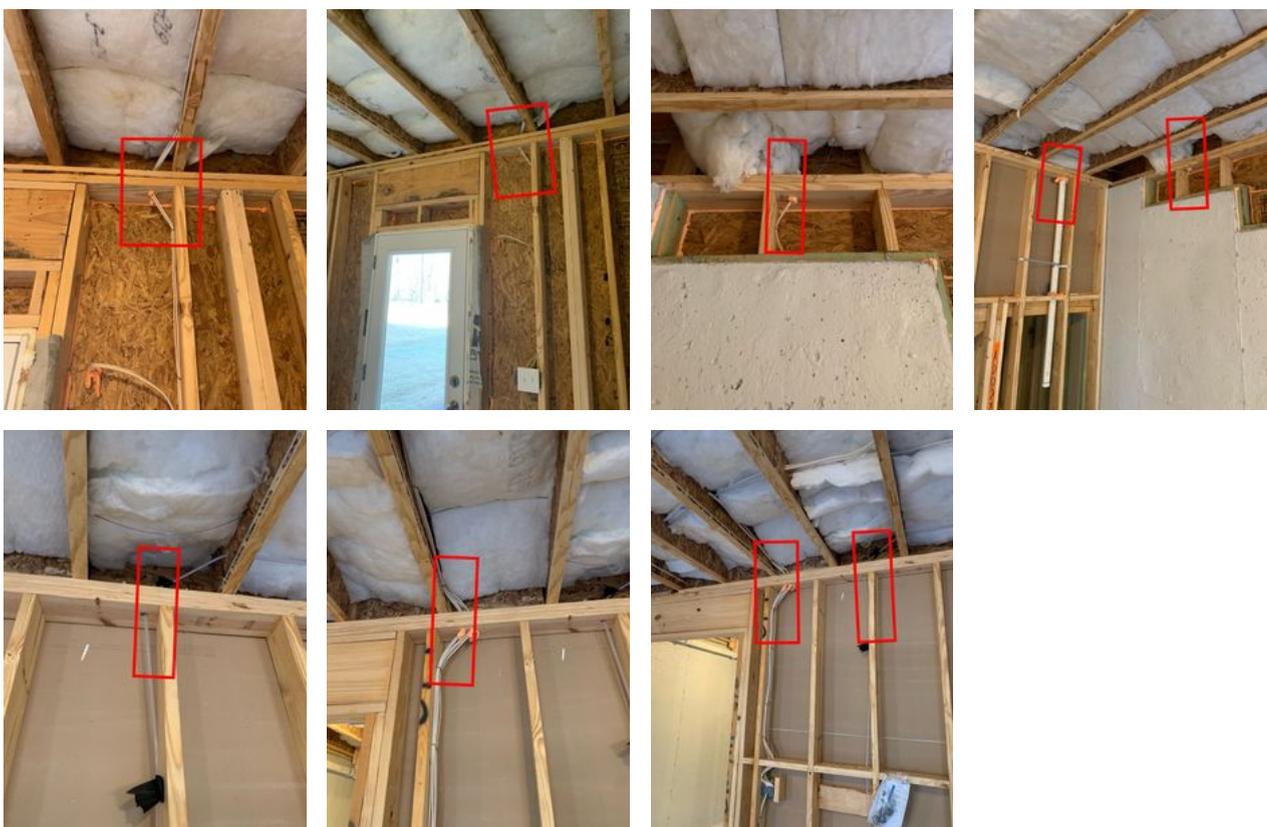
Structure

You need protective metal plates (nail plates or stud guards) in new builds where pipes, wires, or conduits run through wood studs. The general rule is to ALWAYS have them but the specific rule is when they are within 1 1/4 inches of the stud's edge, to prevent punctures from drywall screws and nails. This is standard building code requirements.

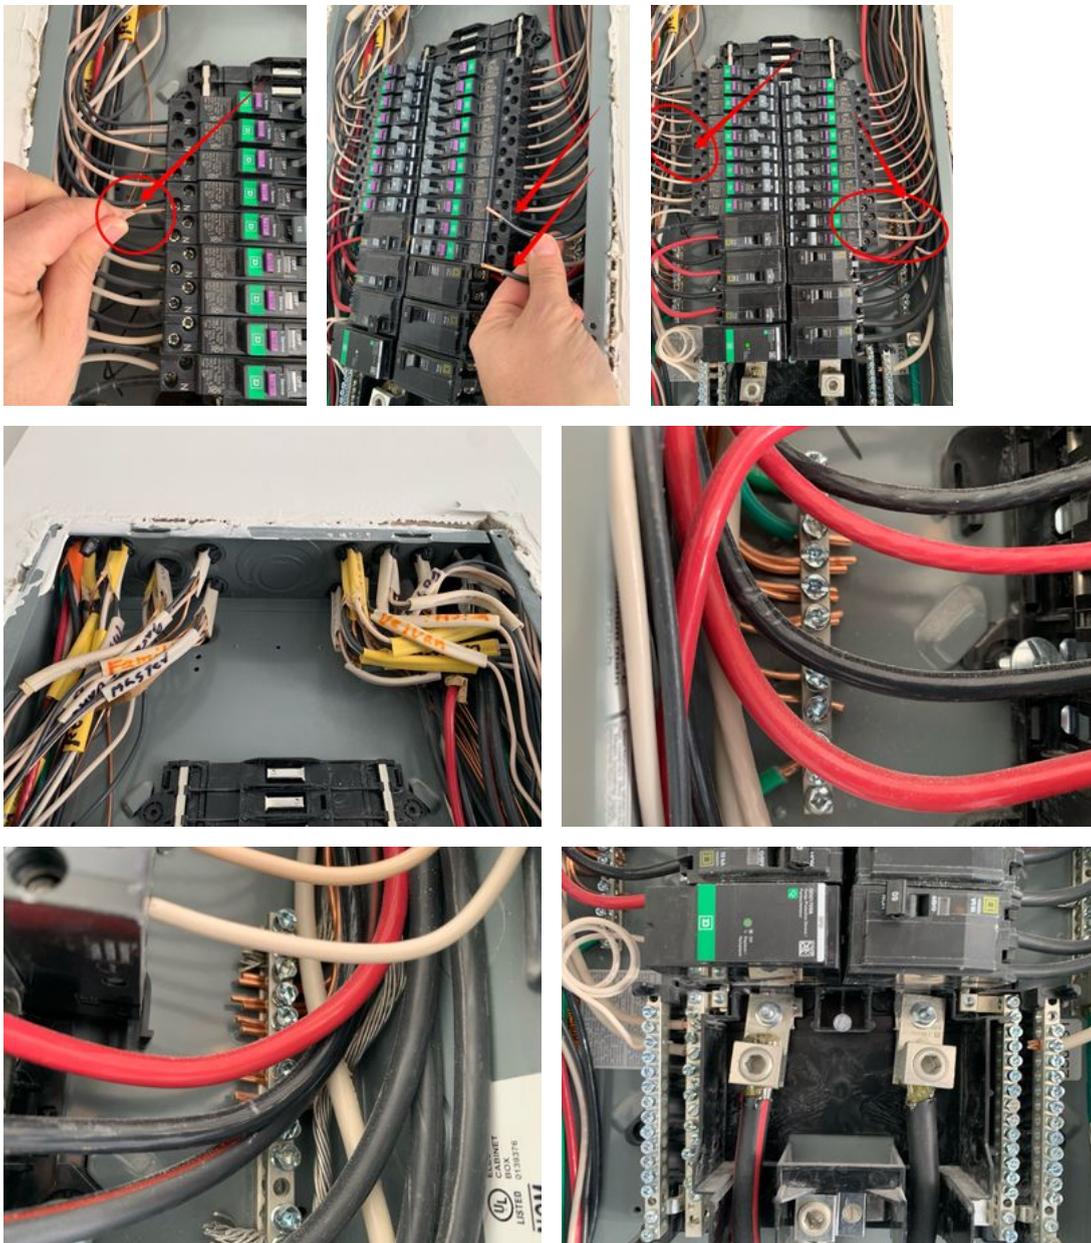
Electrical: Branch Circuit Wiring

There were multiple loose wires in the service panel. This may be the issues with the bathrooms and other circuits, but that cannot be verified until the electrician repairs these areas and provides proper proof of testing the circuits in question.

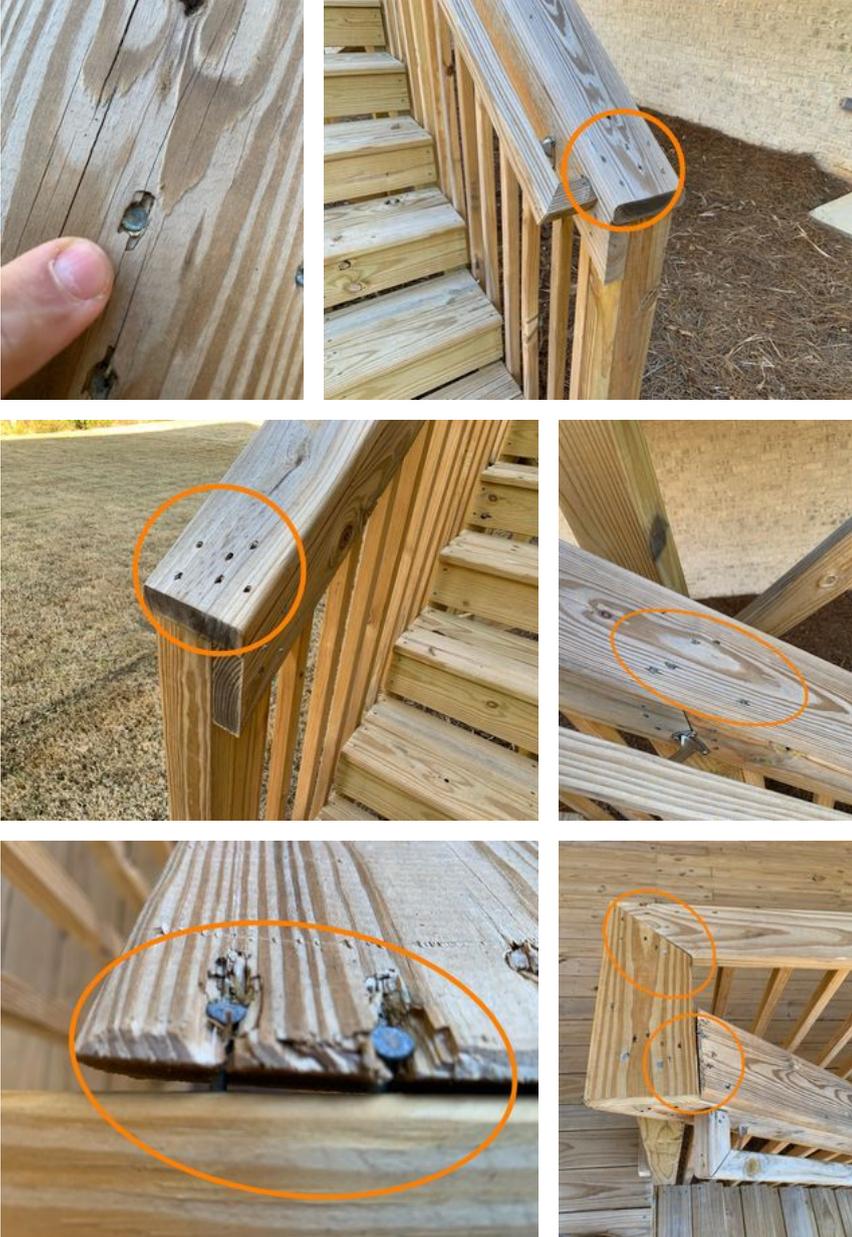
Site: Patios/Decks

There are a lot of nail holes along the railing. This is just simply poor craftsmanship. These areas can easily cause splinters, but also will catch water and cause rot a lot quicker than any other area.

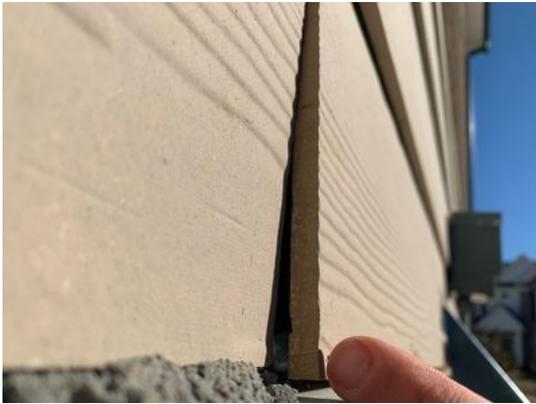
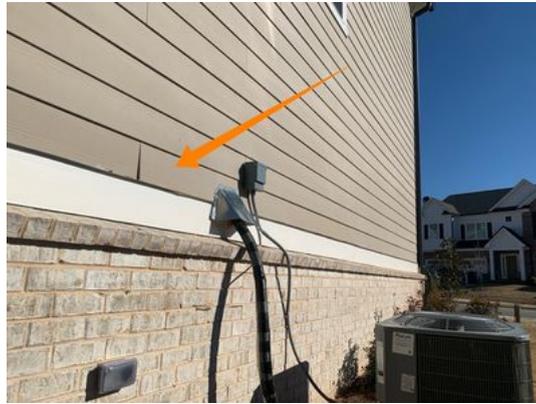
Exterior: Exterior Covering

There were a couple places where the hardy type plank was either not properly secured or not sitting flat.

I was not able to get a depiction of the separation of the siding along the back right corner of the structure. The last picture was the most clear depiction I was able to capture at the time of the inspection.

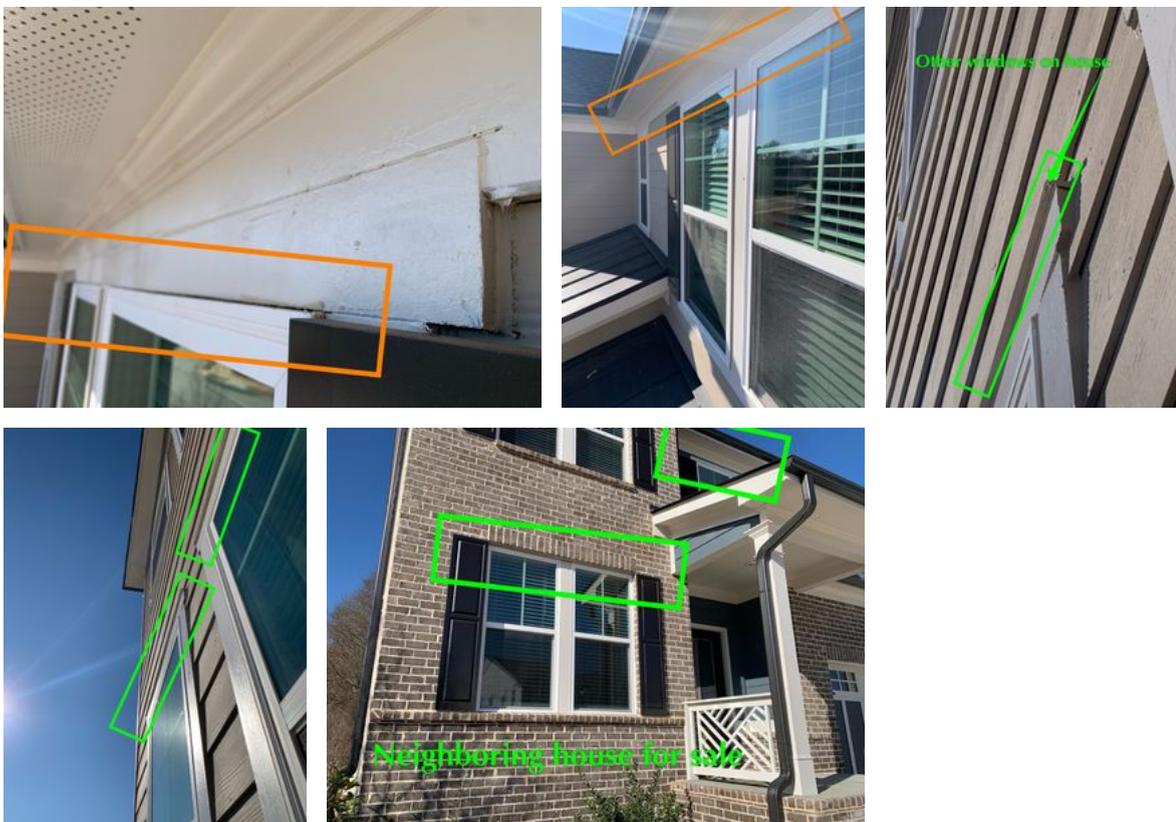
Exterior: Exterior Trim Material

The drip cap or drip edge is missing above the indicated windows. Not only is this an industry standard for new builds, but all other houses in the area built by the same builder have these specific windows, those along the front upstairs area, with drip edge installed along the top of the window.

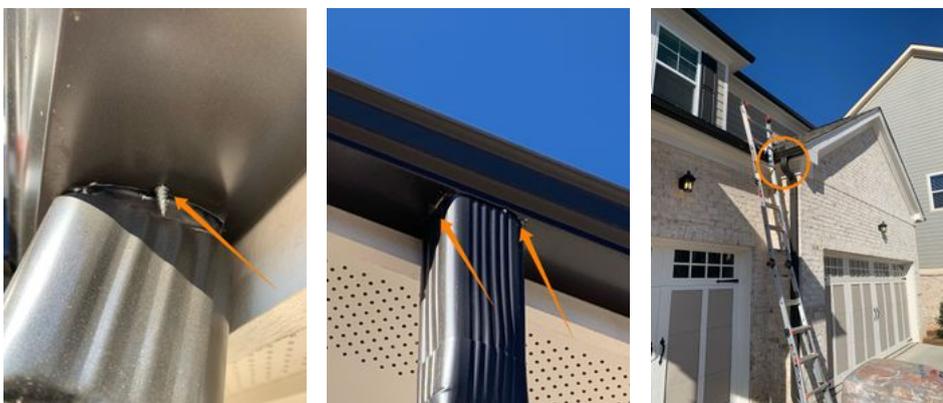
Roofing: Gutters & Downspouts

Screws in downspout should be in the sides where water is not likely to eventually penetrate.

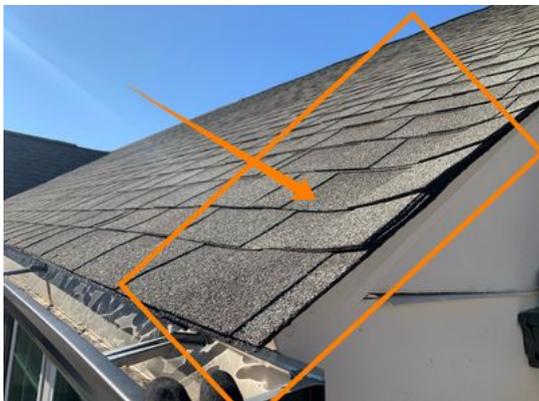
Roofing

There are two areas where there is some improper sloping and dipping in the roof line. These areas will wear out quicker than the rest of the shingles. Would recommend having the roofer come out and assess for repairs.

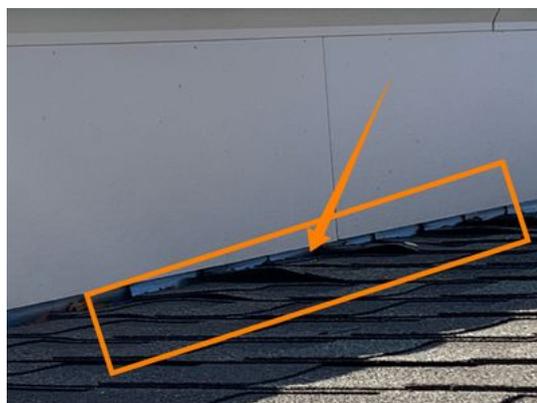
Roofing

There were quite a few shingles along this side of the house are not laying flat. This may be due to nail pops or improper installation. Would recommend having the roofer come out to assess and repair.
