Residential Solutions
7062545330

Home Inspection Report

Inspected By: Christopher Cooke
Inspected On Sat, Feb 7, 2026 at 9:00 AM

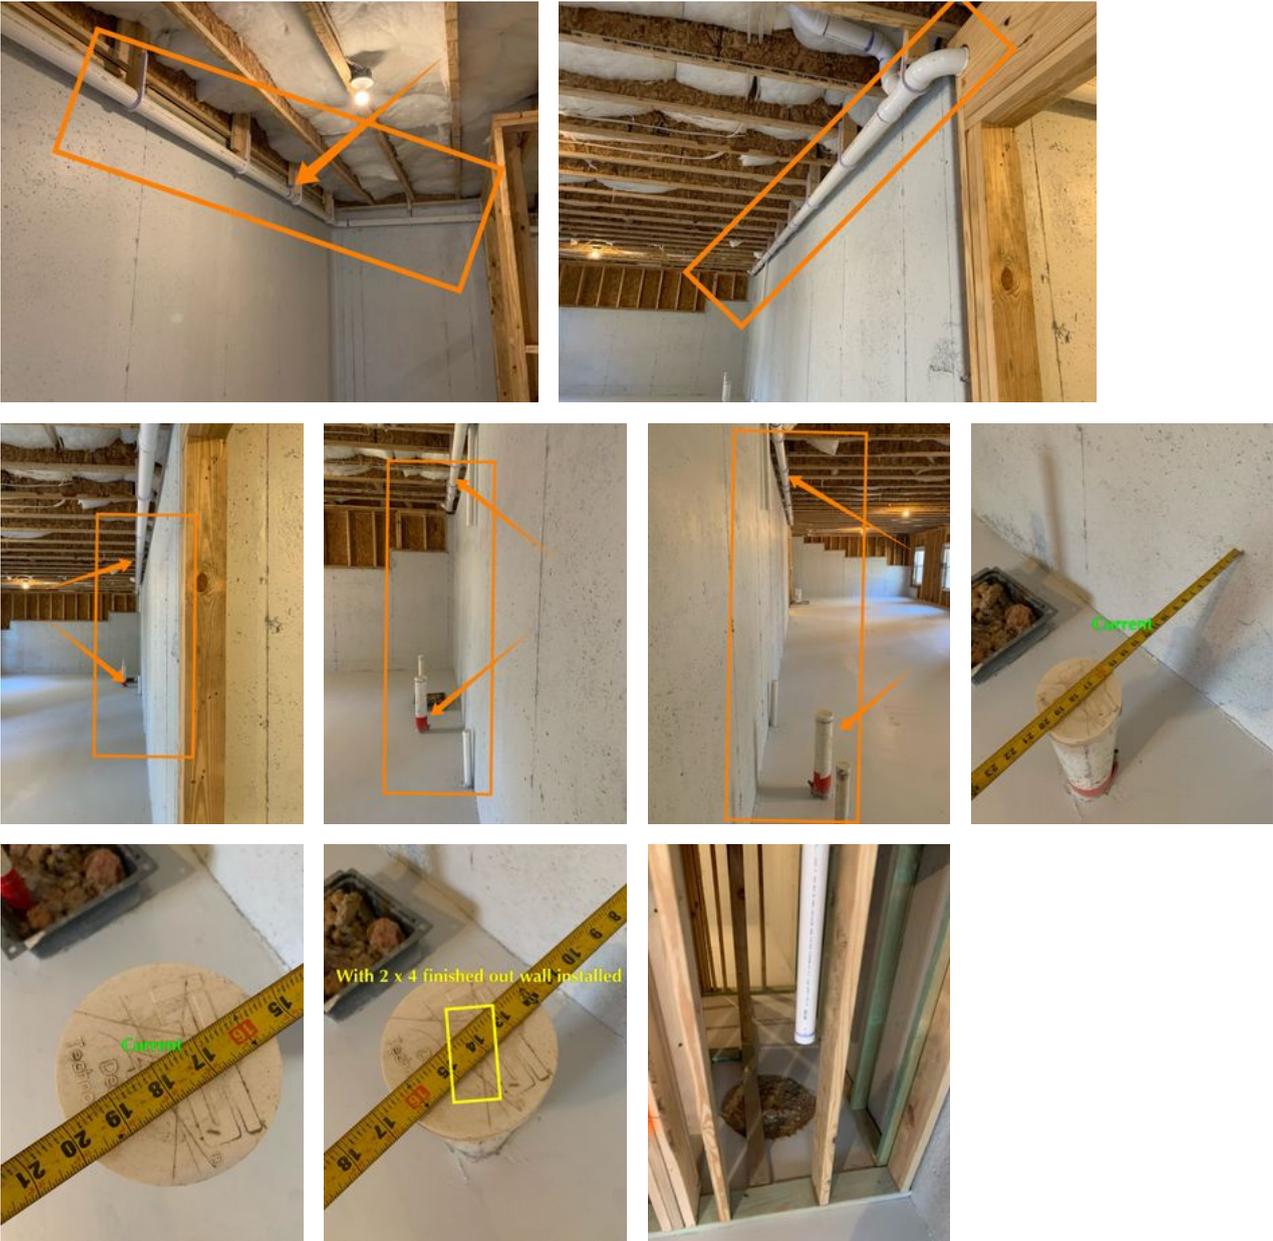
The issue is that where the bathroom is plumbed out in the slab only gives a toilet 18 inches from the basement wall to the center of the toilet, industry standard distance for a toilet from a wall. The minimum requirement is 15 inches.

The main plumbing running exposed under the joists comes out from the wall roughly 5 to 5 1/2 inches. That means in order to frame out a wall to hide the main drain lines properly the space would be reduced for a toilet down to at best 14 inches and at worst 13 to 12 1/2 inches when including a studded wall construction. That does not meet the minimum requirements space for the toilet install a toilet. That means that either the toilet plumbing and the shower plumbing in the slab need to be moved or the main drainage plumbing needs to be redone to run up into the floor joist in order to properly accommodate a finished area.

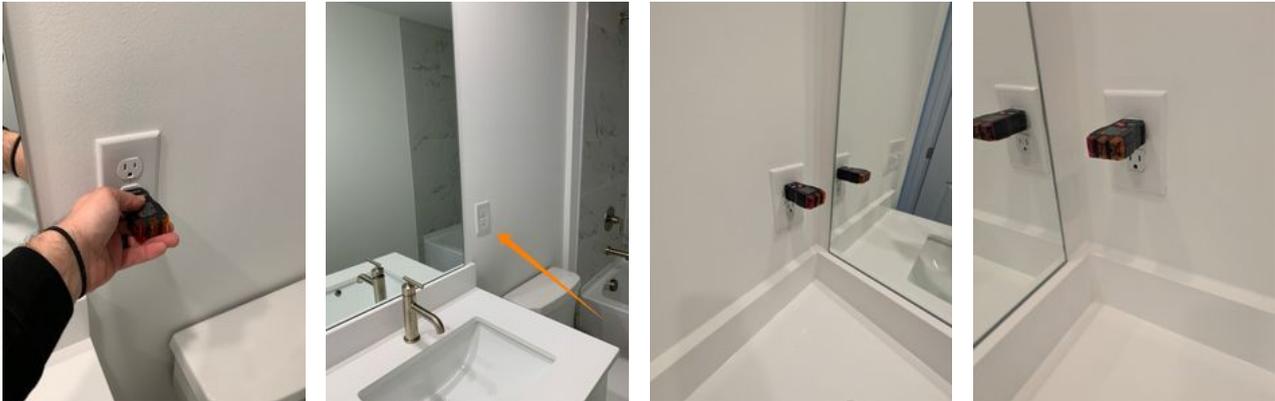
Bathrooms

After tripping the bathroom outlets to test the circuit, we were not able to get the bathroom outlets to reset and the actual circuit itself was NOT tripped at the breaker panel. There were no discernible GFCI outlets anywhere in the structure. More than likely, this is due to the loose electrical wiring in the service panel, but would definitely recommend having the electrician double check that the circuit is properly functioning when they come out to make corrections.

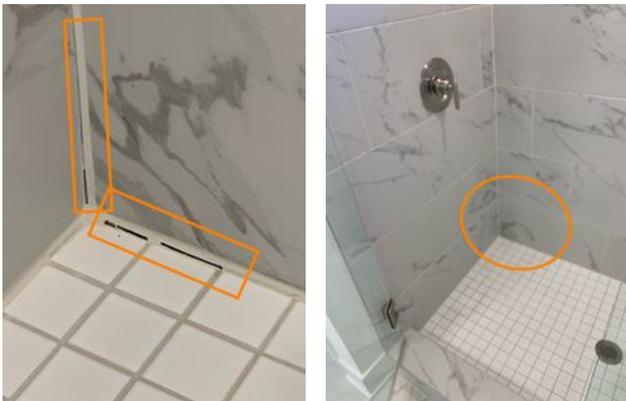
Bathrooms: Master Bathroom

This area needs to have its corners re-grouted or caulked in order to keep water from getting back behind the tile.

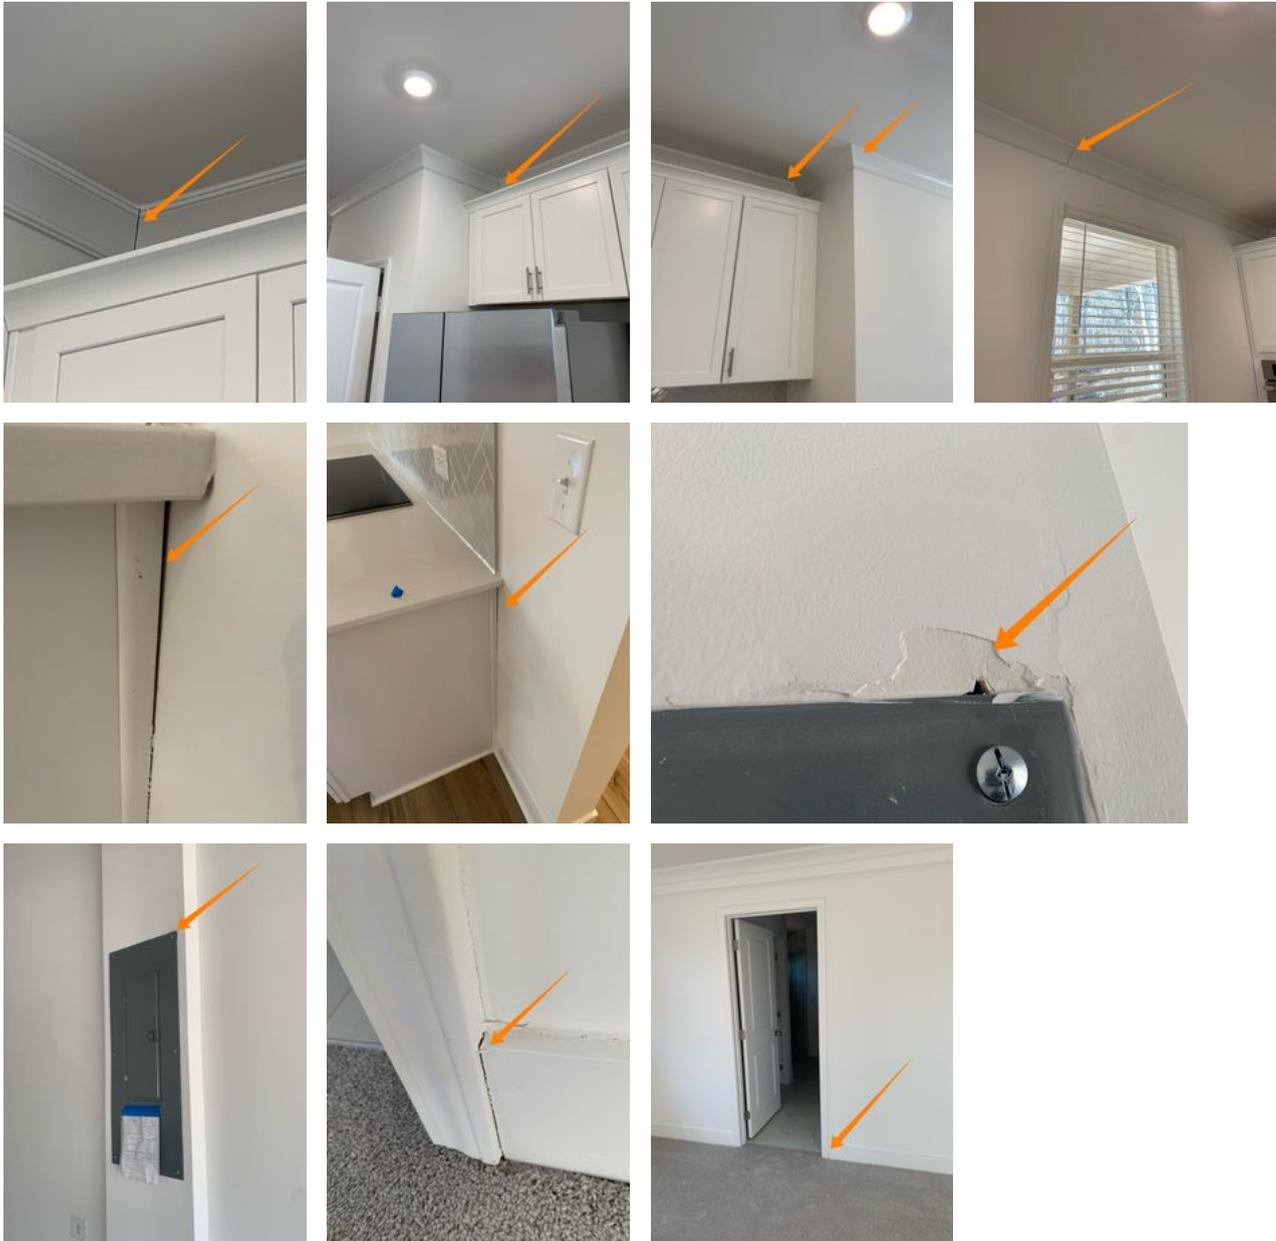
Interior

There are multiple areas throughout the house where the trim needs caulking and repainting. These are just a couple of examples of the areas and types of repairs that may be needed. I would make sure to point out these and others to the builder on the final walk-through and ask them to sweep the entire interior. There is one area in the garage around the electrical panel where the drywall needs to be repaired.
