Residential Solutions
7067673336

Home Inspection Report Sample

Inspected By: Christopher Cooke
Inspected On Sun, Jan 11, 2026 at 8:00 AM

Church

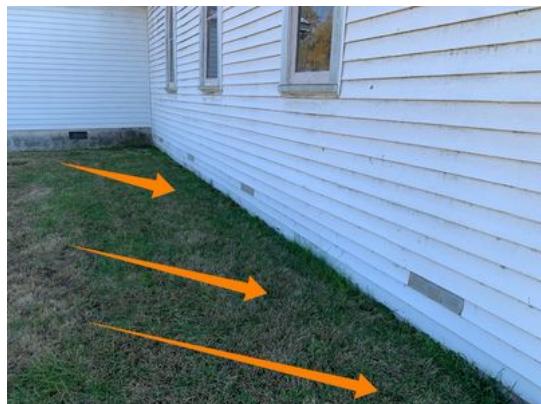
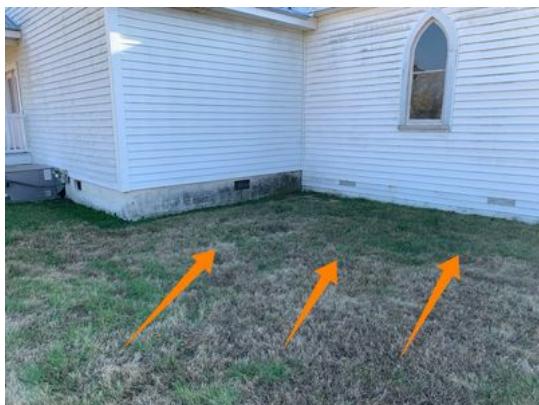
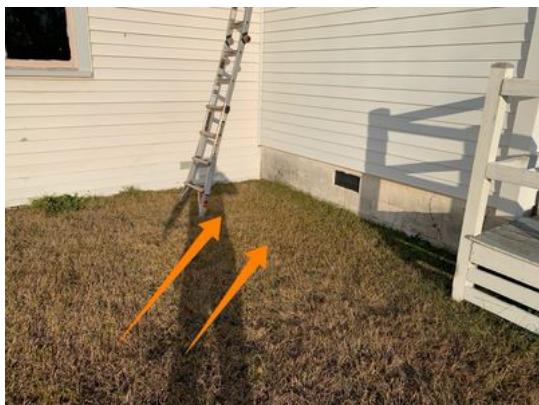
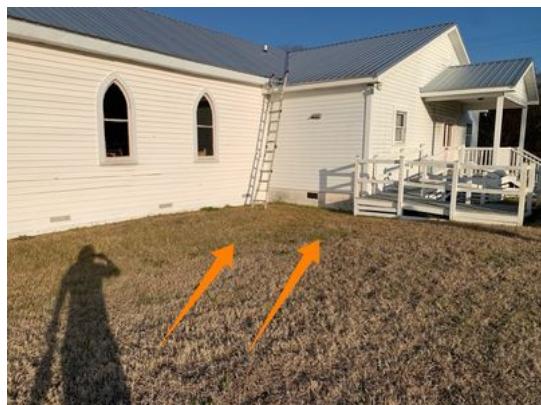
Comment 2

The grading slopes toward the structure and will not shed water away properly. This is a common cause of wet crawl spaces and leaking basements. Suggest adding fill dirt at low areas to prevent water from sitting next to home.

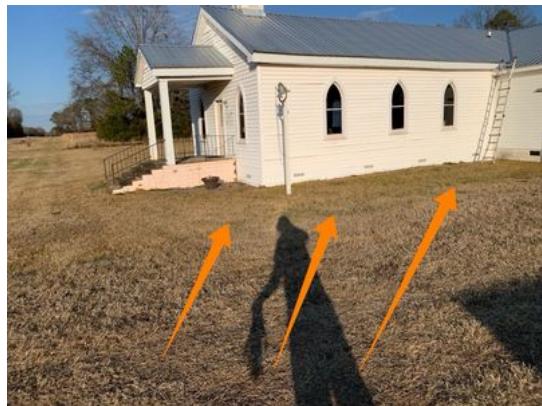
Comment 3

There appears to be a burrow in this area. Would recommend having the critter removed and the hole filled.

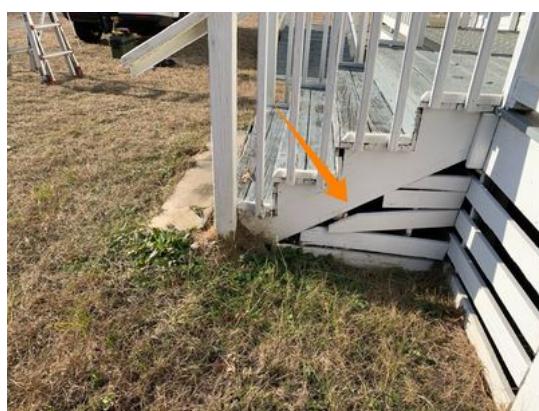
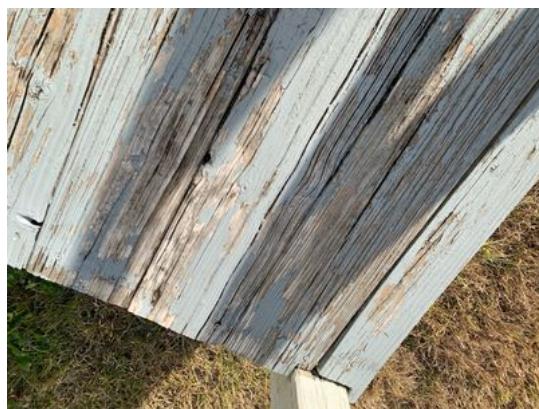
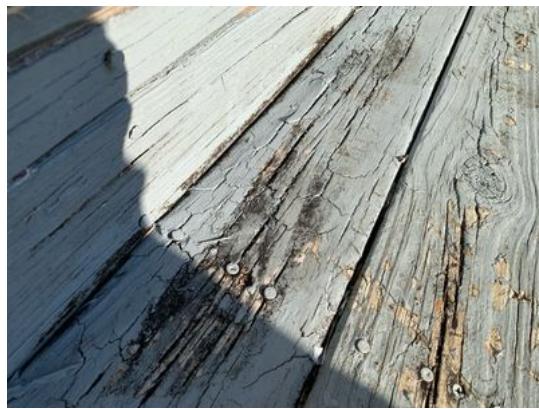
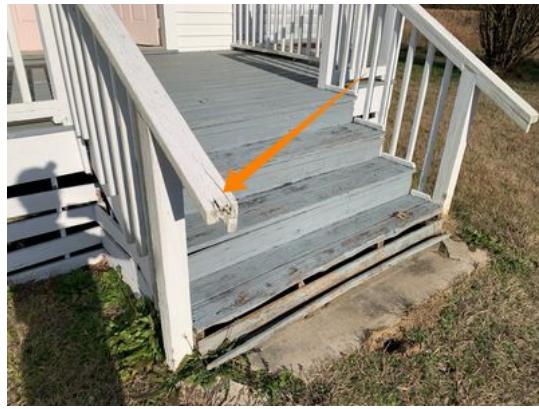
Comment 6
Repair or Replacement Needed

There are several areas where the wood may need to be repaired or replaced on the back deck. Would recommend pressure washing and reseal the back deck after these repairs are made.

The supportive construction of the deck is in good condition.

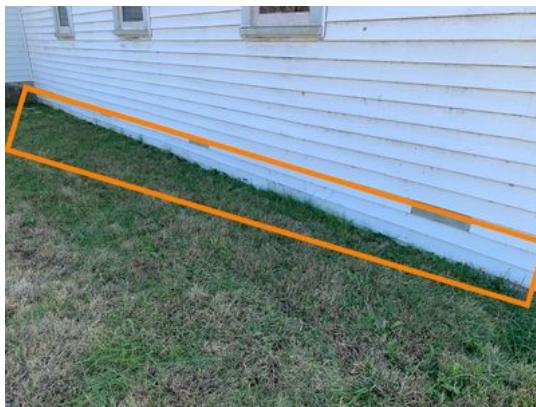
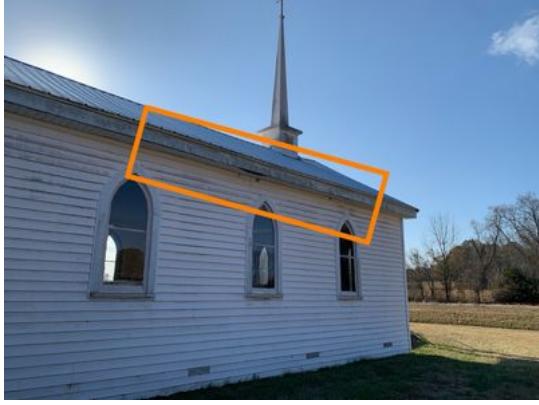
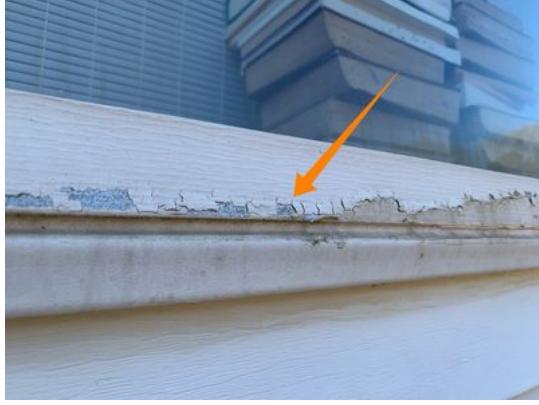
Comment 7

There are several places where the vinyl siding or trim has been damaged. Would recommend having all penetration sealed in order to prevent pest or moisture from affecting the interior of the structure.

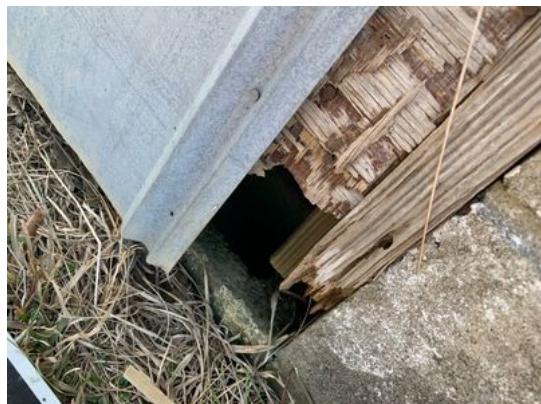
Comment 8

There are places along the entire exterior where the trim need to be repaired, caulked and repainted.

These pictures are for reference to the areas and types of repairs that may be needed. They are not exhaustive. Make sure to have your contractor sweep the entire exterior.

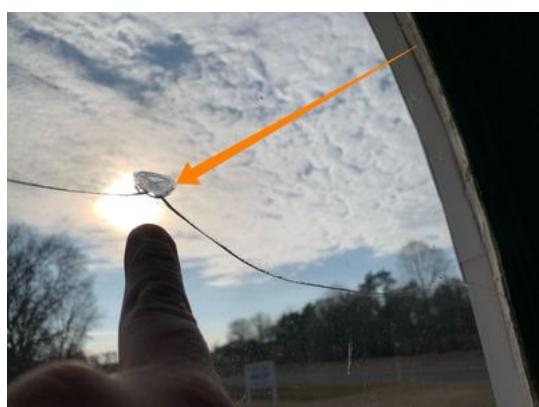
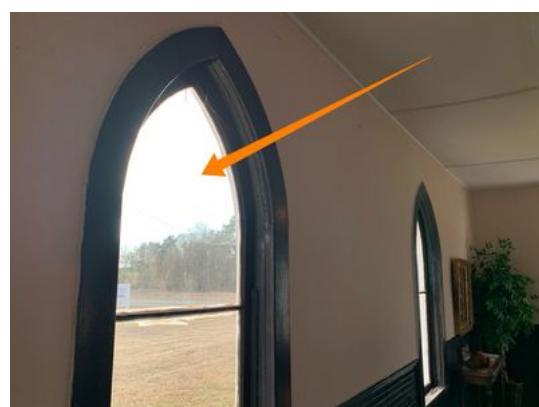
Comment 9

This glass is broken and needs to be repaired by a local window company.

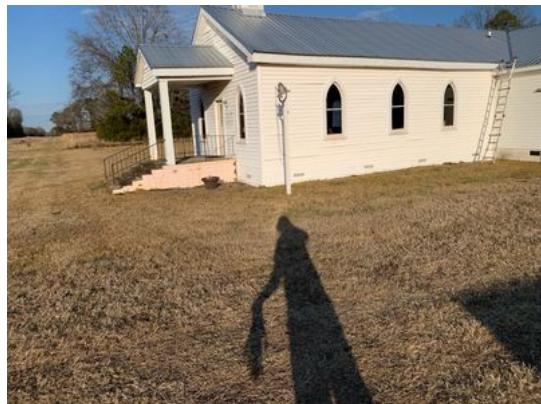
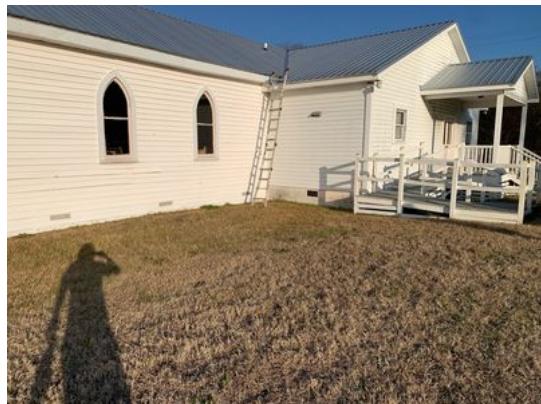
There are no gutters on the exterior of the structure. Gutters are the first line defense for keeping moisture out of the crawlspace and basement and water away from the structure of the home.

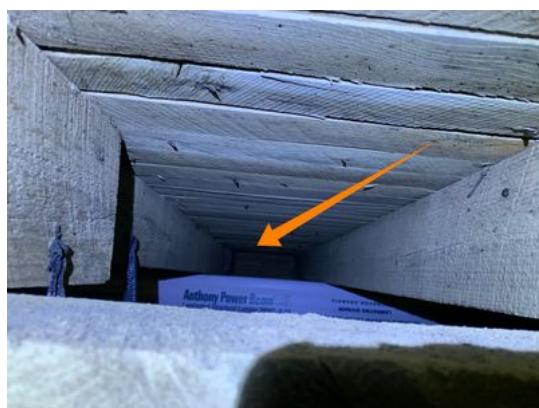
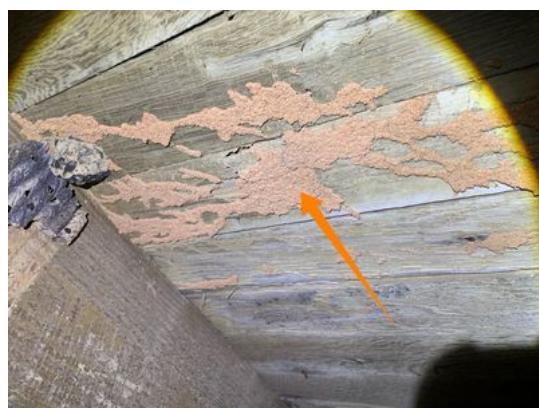
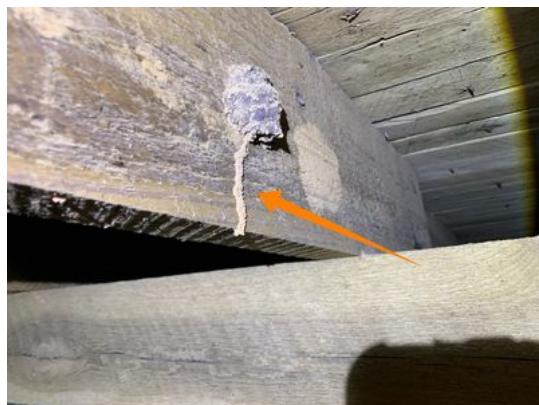
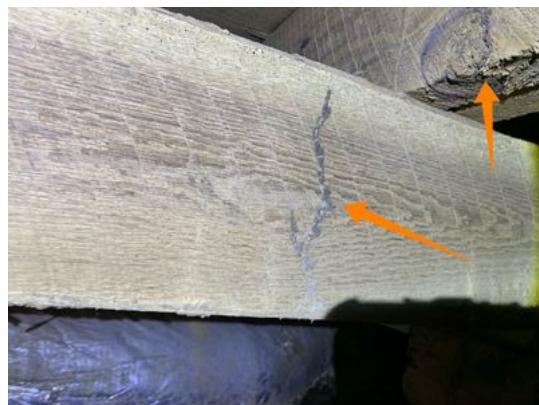
There are signs of termite activity throughout the old sanctuary. I was not able to determine whether they were current lead active in each of the areas. The damage that I was able to assess at the time of the inspection was not to the point where repairs would be needed.

Would highly recommend having a pest specialist come out and assess to see if any of these are current and what treatment options would look like as well, as if there is any deeper damage in some of these areas.

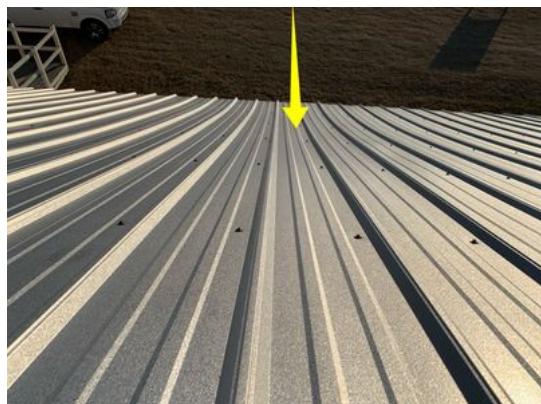
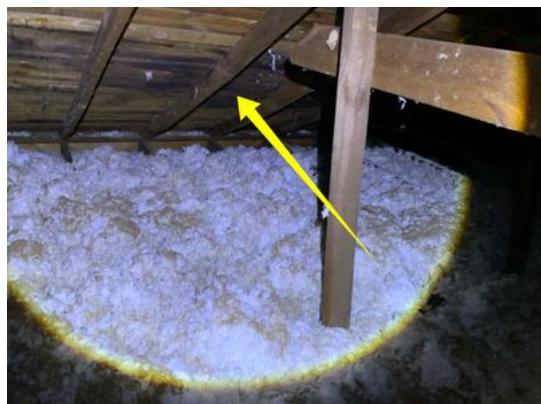
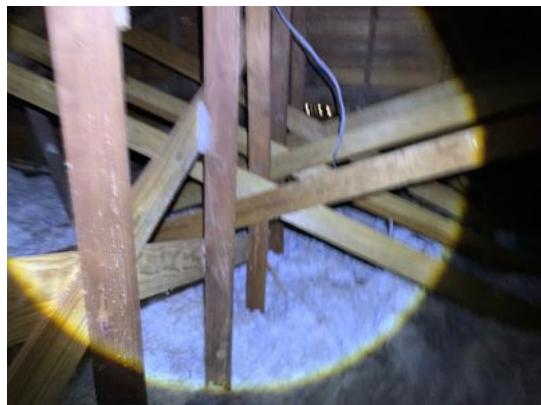
There's a minor bowing in the roof along the right side of the sanctuary. This looks to be an older issue as the older beams have some slight bowing in them as well, but no signs of any unused stress or cracks. There is also some additional support that has been added to the structure in this general area. Would recommend asking owners for more information about these repairs.

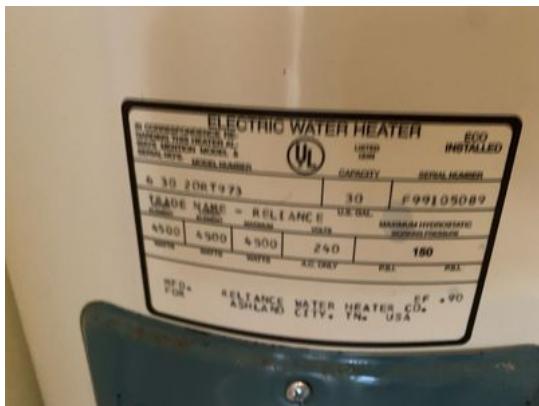
The water heater is a 50 gallon electric unit manufactured in 1999. There was no electrical shut off easily accessible and no expansion tank installed. The unit was functioning properly at the time of the inspection.

***Note : the typical lifespan on a water heater is 8 to 10 years. Would recommend budgeting for replacement.

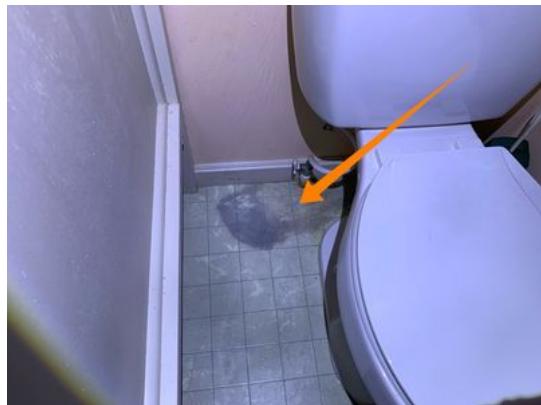
There it appears to be an active water leak in the women's bathroom around this toilet area. I was not able to access this area from the crawlspace at the time of the inspection due to the HVAC ductwork runs. Would highly recommend having this area assessed and repair repaired.

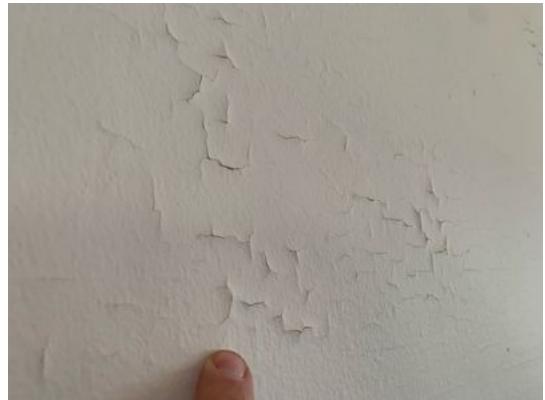
There are a couple areas where the drywall or the flooring has been damaged.

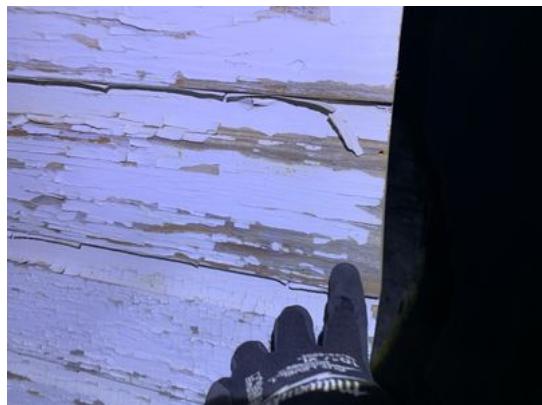
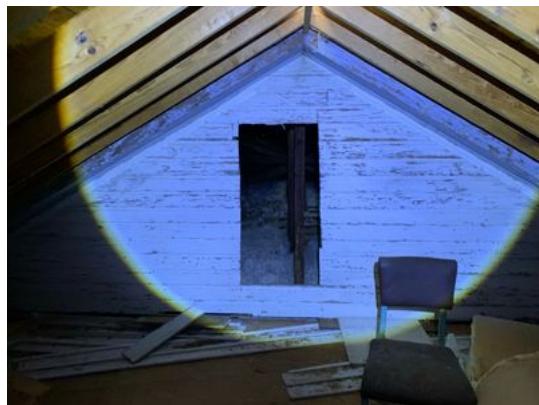
This area of the building where there is old exposed siding. It would look as though there is some lead-based paint in this area. Would recommend caution when interacting with this substance.

Painting over the material with latex, technically encapsulate it, but any sanding of these areas could result in hazard.

If there's any further concern would recommend having some environmental testing done.

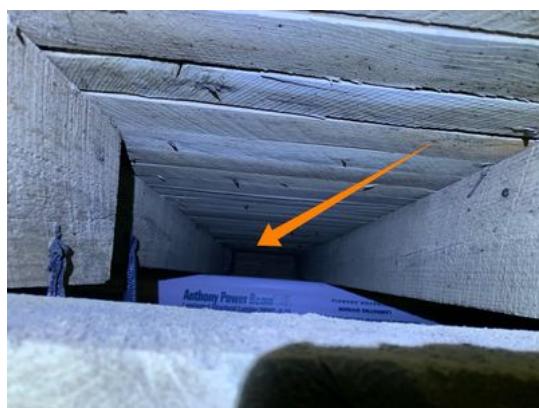
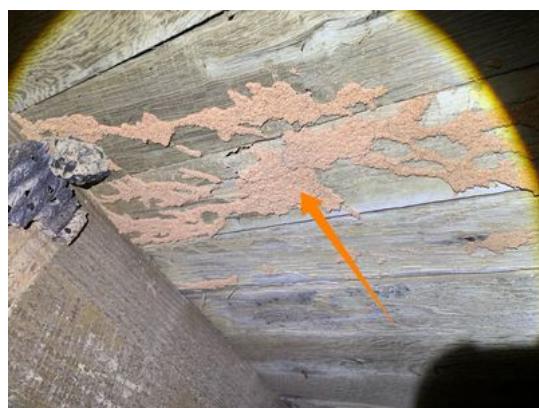
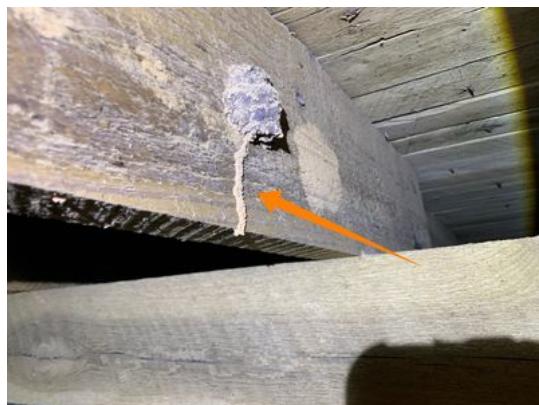
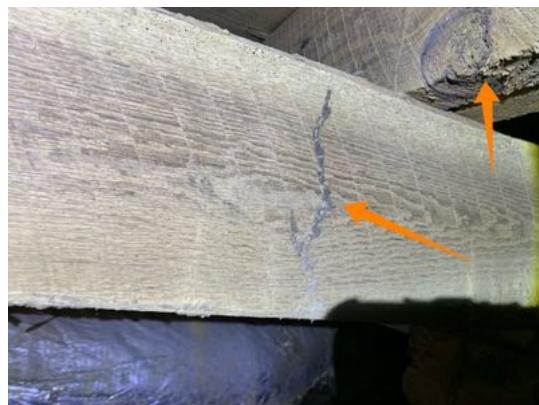
There are signs of termite activity throughout the old sanctuary. I was not able to determine whether they were current lead active in each of the areas. The damage that I was able to assess at the time of the inspection was not to the point where repairs would be needed.

Would highly recommend having a pest specialist come out and assess to see if any of these are current and what treatment options would look like as well, as if there is any deeper damage in some of these areas.

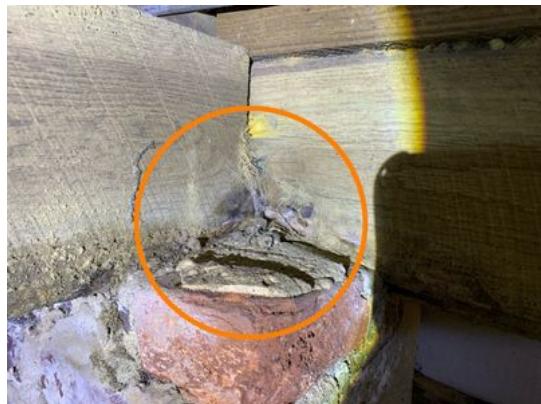
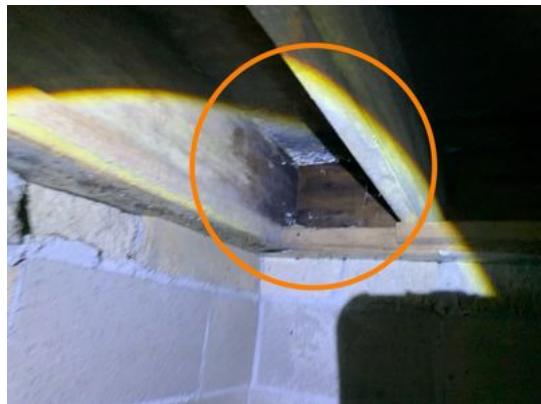
Structure

There are a couple areas where it would appear. There is moisture, making it to the skirt board of the structure. Would highly recommend having these areas repair repaired in order to prevent any further moisture damage.

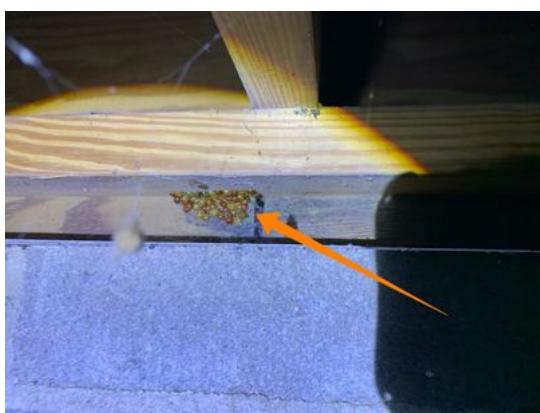
Structure

There are some signs of pest activity in the crawlspace. Would recommend having a pest specialist come out and assess for treatment.

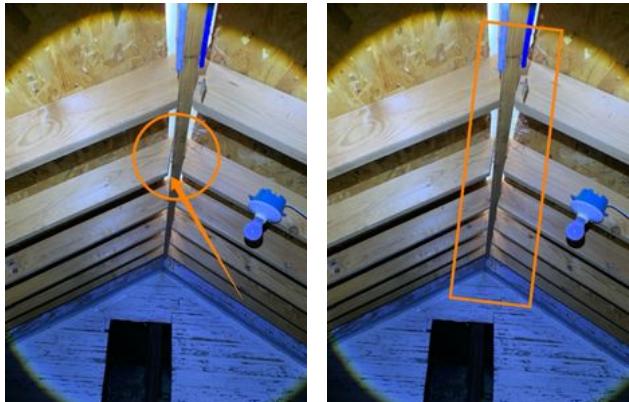
Structure: Attic: Roof Framing Type

There was one section of the roofing where there are no collar ties. Would highly recommend having color ties installed in this area in order to prevent any further pulling away of the rafters from the spine.

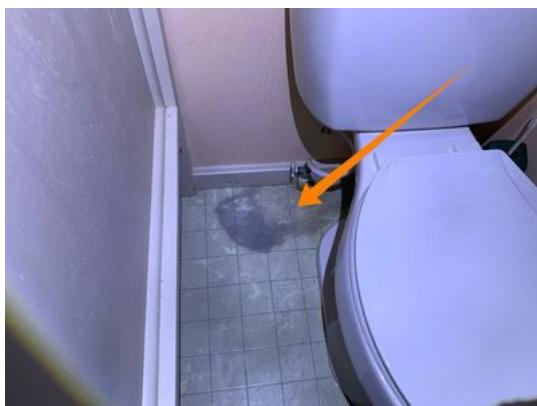
Bathrooms: Half Bath #2

There it appears to be an active water leak in the women's bathroom around this toilet area. I was not able to access this area from the crawlspace at the time of the inspection due to the HVAC ductwork runs. Would highly recommend having this area assessed and repair repaired.

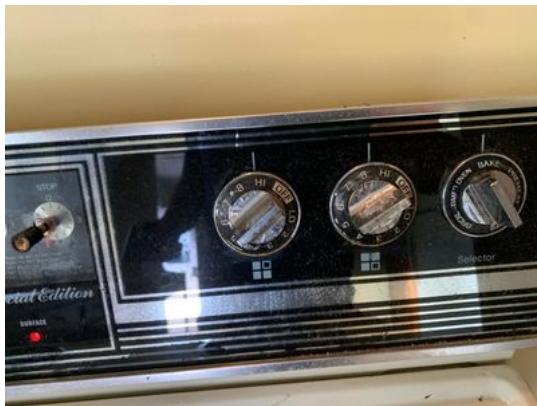
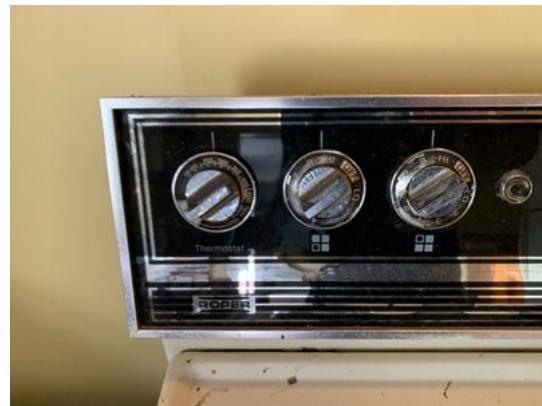
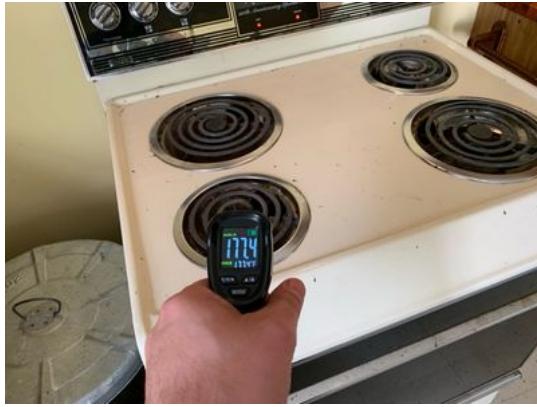
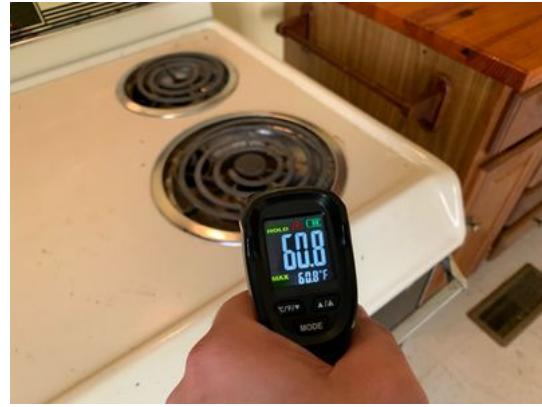
Kitchen: Appliances: Range

Two of the burners are not functional on the stove at the time of the inspection.

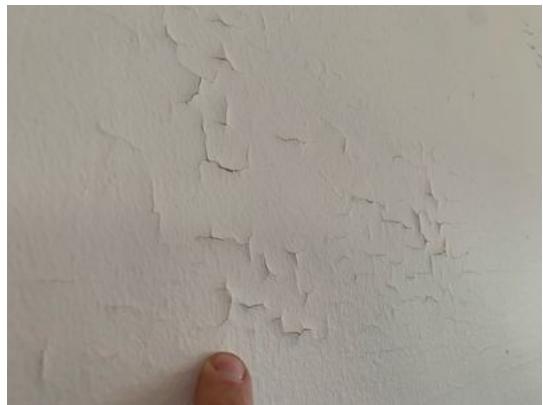
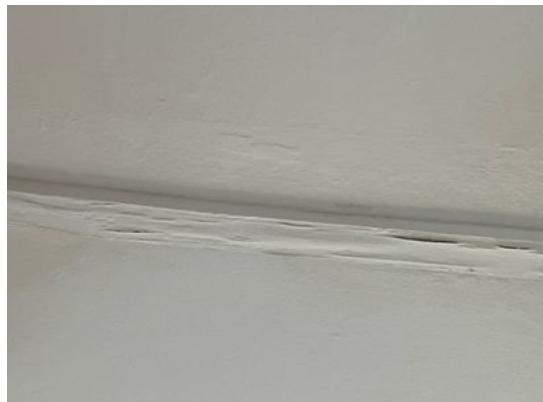
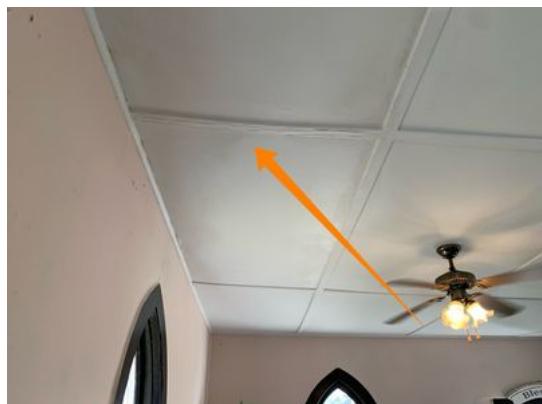
Interior

There are a couple areas where the drywall or the flooring has been damaged.
