PROFESSIONAL HOUSE INSPECTION

**BroadView Home Inspection LLC
Address: 188 Bonad Rd, Chestnut Hill, MA 02467**

Date: 2025-04-18

Address: 188 Bonad Rd, Chestnut Hill, MA 02467

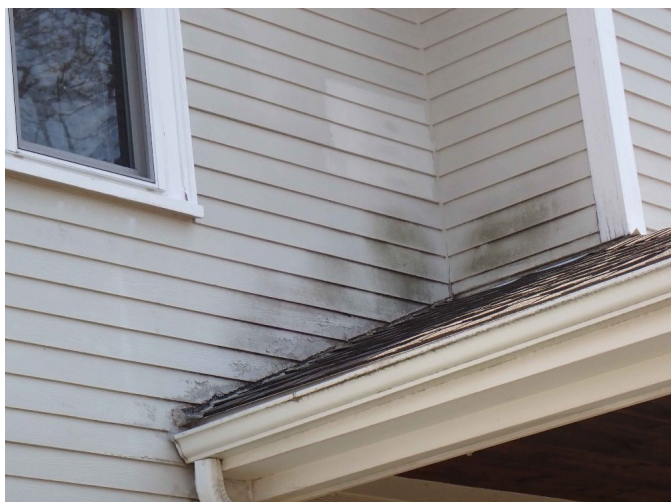
1. (E) Missing the kick-out flashing to divert the water to gutter. Signs of moisture absorption and delamination at the bottom edges. This condition may indicate the presence of moisture, which could lead to further mold growth and potential structural damage if not addressed promptly. It is recommended to investigate the source of moisture and take appropriate remediation measures to ensure a safe and healthy environment.

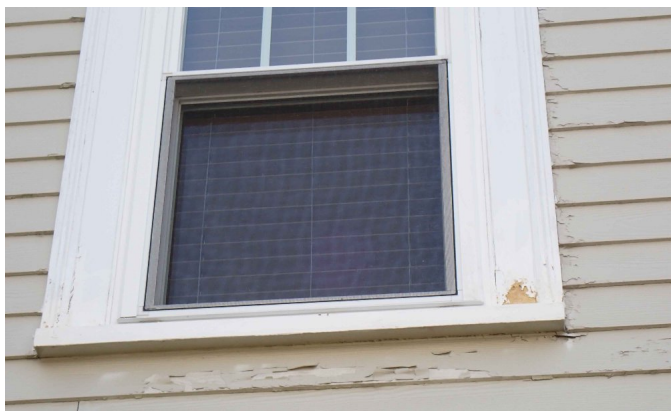
2. (E) Wood rot was observed at the bottom right corner of the vertical window casing, where it meets the windowsill. Additionally, there is extensive paint failure noted across the window trim and the adjacent siding panels. It is recommended to address these issues promptly to prevent further deterioration and potential water intrusion.

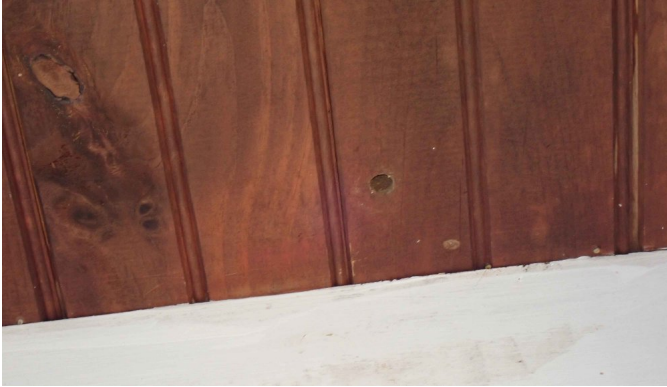
3. (E) During the inspection, evidence of wood-destroying insect (possibly carpenter bee) activity was observed on the porch ceiling. This condition may indicate an ongoing infestation, which can compromise the structural integrity

of the wood components. It is recommended to engage a licensed pest control professional to assess the situation further and determine appropriate treatment options. Regular monitoring and preventive measures are advisable to mitigate potential damage in the future.

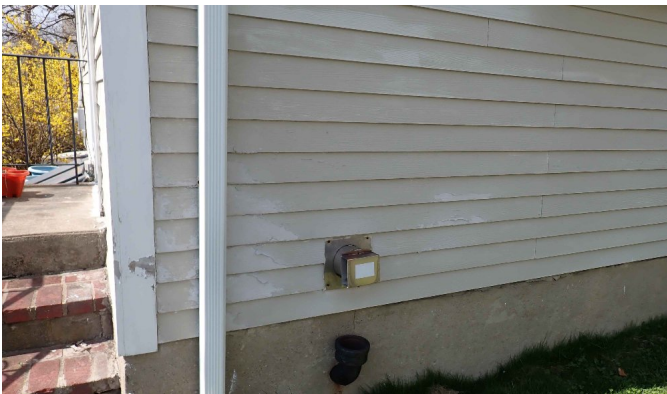
4. (E) The siding panels located adjacent to and below the vent show significant signs of surface delamination and paint peeling. This damage may be attributed to high-moisture, heated exhaust air from the vent, which is likely blowing directly against or swirling back toward the siding. It is recommended to further investigate the venting system and consider repairs or protective measures to prevent further deterioration of the siding.

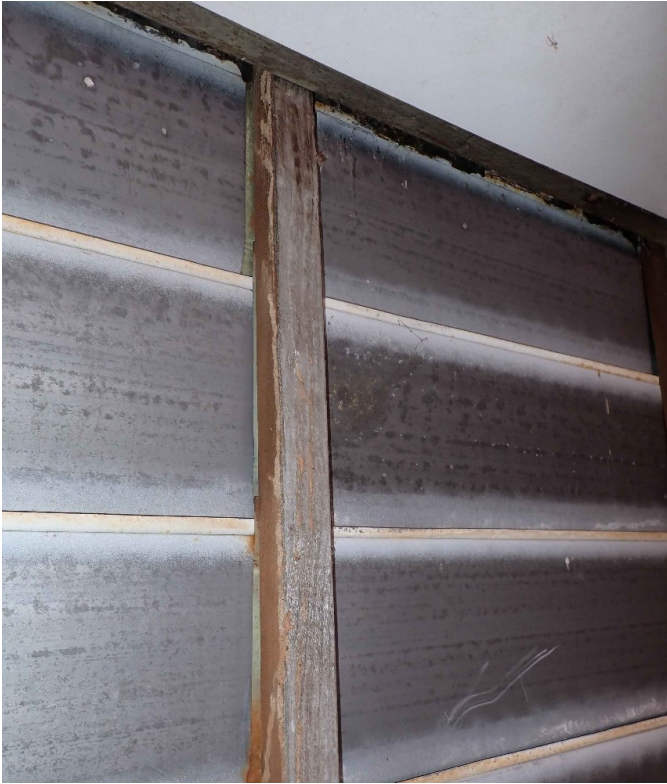
5. (G) Wood-Destroying Insect (WDI) activity has been detected during the inspection. Subterranean termite mud tubes were observed, indicating potential infestation. It is recommended to consult a qualified pest control professional for further evaluation and treatment options.

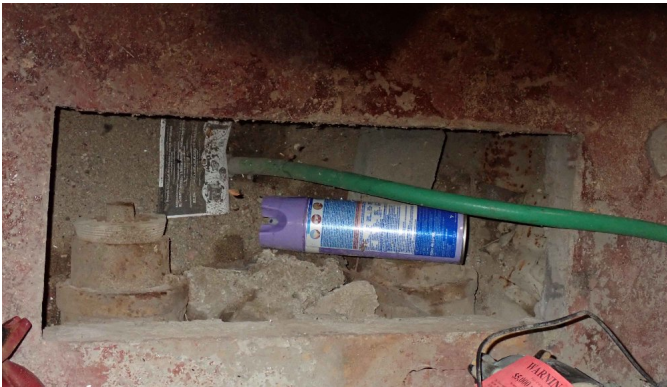
6. (B) There is a significant rectangular opening in the concrete slab that lacks a flush-mounted, load-bearing cover. This condition may pose safety risks. It is recommended to address this issue by installing an appropriate cover to ensure stability and safety.

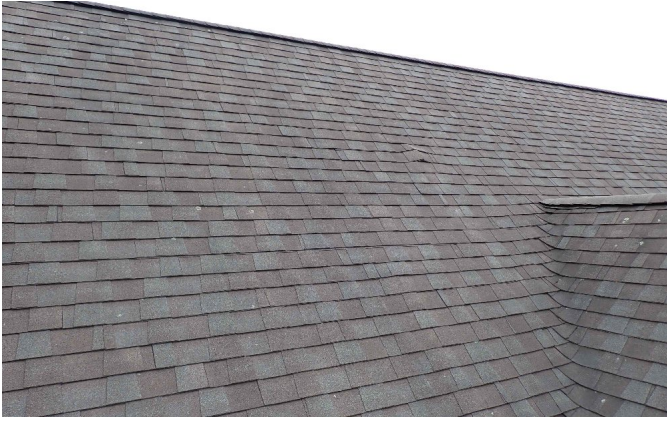
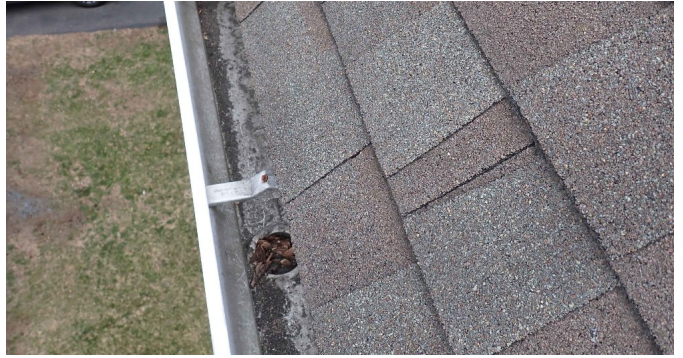
7. (R) The shingles on the roof are lifted and distorted, which may indicate potential water infiltration or damage to the roofing system. Additionally, the downspout opening is completely clogged, which could lead to water overflow and drainage issues. It is recommended to repair the shingles and clear the downspout to prevent further complications.

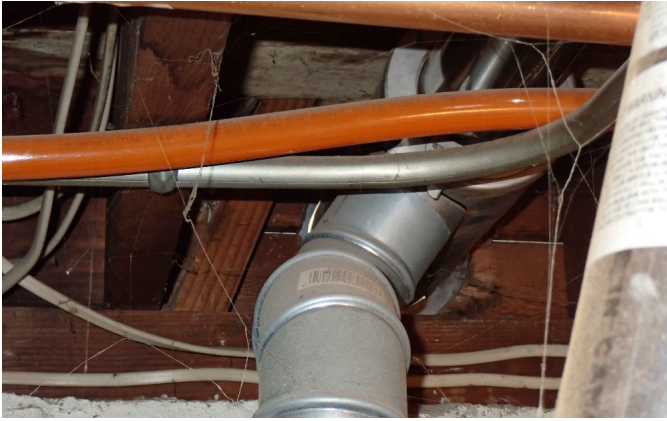
8. (P) The metal vent pipe, a single-wall connector, penetrates the rim joist and exterior wall without the installation of a fire-stop or air seal. This condition may pose a potential fire hazard and allow for air leakage. It is recommended to have a qualified professional evaluate and address this issue to ensure proper safety and energy efficiency.

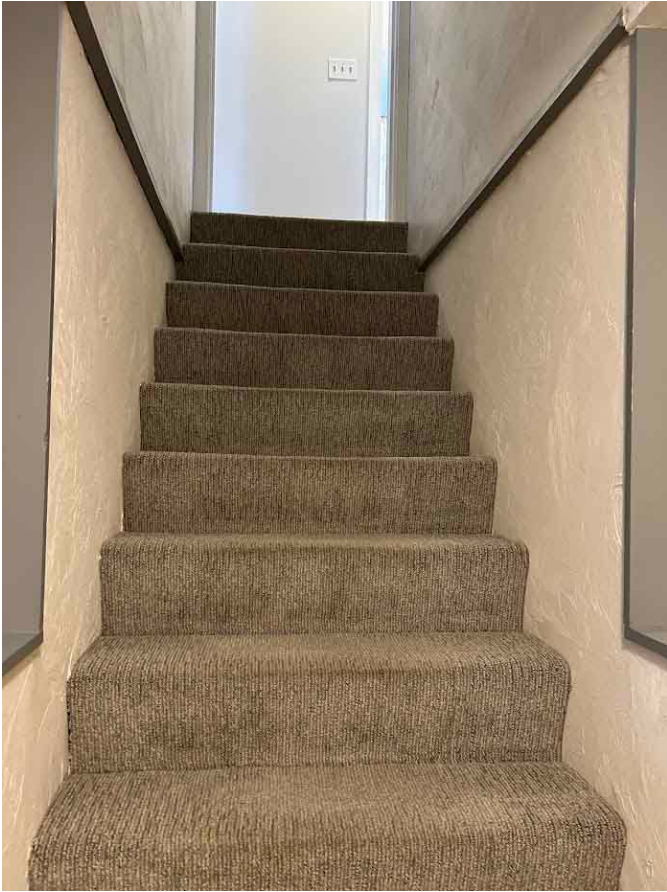
9. (S) No handrails are present on the stairway. It is recommended to install handrails to enhance safety and provide support while navigating the stairs. Lack of handrails can increase the risk of falls, particularly for individuals with mobility challenges. Proper installation of handrails should comply with local building codes and safety standards.

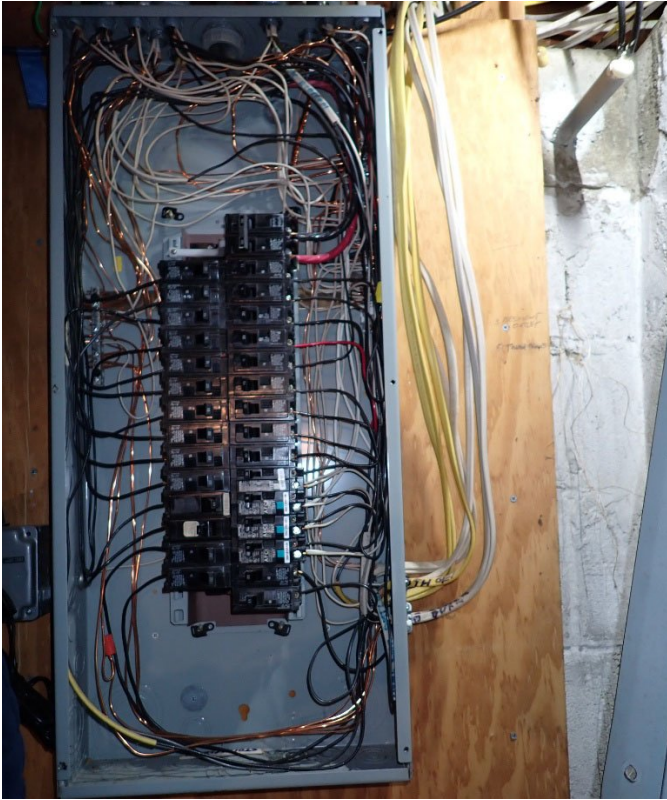
1. (E) The electrical panel exhibits several concerns that should be addressed for safety and compliance. Firstly, there are missing bushings and connectors, which can lead to potential wear and tear on the electrical wiring. Additionally, double-tapping has been observed, where two wires are connected to a single circuit breaker, potentially causing overheating and circuit failure. Furthermore, the grounding and neutral wires are mixed at both bus bars, which poses a significant safety hazard and may lead to electrical malfunctions. It is strongly recommended to consult a licensed electrician to evaluate these issues and perform the necessary corrections.

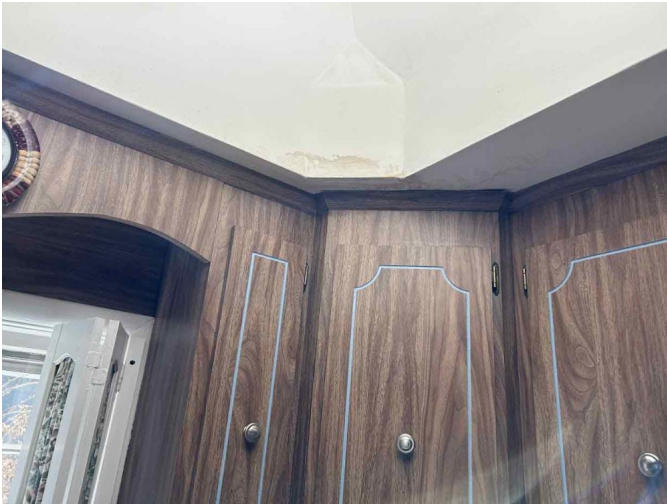
2. (R) There are indications of previous water damage observed beneath the skylights; however, no active leaks are present at this time.
2. 天窗下方有迹象表明之前曾有水渍损坏;但是, 目前没有发现漏水点。

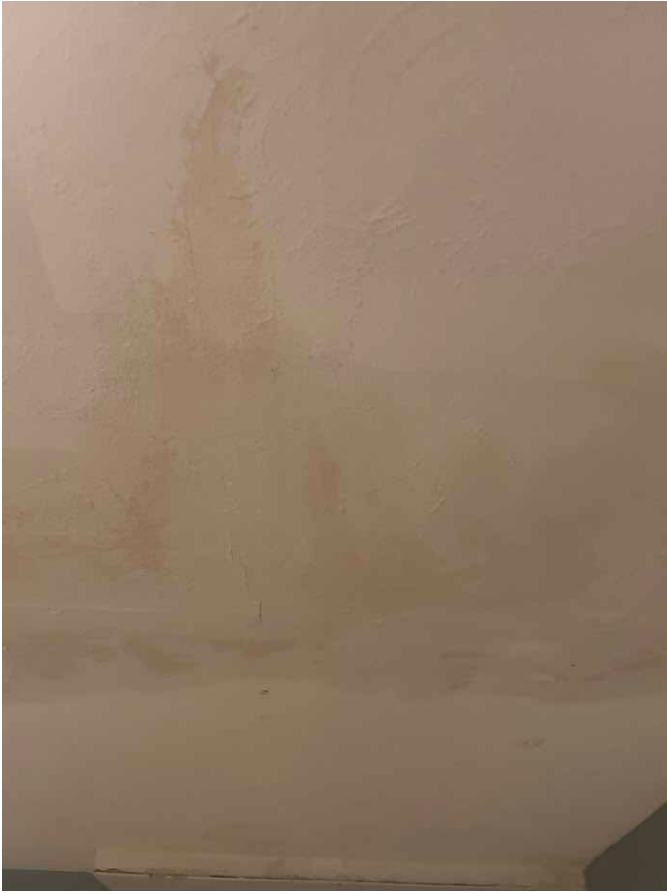
3. (L) There are signs of previous water damage on the ceiling. Currently, there are no active leaks observed.
3. 天花板上有之前漏水的痕迹。目前未发现漏水点。

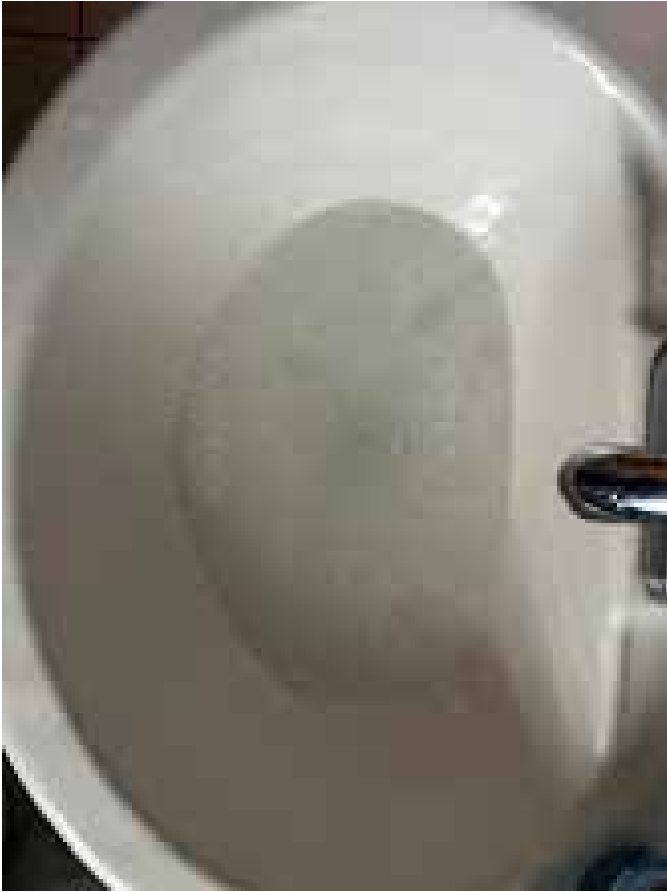
4. (B) The sink exhibits a slow drainage issue. This condition may indicate a partial blockage or buildup within the plumbing. It is recommended to monitor the situation closely and consider having a professional assessment or cleaning performed to prevent potential future complications such as water damage or further plumbing issues.

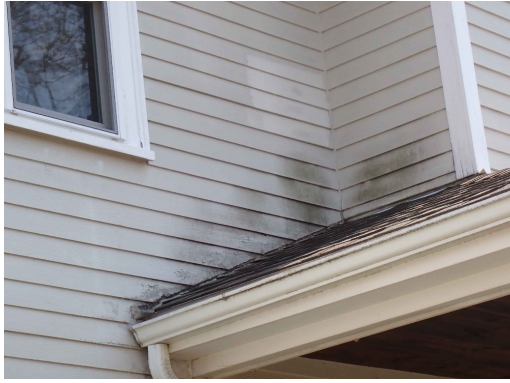
Porch	<input type="checkbox"/> Masonry	<input checked="" type="checkbox"/> Deck/Timber <input type="checkbox"/> NT <input checked="" type="checkbox"/> OK <input type="checkbox"/> MM <input type="checkbox"/> RR <input type="checkbox"/> EV <input type="checkbox"/> NA
Gas Meter/Entrance	<input checked="" type="checkbox"/> No Gas Odor noted Nearby Meter or in Utility Room	<input type="checkbox"/> NT <input checked="" type="checkbox"/> OK <input type="checkbox"/> MM <input type="checkbox"/> RR <input type="checkbox"/> EV <input type="checkbox"/> NA
NOTE:	<p>(Defect/Action Needed) Missing the kick-out flashing to divert the water to gutter. Signs of moisture absorption and delamination at the bottom edges. This condition may indicate the presence of moisture, which could lead to further mold growth and potential structural damage if not addressed promptly. It is recommended to investigate the source of moisture and take appropriate remediation measures to ensure a safe and healthy environment.</p>

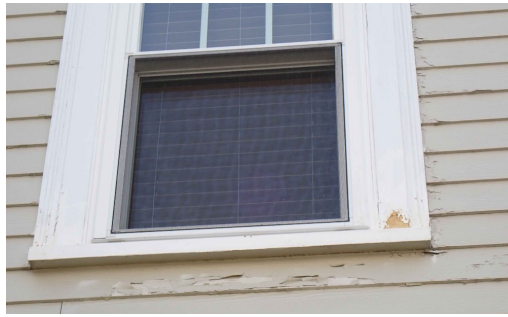
NOTE:	<p>(Defect/Action Needed) Wood rot was observed at the bottom right corner of the vertical window casing, where it meets the windowsill. Additionally, there is extensive paint failure noted across the window trim and the adjacent siding panels. It is recommended to address these issues promptly to prevent further deterioration and potential water intrusion.</p>

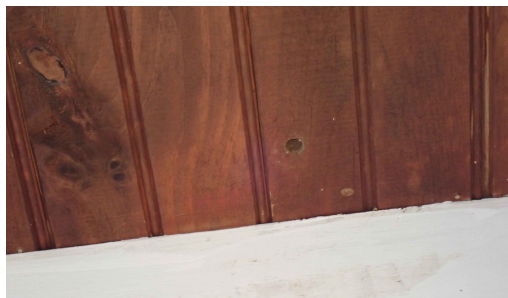
(Defect/Action Needed) During the inspection, evidence of wood-destroying insect (possibly carpenter bee) activity was observed on the porch ceiling. This condition may indicate an ongoing infestation, which can compromise the structural integrity of the wood components. It is recommended to engage a licensed pest control professional to assess the situation further and determine appropriate treatment options. Regular monitoring and preventive measures are advisable to mitigate potential damage in the future.

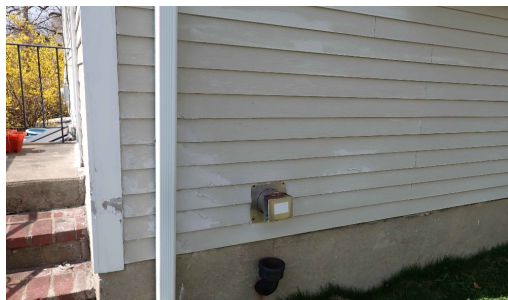
(Defect/Action Needed) The siding panels located adjacent to and below the vent show significant signs of surface delamination and paint peeling. This damage may be attributed to high-moisture, heated exhaust air from the vent, which is likely blowing directly against or swirling back toward the siding. It is recommended to further investigate the venting system and consider repairs or protective measures to prevent further deterioration of the siding.

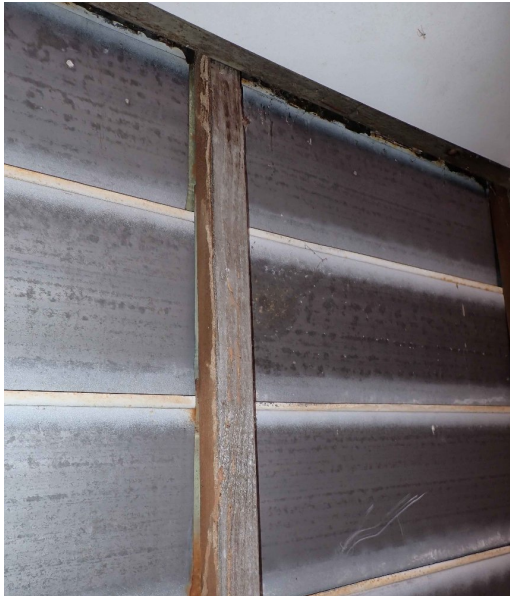
Garage Wall/Ceiling	<input type="checkbox"/> Drywalled	<input checked="" type="checkbox"/> Un-finished	<input checked="" type="checkbox"/> NT <input type="checkbox"/> OK <input type="checkbox"/> MM <input type="checkbox"/> RR <input type="checkbox"/> EV <input type="checkbox"/> NA
Fire Door			<input type="checkbox"/> NT <input type="checkbox"/> OK <input type="checkbox"/> MM <input type="checkbox"/> RR <input type="checkbox"/> EV <input type="checkbox"/> NA
Attic Above Garage	<input type="checkbox"/> Not Accessible	<input type="checkbox"/> Further Check Recommended	<input type="checkbox"/> NT <input type="checkbox"/> OK <input type="checkbox"/> MM <input type="checkbox"/> RR <input type="checkbox"/> EV <input checked="" type="checkbox"/> NA
NOTE:	<p>(Defect/Action Needed) Wood-Destroying Insect (WDI) activity has been detected during the inspection. Subterranean termite mud tubes were observed, indicating potential infestation. It is recommended to consult a qualified pest control professional for further evaluation and treatment options.</p> <div style="text-align: center;">

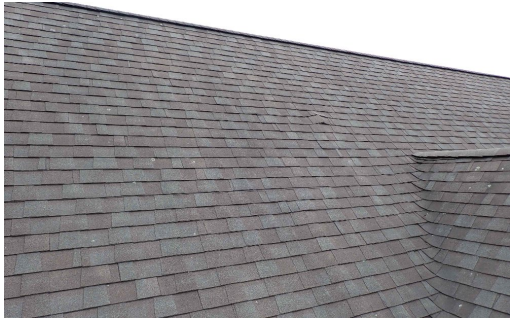
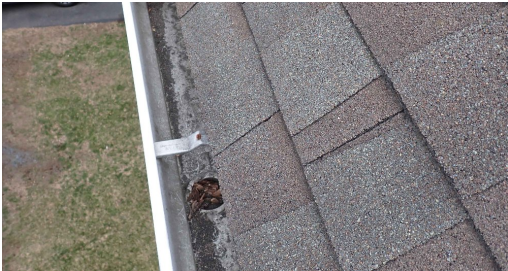
NOTE:	<p>(Defect/Action Needed) The shingles on the roof are lifted and distorted, which may indicate potential water infiltration or damage to the roofing system. Additionally, the downspout opening is completely clogged, which could lead to water overflow and drainage issues. It is recommended to repair the shingles and clear the downspout to prevent further complications.</p> <div style="display: flex; justify-content: space-around;">

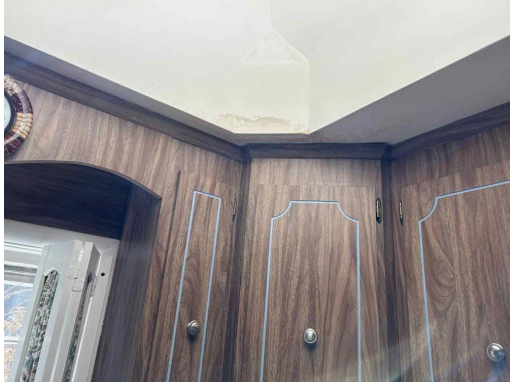
</div>		
NOTE:	<p>(Marginal/Deferred Maintenance) There are indications of previous water damage observed beneath the skylights; however, no active leaks are present at this time.</p>

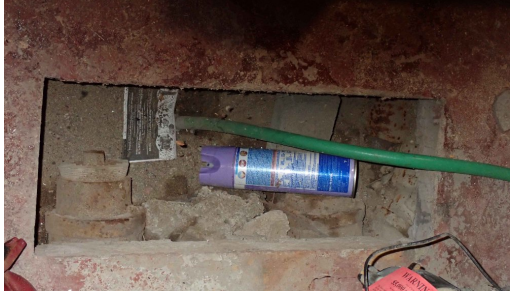
Sump Pump	<input type="checkbox"/> Pump <input type="checkbox"/> Cover Sealed	<input type="checkbox"/> Well	<input type="checkbox"/> NT <input type="checkbox"/> OK <input type="checkbox"/> MM <input type="checkbox"/> RR <input type="checkbox"/> EV <input type="checkbox"/> NA
Stairway			<input type="checkbox"/> NT <input type="checkbox"/> OK <input type="checkbox"/> MM <input type="checkbox"/> RR <input type="checkbox"/> EV <input type="checkbox"/> NA
NOTE:	<p>(Defect/Action Needed) There is a significant rectangular opening in the concrete slab that lacks a flush-mounted, load-bearing cover. This condition may pose safety risks. It is recommended to address this issue by installing an appropriate cover to ensure stability and safety.</p>

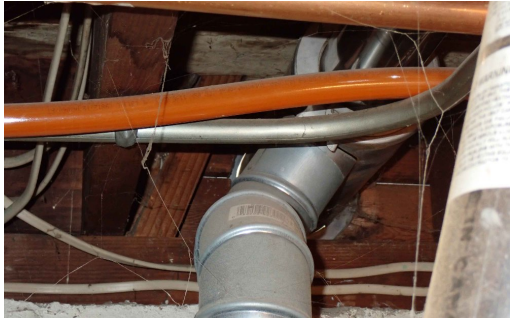
NOTE: **(Defect/Action Needed)** The metal vent pipe, a single-wall connector, penetrates the rim joist and exterior wall without the installation of a fire-stop or air seal. This condition may pose a potential fire hazard and allow for air leakage. It is recommended to have a qualified professional evaluate and address this issue to ensure proper safety and energy efficiency.

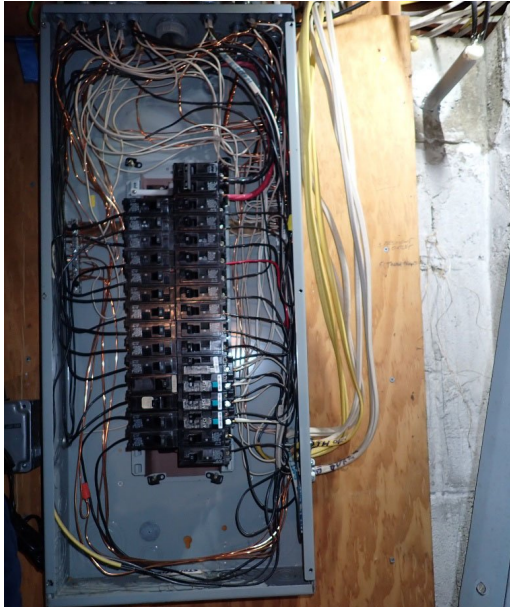
NOTE:	<p>(Marginal/Deferred Maintenance) The electrical panel exhibits several concerns that should be addressed for safety and compliance. Firstly, there are missing bushings and connectors, which can lead to potential wear and tear on the electrical wiring. Additionally, double-tapping has been observed, where two wires are connected to a single circuit breaker, potentially causing overheating and circuit failure. Furthermore, the grounding and neutral wires are mixed at both bus bars, which poses a significant safety hazard and may lead to electrical malfunctions. It is strongly recommended to consult a licensed electrician to evaluate these issues and perform the necessary corrections.</p>

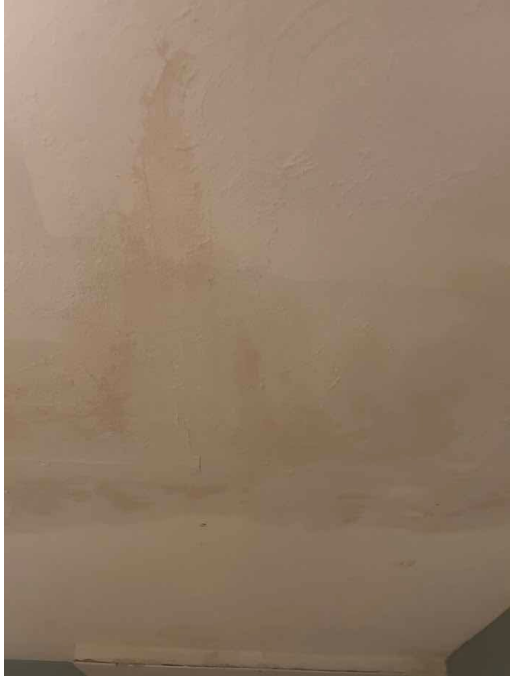
Trim			<input type="checkbox"/> NT <input type="checkbox"/> OK <input type="checkbox"/> MM <input type="checkbox"/> RR <input type="checkbox"/> EV <input type="checkbox"/> NA
NOTE:	<p>(Marginal/Deferred Maintenance) There are signs of previous water damage on the ceiling. Currently, there are no active leaks observed.</p> <div style="text-align: center;">

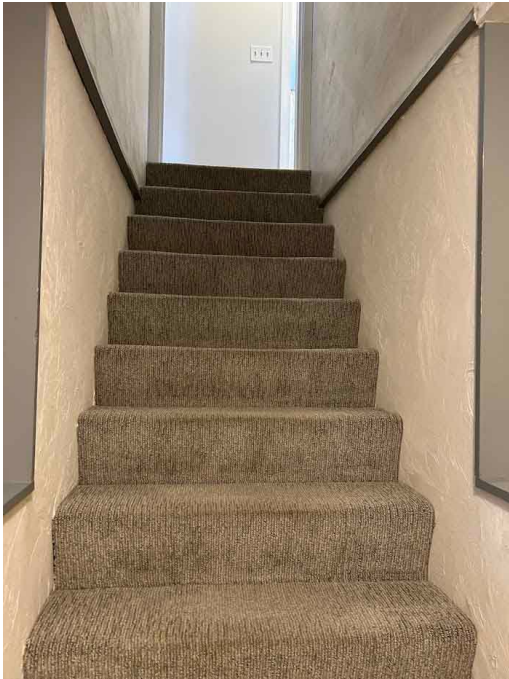
Headroom		<input type="checkbox"/> NT <input checked="" type="checkbox"/> OK <input type="checkbox"/> MM <input type="checkbox"/> RR <input type="checkbox"/> EV <input type="checkbox"/> NA
Lighting		<input type="checkbox"/> NT <input checked="" type="checkbox"/> OK <input type="checkbox"/> MM <input type="checkbox"/> RR <input type="checkbox"/> EV <input type="checkbox"/> NA
NOTE:	<p>(Defect/Action Needed) No handrails are present on the stairway. It is recommended to install handrails to enhance safety and provide support while navigating the stairs. Lack of handrails can increase the risk of falls, particularly for individuals with mobility challenges. Proper installation of handrails should comply with local building codes and safety standards.</p>
