SECOND BUILD LLC

PROPERTY VERIFICATION REPORT | COMMERCIAL INSPECTION

| Property Address | 125 New Franklin Road, LaGrange, Georgia 30240 | | |
| Property Type | Retail — Dollar General | Report ID | SB-2024-DG-001 |

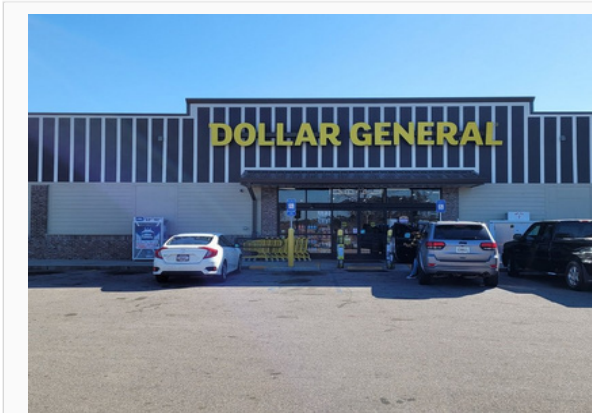
Photo 1 — Front Facade | Entrance & Signage

| 1 | Exterior / Facade | Building exterior in good condition. Facade panels intact, paint fresh, no visible damage or staining. |
| 3 | Signage | Lit pylon sign in good working condition. Facade channel letter signage intact and properly illuminated. |

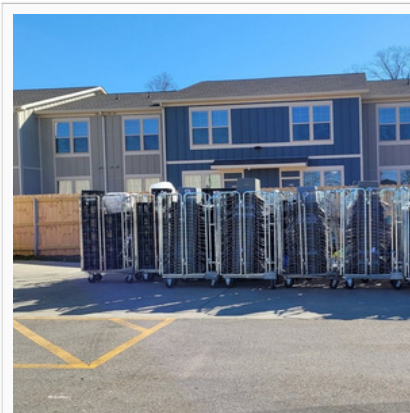
Photo 4 — Rear / Equipment Area

| 6 | Equipment (Rear) | Multiple wire roll cages and delivery equipment staged along the rear and side of the building. Equipment appears operational but creates visual clutter. |

| Rear Equipment Staging | Large volume of roll cages stored along the rear and side perimeter. May reflect standard delivery operations but warrants monitoring for lease compliance. |
