# Stratford Green Condominium Association

Willowbrook, IL • December 20, 2022

FULL RESERVE STUDY

STRATFORD GREEN

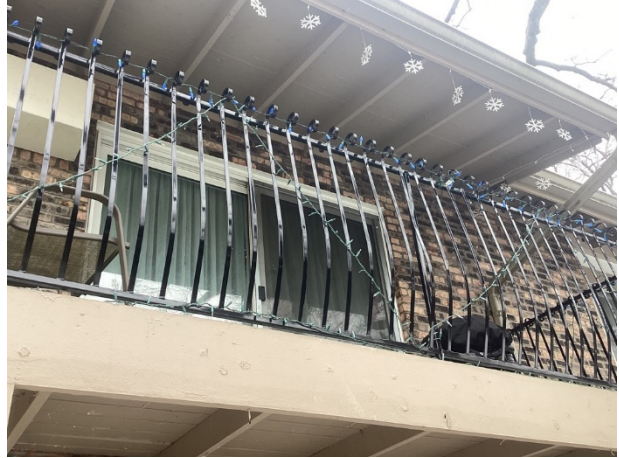
**Replaced railings**

**Railing rust**

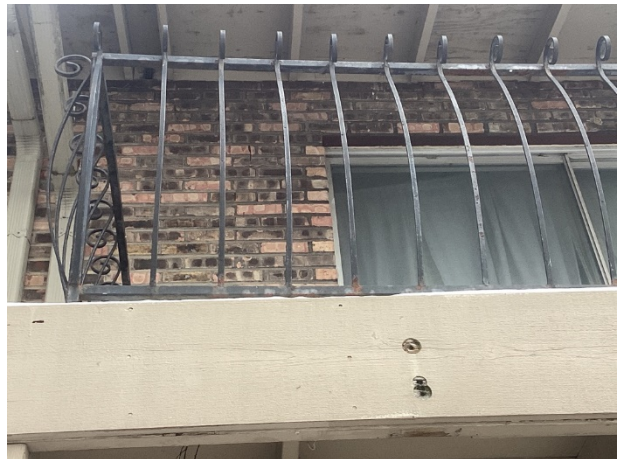
**Railing rust**

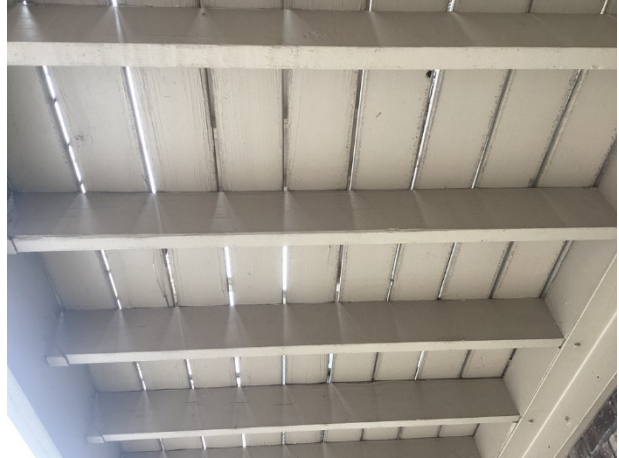
**Wood deck boards**

**Fascia rot**

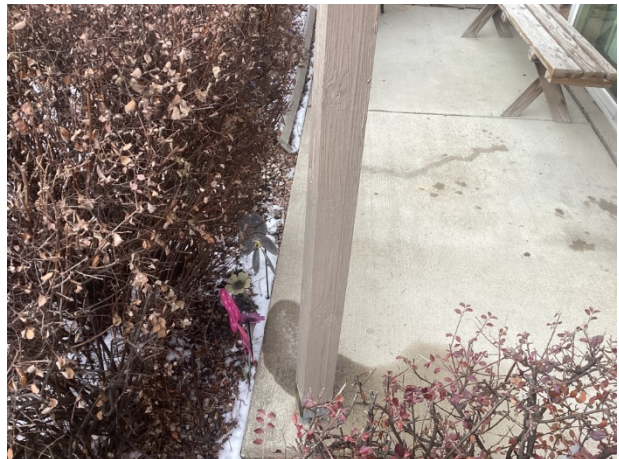
**Support torsion**

**Replaced support**

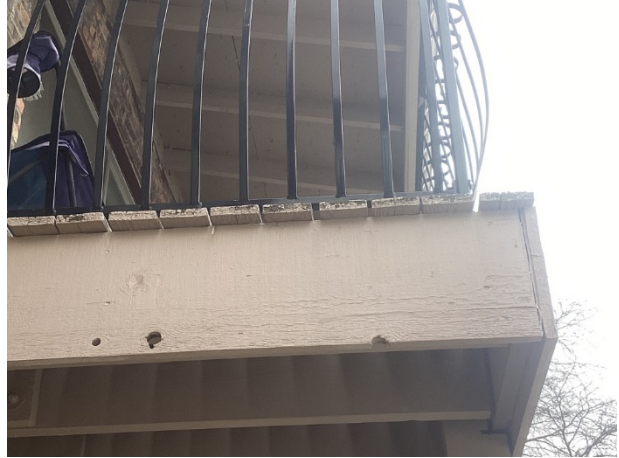
**Deck board finish deterioration and organic growth**

**Deck board and fascia wood rot – note finish deterioration**

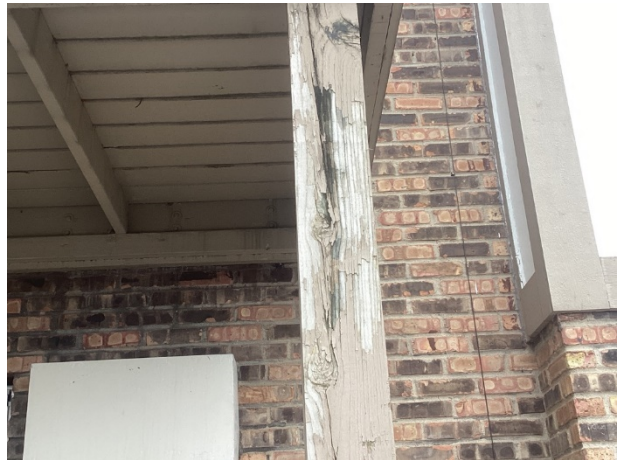
**Support rot and wood split**

**Bowed support**

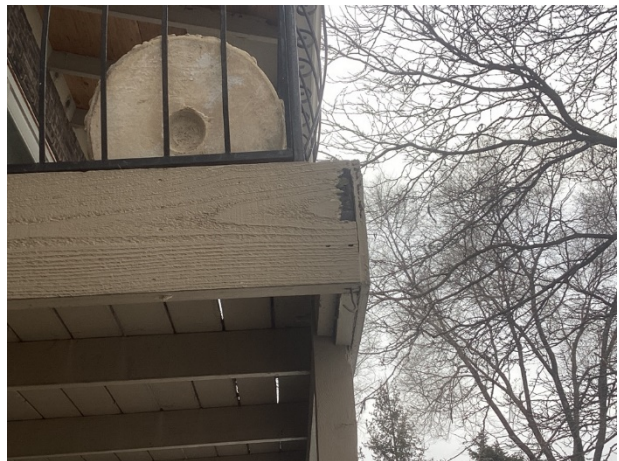
**Fascia wood rot**

**Replaced deck boards**

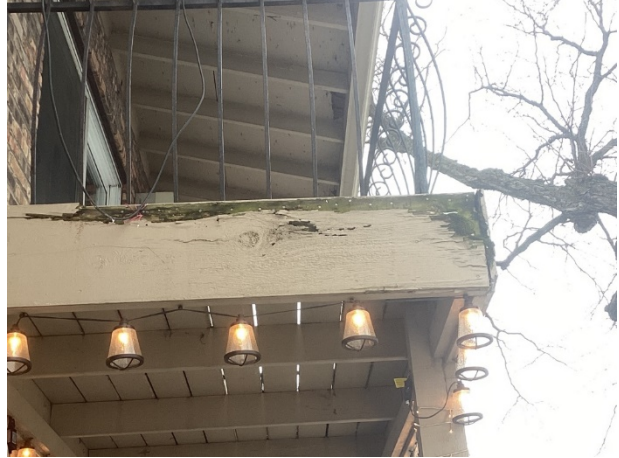
**Wood rot and organic growth**

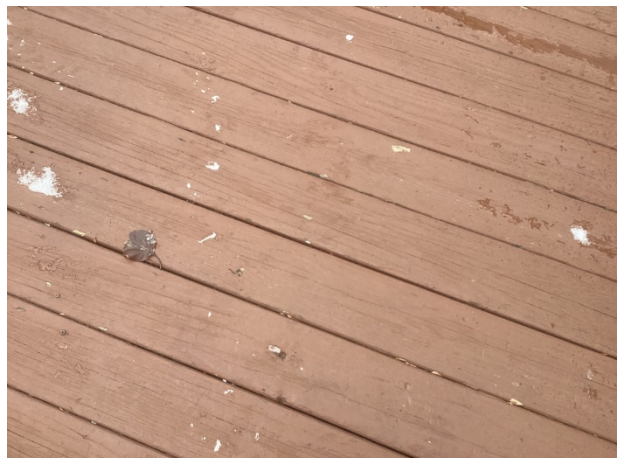
**Bowing deck boards**

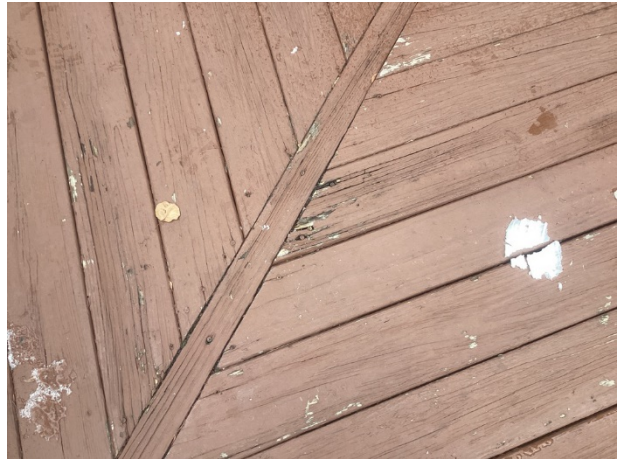
**Wood rot and damage**

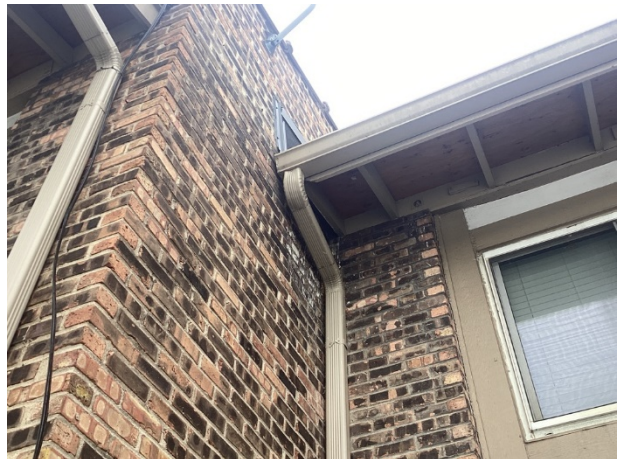
**Downspout damage – note small capacity at building 13**

**Typical gutters and downspouts**

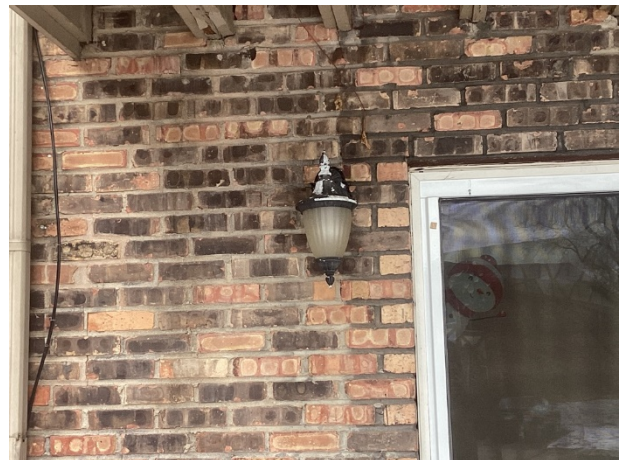
**Fixture finish deterioration**

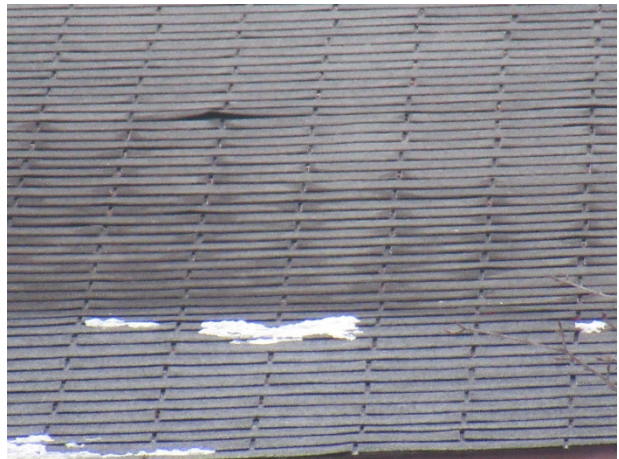
**Shingle lift – note dimensional shingles (building 10 shown)**

**Shingle lift (building 18 shown)**

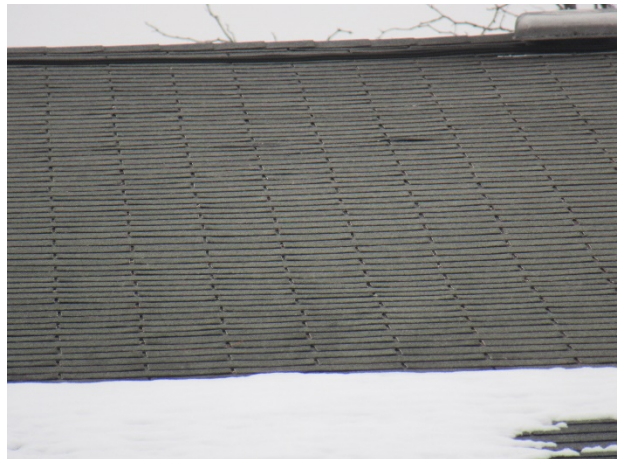
**Three tab shingles – note shingle lift (remaining roof shown)**

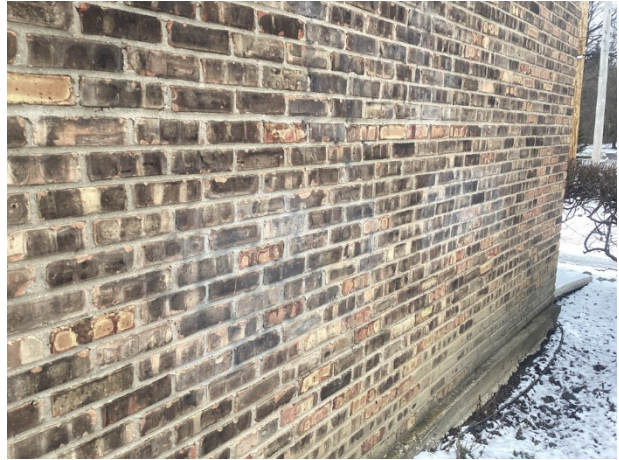
**Masonry cracks**

**Masonry efflorescence**

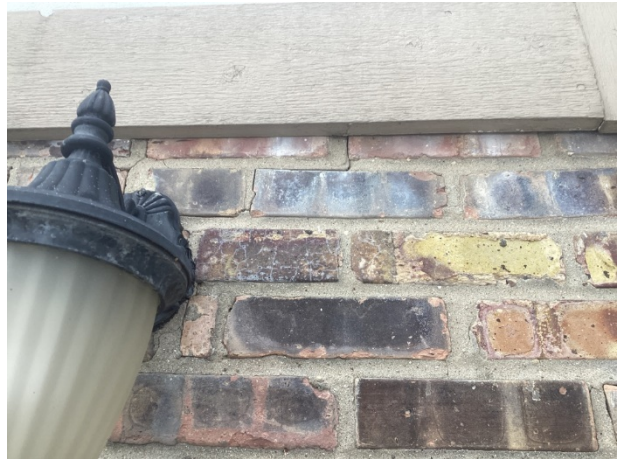
**Mortar deterioration**

**Step crack and efflorescence**

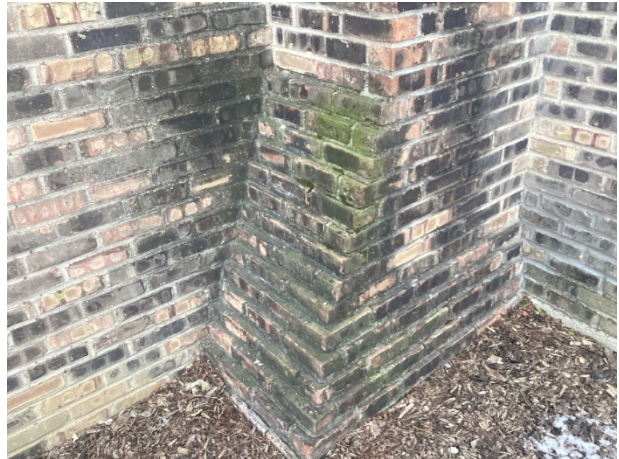
**Masonry cracks**

**Organic growth**

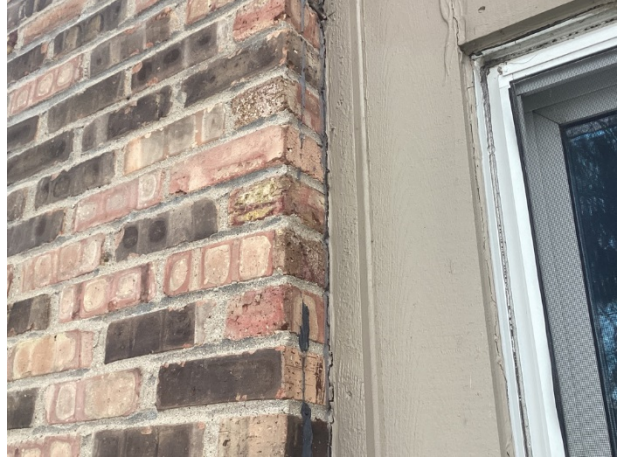
**Sealant deterioration**

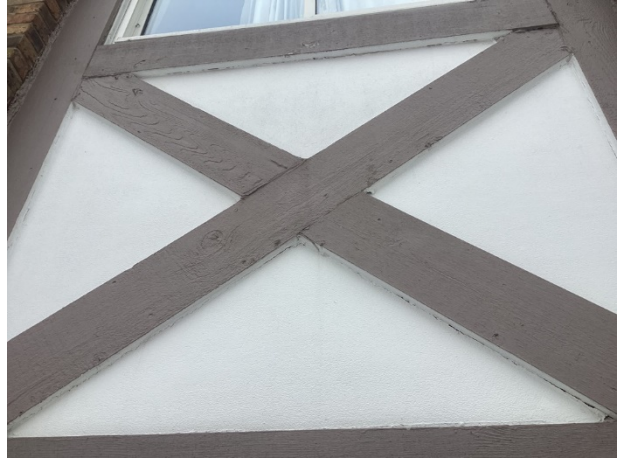
**Trim finish deterioration**

**Fiber cement panel overview – note good condition**

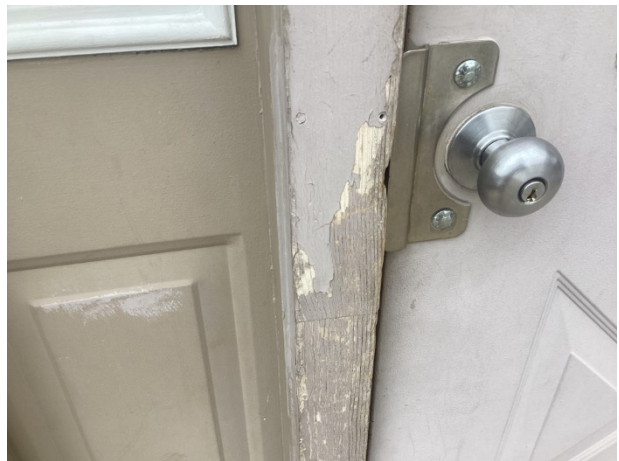
**Plywood siding deterioration**

**Trim finish deterioration**

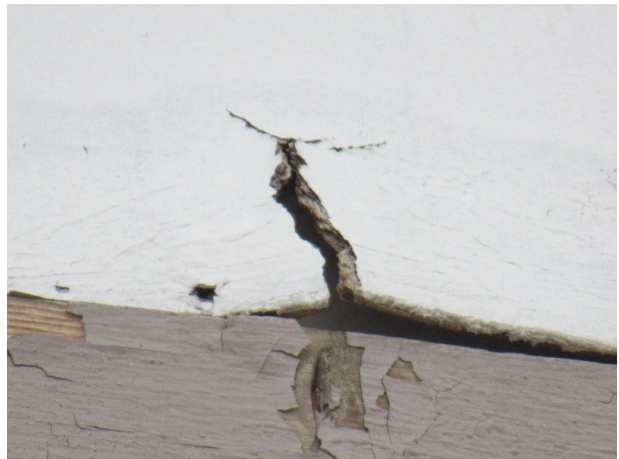
**Plywood damage**

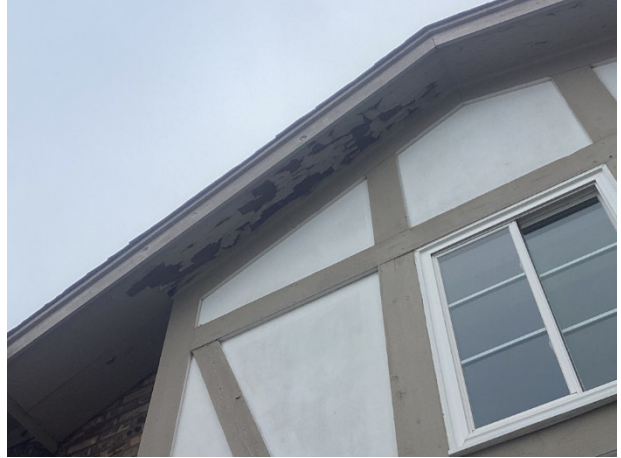
**Fascia trim deterioration**

**Wood soffit deterioration**

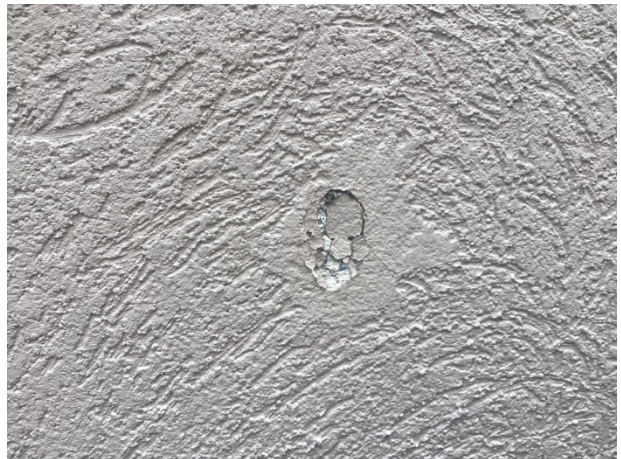
**Wood soffits and fascia – note finish deterioration**

**EIFS damage at the clubhouse**

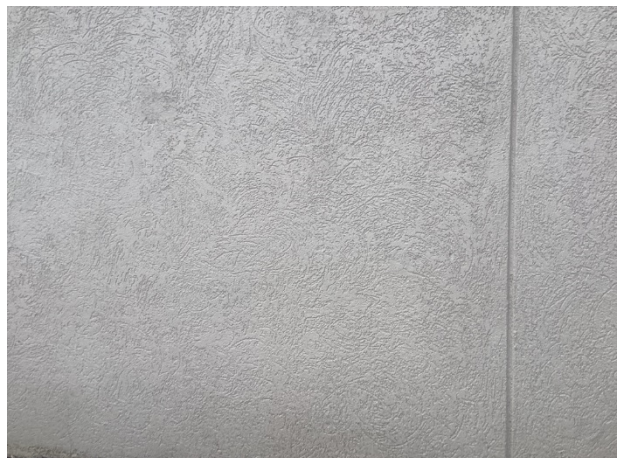
**EIFS damage (clubhouse shown)**

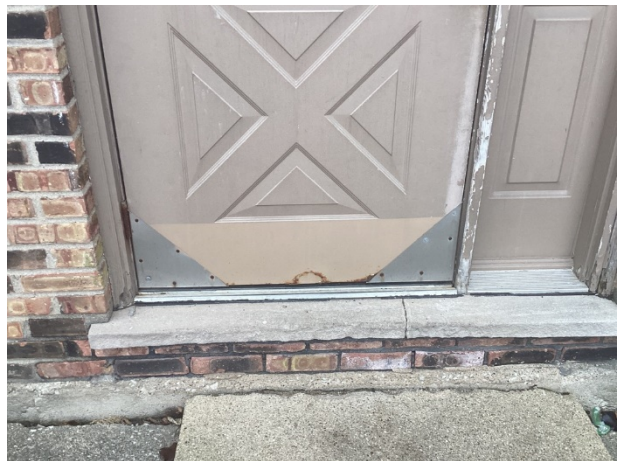
Common entrance door rust

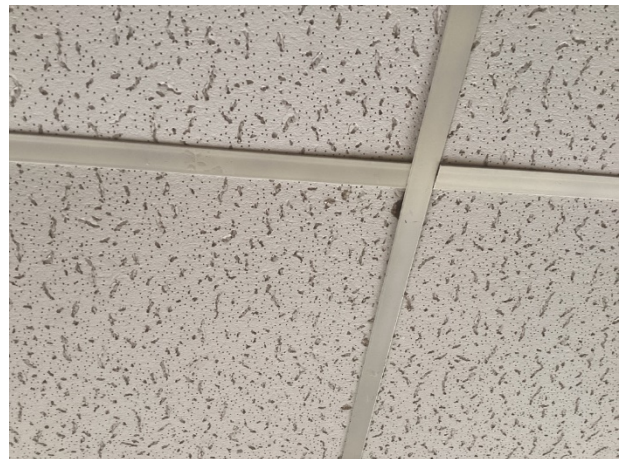
**Ceiling tile damage**

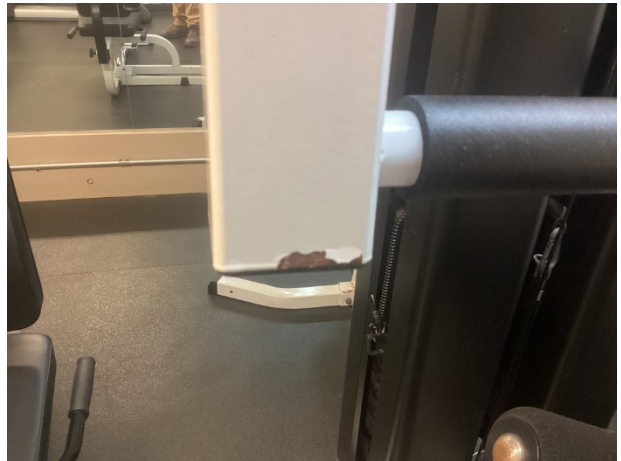
Exercise equipment rust

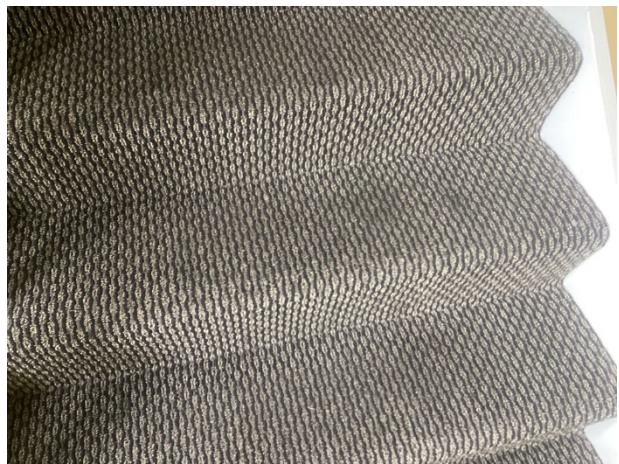
**Carpet overview – note stains**

**Carpet stains**

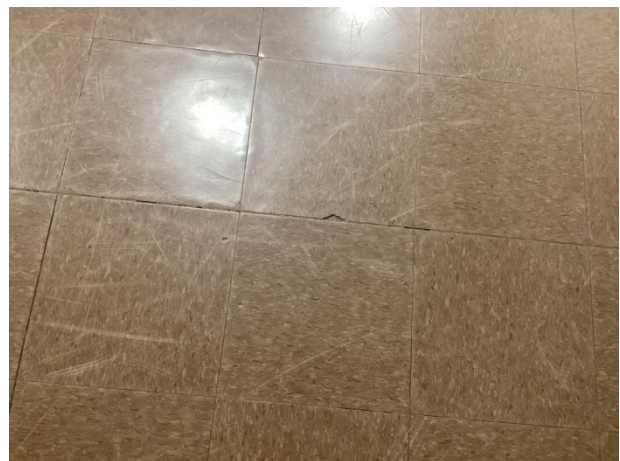
**Vinyl tile damage**

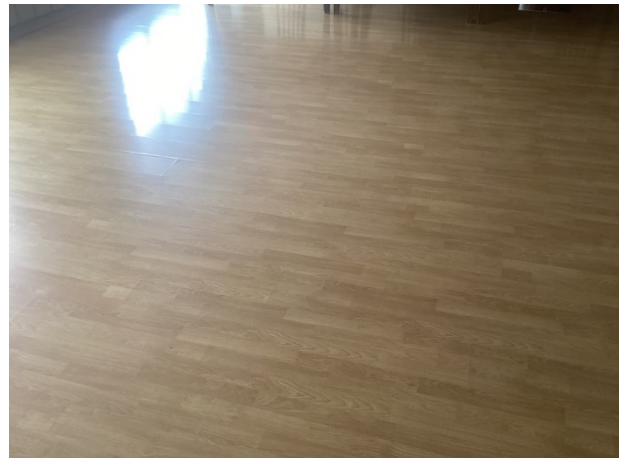
Laminate floor damage

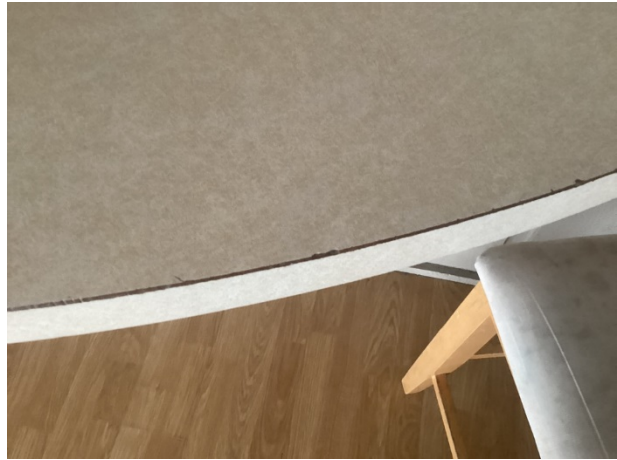
Countertop damage

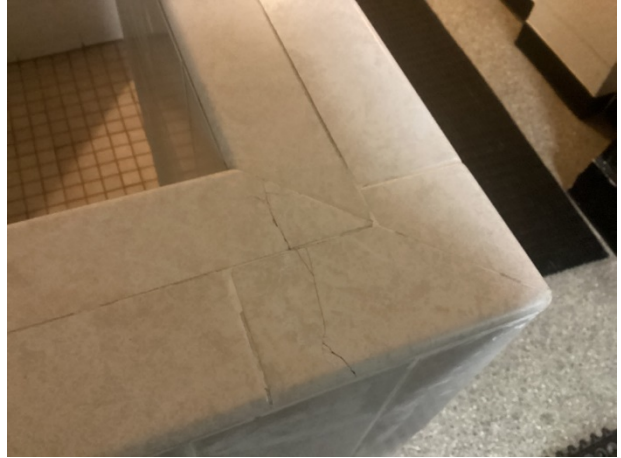
**Shower tile crack**

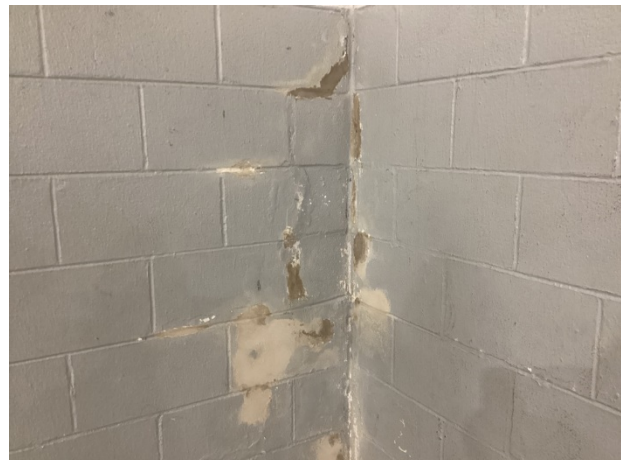
**Wall scuffs and inconsistent paint finishes**

**Finish deterioration (gymnasium shown)**

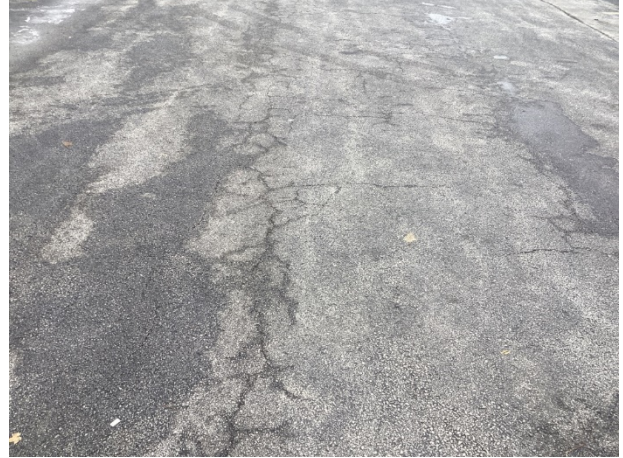
**Alligator cracks**

**Pavement cracks**

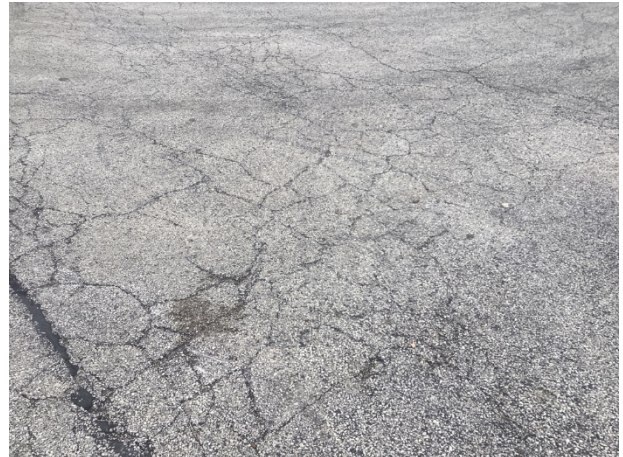
**Asphalt pavement access drive overview – note alligator cracks**

**Pavement cracks**

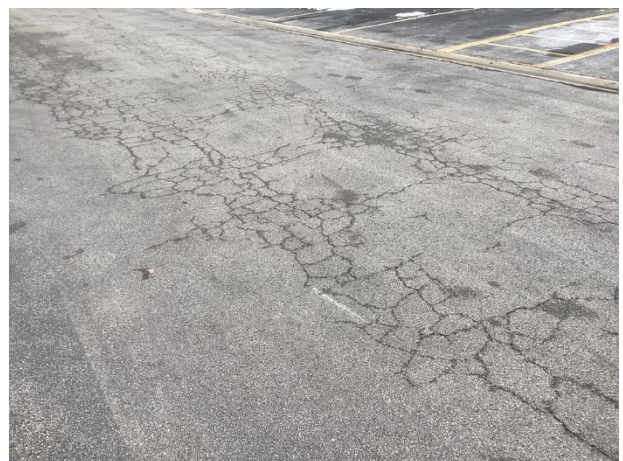
**Pavement cracks**

**Pavement alligator cracks**

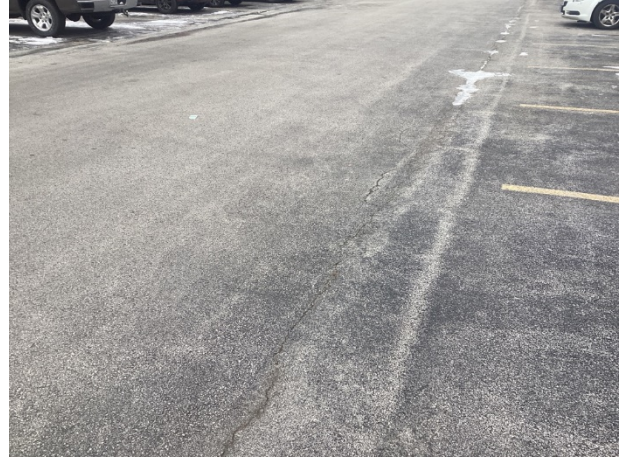
**Pavement spalls**

**Asphalt pavement access drive overview – note cracks**

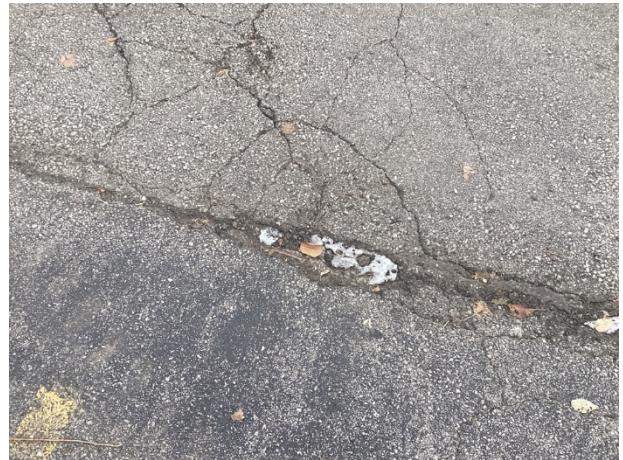
**Pavement cracks**

**Damage and cracks**

**Component Detail Notes:** Patch repairs are conducted at areas exhibiting settlement, potholes, or excessive cracking. These conditions typically occur near high traffic areas, catch basins, and pavement edges.

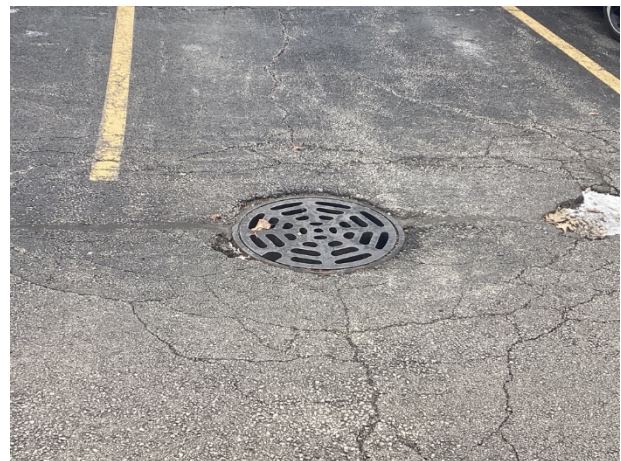
**Catch basin settlement**

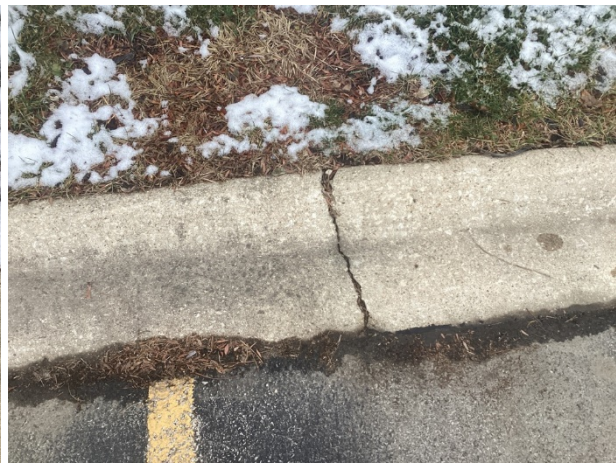
Concrete curb crack

Concrete curb and gutter crack

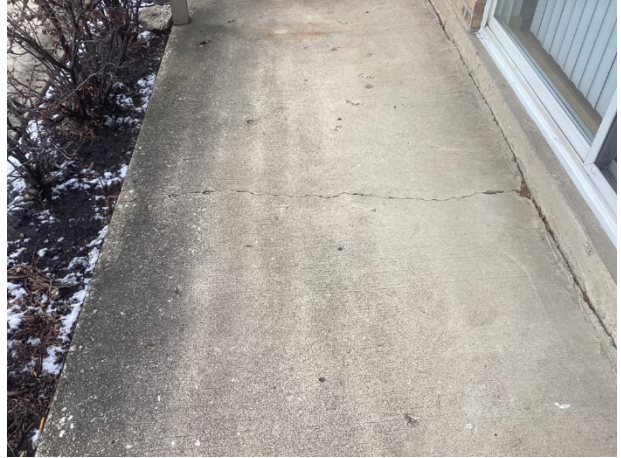
**Sidewalk cracks**

**Patio crack**

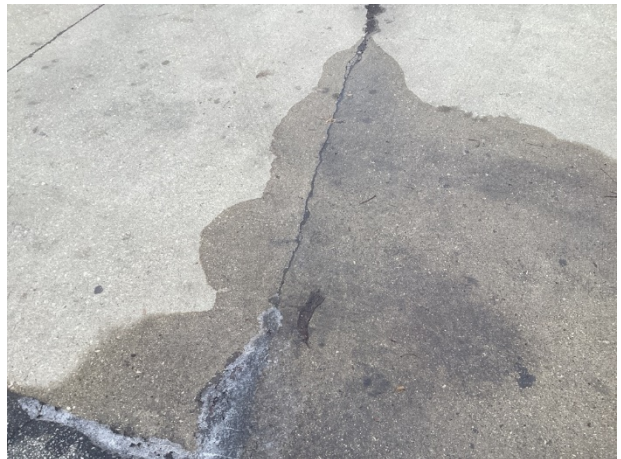
**Sidewalk crack**

**Trash pad crack**

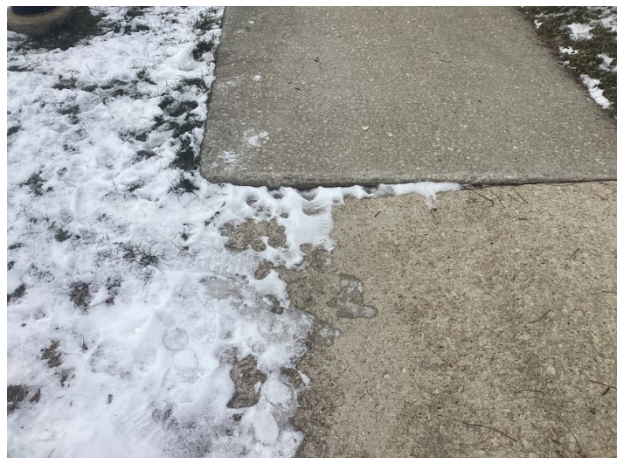
**Sidewalk crack**

**Trip hazard**

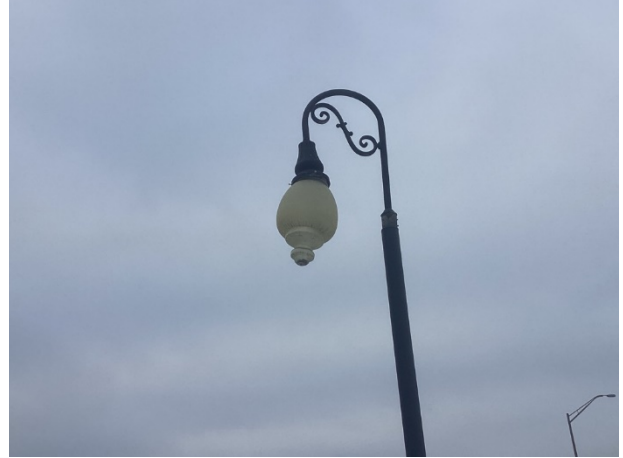
**Loose fixture**

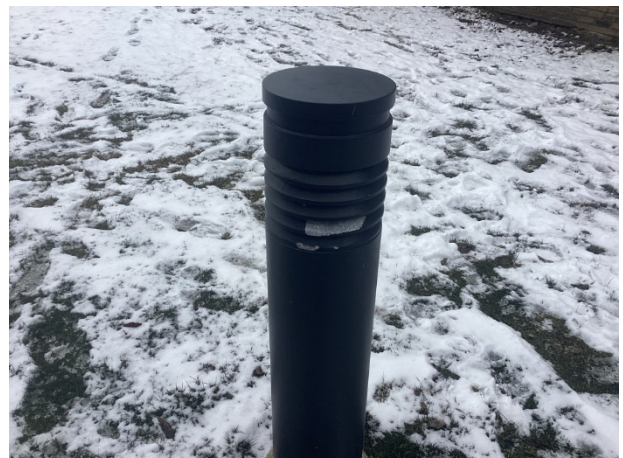
**Bollard light fixture – note finish deterioration**

**Bollard light finish deterioration**

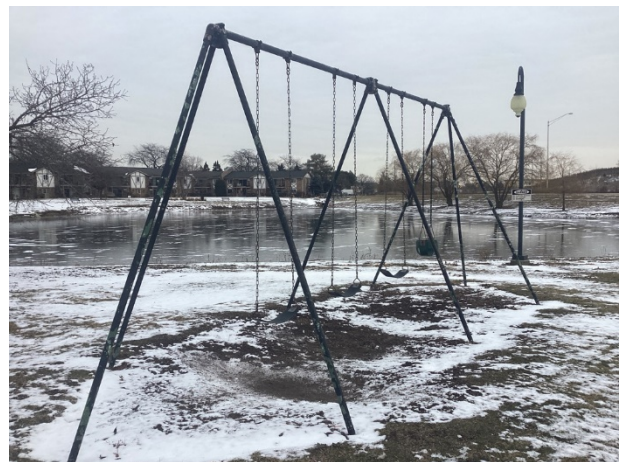
**Swings – note finish deterioration**

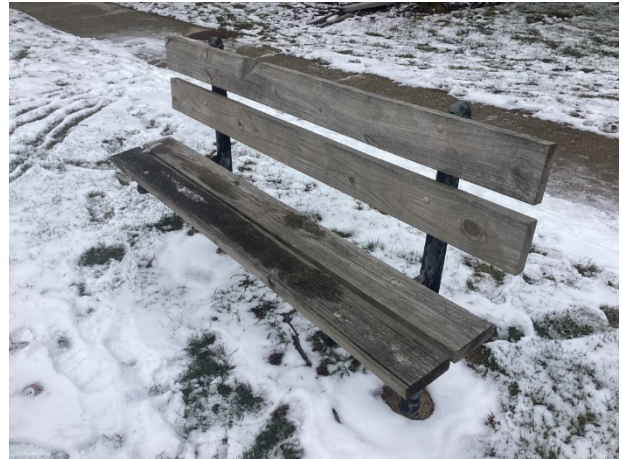
**Picnic table – note deterioration**

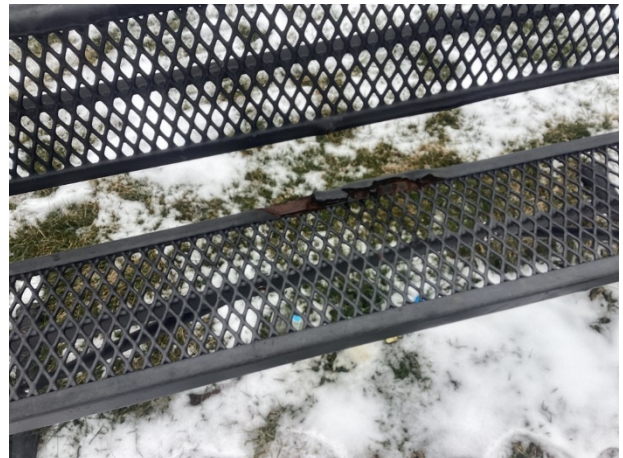
**Picnic table – note damage and rust**

**Bench rust and damage**

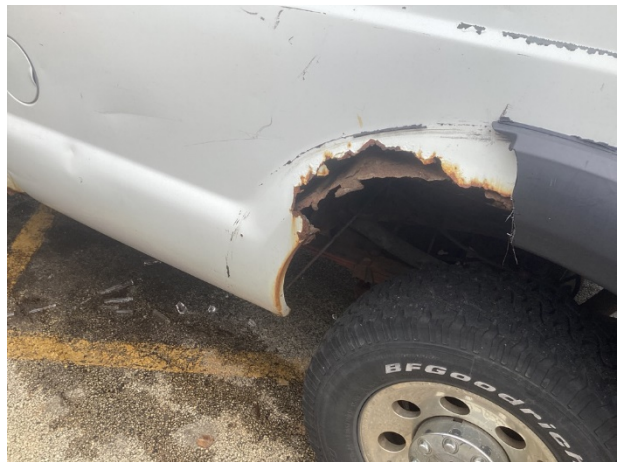
**Rust at wheel-well**

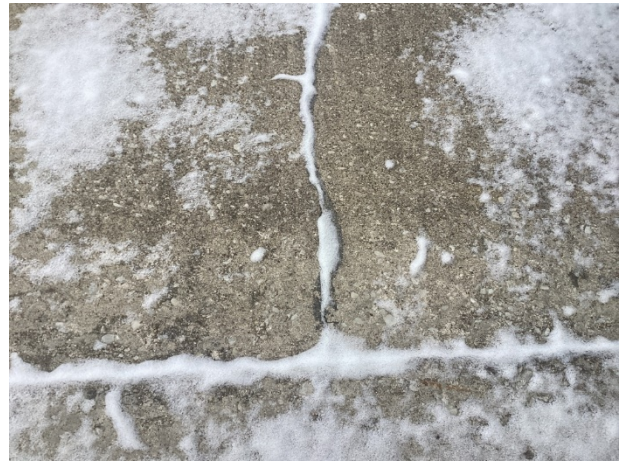
**Pool deck cracks**

**Pool deck crack**

**Useful Life:** The useful life of a concrete pool deck is up to 60 years or more with timely repairs. We recommend the Association conduct inspections, partial replacements and repairs to the deck every 8- to 12-years.

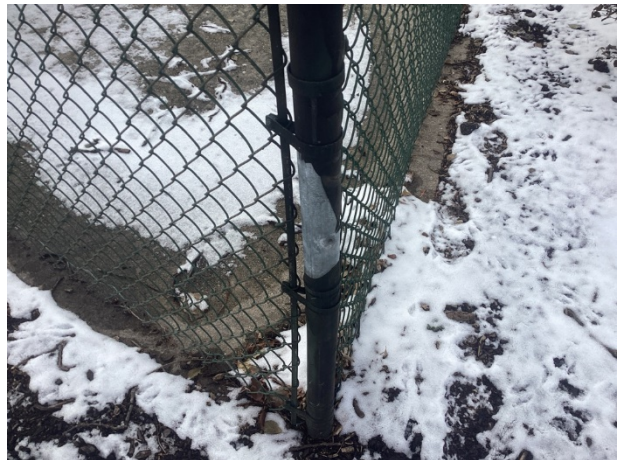
**Fence warped webbing**

**Post finish deterioration**
