# Home Inspection Report

## Street address here City, State & zip here

## File # 6030

Inspection date: 3.15.2025 Inspected by: Jerry @ JNS Inspections Cell: 541-921-5150 E-mail: jnsinspections30@gmail.com OCHI #1544 | CCB #79989

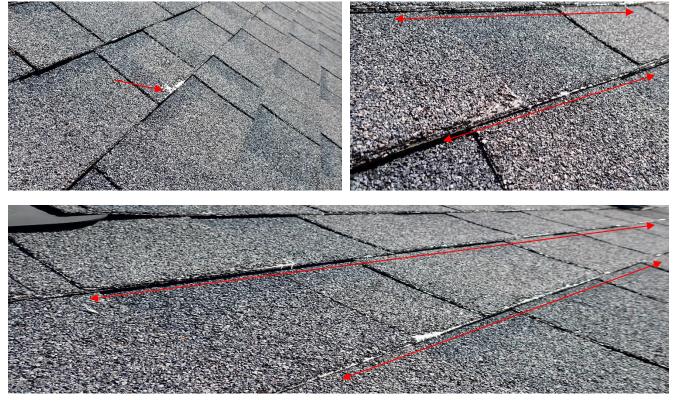
☑This roof is showing signs of ending lifecycle, consider replacement. Have roofing contractor evaluate.

Examples below of exposed fibers along composition edges.

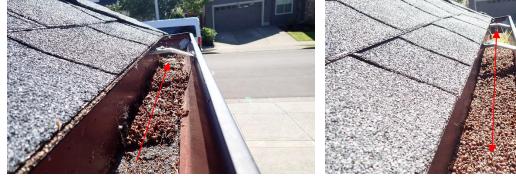
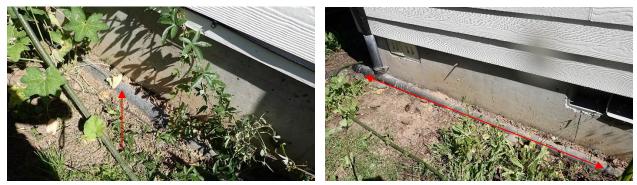
☑ Gutters contain organic material and can plug drain to downspout, recommend removing material.

- □ Several perimeter nail-heads securing gutters to roof system are loose and need tightened.
- Downspouts need to terminate away from foundation a minimum of **5-10'**.
- $\Box$  Areas of downspouts have poor connection to rain drain system, recommend repairs.
- □ Gutters pulling away from roof support, recommend re-securing.
- ☑ Recommend covering rain-drain pipes for protection 3-6"... see pictures.

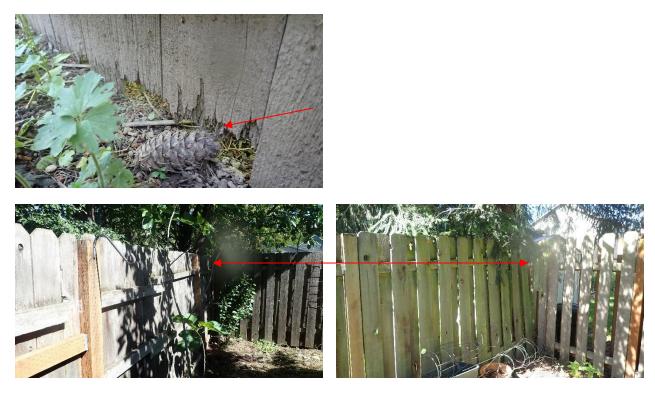
Wood fencing is dry-rotted in areas and leaning in several spots, review/repair as needed.

Fence leaning in several areas.
