The Dam at Laurel Forge Pond (Laurel Lake) in Pine Grove Furnace State Park

compiled by Andre Weltman, 2013-2024

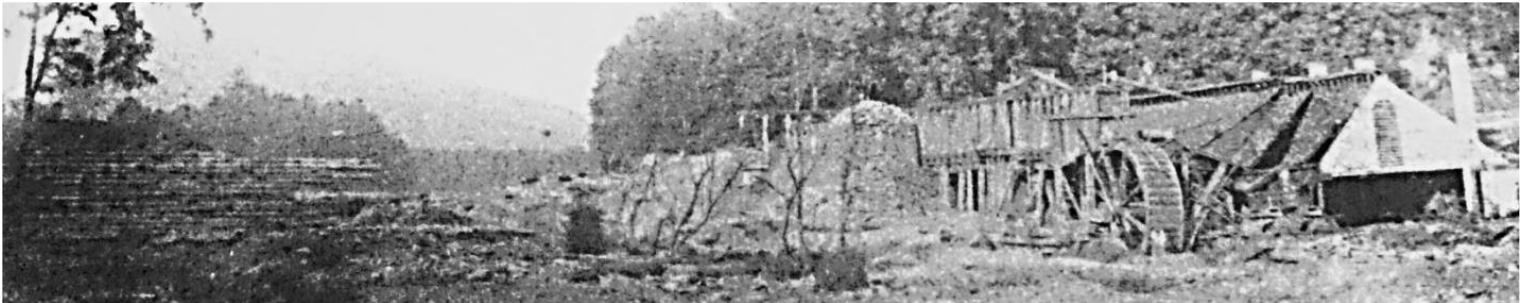
Bottom: Laurel Forge dam after it failed in May 1889. Horizontal logs in the “timber crib” are visible to left. The dam is missing in the middle. Note forge waterwheels.

June 1889: The forge dam burst after storms that also led to many floods & dam failures across Pennsylvania, most famously in Johnstown. Laurel Forge and a house were swept away (and bridges and a Mt. Holly paper mill dam downstream were also destroyed). The dam and forge were again rebuilt.
