SECOND BUILD LLC

PROPERTY VERIFICATION REPORT | COMMERCIAL INSPECTION

Property Address	125 New Franklin Road, LaGrange, Georgia 30240		
Property Type	Retail — Dollar General	Report ID	SB-2024-DG-001
Date of Inspection	February 22, 2026	Time of Inspection	10:00 AM
Inspector	Second Build LLC	Client Type	Property Owner / NNN Investor

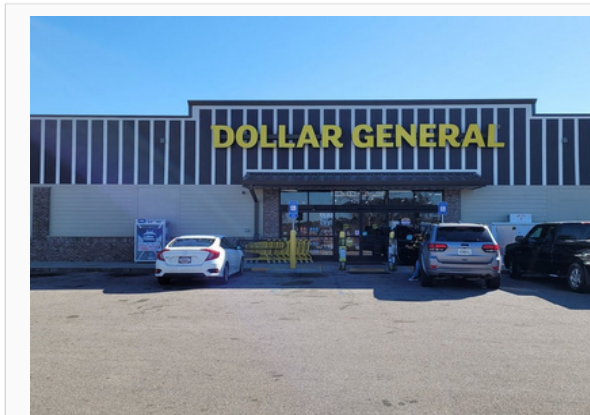
Photo 1 — Front Facade | Entrance & Signage

1	Exterior / Facade	Building exterior in good condition. Facade panels intact, paint fresh, no visible damage or staining.
2	Roof (Visible)	Metal standing-seam roof visible from street. No visible sagging, missing panels, or storm damage noted at time of visit.
3	Signage	Lit pylon sign in good working condition. Facade channel letter signage intact and properly illuminated.
4	Parking Lot	Surface lot is functional. Minor pavement cracking and early-stage pothole formation observed in two areas. Light debris and litter scattered across the lot near the entrance.
5	Landscaping / Grounds	Grass areas adjacent to the lot perimeter show uneven growth and overgrown weeds along the fence line. Grounds lack recent maintenance. Dead vegetation visible along the eastern boundary.

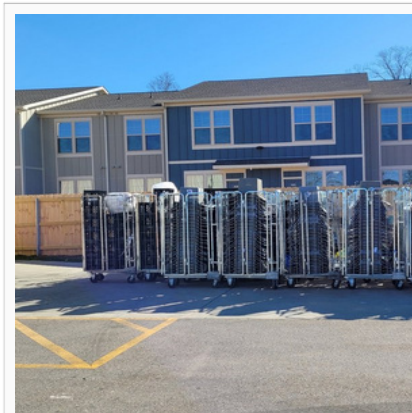
Photo 4 — Rear / Equipment Area

6	Equipment (Rear)	Multiple wire roll cages and delivery equipment staged along the rear and side of the building. Equipment appears operational but creates visual clutter.
7	Adjacent Property	Multi-family residential complex (townhomes) directly behind the subject property. Fence line separates properties. Residential units appear occupied and in good condition.
8	Business Activity	Store was open and active at time of inspection. Multiple customers and vehicles present. Adequate traffic for a mid-morning weekday.
