Inventory & Check In

Address	123 Sample Street, Sample City, Sampleshire, AB1 2CD
Date	May 9th 2026
Clerk	A. Clerk
Client	Example Lettings Ltd

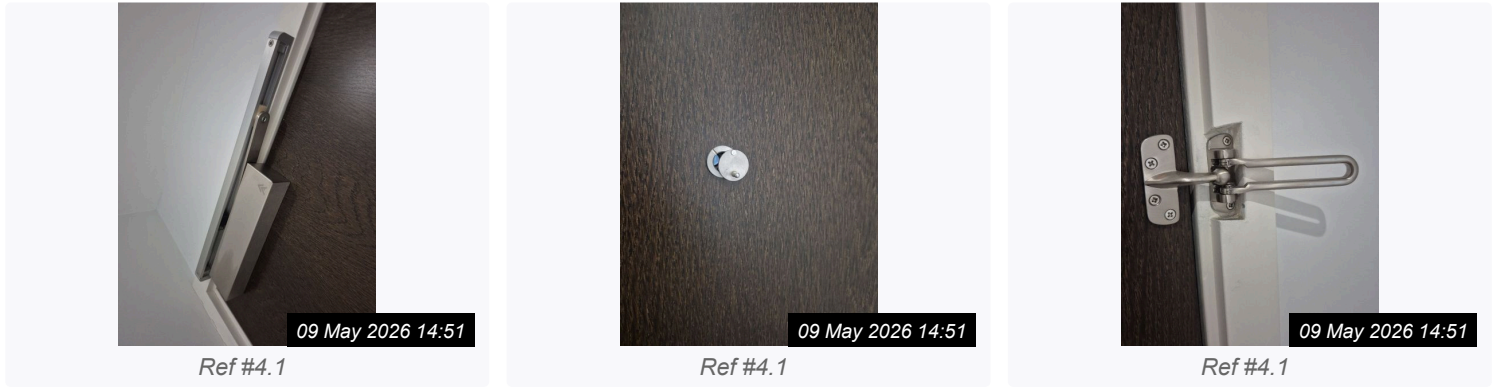
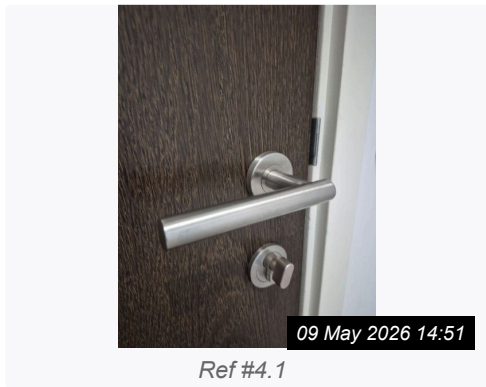
4.2	Walls & Ceiling	Painted walls and ceiling.	Fair to good used condition; paint marks, patch mark, wall screw and minor scuff mark visible to ceiling / wall areas.	
-----	-----------------	----------------------------	--	--

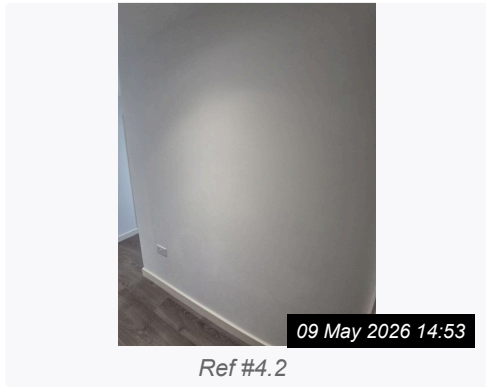
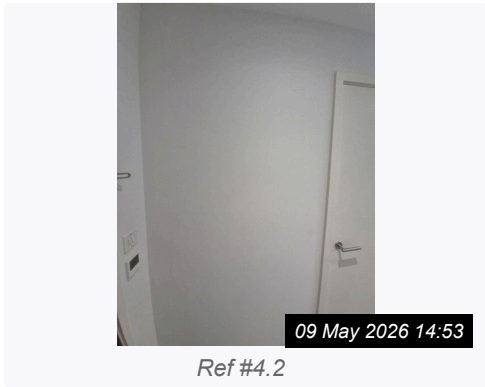
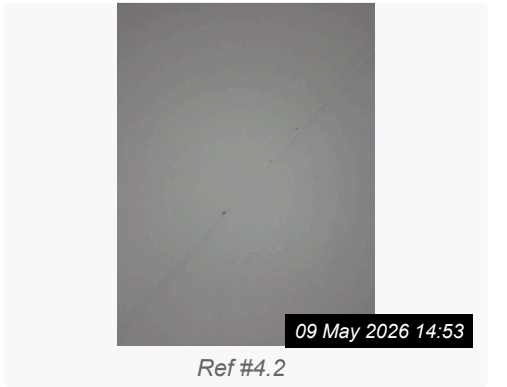
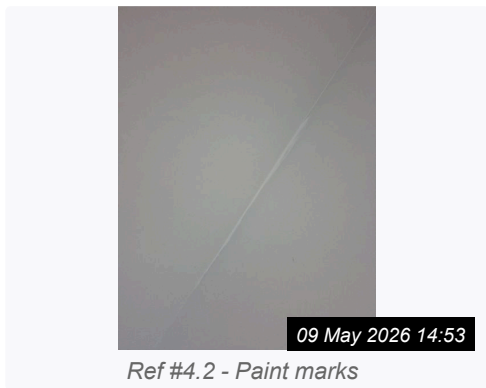
4. ENTRANCE HALLWAY (CONT.)

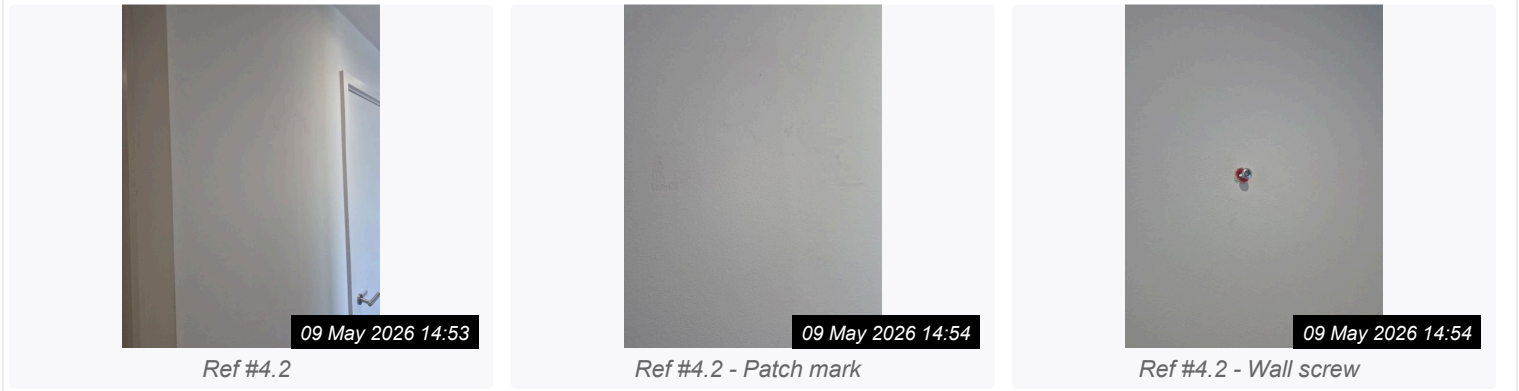
4.3	Lighting	Recessed ceiling spotlights	Good used condition; tested and operational.	
-----	----------	-----------------------------	--	--

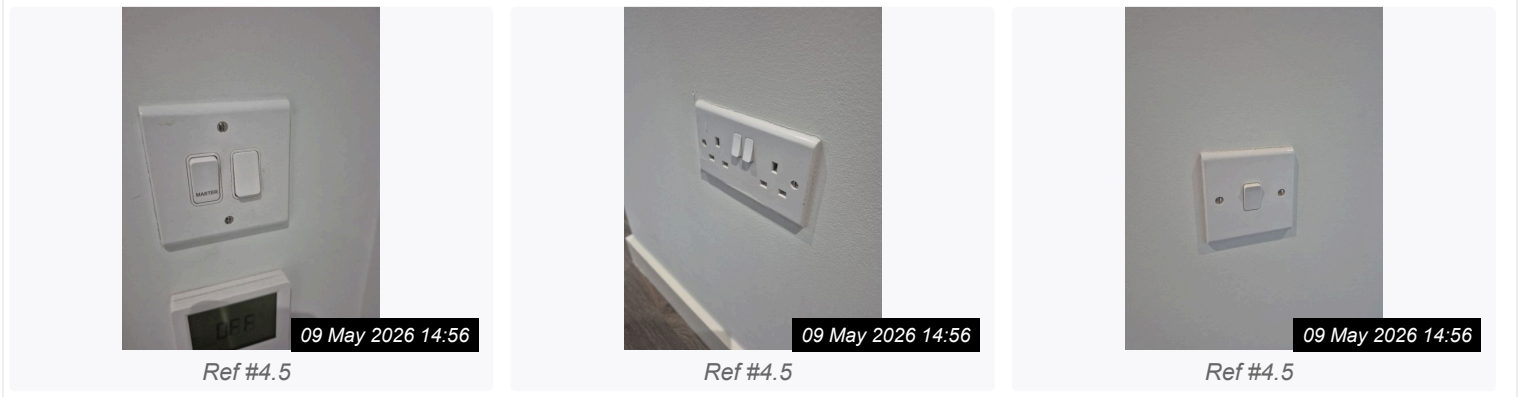
4. ENTRANCE HALLWAY (CONT.)

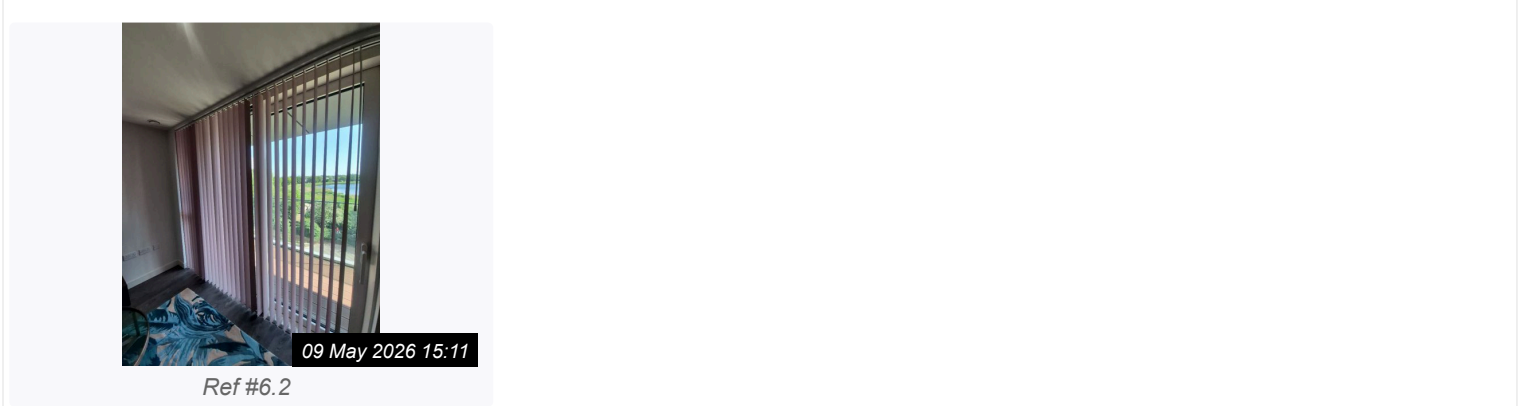
6.3	Window(s) / Sill	Full-height glazed door / window units with handles and balcony aspect.	Good used condition	
-----	------------------	---	---------------------	--

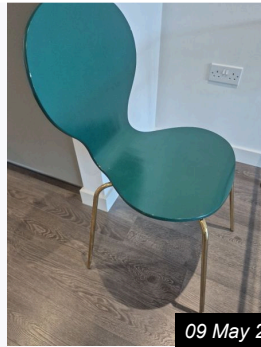
Ref #6.8 - 2x green wooden chair with metal gold legs (slight wear and tear)

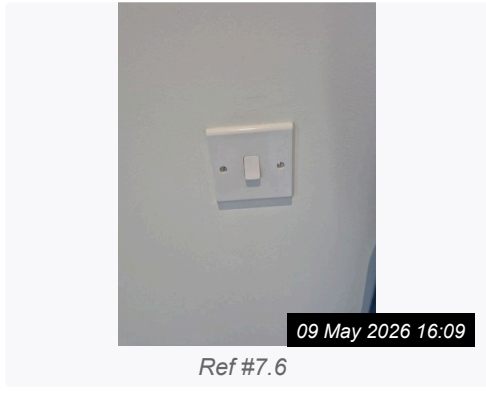
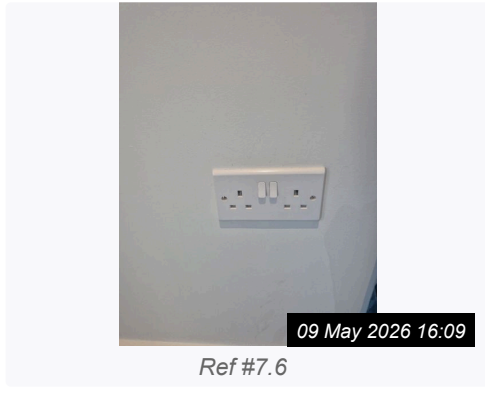
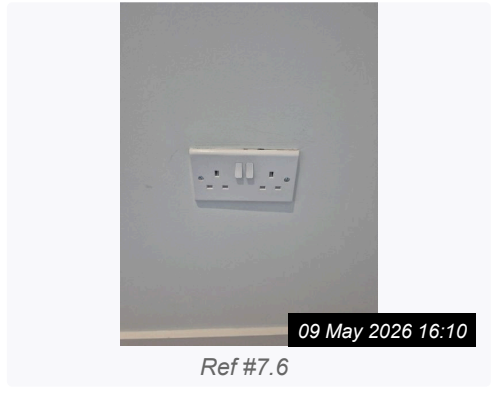
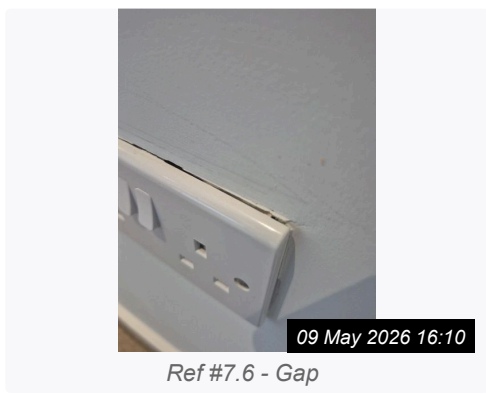
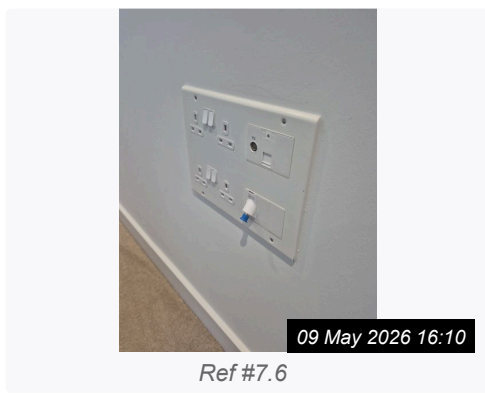
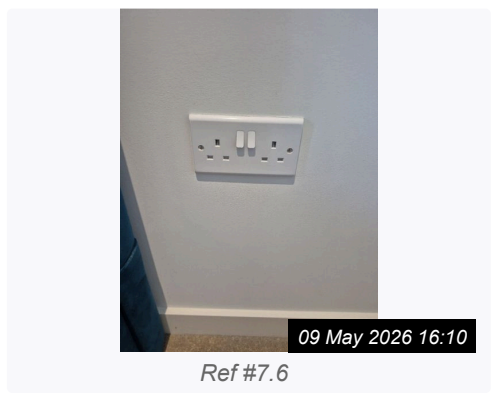
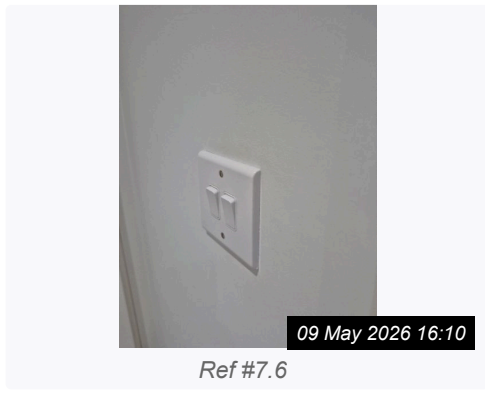
7.7	Heating	Wall-mounted thermostat / heating control.	Good used condition.	
-----	---------	--	----------------------	--

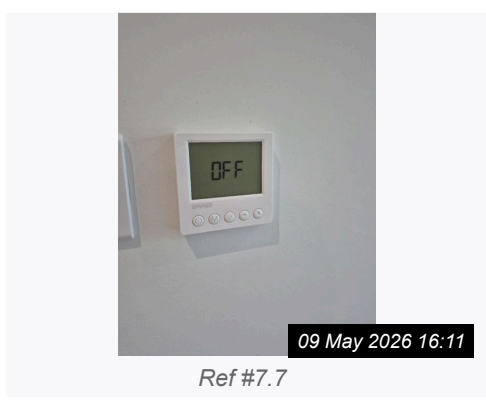
7. BEDROOM 1 (CONT.)

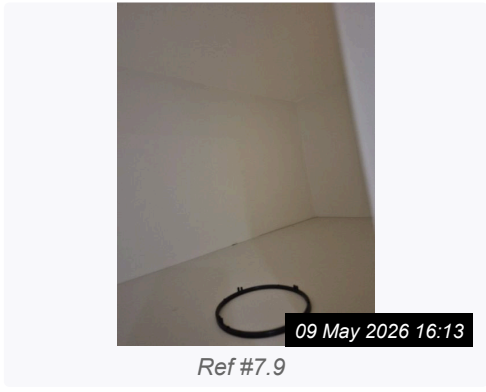
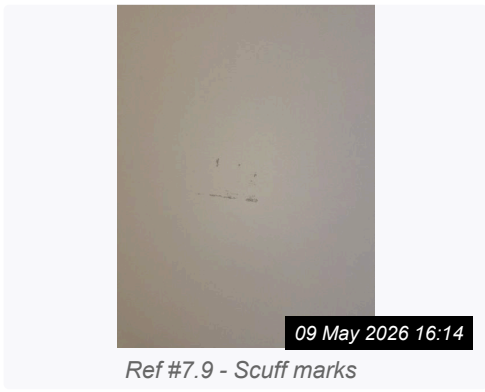
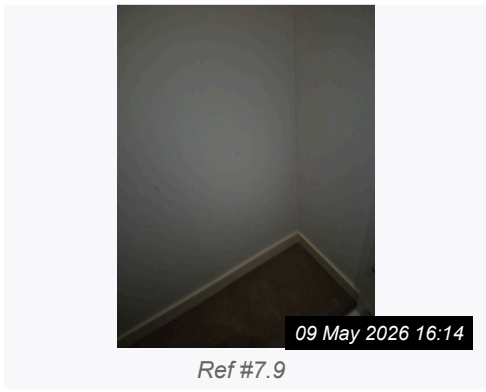
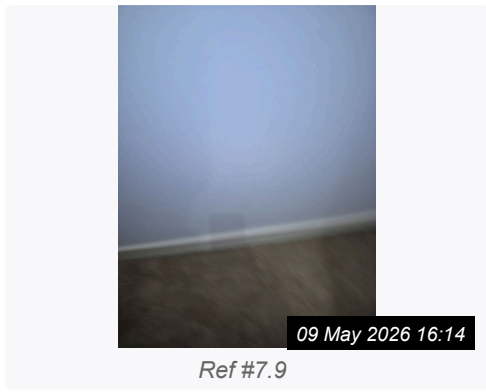
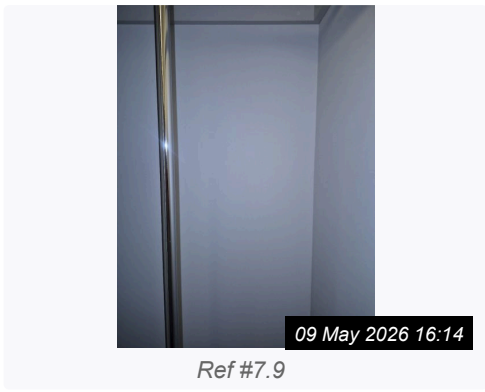
7.10	Furnishings	Blue upholstered cloth bed frame and memory foam mattress.	Fair to good used condition.	
------	-------------	--	------------------------------	--

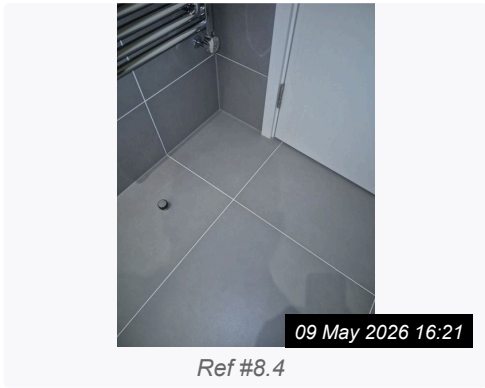
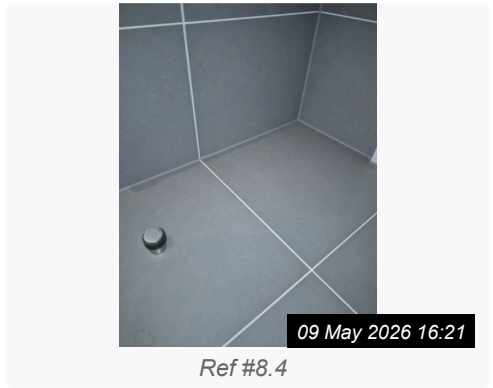
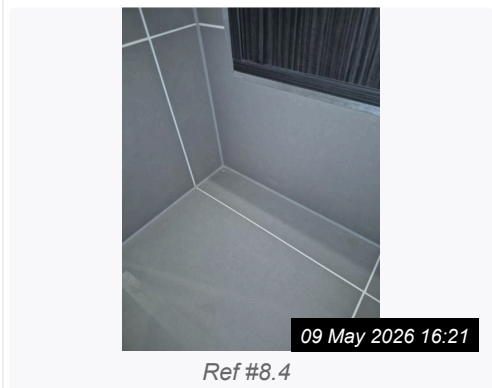
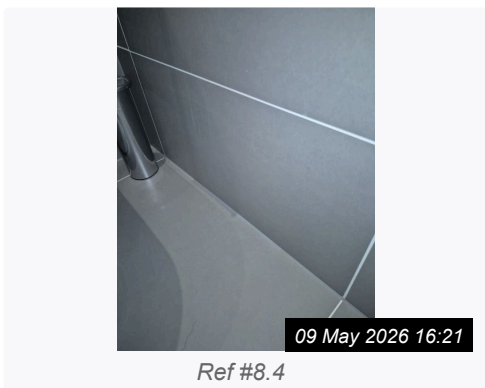
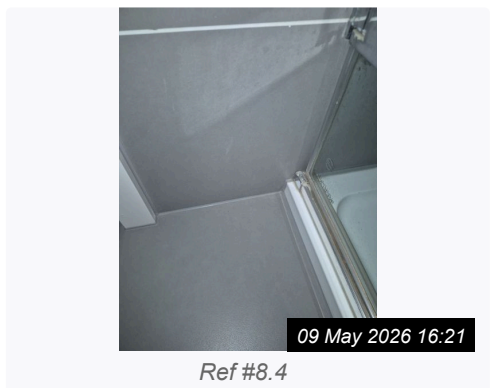
8.5	Extractor Fan	Ceiling-mounted extractor vent.	Good used condition.	
-----	---------------	---------------------------------	----------------------	--

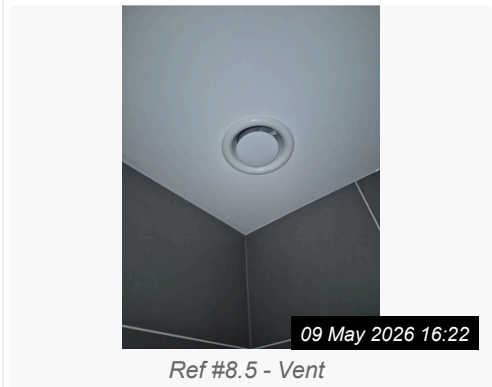
8.6	Lighting	Recessed ceiling spotlights.	Good used condition; tested and operational.	
-----	----------	------------------------------	--	--

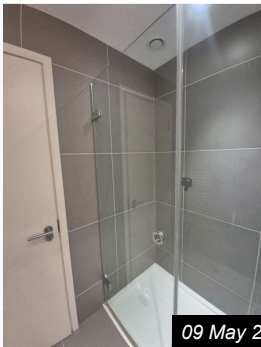
8.9	Shower Unit / Cubicle	Glazed shower enclosure with chrome fittings and shower tray.	Good used condition.	
-----	-----------------------	---	----------------------	--

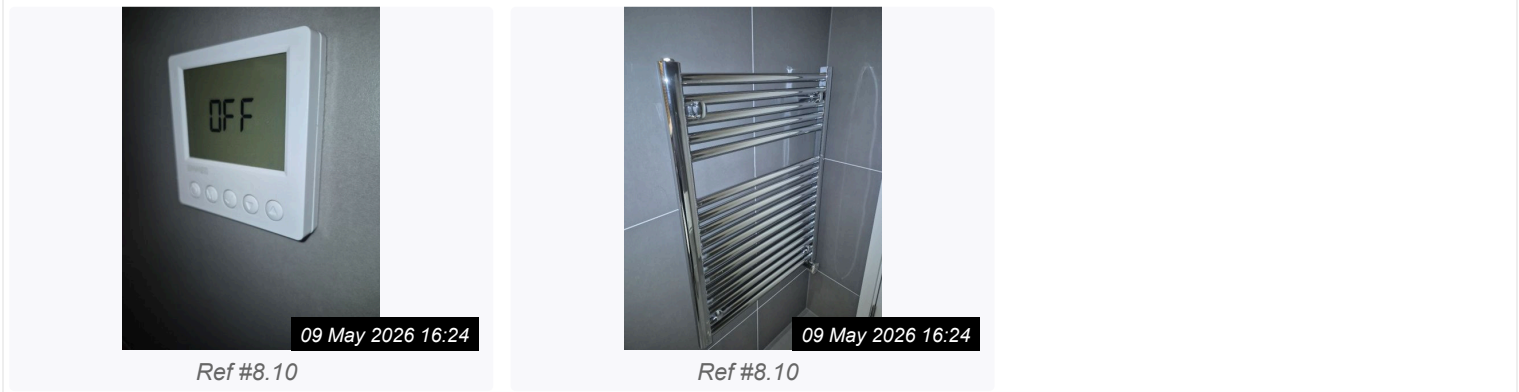
8.11	Accessories	Towel ring, toilet brush holder, mirrored cabinet / storage and bathroom shelf / vanity areas.	Fair to good used condition; some internal / lower areas lightly grubby.	
------	-------------	--	--	--

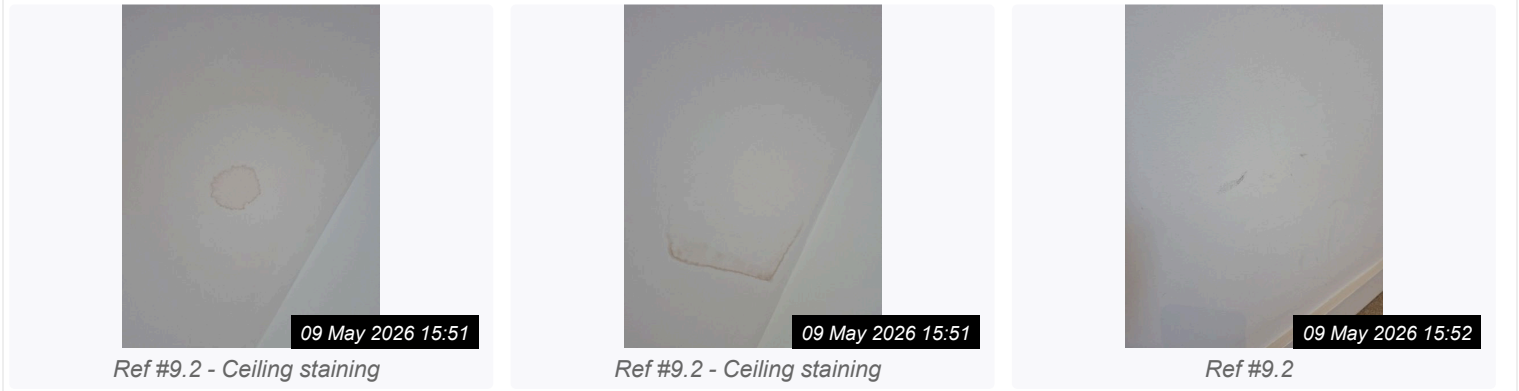
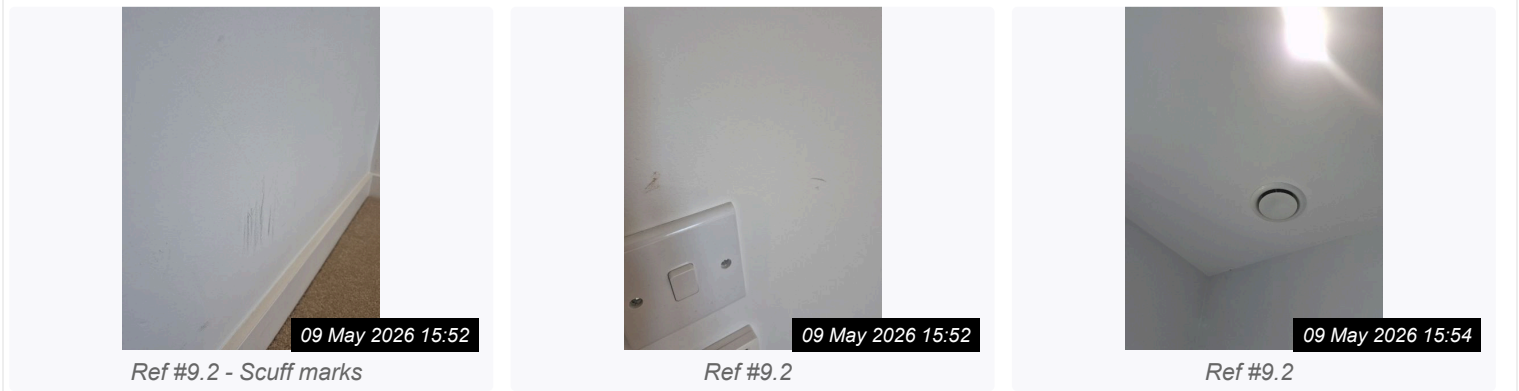
9.3	Lighting	Recessed ceiling spotlights	Good used condition; tested and operational.	
-----	----------	-----------------------------	--	--

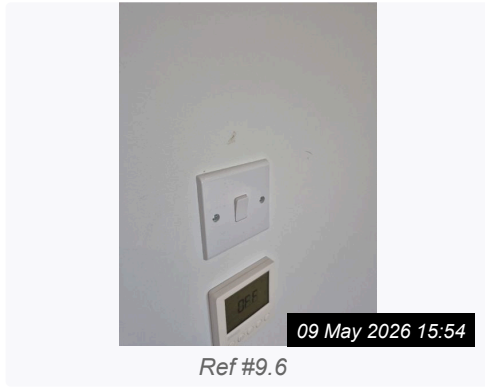
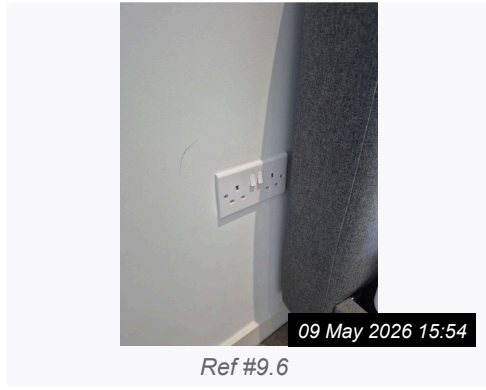
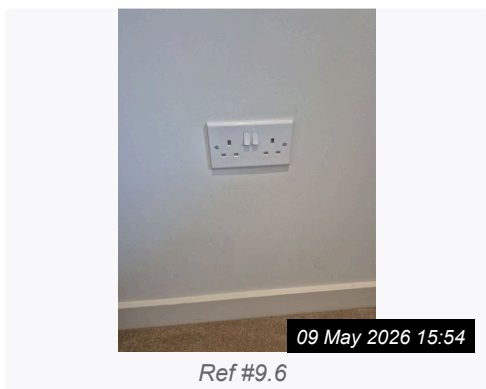
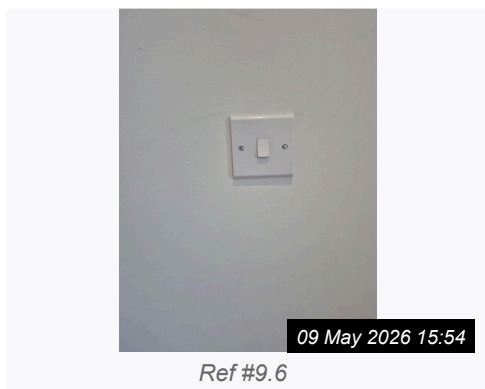
9.7	Heating	Wall-mounted thermostat / heating control.	Good used condition.	
-----	---------	--	----------------------	--

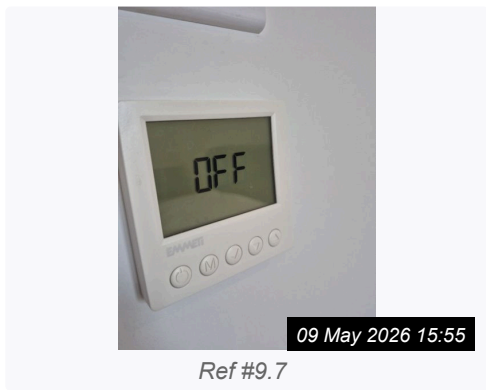
9.8	Flooring & Skirting	Carpet flooring with painted skirting boards.	Good used condition.	
-----	---------------------	---	----------------------	--

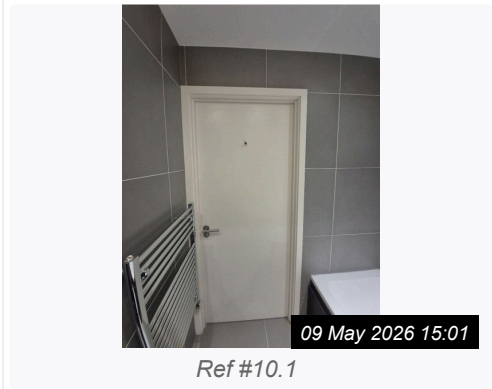
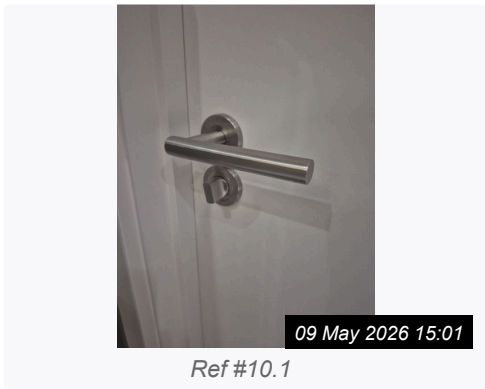
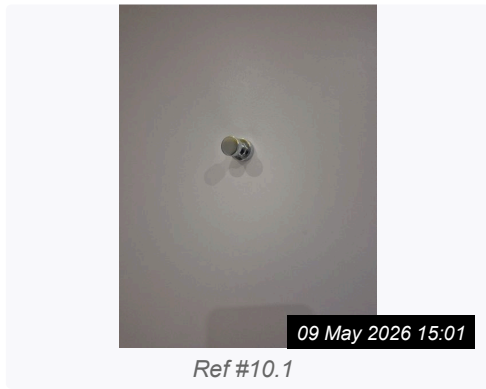
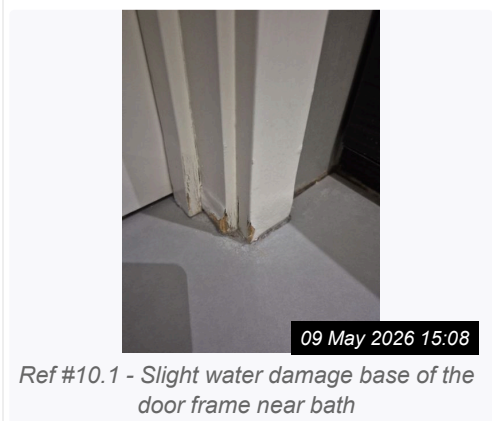
10.2	Walls & Ceiling	Tiled walls and painted ceiling.	Good used condition.	
------	-----------------	----------------------------------	----------------------	--
