# Rilevamento frane e misure correttive a basso impatto ambientale

Nicola Casagli

# Montaguto landslide

# **GB-InSAR monitoring and observational method for landslide emergency management: the Montaguto earthflow (AV, Italy)**

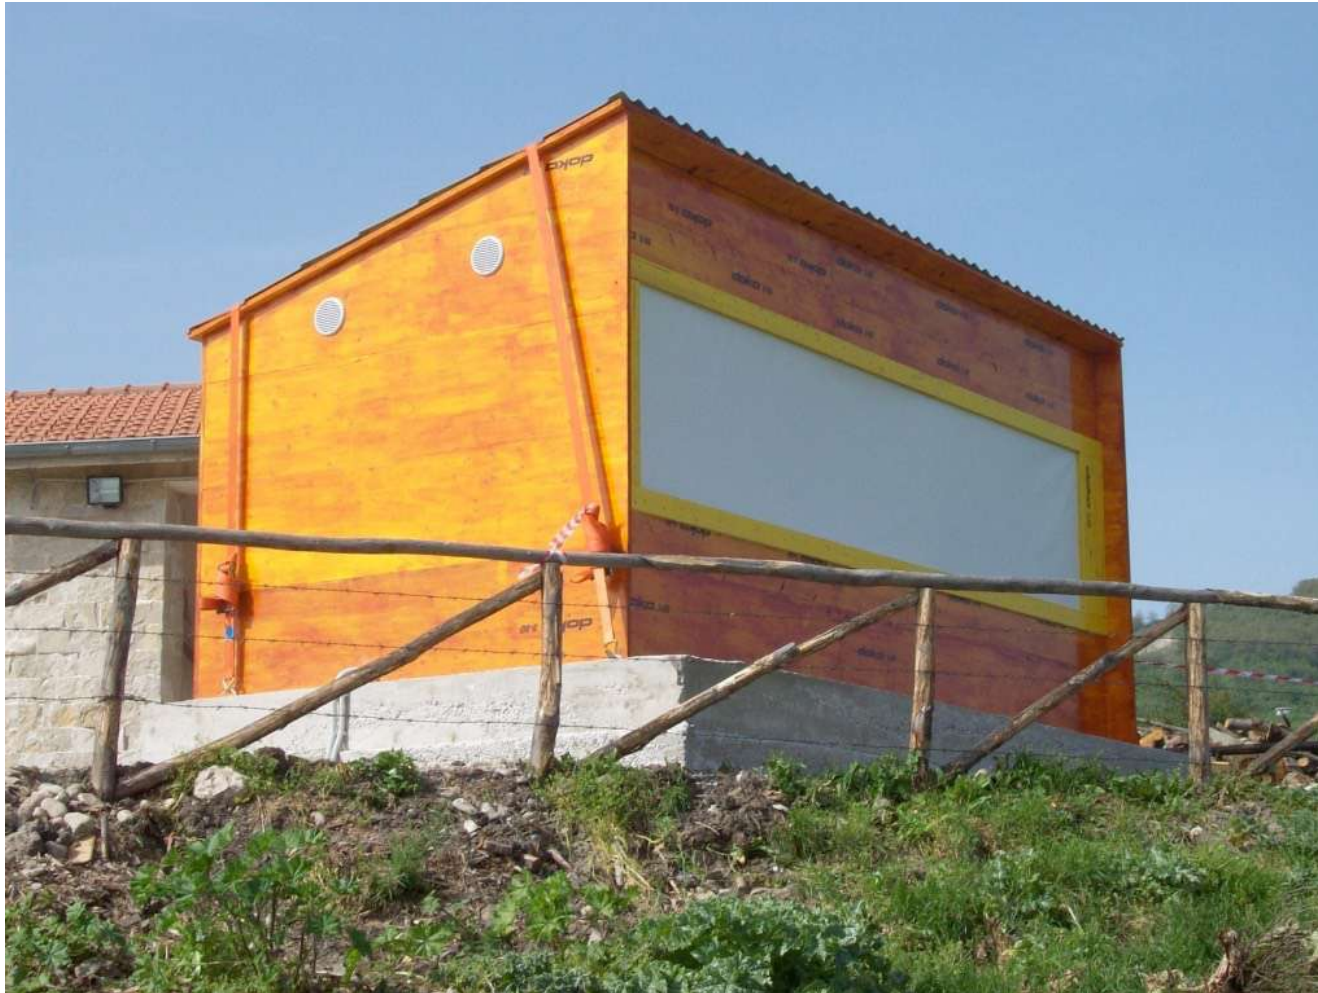
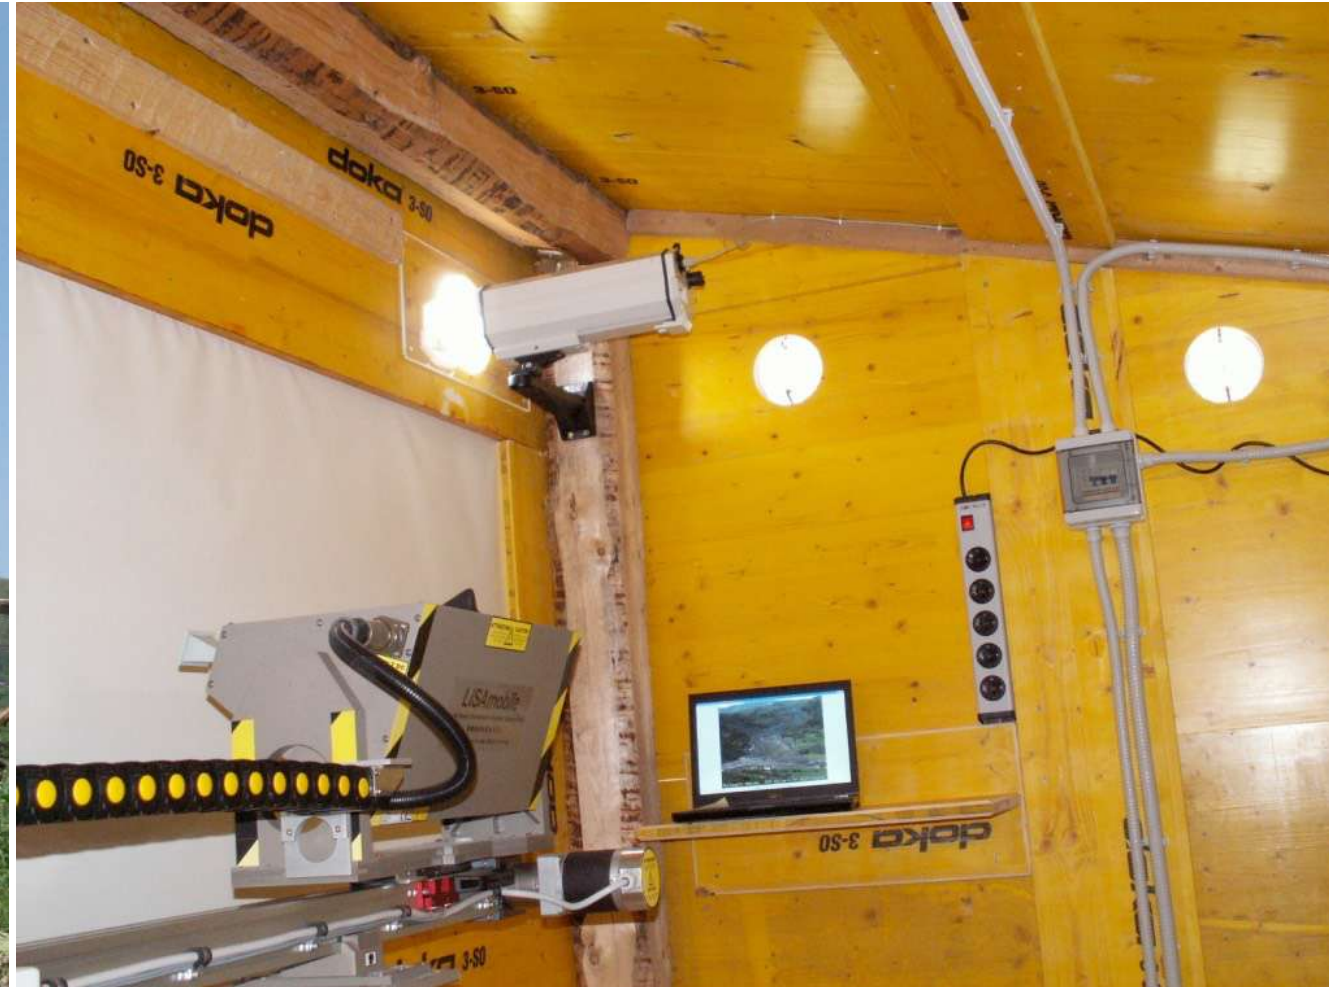
## Installation 29th April 2010

GB-InSAR, LIDAR, thermal and optical imaging
