NEWSLETTER June/July 2020

BRENDA 4 ~ A 24 cc Overhead Cam Flat 4 IC Engine

My Greenhouse Door – The tale of a 5 minute job.....

The *Doxford* Marine Diesel Engine And Other Seafaring Tales.

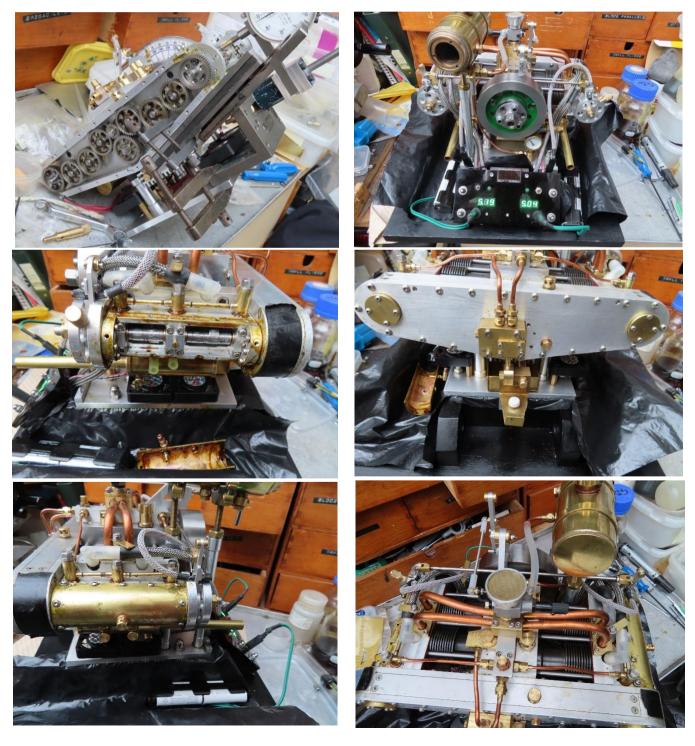
Freelance 24 cc Overhead cam flat 4 IC engine with gear driven camshafts. 2019

Bore: 22mm, Stroke: 17mm, Compression Ratio: 8 to 1.

The crankshaft, timing gears and camshafts were all machined on the Sherline milling machine.

The following six photographs are of the completed model and include a side view showing the camshaft and one showing the cam gear train.

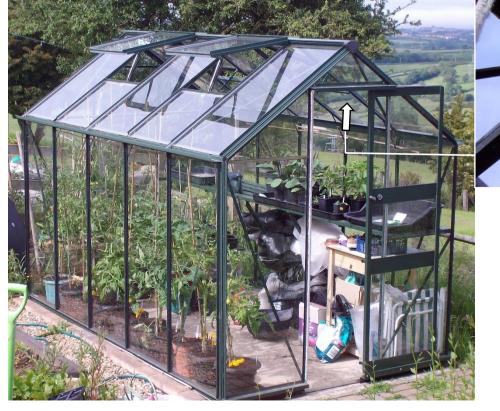
Detail Of The Top Runner 'In-Situ'

Now I am not an engineer by training, but would guess these slides are designed to work (for example on a filing cabinet or kitchen draw ~ see the photos on the next page) in what I would call 'shear', that is to say the weight is placed vertically pressing down on the ball runners edge-wise. The way the slides have been employed on the new door design is at 90° to this i.e. width-wise (see top runner detail below).

I will say in defence of the design, that thought has been given to this obvious weakness by fitting them in such a way that allows at least one of them to be closed whether the door is open or shut. This means that when the door is shut, the three parts are all enclosed together whilst the bottom one is fully extended and vice-versa when the door is open.

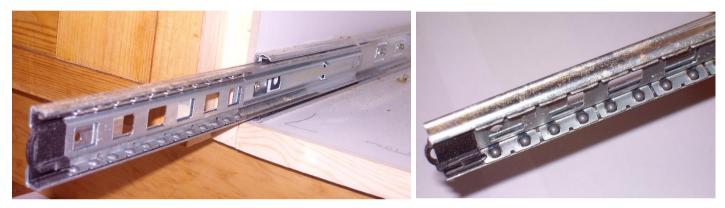
Same type of runner as used normally in shear loading (i.e. kitchen cupboard) with loading on bearings edgewise.

My own view, (putting aside the fact that I am sure this type of runner is not ideally suited to this application), is that the slides are designed to operate assuming that everything is plumb, that is straight, and that the ball bearings are working in two parallel tracks simultaneously. If these tracks are misaligned because of wear or damage, then the balls may jam whilst running, and act as a locking device. As one is pushed up the other may be pushed down particularly if the weight is being born in the wrong plane (90° out). – What do you think?

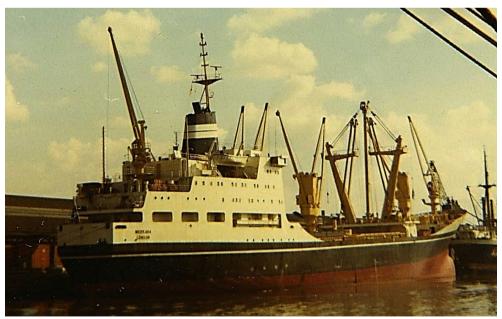
MV Merkara - Photo: Paul Strathdee

Merkara was a relatively new general cargo ship, delivered in 1971 from *Swan Hunters* on the Tyne. At 11143 gross tons and with a contracted speed of 19 kts, *Merkara's* main engine was a 6 cylinder *Sulzer* RND90 (900mm diameter x 1550mm stroke) - but this is about *Doxfords* so I'll offer no further details other than this was a conventional one piston per cylinder, 2 stroke diesel with loop flow scavenging – in other words no exhaust valve or

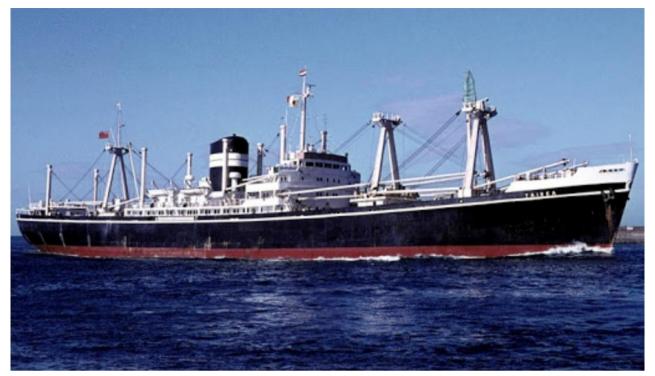
MV Tairea - Photo: Trevor Jones

MV Tairea, also a general cargo ship, was a bit smaller and slower than *Merkara*, 8199 gross tons and with a 15.5 knot contracted speed. *Tairea* was built at *John Brown's* yard on the Clyde in 1956 (and named *Aradina* at the time) so it was not new when I joined! It was on *Tairea* that I had my first encounter with a *Doxford* opposed piston two stroke diesel engine.

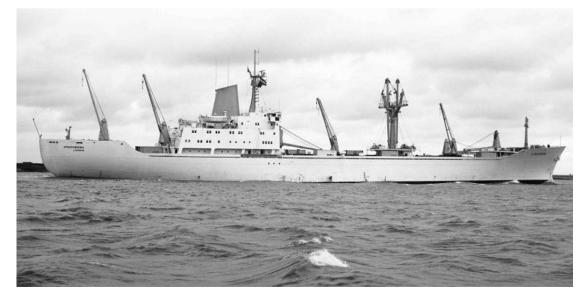
MV Strathbrora - Photo: Malcome Cranfield

After arriving in *Avonmouth* I paid off and went home for a couple of weeks leave before joining *MV Strathbrora* in Bahrain. *Starthbrora* was a 12539 ton fast cargo vessel, built in 1967 in Japan, with a 20,700 bhp 9-cylinder *VT2BF B&W* engine giving a design speed of 21 knots. I spent six months on *Strathbrora* operating a liner service between Japan and the Persian Gulf - with much of that being out in the sun looking after the 6 hydraulic cranes which created more work on the ship than any other single item. I also undertook my first dry-docking – in Japan.

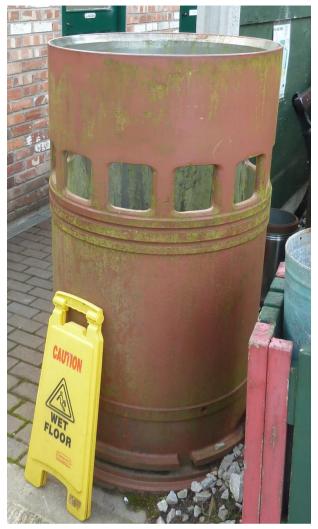
Lower cylinder liner - Photo: David Proctor

The multi piece liner had the effect of allowing a lower headroom in the engine room as it was necessary to allow space for removal of the liner and this was normally the tallest object that could reasonably be changed by ships staff using the engine room crane. The disadvantage of the multi piece liner was that cooling water seals at the combustion belt sometimes failed thus requiring removal and reseating of the liner parts – never had to do this myself but I was informed this is a "pig of a job".
