# INVESTIGATIVE METHODS IN FORENSIC CIVIL ENGINEERING

N. Krishnamurthy, Ph.D.<sup>1</sup>

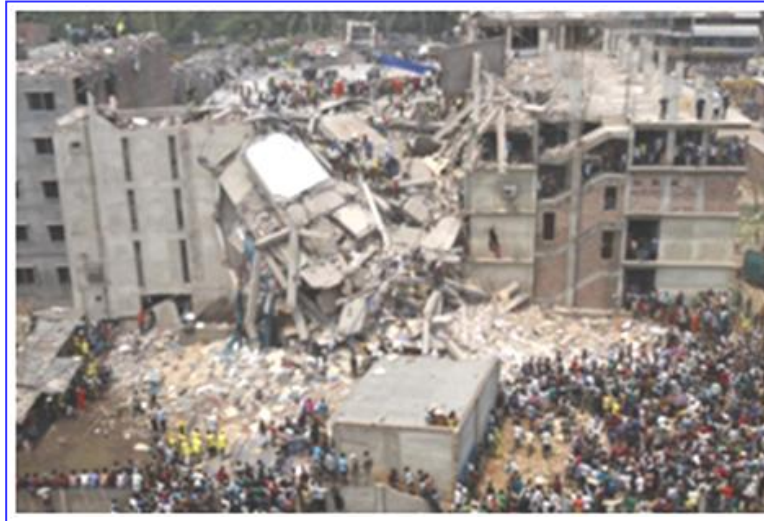
Fig. 1. Rana Plaza Building Collapse

The head of the Bangladesh Fire Service and Civil Defence said that the upper four floors had been built without a permit. Rana Plaza's architect said the building was planned for shops and offices – but not factories. Other architects stressed the risks involved in placing factories inside a building designed only for shops and offices, noting that the structure was potentially not strong enough to bear the weight and vibration of heavy machinery.

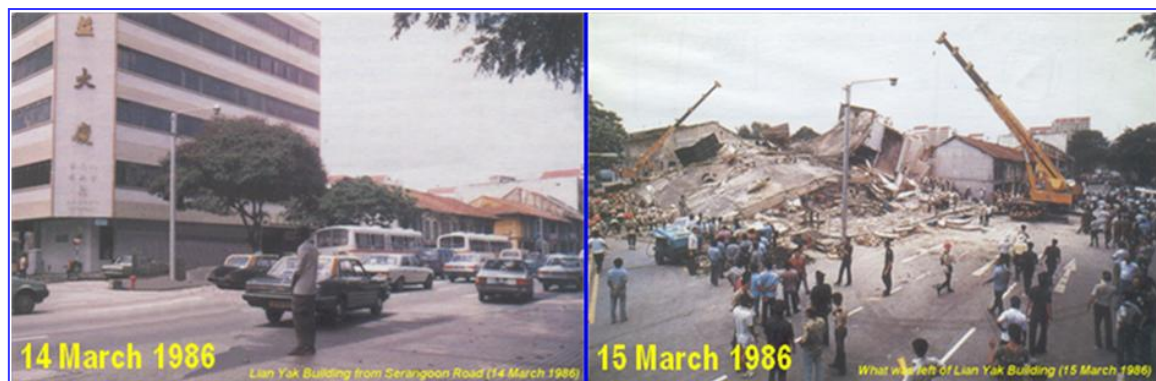
Fig. 5. Hotel New World, before and after collapse

The structural engineer had forgotten to add the dead load of the reinforced concrete building to his calculations when determining how strong he needed to make the support pillars that held up the building during construction in 1971. On top of it, the owner added quite heavy water tanks and air-conditioning units on the roof, and a bank tenant added a heavy vault, both the actions done without checking or approval, [10].

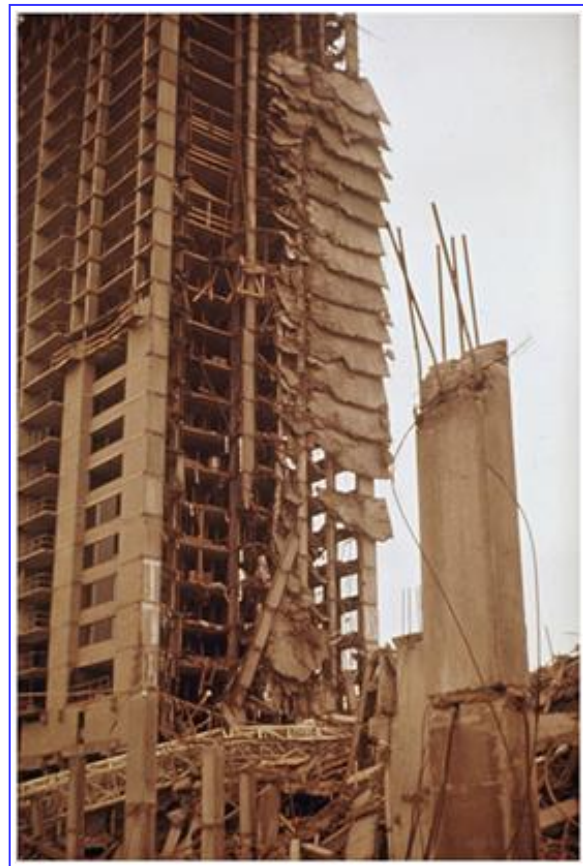
Fig. 7. Skyline Plaza

Probable cause of the collapse was a punching shear failure of the 23rd floor, caused by the premature removal of forms supporting the 23rd story slab, resulting in the shear stresses exceeding the concrete capacity at the time of the incident. The accumulation and impact of falling debris from the collapsing 23rd and 24th floors overloaded the 22nd floor slab and induced the progressive collapse of successive floors down to the ground.

Average air temperature was 6-7°C, at which, concrete takes twice as long as in a laboratory to gain strength. Field-cured concrete cylinders should have been used rather than laboratory cured cylinders to ensure that the concrete had achieved sufficient strength before removing shores and forms.

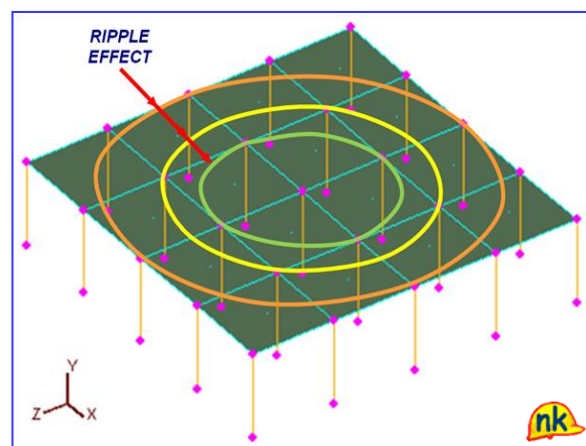
Fig. 14. Local failure and ripple effect

analysis of loss of the central 1, 5 and 9 legs (Fig. 14), and (alternatively) the corner 1, 3, and 6 legs. The reactions simply re-distributed themselves at the still active legs – in what I called the ‘ripple effect’, surviving at least for the first two rounds of losses.

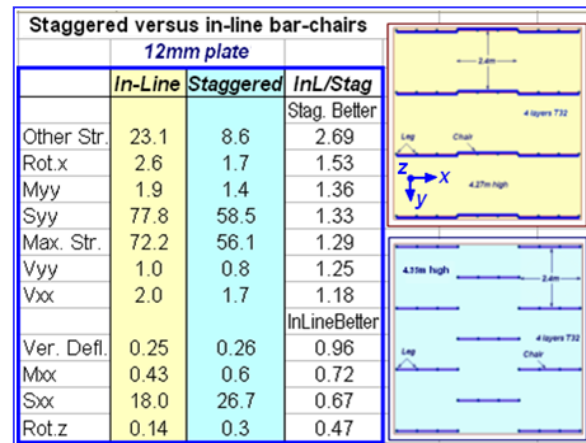
Fig. 15. Collinear vs. staggered supports

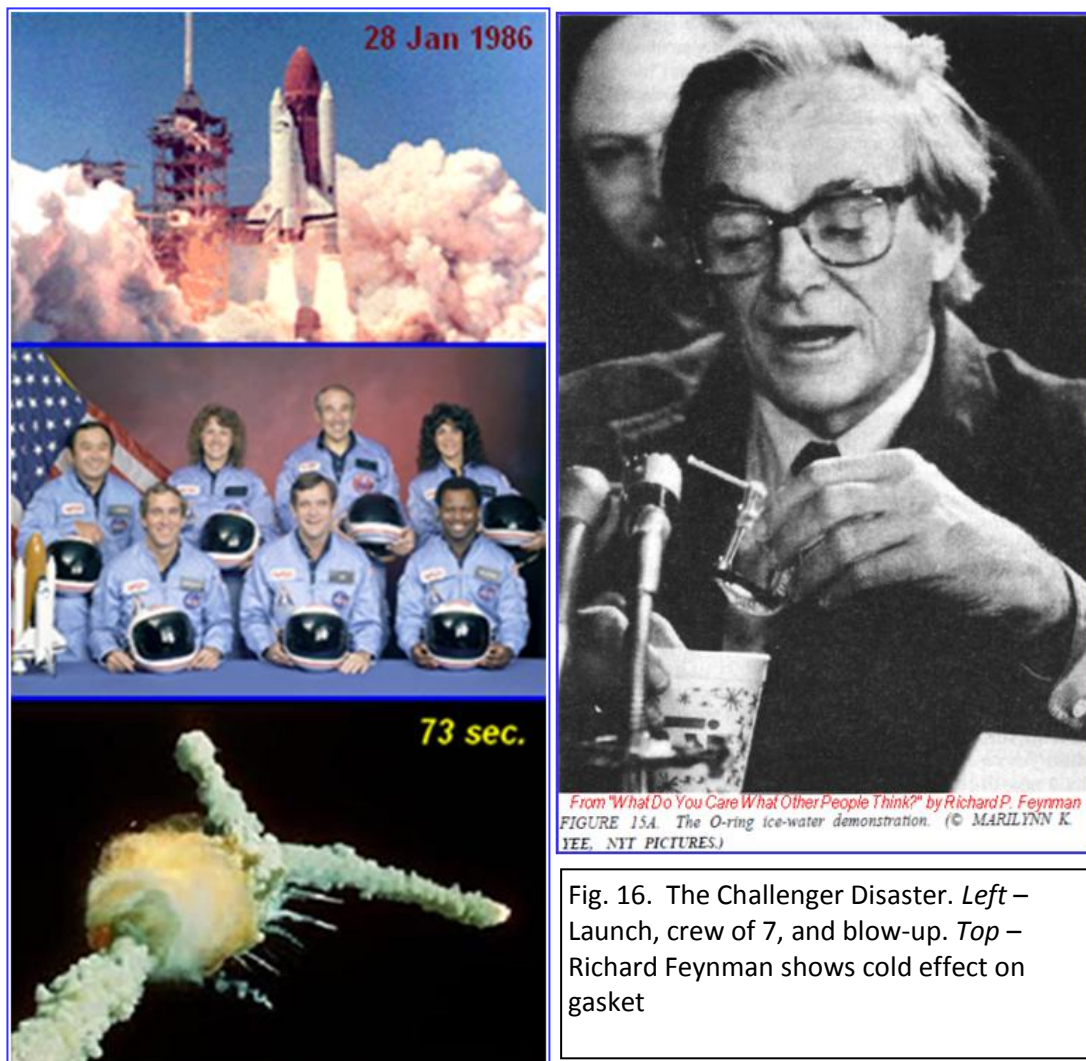
Fig. 16. The Challenger Disaster. Left – Launch, crew of 7, and blow-up. Top – Richard Feynman shows cold effect on gasket

It was during the tenth mission on 28 January 1986, launched in very cold weather against the warnings of some of the engineers involved, at about 73 seconds after launch, the shuttle blew up, and the pieces fell into the ocean, killing all the seven crew members, (Figure 16.)

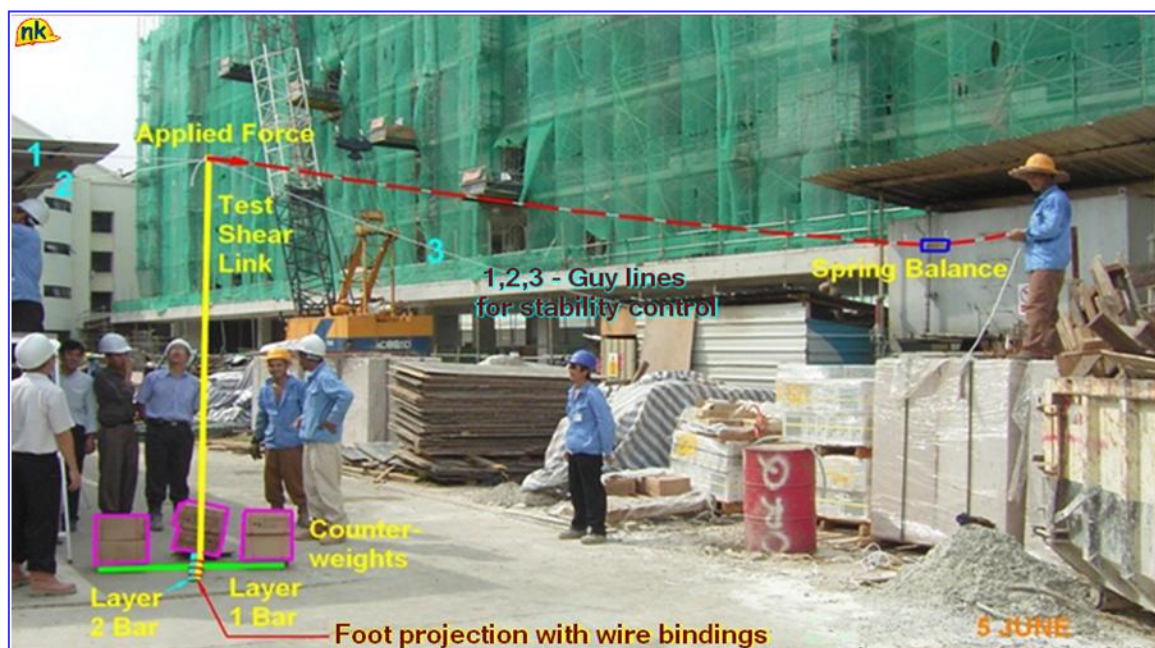
Fig. 17. Author's field test for rotational capacity

I had my lawyers arrange with a local contractor to set up a single bar of the same size as the leg

of the collapsed bar-chair with same end conditions. I got a worker pull gradually at top with a rope, with the pull force being measured by a simple spring balance, (Figure 17.)

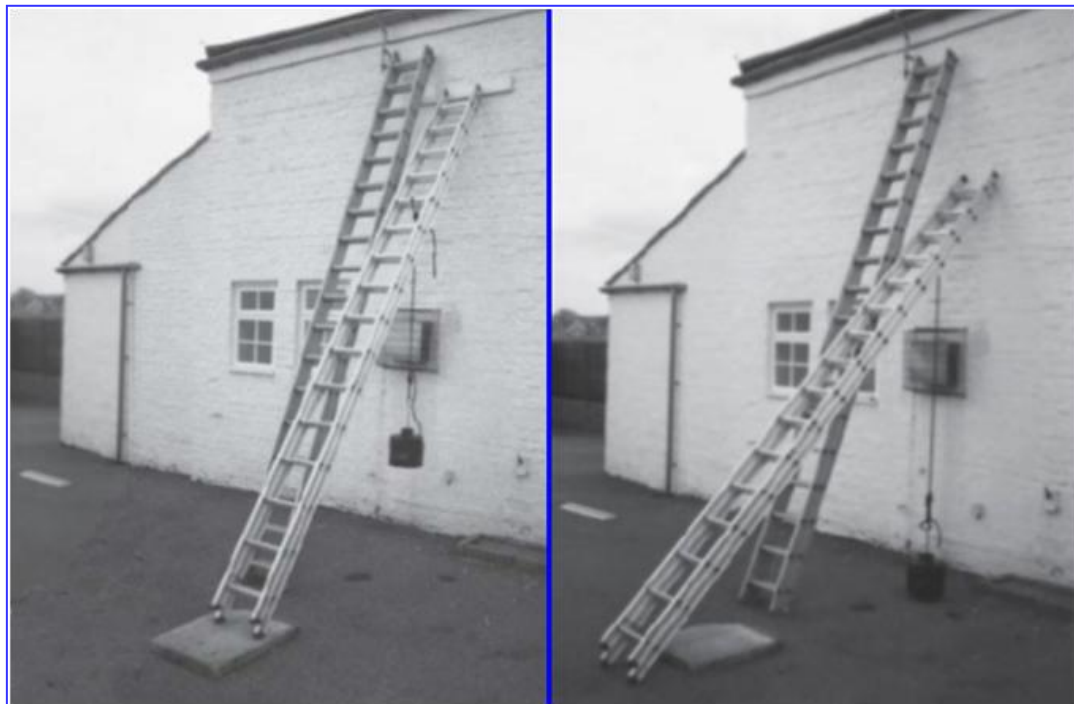
Fig. 18. Re-creation of ladder fall (Far ladder is for control.)

A case which illustrates such a re-creation is the forensic analysis of a fall from a ladder in UK in the 1990s. The 73kg owner of a house cleaning the second floor window from his recently bought extensible ladder fell while climbing. He approached the Legal Aid Board for an opinion on whether

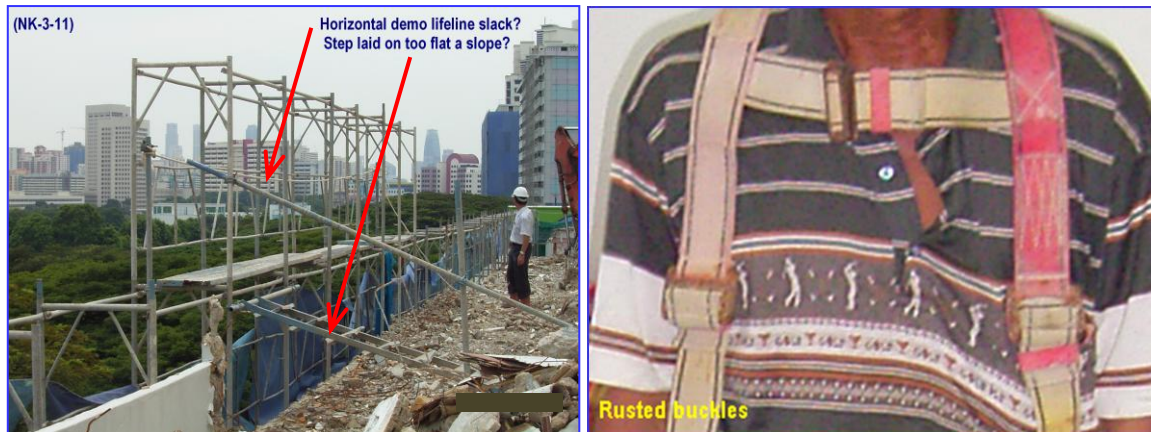
Fig.23. Specimen photos from author's investigation of worker fall

I also attached 17 pictures such as the two in Fig. 23, on each of which I pointed out various deficiencies.
