Retrofit of R.C. Beams & Columns by Finite Element Analysis

N. Krishnamurthy, Structures and Safety Consultant, Singapore

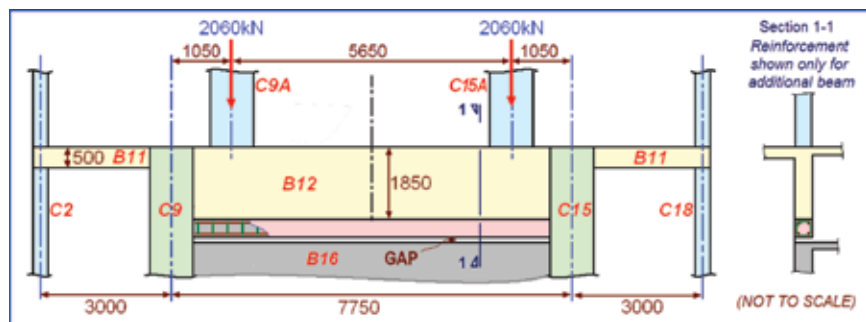
Figure 3: SCE's Solution for Additional RC Section

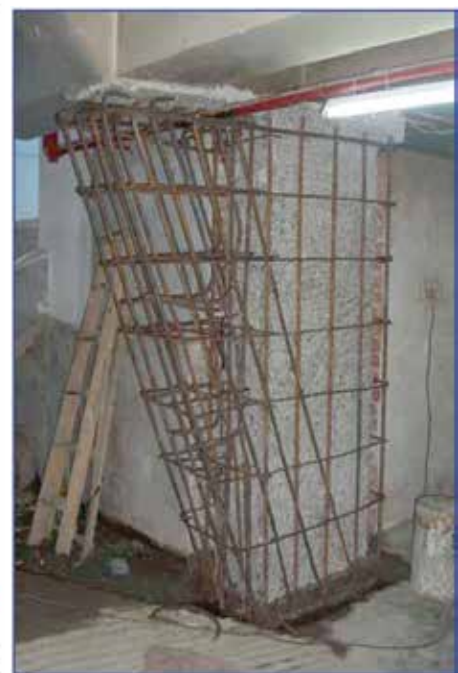
Figure 17: Jacket Reinforcement for C9

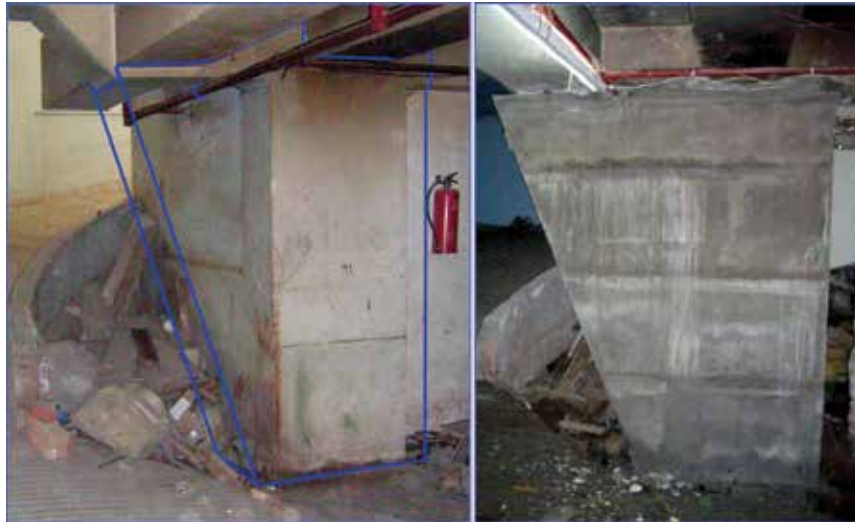
Figure 18: Column C9, (Left) Before Retrofit, with Retrofit Jacket Outline Superposed, and (Right) After Jacketing
