FORENSIC CIVIL ENGINEERING AND RISK MANAGEMENT

Dr. N. Krishnamurthy

ABSTRACT

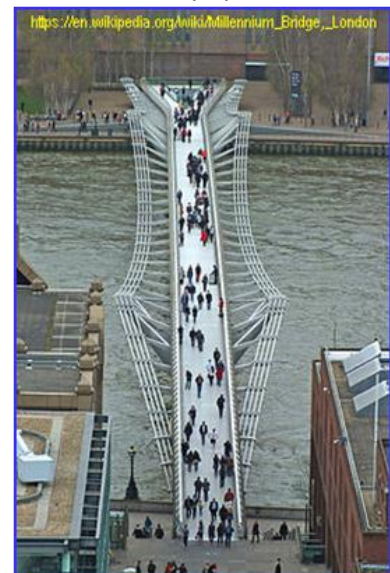
Fig. 5. Millennium Bridge

Subsequent analysis showed that the cause was 'positive feedback' phenomenon, known also as 'synchronous lateral excitation'. It took nearly two years and 5 million pounds to fix the problem.

But this problem was not unknown! While vertical resonance was known more than a century earlier, horizontal resonance had also been documented from the early 1970s for bridges with lateral frequency modes of less than 1.3 Hz, and sufficiently low mass.

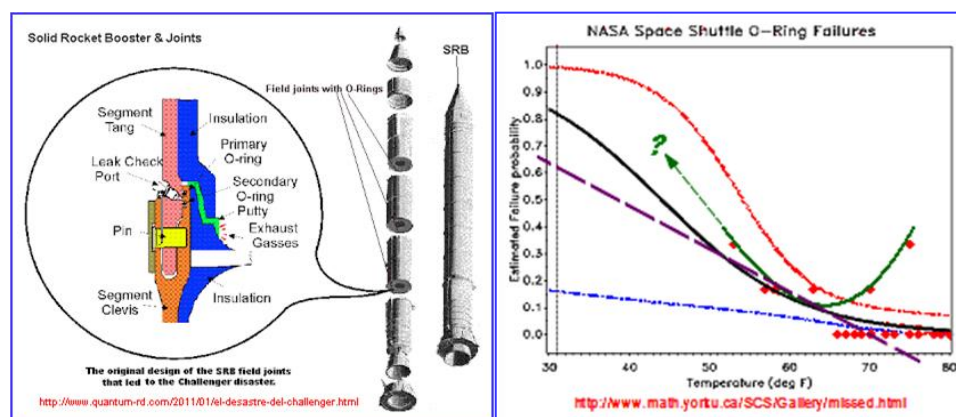
Fig. 6. (Left) The 'O' ring that froze; (Right) Various curve fits to failure

Data on failure probabilities at various low temperatures for the freezing of the 'O' ring sealing the connection for burning gases was available, as shown in Fig. 6, all predicting high probabilities of failure at temperatures below about 65°F.

Engineers had done a certain kind of risk assessment and concluded that with the overnight temperature of 18°F (−8°C) and even at the launch morning temperature of 28°F (−2.2°C) it was too risky to launch.

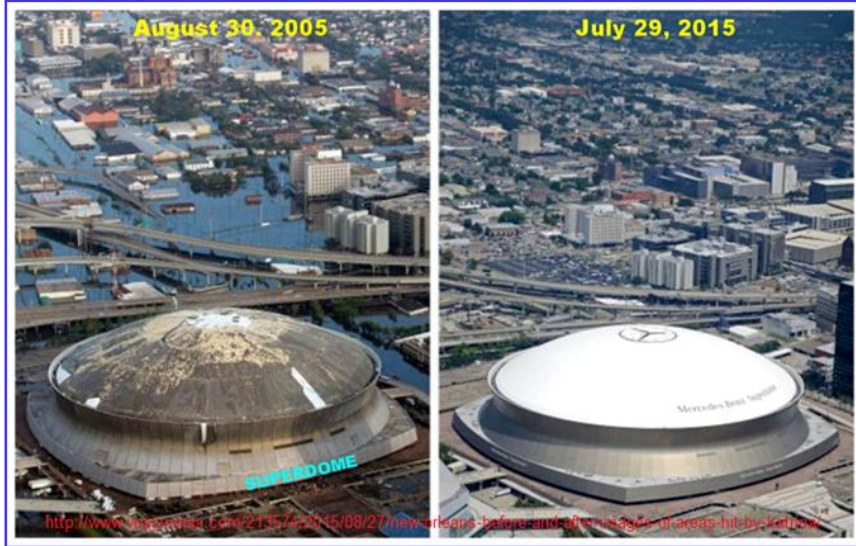
Fig. 12. New Orleans, during Katrina and a decade later

The levee and flood wall failures caused flooding in 80% of New Orleans and many townships in the vicinity. Tens of billions of gallons of water spilled into vast areas of New Orleans, flooding over 100,000 homes and businesses (Fig. 12).

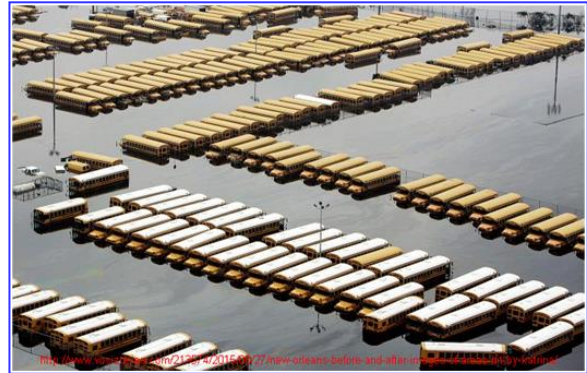
Fig. 13. Rescue Buses Stranded in Flood

Even the National Guard headquarters were flooded. Figure 13 shows the hundreds of school buses which were expected to have been utilized for evacuation purposes, themselves stranded in the flood due to inadequate risk assessment and control.
