SULY HOME INSPECTIONS

XXXXXXXX

Fort Worth, TX 76135

Inspector: ***Akram Amen*** TREC # **25896**

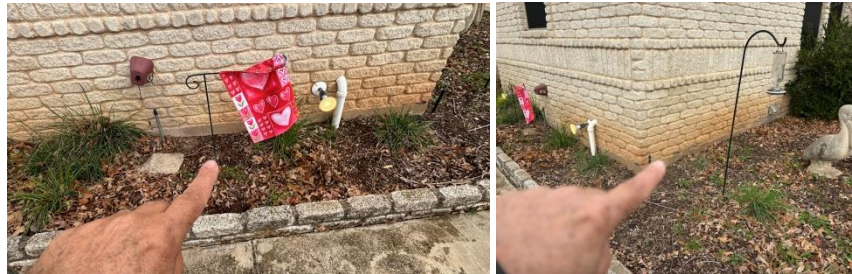
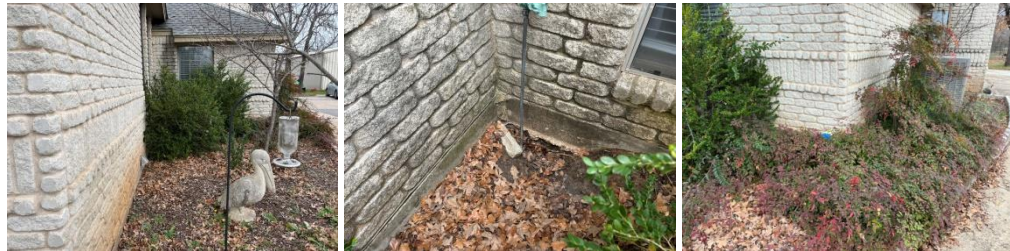
- *Gutters Present: partially (only in the back of the house)*
- *Positive Slope on All Sides of Home: No*

2: Missing Gutters(Partially): Recommendation: All slopes of the roof should have gutters to ensure that water is adequately diverted away from the structure.

3: Inadequate Grading: The grade of the ground should be improved to direct the flow of water away from the home. This can be achieved by adding or removing top soil and/or installing a drainage system. The ground should slope away from the home at the rate of 6" for the first 10 feet. Recommendation: Contact a qualified landscaping contractor.

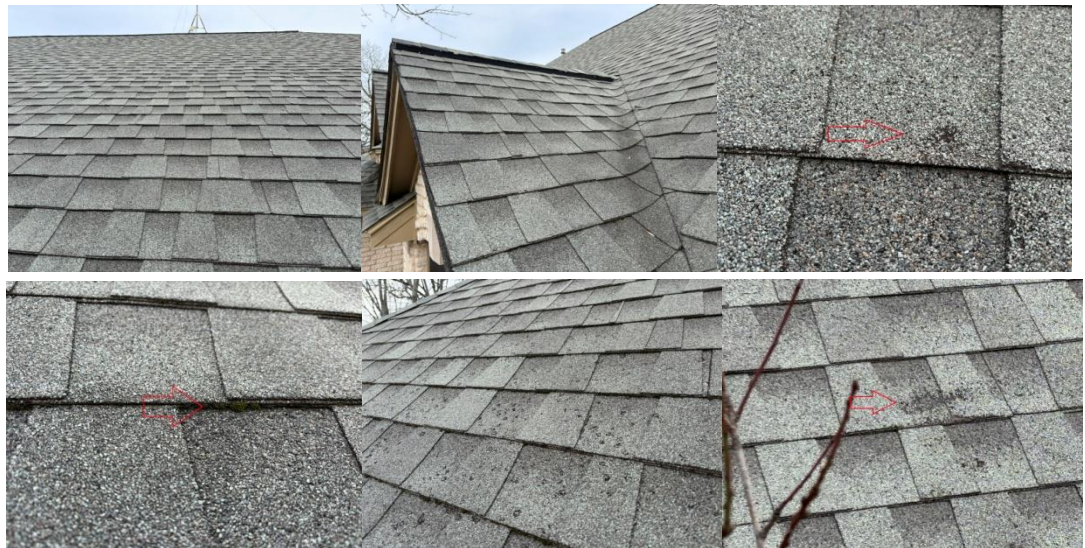
- 1: Spotty Damage: There were areas of spotty damage. Recommendation: Contact a qualified roofing professional.
- 2: Kick out Flashing: Kick out flashing was not observed at the wall/roof connection point. Kick out flashing should be installed where the roof terminates along a vertical wall so as to reduce the possibility of water entering the home.

- 3: Aggregate Loss – Edges: There was aggregate loss present at the shingle edges. Recommendation: Contact a qualified roofing professional.
- 4: Possible Hail Damage - Front-left of the roof showing hail damage. Recommendation: Contact a qualified roofing professional.

- 5: Satellite Dish: There was a satellite dish installed on the roof.
- 6: There are tree limbs and/or shrubs in direct contact with the roof at east side. All trees should be trimmed back 3 to 5 feet from the structure. When trees are close to the house, their limbs should never touch the building, or serious damage can result.

- 7: Missing flashing around the Chimney. Recommendation: Contact a qualified roofing professional.
- 8: Missing Kick-out flashing to avoid water touch the wall.

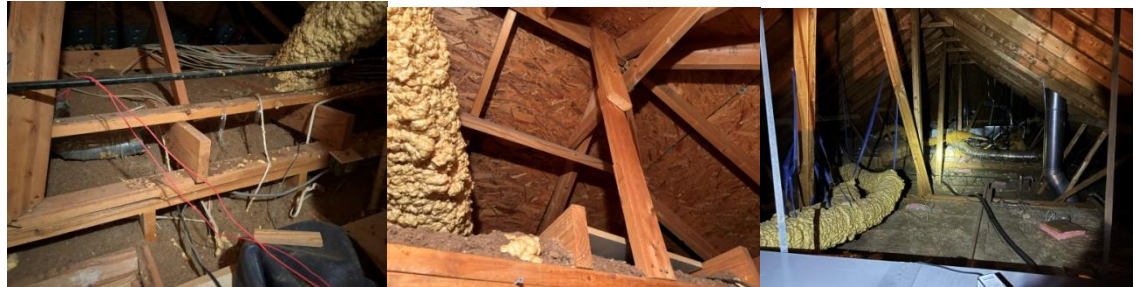
Attic Ventilation Type: *Ridge vent, Soffit vent.*

Attic Insulation: *Blown in Cellulose.*

Ventilation observed: *Yes* Condition: *Good*

Structure OK: All components were found to be performing and in satisfactory condition on the day of the inspection.

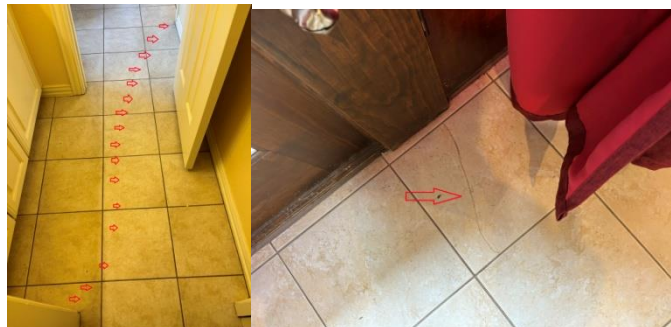
1: Crack observed in the bathroom between the office and bedroom.

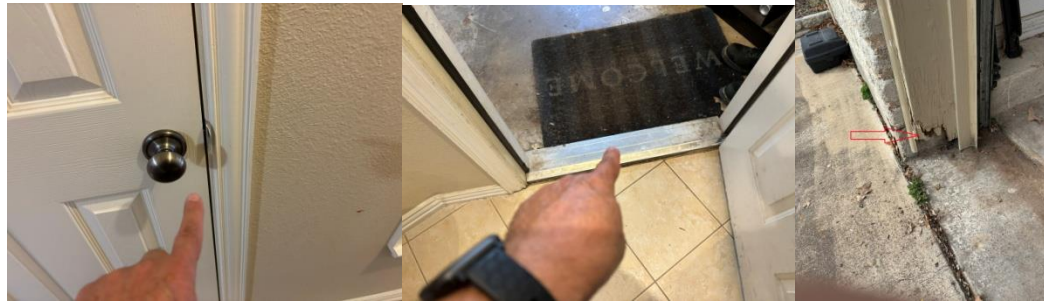
1: Weather-stripping improvements are recommended for the front entry, backyard entry exterior door(s).

1: Garage Door sides – Damaged: There are damaged siding on the overhead garage door.

2: It is recommended to lubricate the overhead garage door components, such as rollers, tracks and hinges.

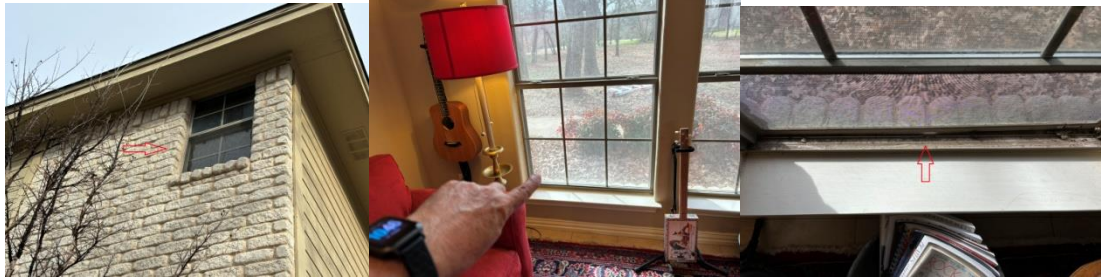
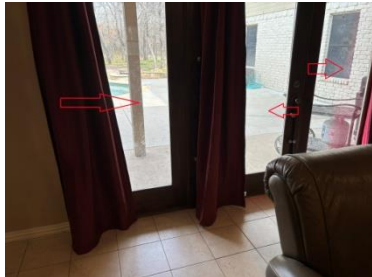
1: Missing Screens: There were missing window screens.

2: There are a few windows that are jammed not able to open. Repairs can be performed by a handyman service, or a painting contractor.

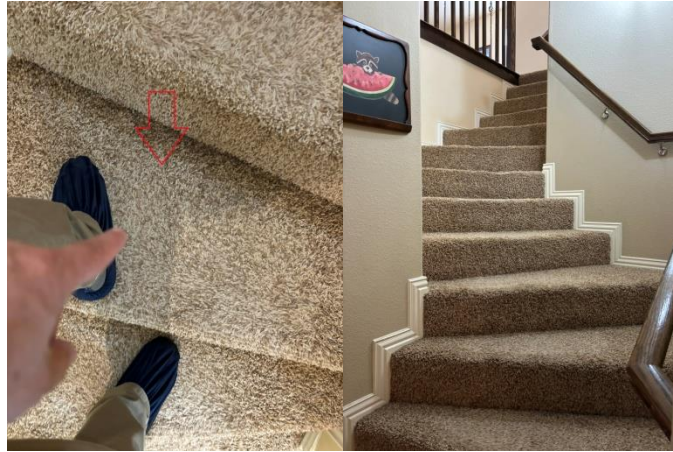
1: One or more of the steps was observed to be loose and make noise when you step on it.

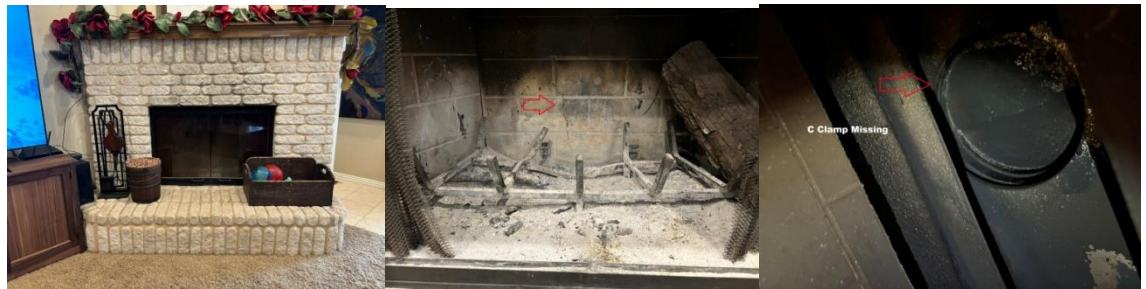
1: Crack observed in the interior wall of the Fireplace.

2: C Clamp – Missing: The damper stop clip is missing. There are gas logs inside of the unit and this clip should be installed to prevent combustion gases from entering the home if the damper is closed. Recommendation: Contact a qualified fireplace contractor.

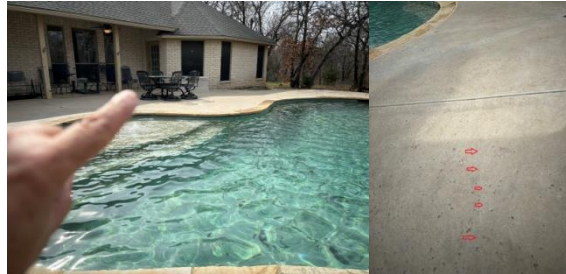
- 1: Patio/Porch Cracking: There is hairline cracking noted at the patio/porch concrete surfaces.
- 2: Between the Patio and the Pool missing safety fence, Safety Concern.

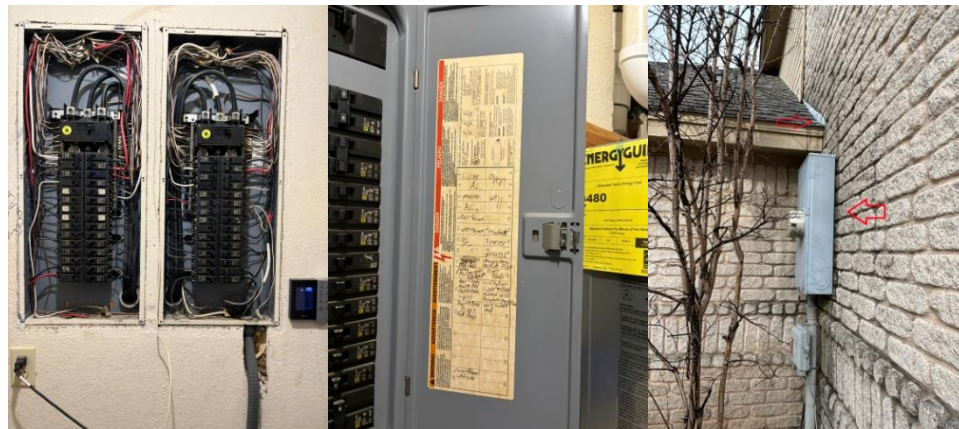
1: Un proper location, un protected the (Electric Service Entrance), because of missing the gutter and kick out flashing, all the rain water falling on the electric box, recommending certify electrician.

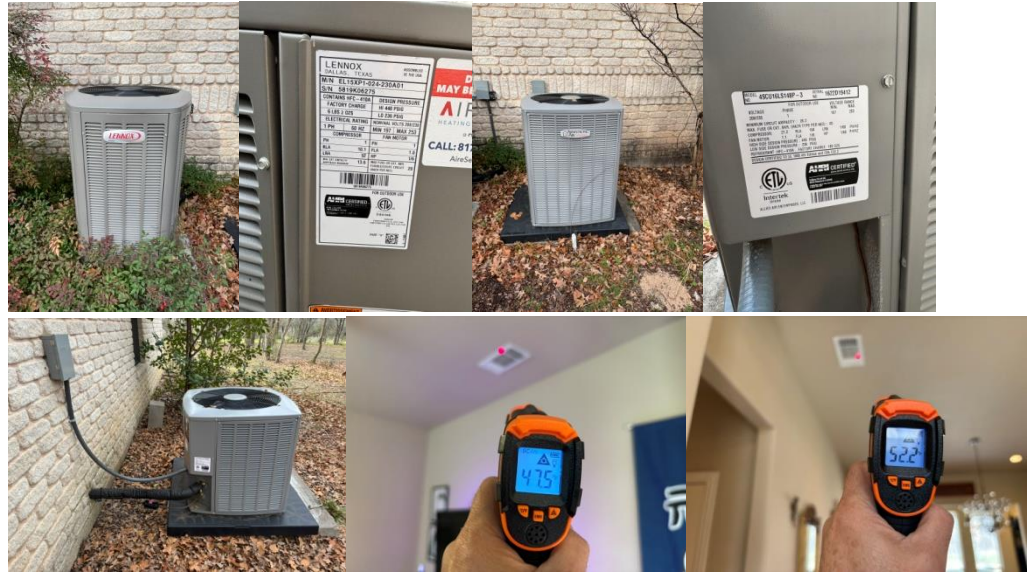
- *Main Unit Functional: The main house interior and exterior cooling equipment was inspected and no deficiencies were noted at the time of the inspection.*
- *Upstairs Unit Functional: The upstairs interior and exterior cooling equipment was inspected and no deficiencies were noted at the time of the inspection.*

1: The Outside Unite should be clear from bushes and clean, recommend landscape contractor.

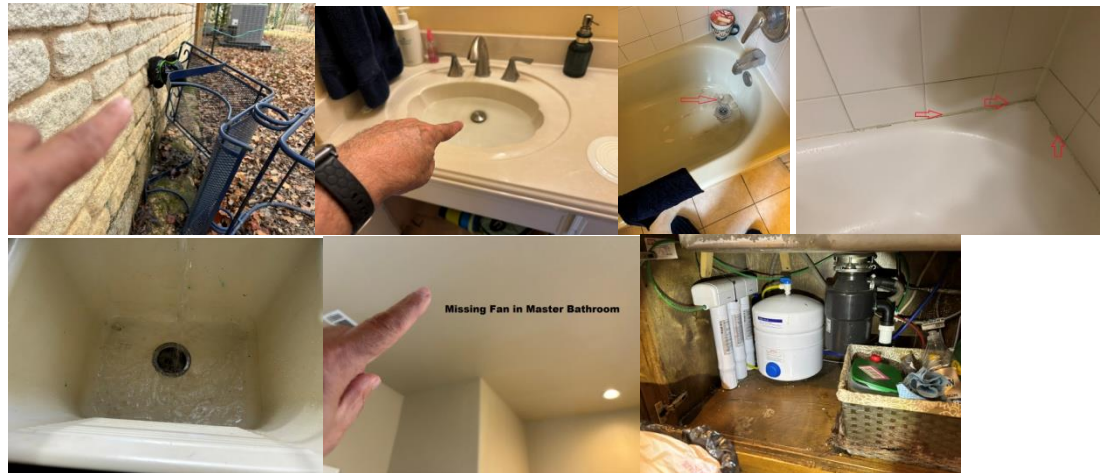
1: Slow drain: Jack and Jill bathroom sink has slow draining water.

2: One or more of the exterior water hose bibbs (faucet)is leaking, Recommend contact certified Plumber.

3: Surface Damage – Landry room sink There was surface damage present at the bathroom bathtub.

4: Surface Damage – Bathtub: first floor Bathroom There was surface damage present at the bathroom bathtub.

5: First floor bathtub caulking seal damage and need to be fixed.

7: Master Bathroom missing ventilation fan to remove moisture.

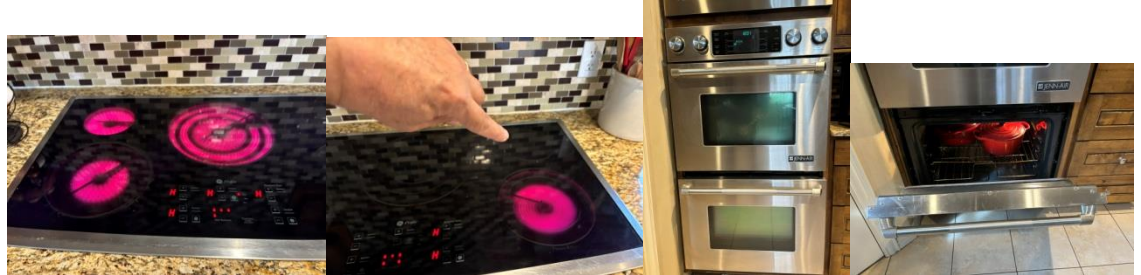
1: Burners Functioned Properly: All range burners functioned except one as intended at the time of inspection.

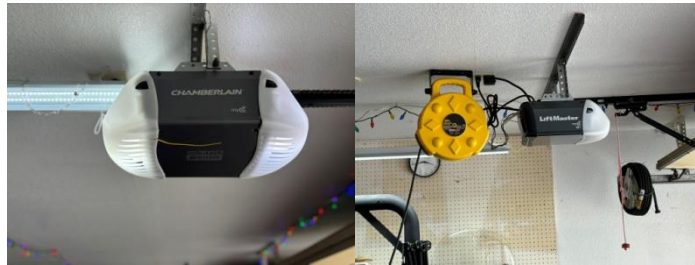
Door Operated: Yes - Automatic door controls
Sensors 6 Inches Or Less From Garage Floor: No
Unit Operational: Yes
Electric Eye Reverse Test Acceptable: Yes

1: Auto Reverse Test: Not working

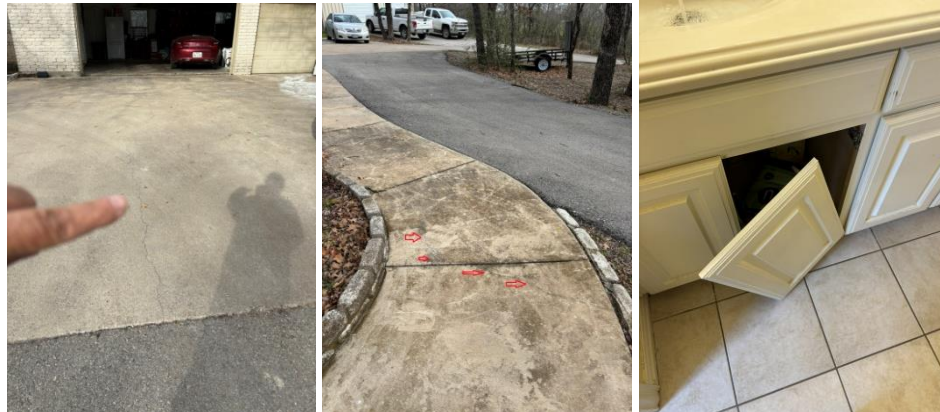
*1: Driveway Cracking:
 Cracking was observed at the driveway. Recommend a qualified professional evaluate and repair as needed. Recommendation: Contact a qualified professional.*

*2: Walkway Cracking:
 Cracking was observed at the walkway.*
