# PODIUM TILE INSTALLATIONS: POTENTIAL PROBLEMS DUE TO LACK OF APPLICABLE STANDARDS

The introduction of podium tile installation systems represents a forward-thinking development in the tile and building industry. While these systems provide solutions to many building and tile problems, they cannot eliminate traditional tile installation methods altogether, according to Tim Christopher, principal at Consultile Consulting Australia.

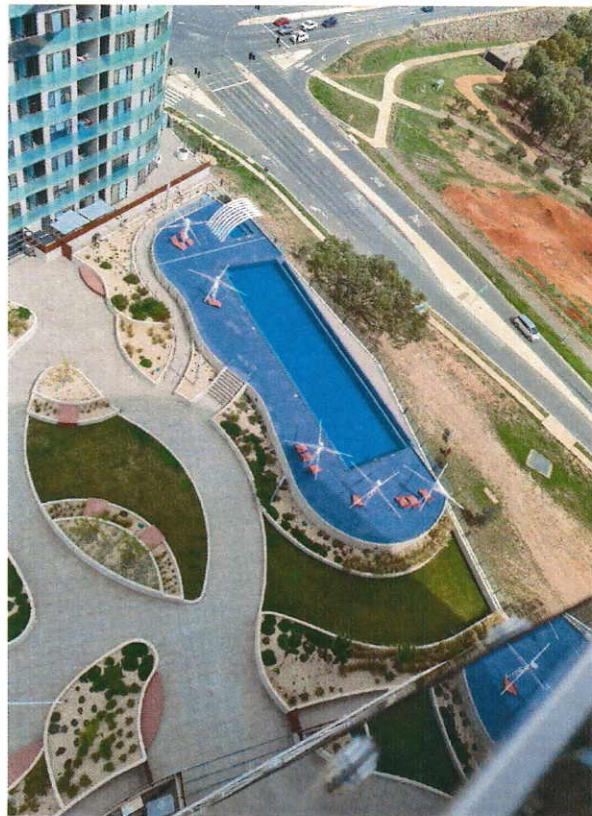
Common podium tile installations are used in large public areas such as this 420 unit apartment block 'Sky Park' on level 5

I have observed an increased use of podium and “pedestal” tile installations. These installations have also become increasingly ambitious in area and pedestrian intensive scenarios. A typical private balcony installation may be 8 to 10 m<sup>2</sup>, (86 to 107 square feet), but podium systems are increasingly being utilised in larger areas, such as commercial areas for building entryways, and public spaces. I have seen areas of approximately 500 m<sup>2</sup> (5,381 square feet) at apartment blocks in facilities designated as common use areas.

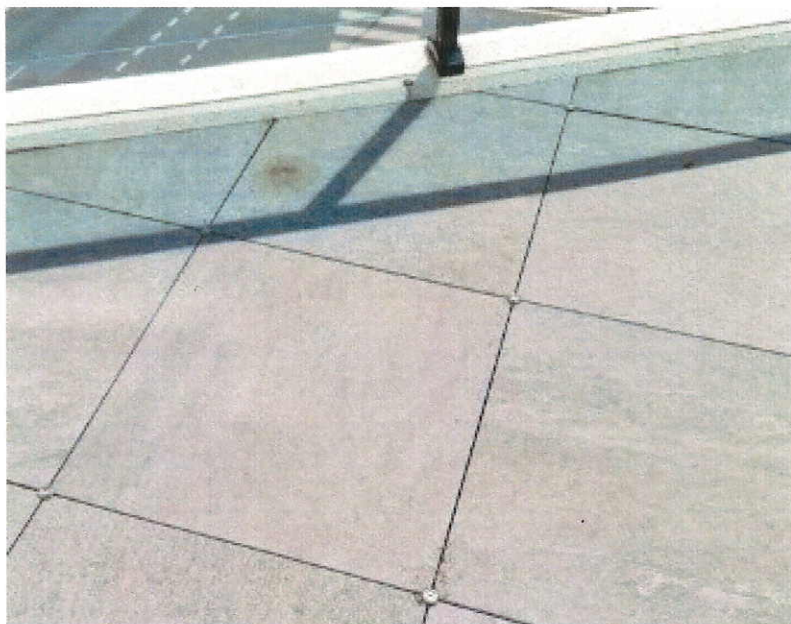
**PHOTOGRAPH 2** depicts a mechanical fixing system to prevent dislodgement of tiles that were previously flipping over in high winds

Wind related references provide guidance to determine the set down distances for external floor levels in relation to the door sill heights. This guidance is specific to prevent ingress of water aided by wind energy. (See **Photograph 2** which depicts mechanical fixings used to restrain tiles which were flipping over in windy conditions.)

Many manufactures of podium systems provide adaptive fixing systems to anchor tiles down in a way that prevents the installations from allowing the tile to lift and flip. When researching podium manufacturers' installation instructions, I was unable to find information or reference to any guidance documents which

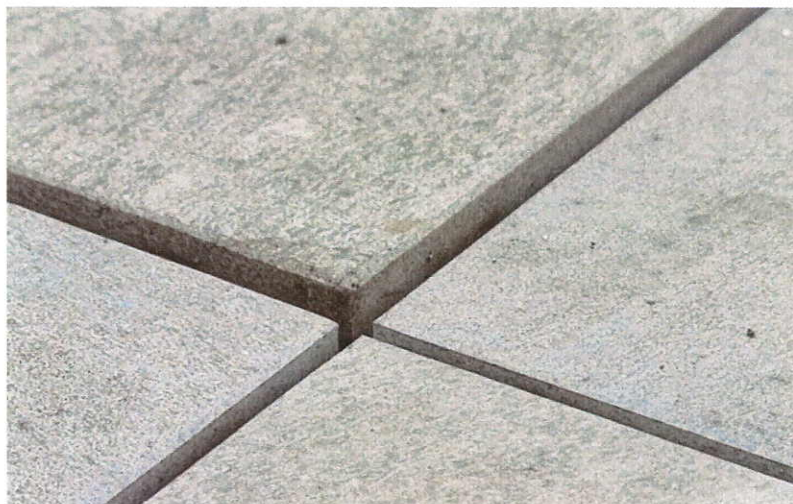
**PHOTOGRAPH 3** depicts lippage between tiles subject to foot traffic

This creates problems such as tiles that can rock from side to side and lippage between tiles (see [Photograph 3](#)). This can

be addressed by subsequent adjustment of the pedestals but in doing so, creates a maintenance requirement. In the instance of this type of maintenance, there is no guidance on the requirements in relation to intervals, qualifications required of the servicing contractor or expected frequency of such maintenance. One manufacturer of the pedestal systems data sheet states movement in excess of 3mm (1/8 inch) will void the podium system warranty [1].

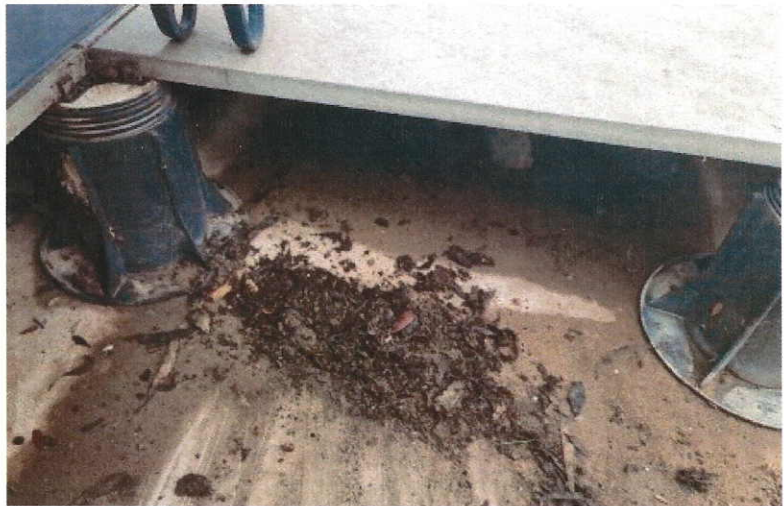
**PHOTOGRAPH 4** depicts debris under a podium system two years after installation

The nature of a podium installation provides that there is no requirement for grout between the tiles. Joint size between the tiles is 3-5mm (0.11 to 0.19 inches). This gap facilitates drainage, but also allows for a degree of environmental debris to be accumulated beneath the tiles. Where dirt and debris do accumulate on the surface of the tiles, regular sweeping or even vacuuming will not remove all the contaminants and some debris will in time cause an increasing build-up beneath the tiles. The installation of a podium tile system also necessitates adequate room for movement between the tiles and adjacent perimeter walls. Wind driven debris accumulates at this location (see [Photograph 4](#)).

a higher amount of dirt, organic matter and dust under tile installations than expected. This creates a need to clean beneath the tiles to facilitate the ongoing drainage function, and to prevent damage to the waterproofing membrane, if present.

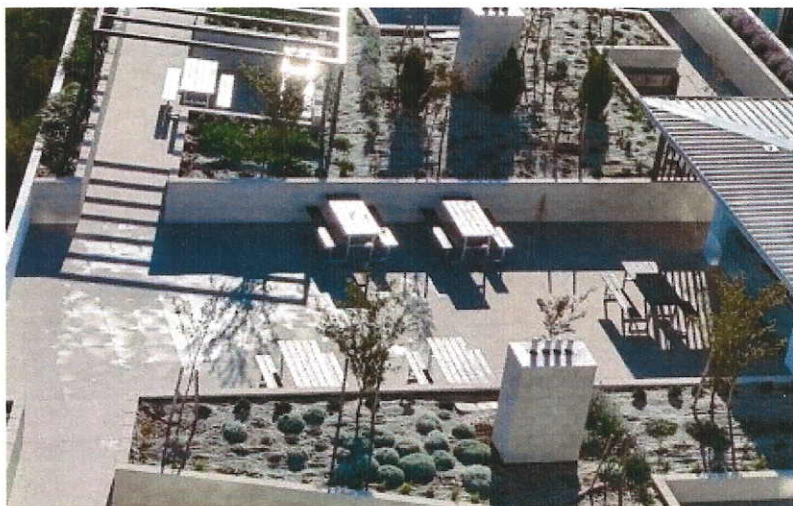
**PHOTOGRAPH 6** depicts water retention on the surface of a podium tile installation

→ potential slip hazards are created if surface water is to freeze. Surface water retention will exacerbate the retention of dust, promote the growth of moss and or lichen type organisms which create additional pedestrian slip potential, along with cleaning and maintenance requirements [see [Photograph 6](#)].

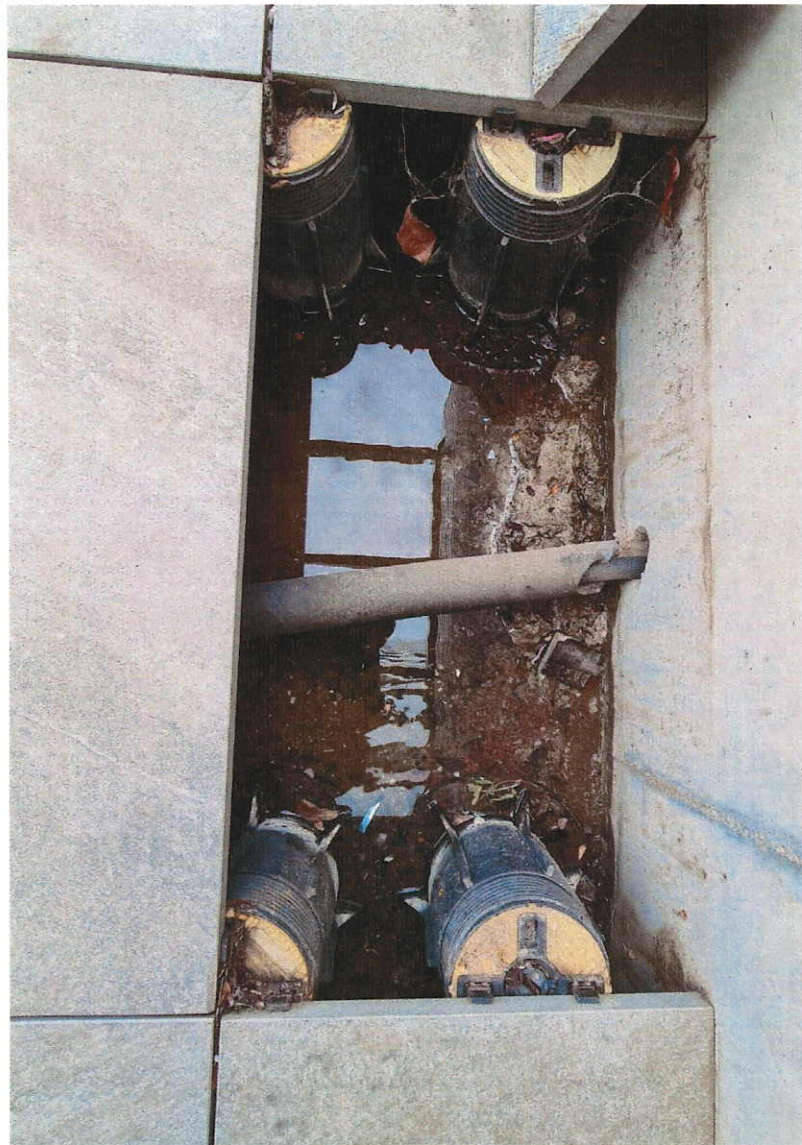
**PHOTOGRAPH 11** shows water retention beneath the tiles due to insufficient gradients

→ is essential. Many membranes are unsuitable to be installed where water retention is a regular occurrence (see [Photograph 11](#)). This necessitates that the entire subfloor falls to the drainage outlets from all the extremities of the floor area.

Installing a gradual and consistent gradient during a large concrete placing process is difficult or impossible when considering timing and volume of material to be installed at the concreting stage. Often the concrete slabs which have podium systems installed do not have consistent fall and only drain from limited areas or over a reduced distance as was dictated by the concrete placing process.

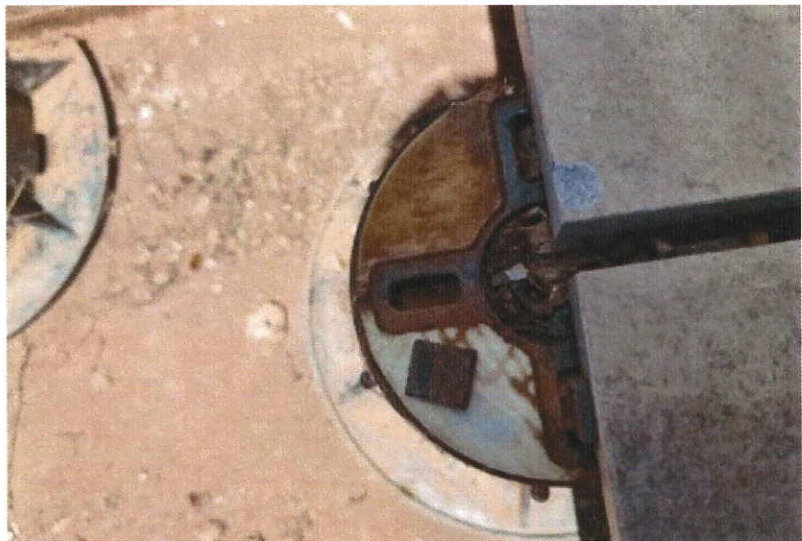
PHOTOGRAPH 9 shows broken spacer lug

While the exposure to UV light by the pedestals themselves is reduced due to the cover of the tiles, I have observed damage to the spacer lugs which keep the individual tiles separated and evenly spaced out. The UV levels in the daytime hours in Australia are some of the strongest globally (up to 15% higher than Europe) [7] and subsequently degrade many plastics through the action of breaking down polymers. The plastics which make up the pedestal construction are listed in technical data sheets as UV resistant. However, there is no accompanying information as to whether this prolongs the time for damage to occur, or indicates a consistent high level of protection provided.

The damage through UV seems trivial on face value, until the resulting tile movement due to broken spacer lugs is considered. Once the spacing between the tiles is absent the tiles could move under foot traffic, allowing the tile to become chipped (see [Photograph 8, 9 and 10](#)). The adjustment of the individual pedestals is then knocked out of balance by pedestrian movement, allowing the tiles to rock from side to side and lips to occur. This results in

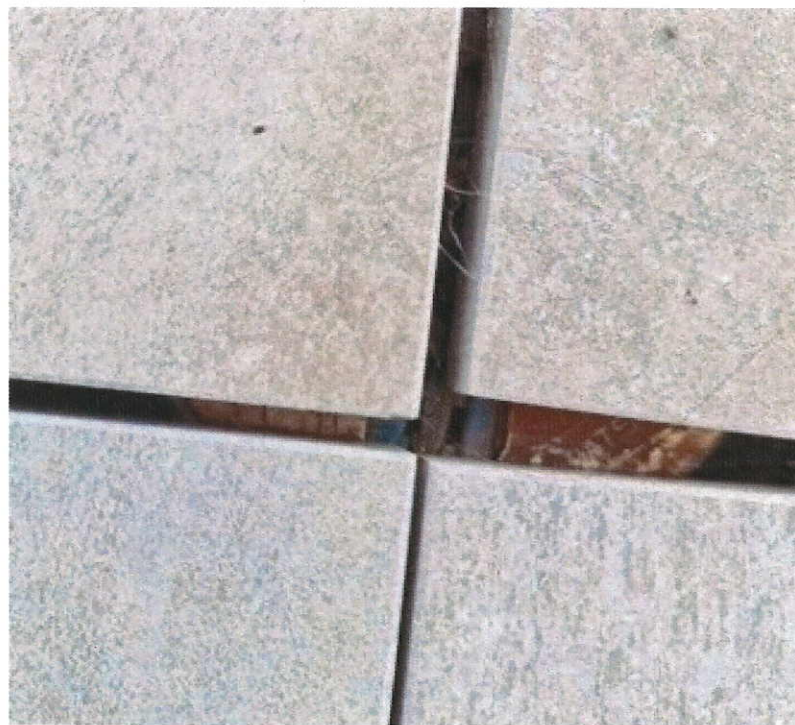
PHOTOGRAPH 10 shows missing spacer lugs
