# Butterfield Overland Mail's Horsehead Crossing Station

Tom Ashmore

February 2020, updated 2025

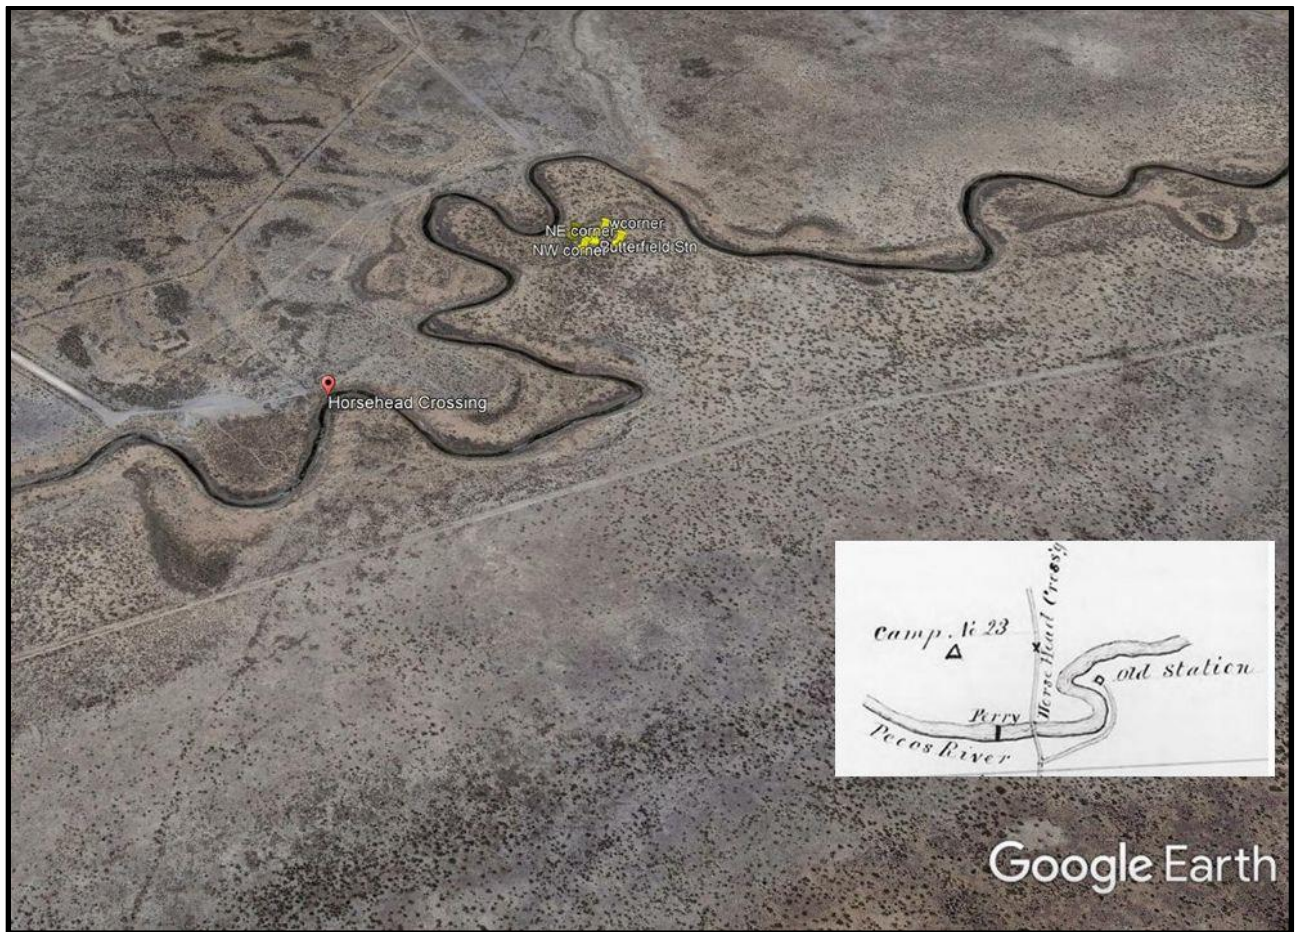
**Comparison of Hunt 1869 map and identified location of the station through imagery interpretation.**

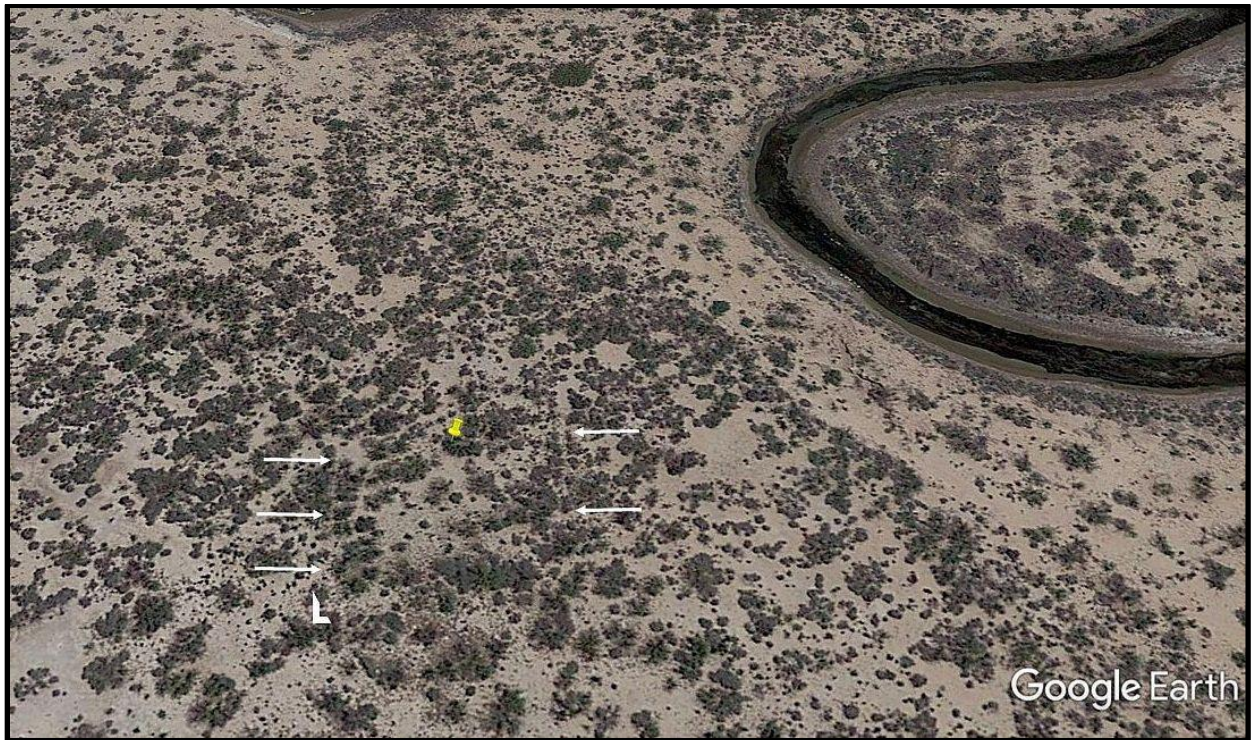
To search properly in Google Earth, the application's historical capabilities are invaluable, since images are taken in different seasons over the years. Years of drought may reveal things that were covered during wetter years. In this case, 2014 was a drought year and the year in which vegetation anomalies were indicated. Two straight line remnants of wall structures and one 90-degree angle can be seen in this image.

### **Anomalous straight lines and 90-degree angles in vegetation**

Using the Google Earth measuring tool on the best 2014 imagery of the wall remnants indicates the walls were about 3.5 feet thick. This is an expected width for an adobe structure, since there is very little reinforcement, and a thick wall must be maintained to maintain the integrity of the structure.

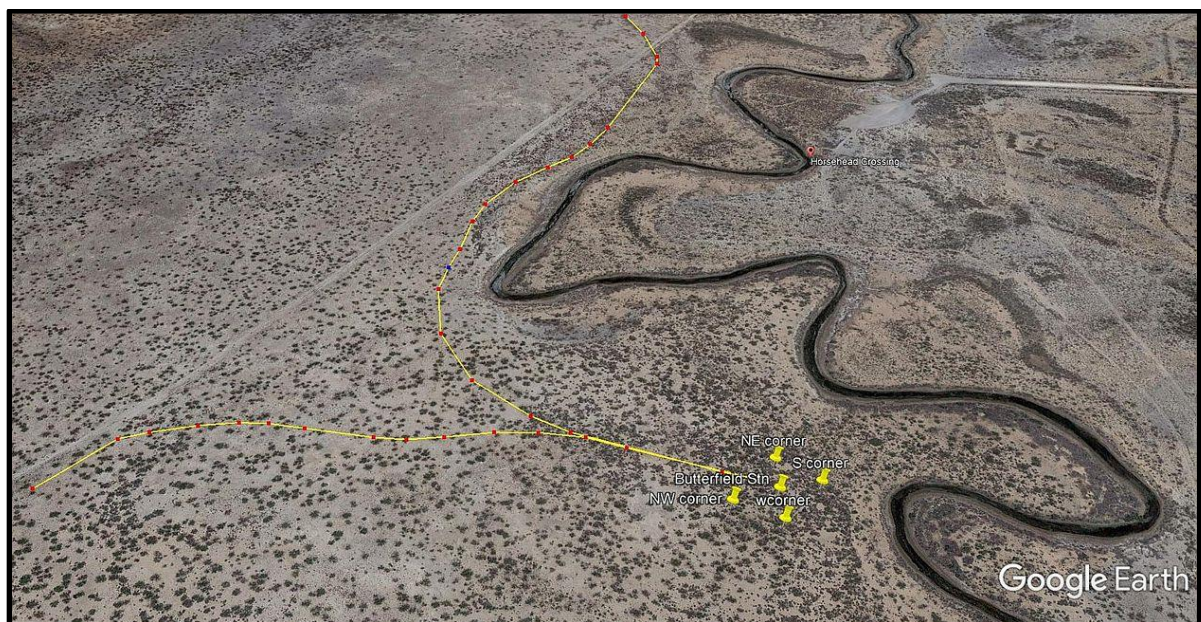
After finding what appears to be the remnants of a structure, it is time to look for roads leading to it and to determine where they come from. In this case, there is a well-known wagon road from the Horsehead Crossing cutoff, heading upriver to the next crossing point, Emigrant Crossing, which passes by this bend in the river. From that wagon road, another, less well-traveled wagon road can be seen in satellite imagery leading in and out of the bend and directly to the location of this former structure.

**Wagon road leading in and out to the former structure. Note: The long straight line in the upper-left corner is the modern fence line.**

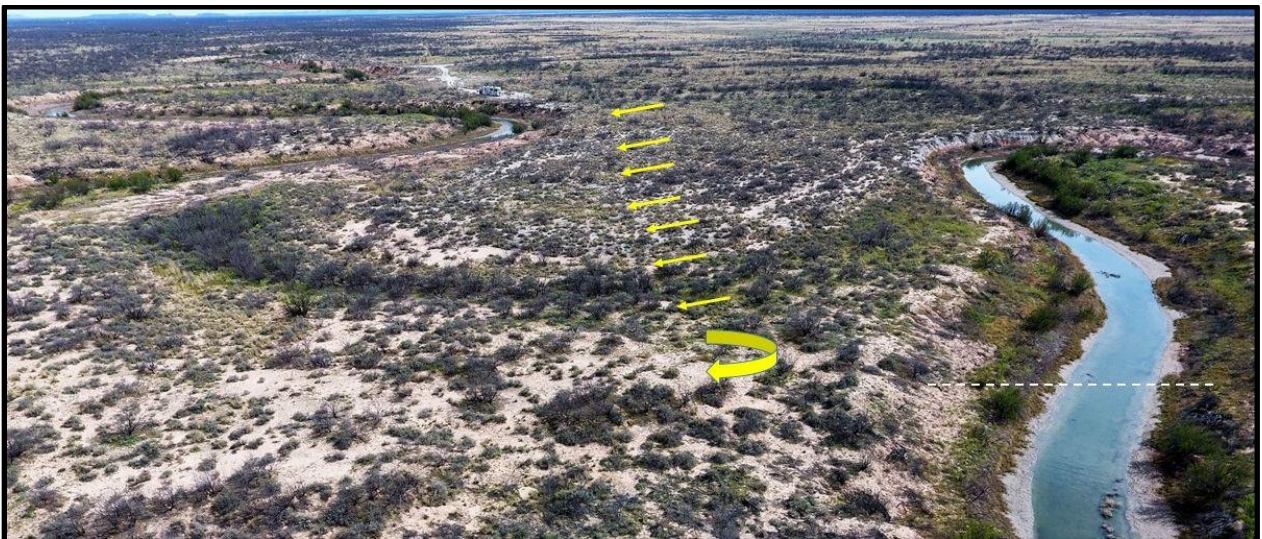
To verify that the wagon road from the station was for the ferry crossing, a review of any wagon trail on the other side of the river was required. The result was that a wagon trail could be seen departing the established Fort Stockton road before it reached Horsehead Crossing proper and headed straight to the riverbank directly opposite the wagon trail turnaround on the other side.

**Dark line of bushes is an old wagon road from Fort Stockton road to ferry crossing point on west side of Pecos**
