# Butterfield Overland Mail's Horsehead Crossing Station

Tom Ashmore

## Abstract

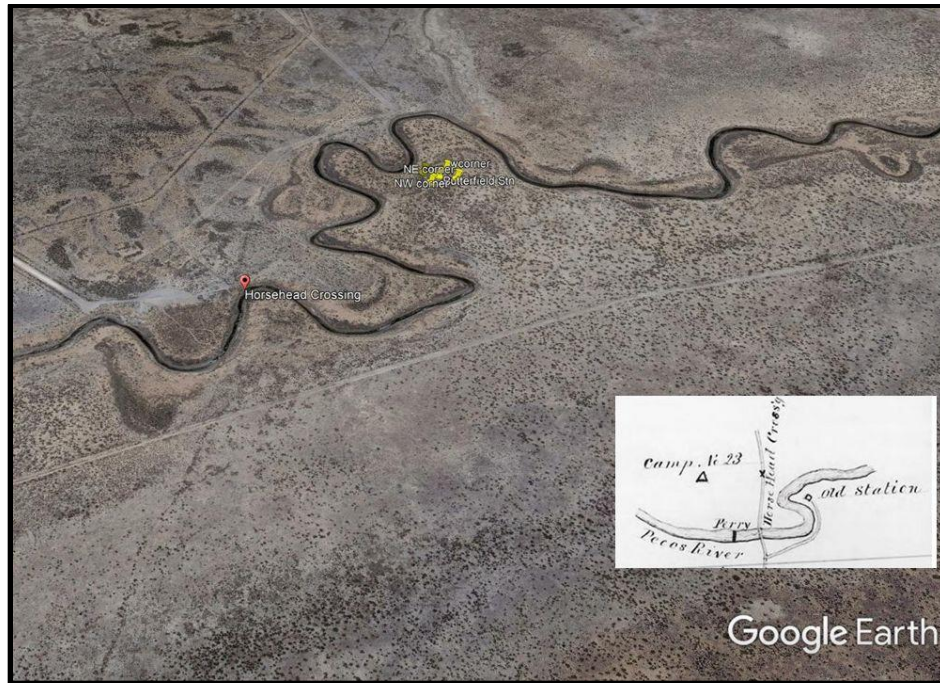
**Comparison of Hunt 1869 map and identified location of station through imagery interpretation.**

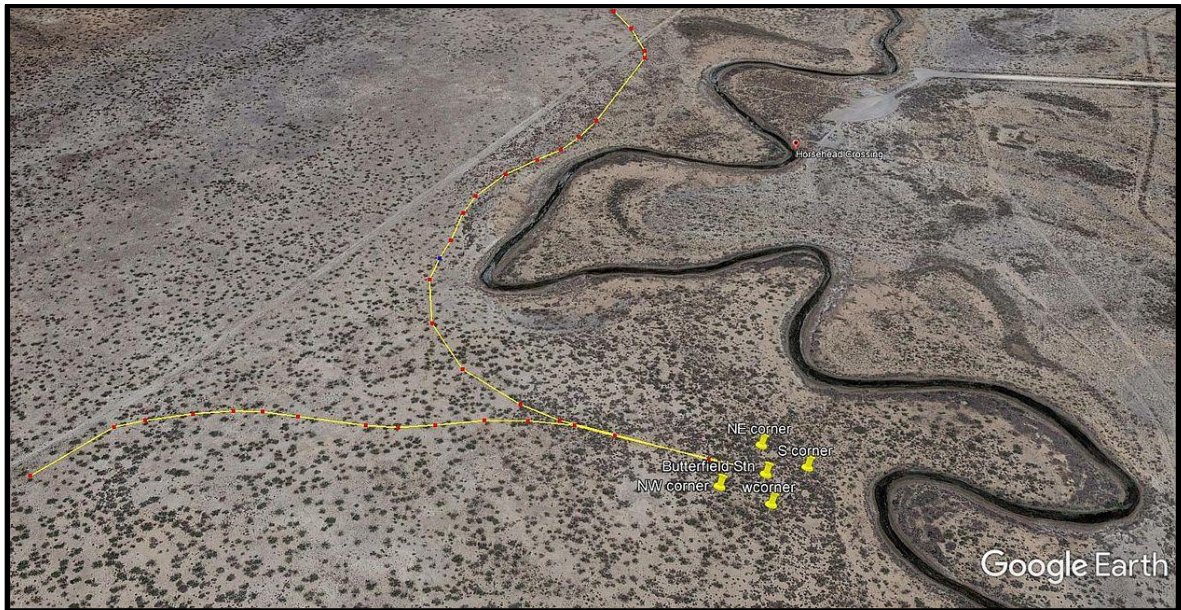
**Wagon road leading in and out to the former structure. Note: Long straight line in upper left corner is modern fence line.**

After finding what appears to be the remnants of a structure it is then time to look for roads leading to it and from where they come. In this case there is a well-known wagon road from the Horsehead Crossing cutoff heading up river to the next crossing point, Emigrant Crossing, and it passes by this bend in the river. From that wagon road another, less well travelled wagon road can be seen in satellite imagery leading in and out of the bend and directly to the location of this former structure.

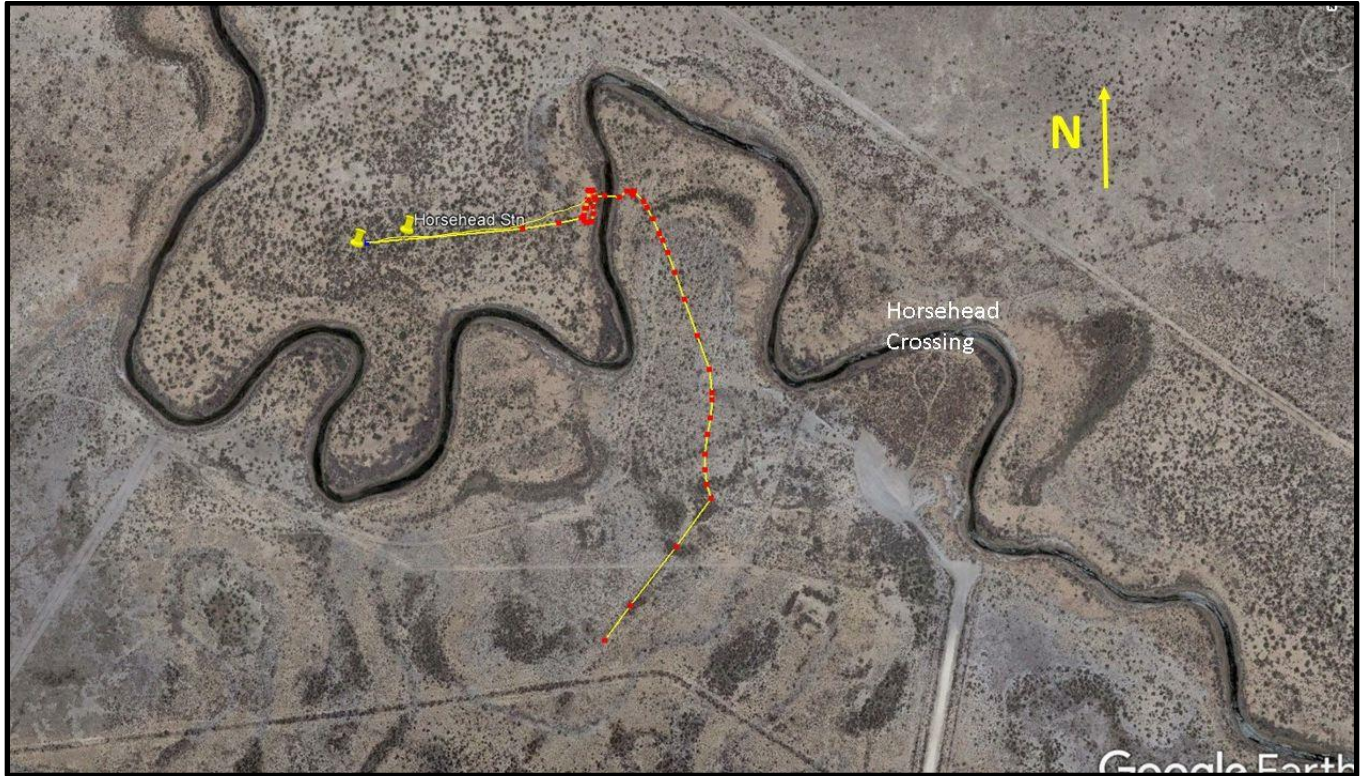
Roads from Ft Stockton road and stage station leading to opposite sides of river

On the west side of the river the road came to what looks like a turnaround area. On the east side it appears the coach may have driven along the bank in a kind of loop around and back to the station.

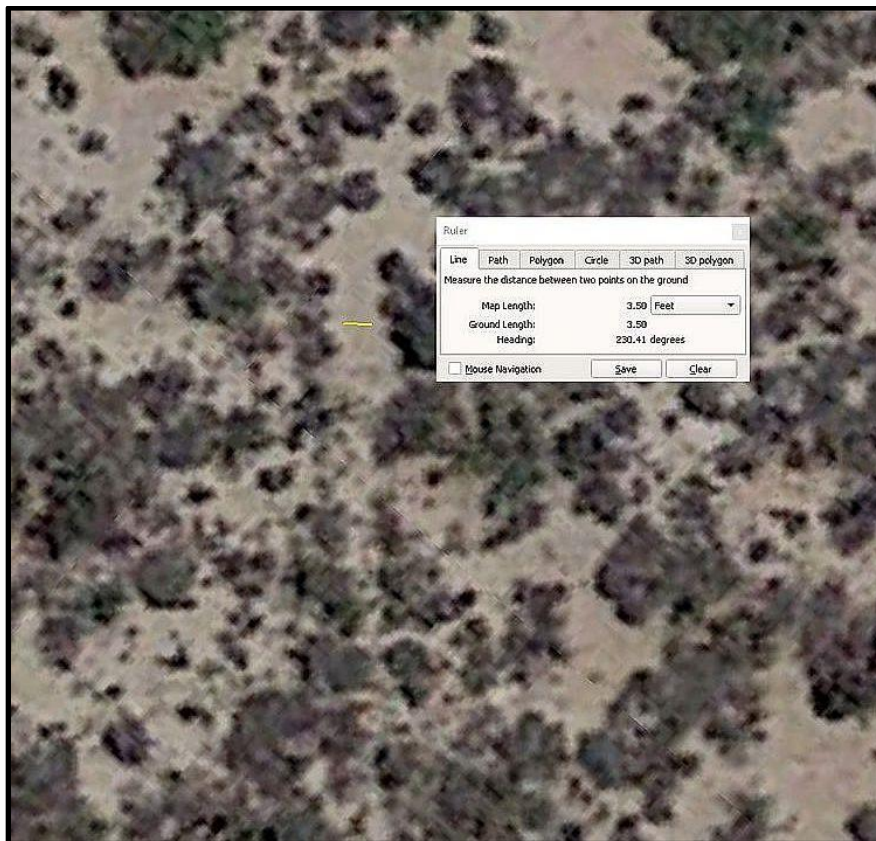
**Measurement of width of wall remnants**

Using the Google Earth measuring tool on the best 2014 imagery of the wall remnants indicates the walls were about 3.5 feet thick. This is an expected width for an adobe structure since there is very little reinforcement and must be a thick wall to maintain the integrity for the structure.

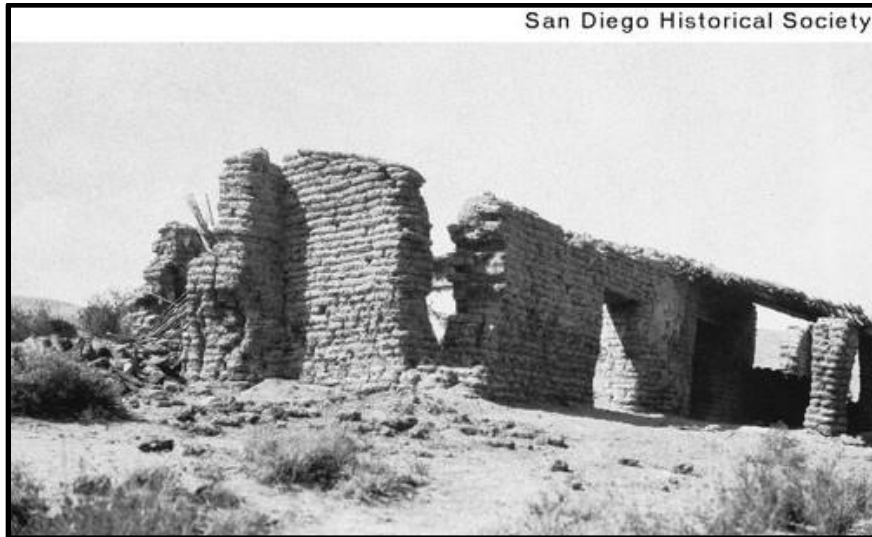
**Vallecito Stage Station, San Diego County, CA (1953)**

A good example of this is the Butterfield's Vallecito Station in San Diego County, CA. This 1953 photo from the San Diego Historical Society shows clearly the width of the walls.
