Pecos Mail Station (41CX1825/1826) & Camp Melvin (41CX20):

The Rest Of The Story

West Texas Archeological Society (westtexasarcheologicalsociety.website)

November 2023 (updated Jan 2025)

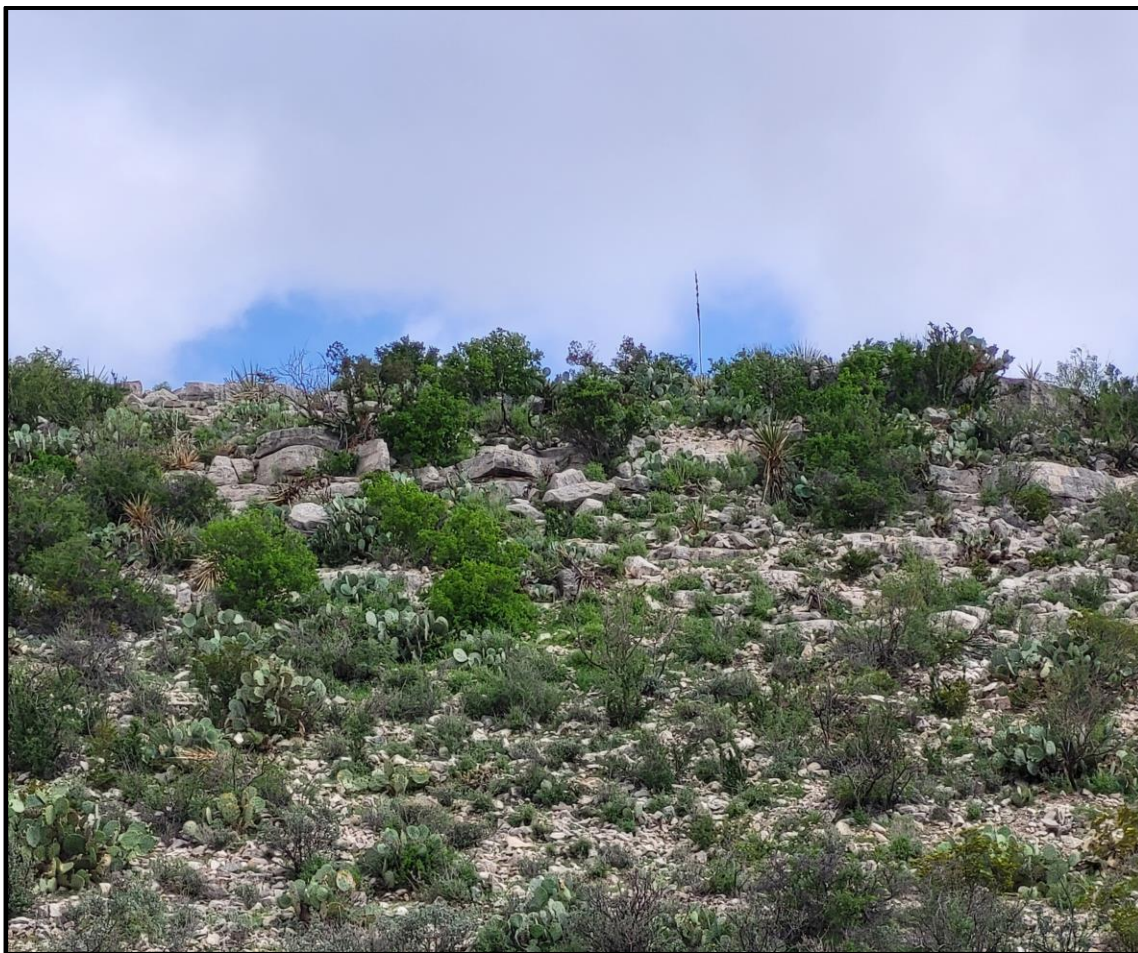
Quarry Site #1: Untouched Area on Left, Quarried Area on Right

There were three quarry sites halfway up the hill at the first large rock shelf. Below them were two sets of loading wagon roads, one high and one low. Below the wagon loading roads we found five tent platforms. The platforms were leveled so we could measure them and determine approximately how many tents were in each platform. Two platforms measured 12 X 3 yds, one 7 X 3 yds, and two 5 X 3 yds. Each was strewn with period can trash and supply box strapping. We estimated these accommodated 12 tents total, probably all large single-man tents.

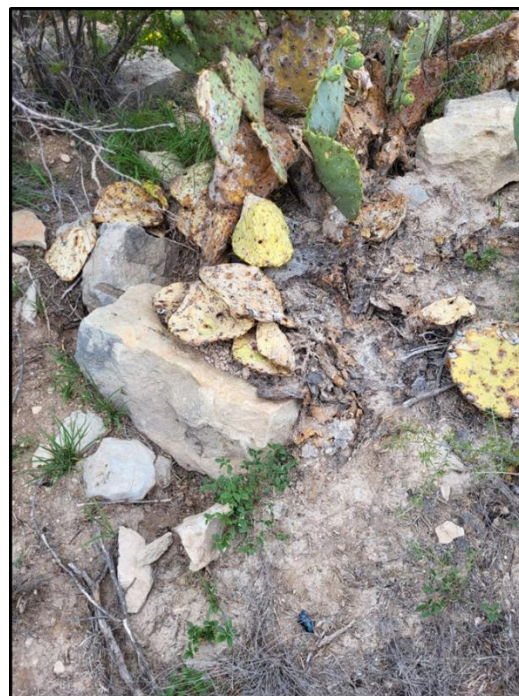
Left behind shaped stones

From the loading areas, the wagon traces went either to one of two stone-shaping camps or straight out to one of the construction sites. Each stone-shaping camp had tent platforms that would have accommodated two tents. Broken rubble was strewn below the shaping site tent areas and the same period cans and trash could be found. In stone shaping camp #2 (east side) several unfinished or unused stone blocks were also left behind.

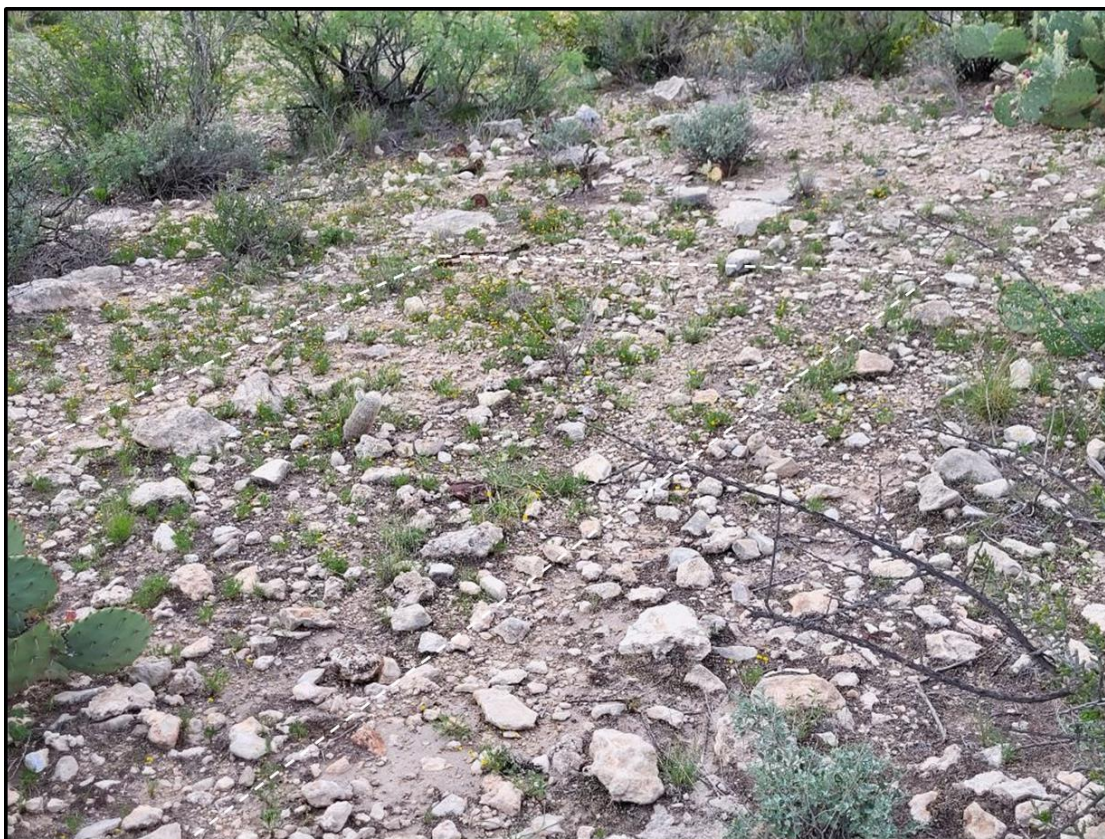
Tent Platform below Quarry Sites

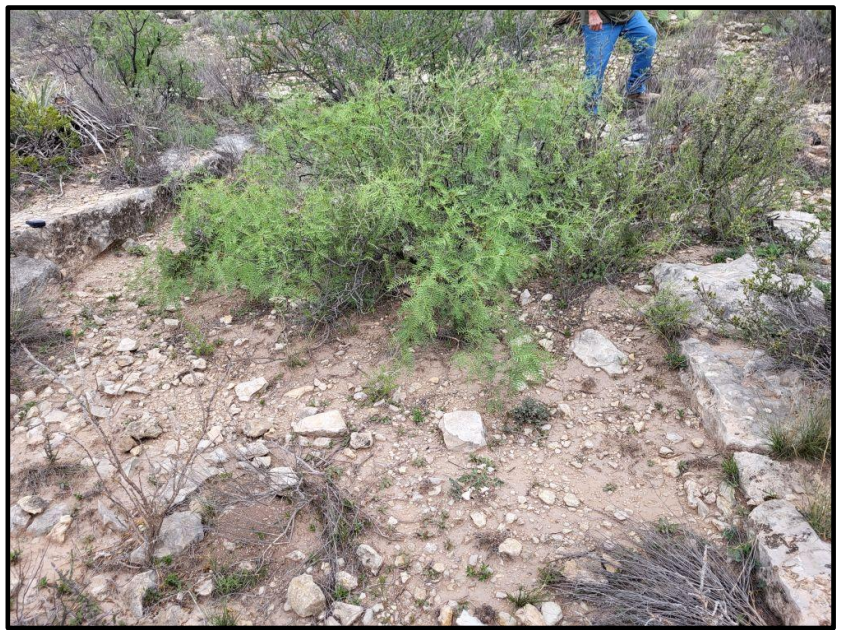
Probable Operation Supervisor's Tent Site

To the far east of the operational area there is one particular site with large quarried stones lining it, which we designated Tent Site #1. It is in line but separated from the other tent sites by 125 feet. The other tent sites are laid out 35 feet apart and dug out to be level, but not rock-lined. This was probably the operations

supervisor's tent site. Any operation of this magnitude would have required an overall supervisor and he would have been given a site created to suit his position. Additionally, we can trace a perimeter wagon road going to this site specifically. This wagon road can be traced to the far western side of the operations area.

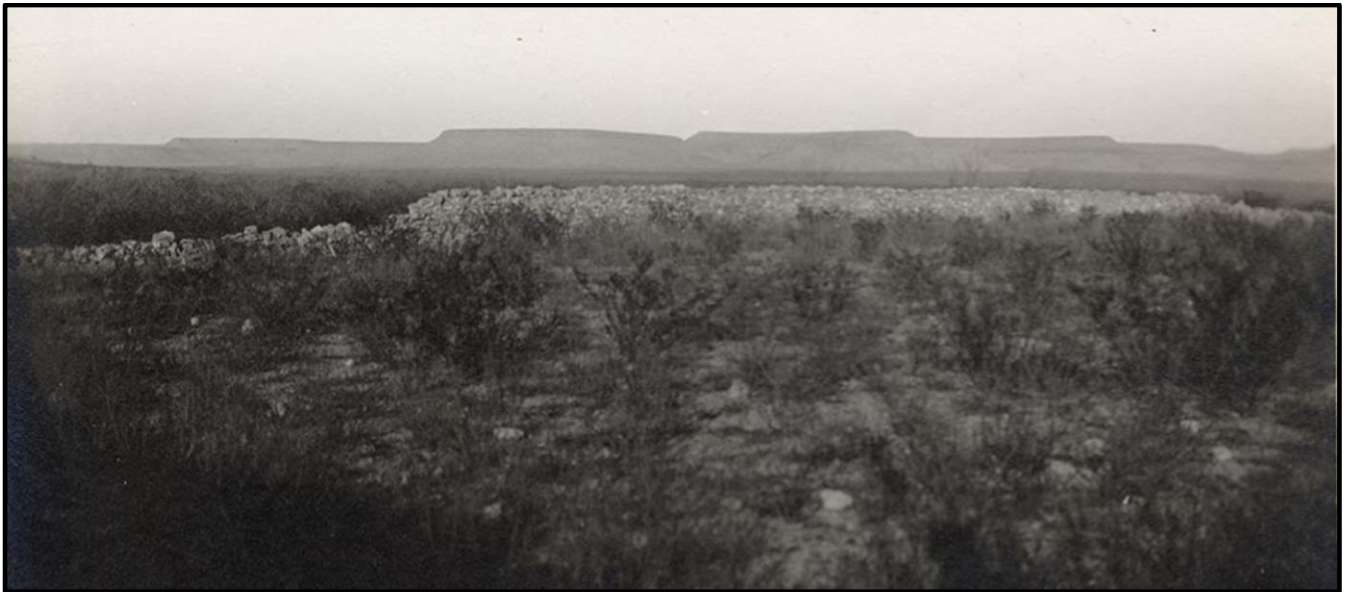
Photograph of Corral from the Early 1900s

The corral itself covered over a half acre and the walls were originally around six feet high. We know this from an early 1900s photograph taken before the walls had completely collapsed. Greasewood stands approximately four feet high at full growth. With this, we can make a good estimate in the photograph of the wall being six feet high. This corral was huge, enclosing .60 of an acre, or 26,136 square feet. We can only speculate why such a large corral was built, with the best guess being that due to the Indian threat, they never wanted the animals to be outside of the corral other than relieving stagecoach teams at the station.

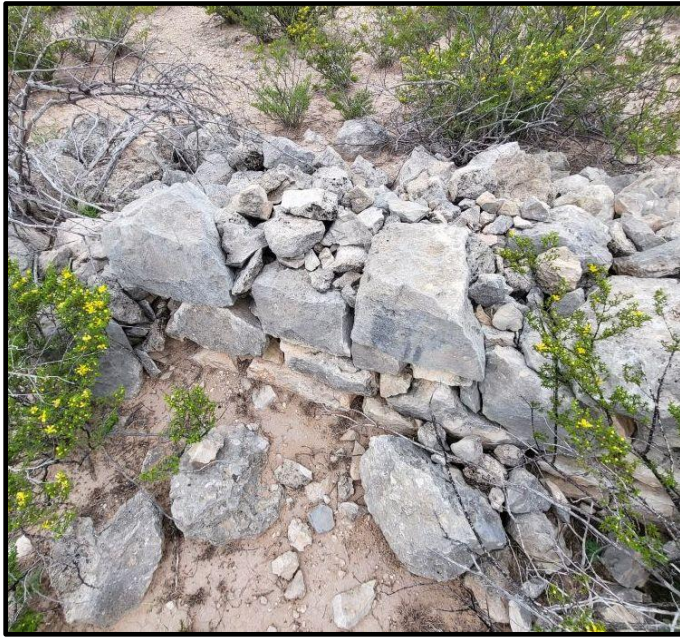
Corral Stone Wall

The walls were built 2.5 feet wide. Two lines of faced rock were laid, with a gap in the middle to be filled in with rubble. In this way, the shaping masons only had to make a flat face on one side of the large stones. This saved quite a bit of work and made a stronger wall

for such a long, straight line.

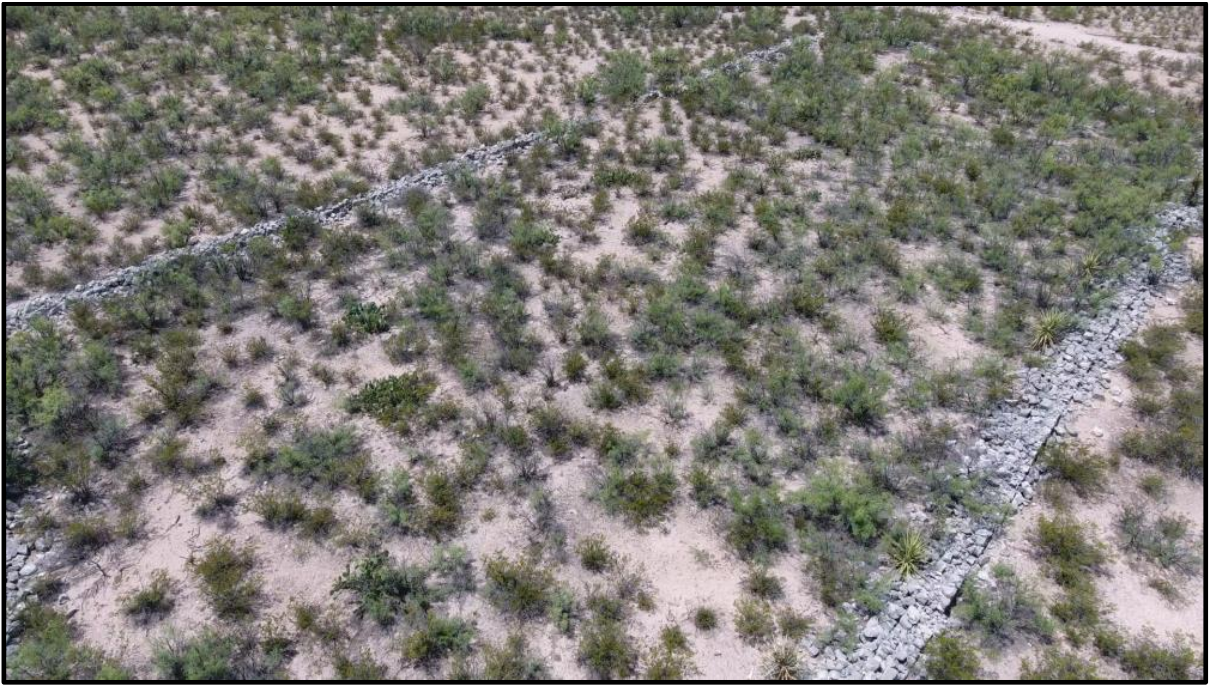
Stone Corral .60 Acre

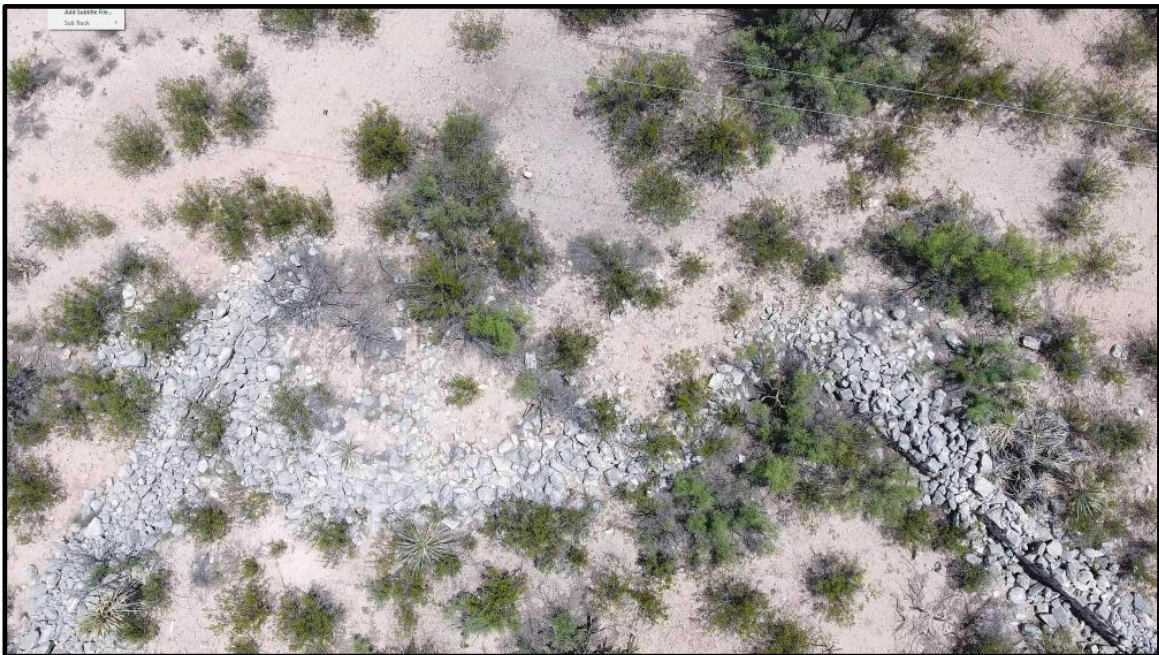
Northeast Corner of Corral's Bulldozed Area and Power Lines Above

Unfortunately, in the 1990s an electrical power line right of way was created that ran past the northeast corner of the corral. The corral had not been designated an historic site and the electrical company bulldozed the corner underneath the right of way. This shows the importance of designating historic sites with the Texas Historical Commission to properly document and preserve these sites against encroaching modernization where alternatives can be considered. This site is now separately designated in the Texas Archeological Research Laboratory database, University of Texas and Texas Historical Commission, as 41CX1826.

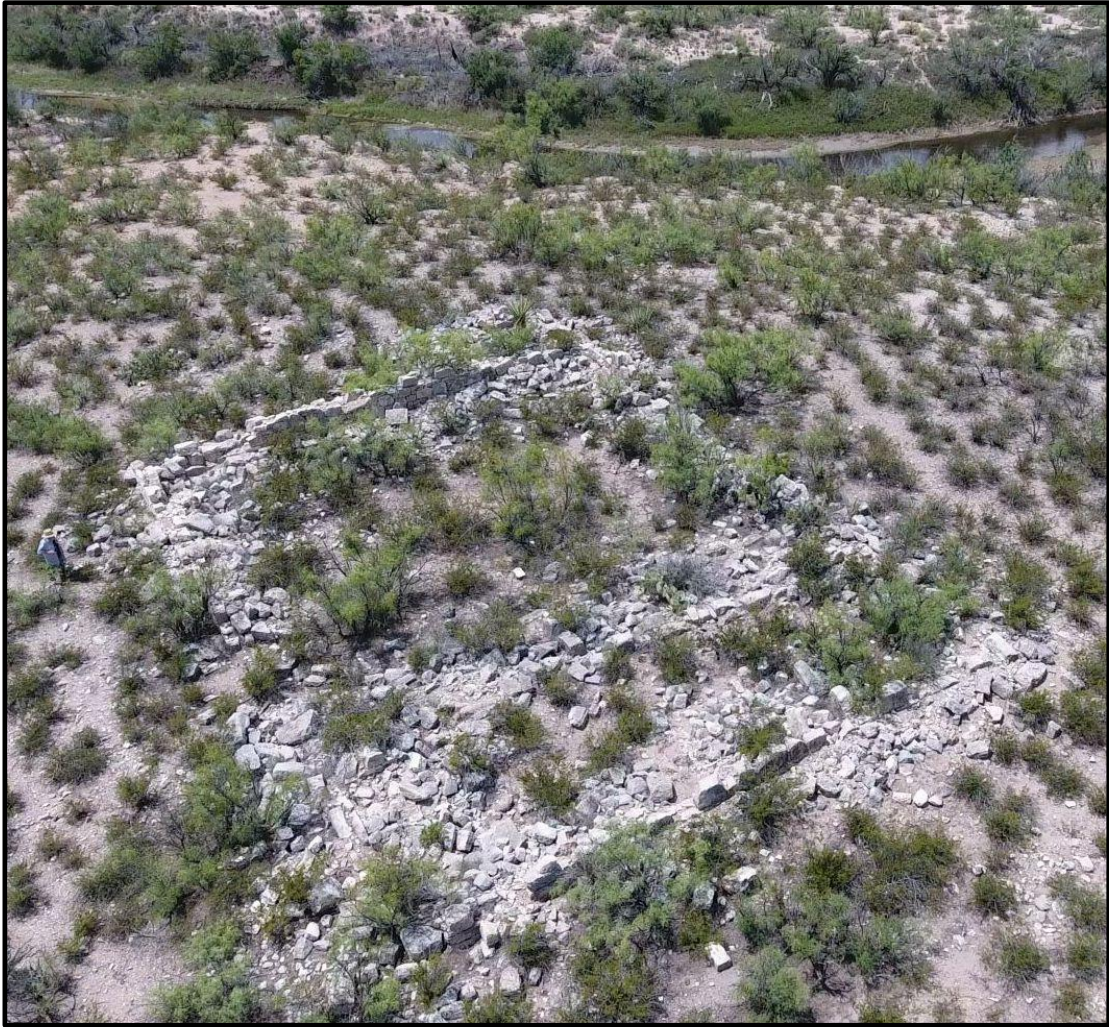
Pecos Mail Station Ruins. (Note C.A. Maedgen standing near the collapsed wall on the left side)

The station consisted of 10-foot high walls (see photo at beginning of the report) with a 45 X 45-foot courtyard that the stagecoaches could drive into for their mule team changeover. The entrance appears to have been a gated 10-foot wide opening. The north side of the station is taken up by two rooms and a storeroom/tack shed. The two rooms probably shared a central fireplace, open to each room. The common area appears to be 15 X 25 feet and has a rear door leading out to a small, stone-lined platform that was their outhouse. The second room was probably sleeping quarters and measured 15 X 15 feet. The storeroom was set back from an alcove and measured approximately 5 X 10 feet.

On the south side of the compound was built a small stone structure that had no entrance into the main compound. The door into it was on the west side. It measures 12 X 12 feet. Based on a wagon road leading to this small structure from the military area, we can assess this was a guard post, and probably a documented guard house used for detaining any military soldiers that were put up on charges. Since they would need to see to the northeast, we can determine it was probably at least as high as the main walls, but the location also gave them a good view of the pontoon bridge crossing, located 170 yards upriver, to the west.

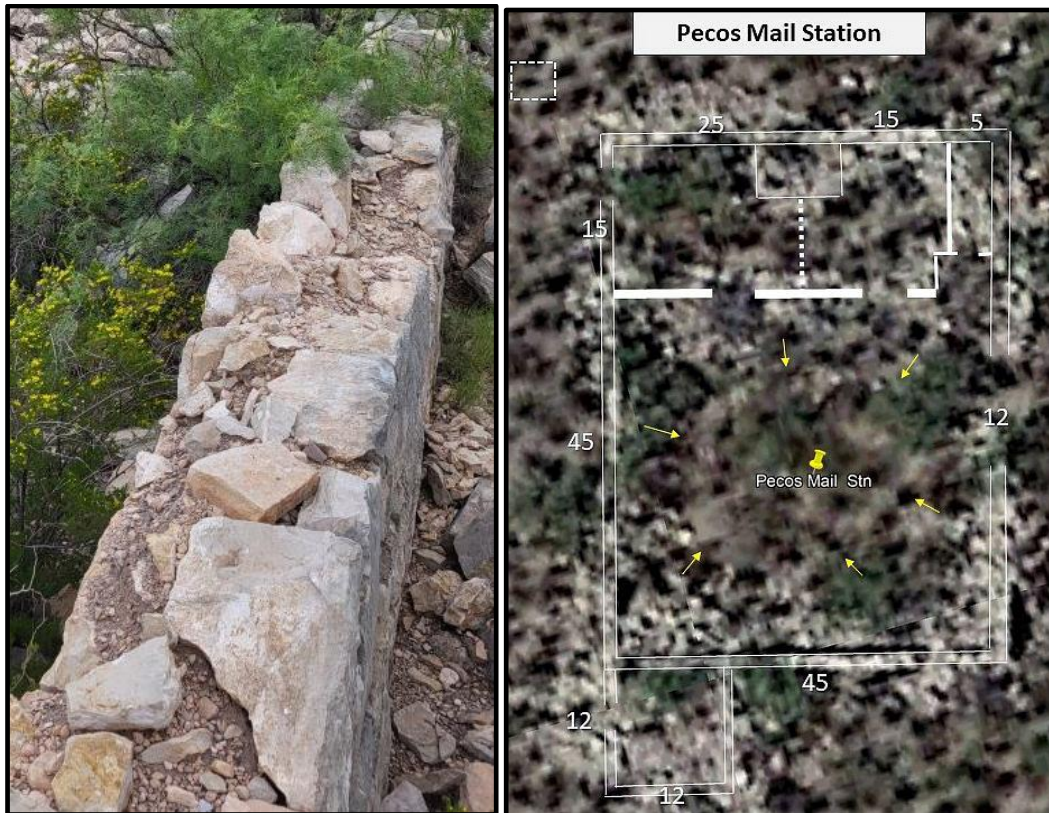
Double-Line Stone Wall

The Pecos Station walls followed a similar construction technique as the corral, but the walls were 2 feet wide versus 2.5 feet. They were laid out in a double line of stone. In some cases, fully squared blocks were used, especially at the base of the wall, and in other cases, it appears only one face of the stone was shaped. Small pieces were placed to level each row of stone and fill in gaps.

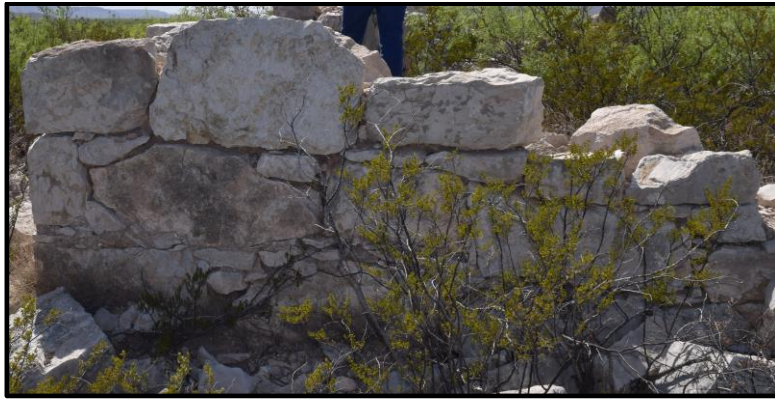
Fully Cut Blocks on Base of Wall

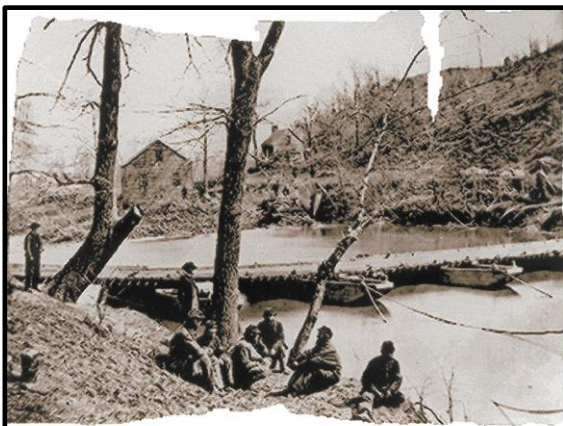
A Civil War pontoon bridge

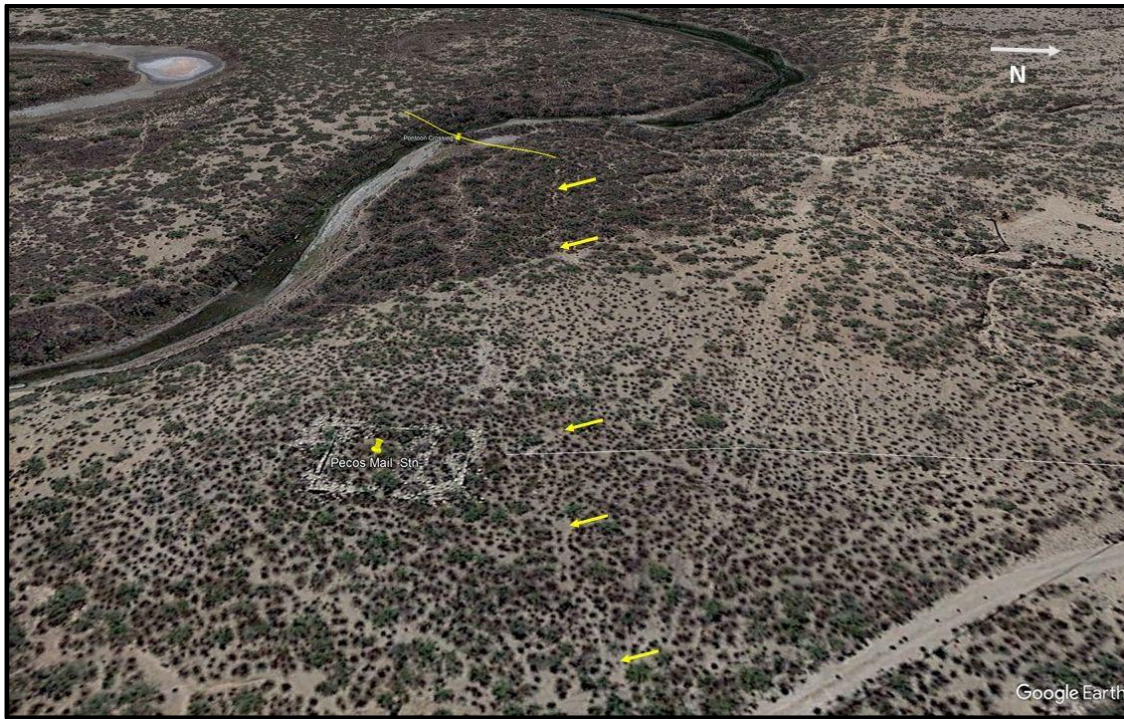
Wagon Trace and Probable Pontoon Bridge Site

The pontoon floating bridge was the second choice that could handle wagons in that period. It is a much larger operation than most today can conceive. And given that the west side embankment is at least 15 feet higher than the north side at water level, the bridge would have been quite long. By following the old wagon trace that runs past the station and down to the bridge area, we could find what would have been the bridge abutment, or east-side entrance. Through Google Earth we can also find the elevation, and these two points on each side of the river are the same. However, a dip in the bridge to the expected water line would still require a fairly mild cut-bank climb out on the west side to keep the bridge angle from becoming too steep. This would make the bridge approximately 170 feet long. A photograph of a very similar pontoon bridge of the period gives a good perspective of the size of this bridge. It also gives a good perspective of the requirements needed to build a structure of this size, far away from the major supplies needed.

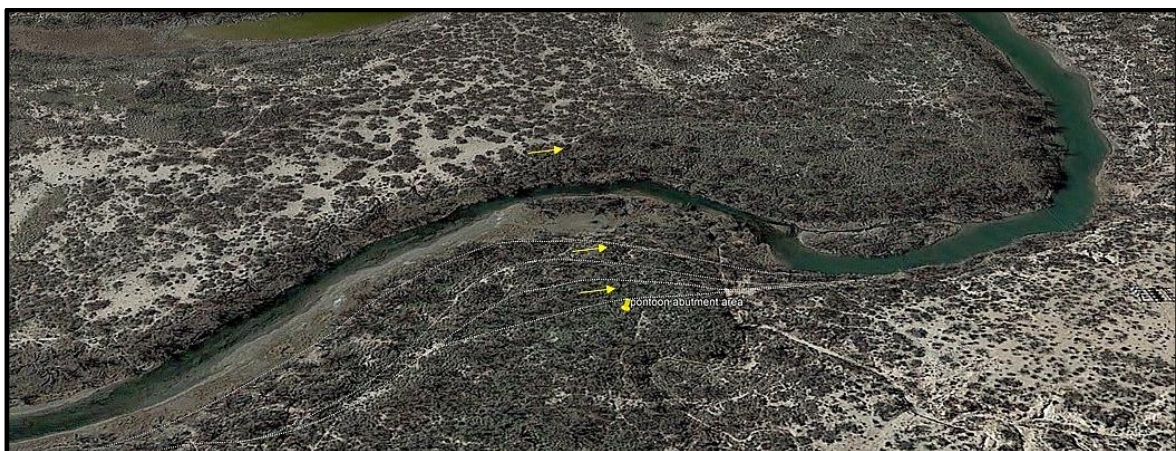
East Side Abutment Area, High Water Lines, and Line Of Bridge

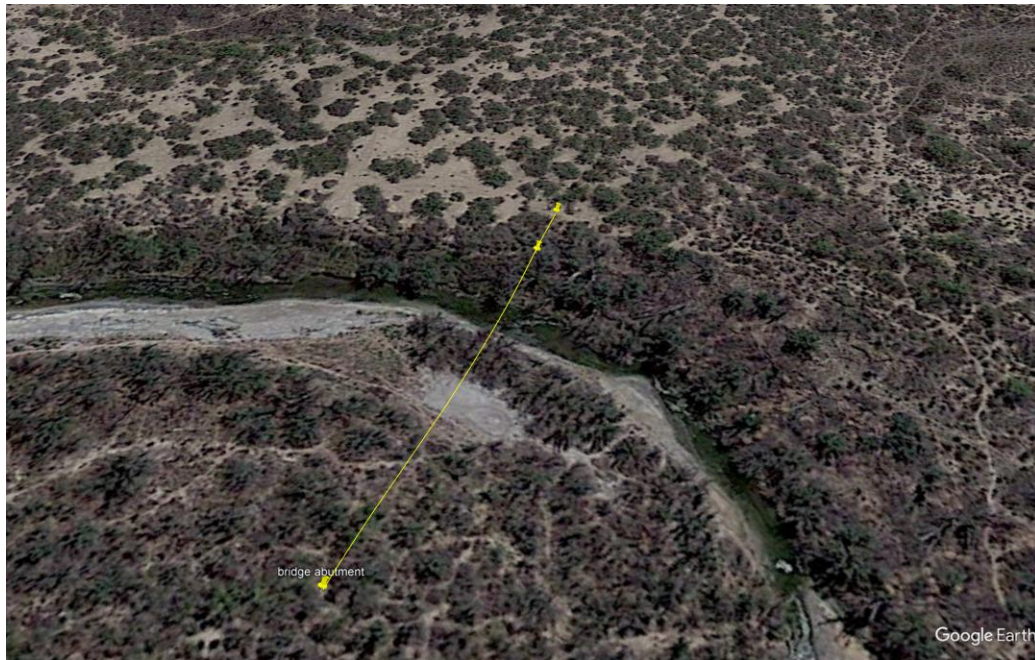
Pontoon Bridge Crossing Area with Cut Bank on West Side

We can also assess the purpose of this particular location for the pontoon bridge. This type of bridge needs many pontoons in the water to stabilize the bridge and decrease the angle on each side. This was one of the widest sections of the river at the time, as can be seen by the wide sandbars exposed now. This location would have provided the most water for floating the pontoons.

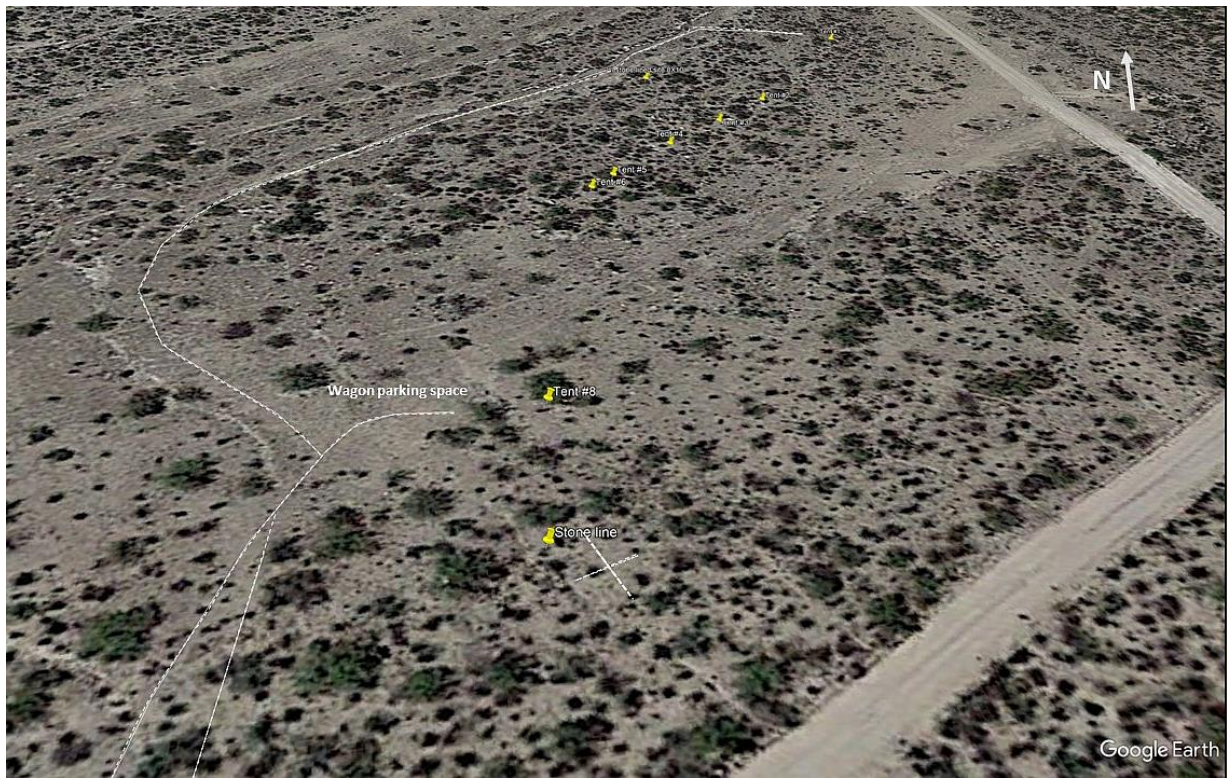
Wagon Trace, Wagon Park Impression, Tent Site, Mule Corral Impression

In addition to the seven original tent sites, we found an additional site that was likely for the wagon driver. This small line of rocks marked a 5 x 7-foot tent spot next to what appears to be a wagon parking spot. Nearby, we found a 21-foot line of placed stones that may have marked one end of a small corral for the wagon mules. A ground impression visible on Google Earth indicates a 20 x 25 space was created for the mules.
