AIR CONDITIONING AND REFRIGERATION JOURNAL

HVAC in Corrosive Environment

By Mahesh R. Mehta
Ecochem Plus, Mumbai

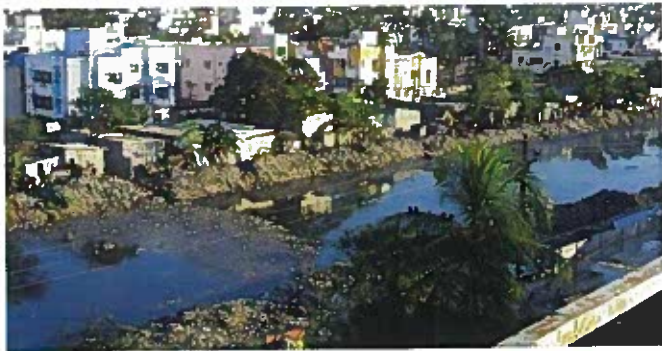
How does environmental corrosion start? Mother Nature has a certain capacity to process waste and refuse slowly, but when heavily dumped, it cannot work overtime. So, the trouble haunts in the form of various corrosive substances generated during the decaying process, viz. sulphur, chlorine, solvents, etc. A small, untreated sewer passing near the site is sufficient to deliver a knockout blow to small or large air conditioning equipment. Sites located near dumping grounds are widely known examples of environmental issues. Some examples are Noida in NCR (sewer), and Malad and BKC in Mumbai (sewer and dumping ground).

Figure 4: Untreated sewers are major polluters

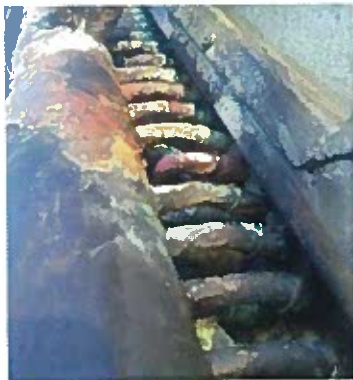
Figure 5: Corroded header due to gases from untreated sewer

environments. An IT site near Kolkata, nestled amidst farm land and greenery, had a severe setback as an untreated waste sewer channel barely one meter wide from a small tannery was passing a few meters away. Before the occupants entered, corrosion had made inroads, heavily affecting the entire HVAC system, steel interiors, steel reinforcement inside concrete slabs, etc. Steel stored at the site corroded at lightning speed, and when it went inside the slab, it was ready to do more harm than good. One could see concrete slabs with cracks in the unoccupied building. The air-cooled chillers, which were installed but lying un-used, had multiple leaks. See Figure 5 depicting the corrosion-affected header.

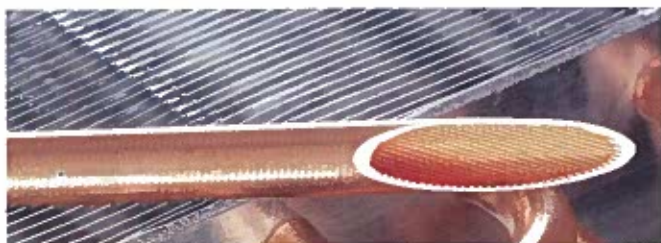
Figure 1: Rifled tube

Tube rifling is a method used to increase refrigerant velocity through coils. The quicker refrigerants move, the faster the cooling/heating cycle. Quicker cooling means less energy consumption and a better star rating. Unfortunately, the walls of rifled tubing are very thin. In acidic and alkaline

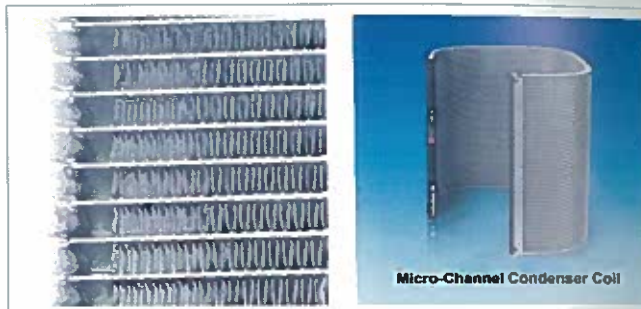
Figure 4: Micro-channel coils

These coils are constructed from separately extruded components, which are then factory-assembled and brazed to construct a coil. Delicate tubes run horizontally into a manifold tube. Once the tube is damaged, it is hard to repair. Repairing and brazing aluminium is more difficult than copper. New technology makes it difficult to find competent repairers.

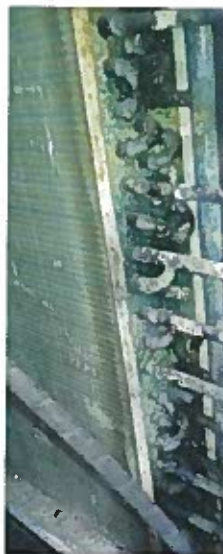
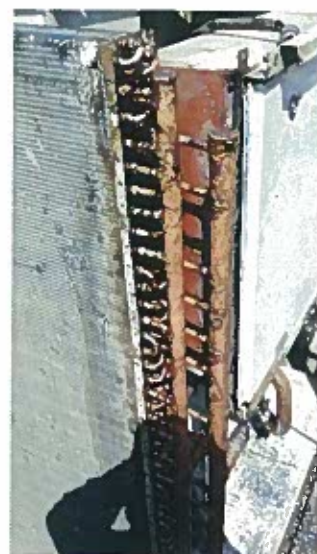
Figure 11: Old header with paint and rust oxides

Figure 12: Chemically cleaned and coated header

In a recent assignment, the author has revived an old unit on the verge of being junked, by repairing the header and U-bend, deep coil cleaning and fin coating. (Note increase in fin sharpness in the final photo). Old copper tubes with multiple coating were also chemically cleaned and re-coated.

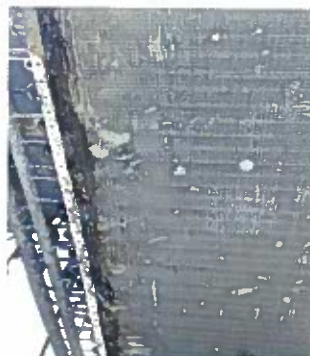
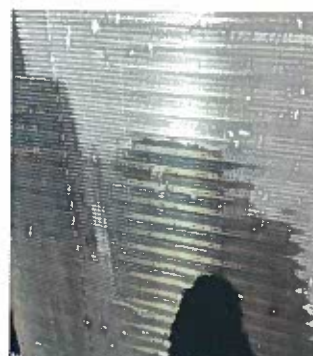
Figure 13: Old coil with dirt and corrosion

Figure 14: Restored coil after fin cleaning and nano coating

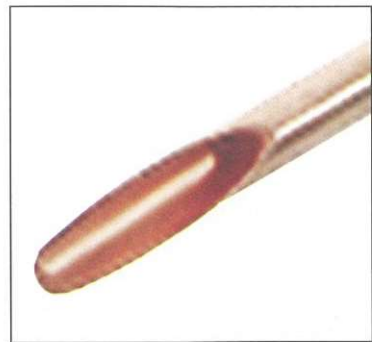
Figure 3: Rifled tube

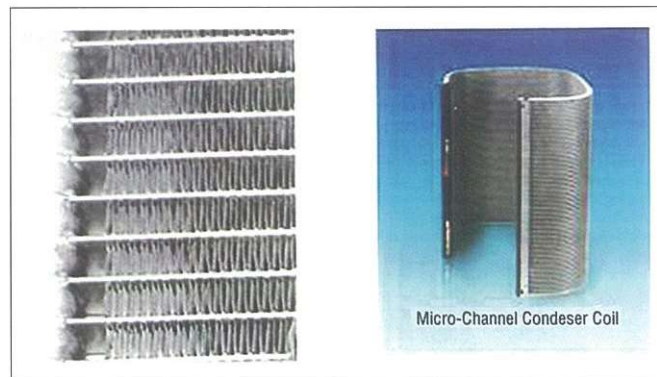
Figure 5: Life of micro channel coil shortened by crude maintenance practices
