Meeting agenda

Review of Cole Point Association

CPA Water System Improvements

Small Water System Management Plan

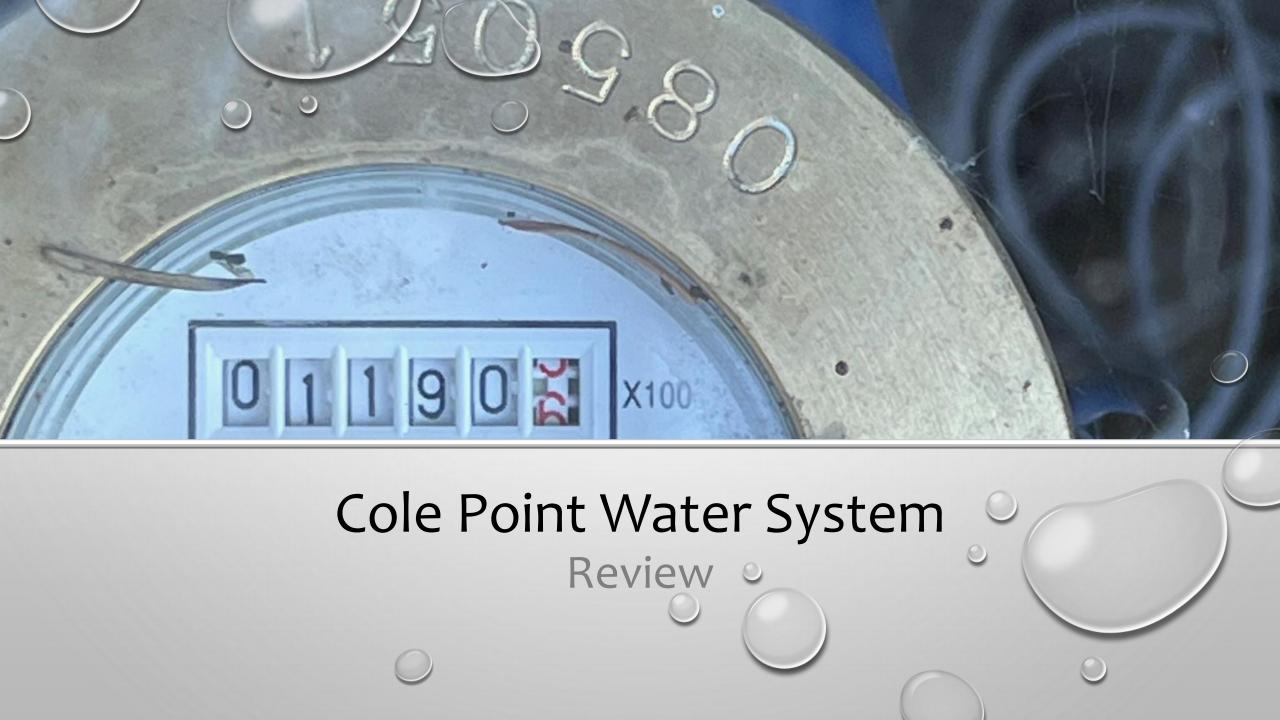
Basic Water System Components

1. Water Source

A **central well** draws groundwater to a **pressurized water tank** that maintains constant water pressure throughout the distribution system, reducing how often the well pump needs to cycle on and off, thereby extending the pump's lifespan

2. Filtration and Treatment

Water passes through filtration and treatment units that remove physical impurities such as sediment, dirt, and debris, as well as chemical contaminants like an excess of minerals and heavy metals (e.g. iron and manganese).

3. Storage Tank and Booster Pump

Treated water is stored in a large tank that holds a reserve of water and ensures a consistent supply even when the well pump isn't actively running. A booster pump increases water pressure and ensures adequate flow to all households

4. Water Distribution Line - Main Water Pipeline

The main water pipelines carry the treated and pressurized water to faucets, showers, and other water fixtures in each home.

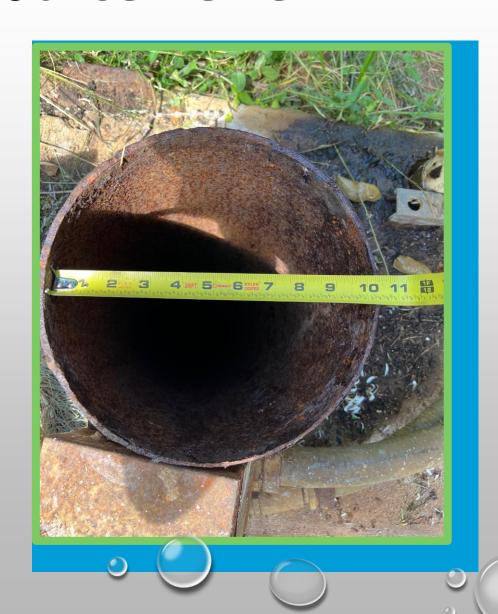
Well #1 (So1)

- 1976: Well #1 was established
- 2006: saltwater intrusion reported
 - + High iron and manganese levels
- **2022:**
 - E. coli detected
 - Pump failed
 - Casing failed
- Well #1 went out of commission

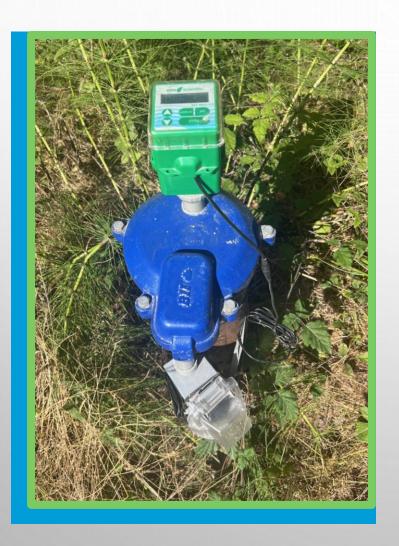
Well #2 (So2)

- 2019: Well #2 was established
- 2022: Source approval obtained
- Running solely on water from Well #2
 - Unproven perched Aquifer
 - Higher iron and manganese levels
 - Water levels drop significantly every summer and with high water use
 - Possibility of burning out the pump

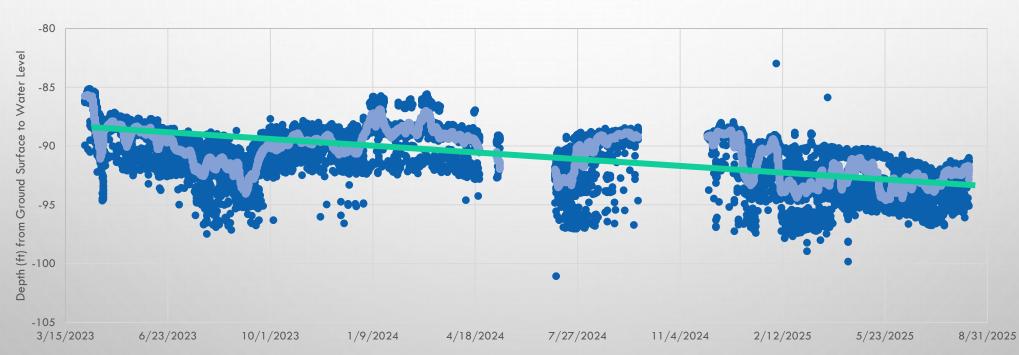
Cole Point Well 2 Water Level Data March 2023 - August 2025

Pump capacity for Well #2 is not sufficient to meet the Association's current and projected Peak Hour Demand

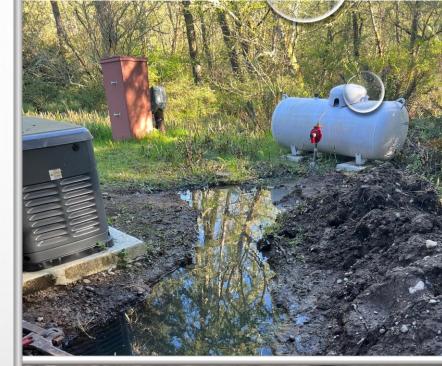
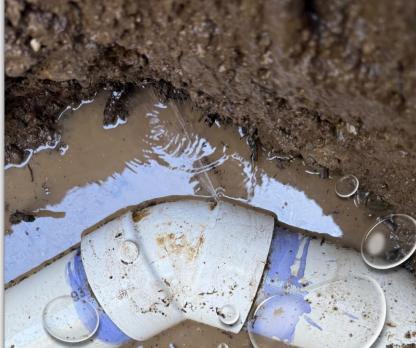
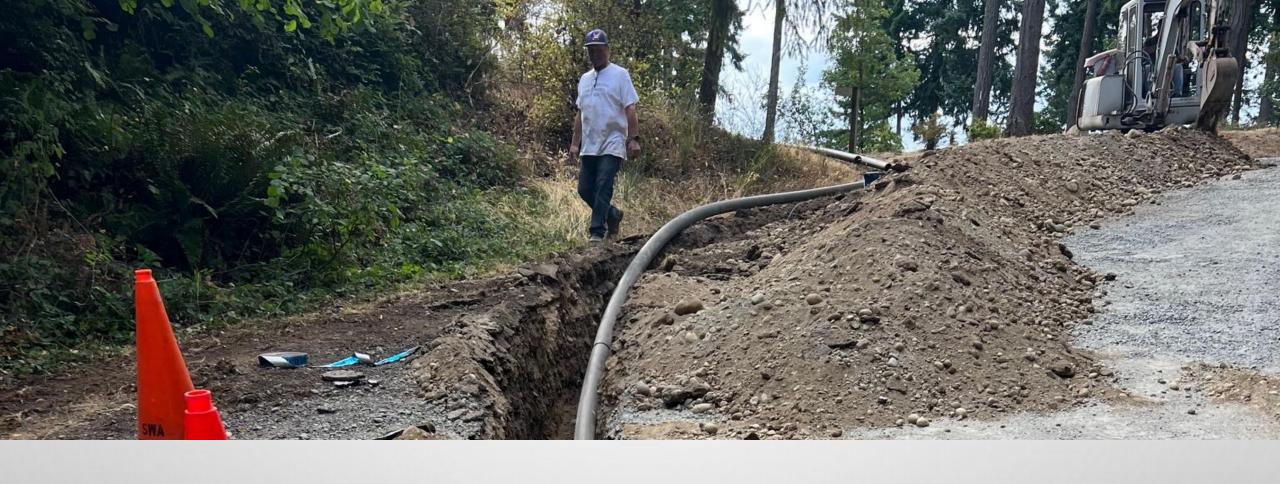
Review of CPA Water Main

- ◆ 1978: CPH water main installed (~50 yrs old)
- Leakage rate: DOH regulations ≤ 10%
 - Normally 20-30 % leakage higher in the summer
 - ♦ 60-80% in the last 9 months
- Multiple leaks 4 major leaks in the past 4 months
- New Pipeline Installation
 - Aug. Oct., 2024: New pipeline installation
 - Aug. Sept., 2025: Will complete new pipeline

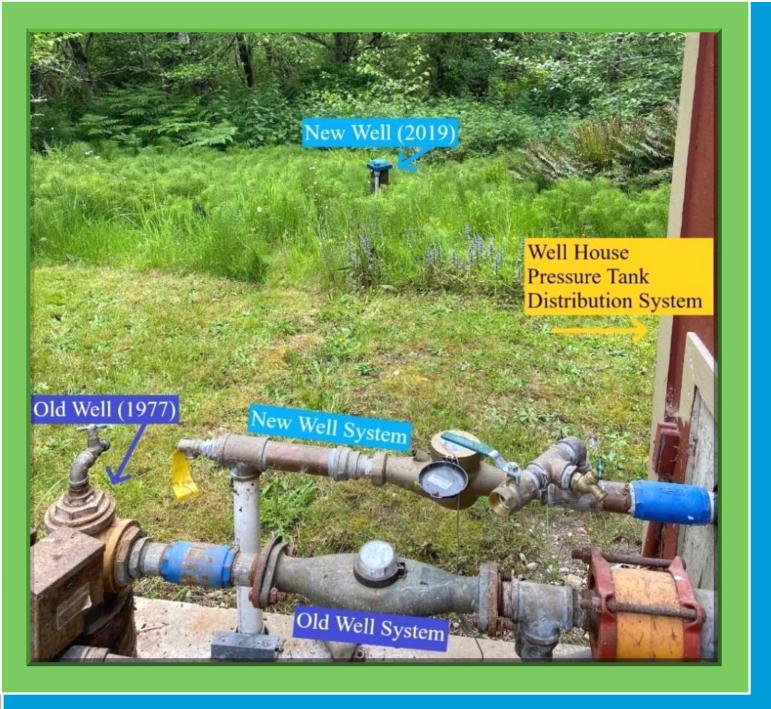
Well #1 Repair

- Advanced Pipeline
 Technologies will repair hole
 in the casing
- Completing requirements for DOH approval
- Waiting for cost estimates for repairs, pumps, and pump installation

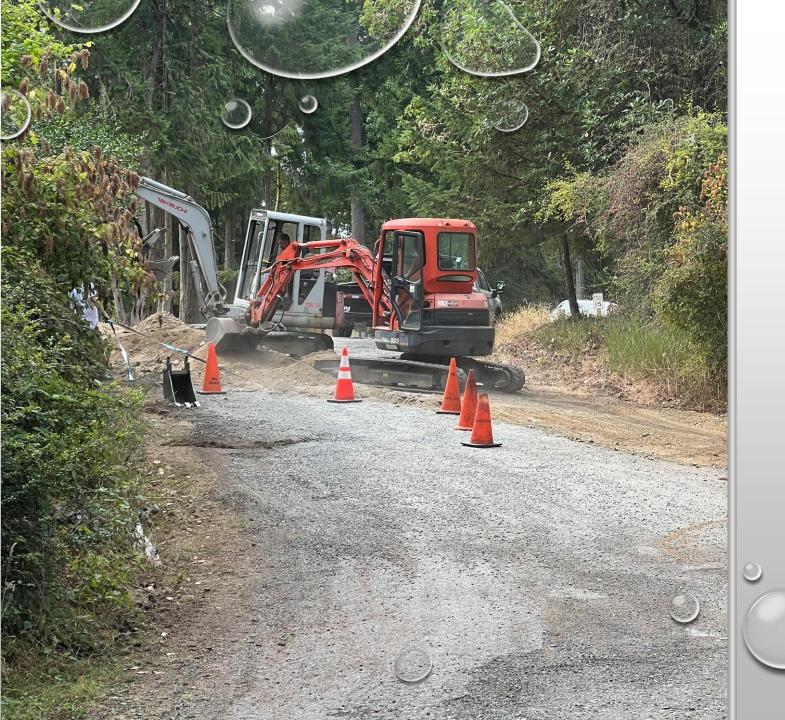
Water Main
Pipeline
Improvements

Pipeline Replacement

August – October 2024:

~ 4,000 linear feet of electrical conduit and water pipe installed along the waterfront portions of Cole Point Drive and 110th Street and Dahlgren Rd.

August – September 2025:

- Complete work on the pipeline along the waterfront properties
- Complete ~2,600 linear feet of pipeline installation on 110th St., Cole Point Drive from pump house to waterfront, 125th St. Ct., and to Farrell Property.
