REVISITING JAGUAR CLOCK REPAIR: THE SMITHS GOLD PLATED CONTACTS CONUNDRUM

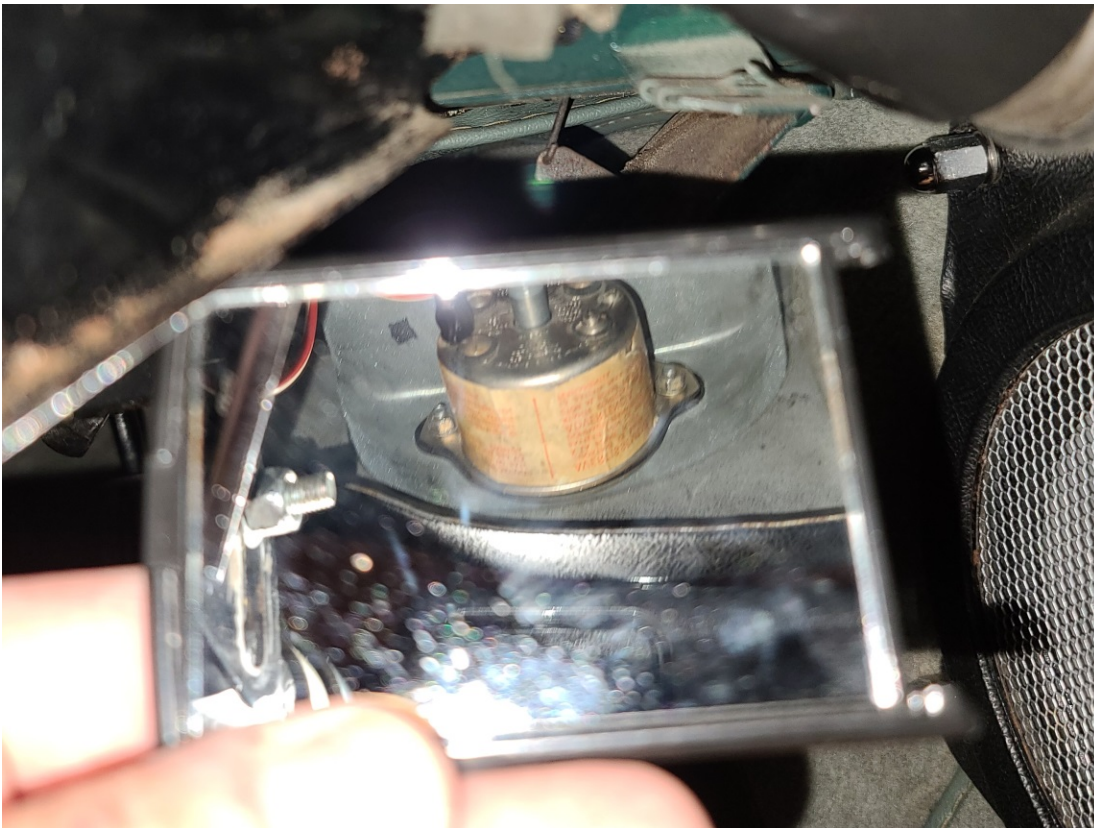
- (1) Clock secured to tachometer as viewed from under the dash with a mirror. It can be removed from the tach with no further disassembly/removal of the dashboard or tach.

It turns out this wasn't such a big job. The clock is accessible from underneath the dash, just above your right leg. First, disconnect the battery. Next, unscrew the fiberboard panel, remove the bezel securing the hand-winding mechanism, and the clock is within reach. You'll need the assistance of a hand mirror and a 1/4" socket wrench with 1-1/2" extension. The clock is fastened with two 1/4" nuts and star washers. Spin the hand-winder off from the back of the clock, and separate the bullet connector securing the hot wire lead. The clock will slip out. Take care with the hands, as they are delicate and exposed. In fact, it's a good idea to tape a piece of cardboard over them at this point. That part of the clock will not be disturbed in the repair process.

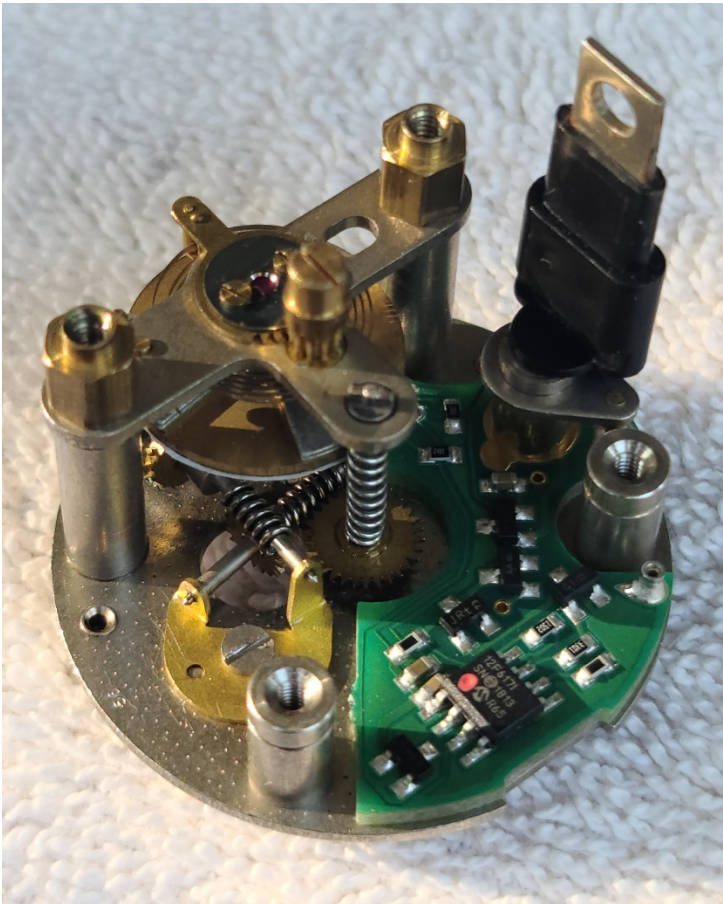
(6) Reassembled clock with PCB board installed, replacing faulty contacts mechanism. Note that the solenoid is not shown; its reinstatement is the final task.

- Replace the faulty contacts mechanism using today's digital technology in the form of a Printed Circuit Board (PCB). This is the Clocks4Classics solution. The process only replaces the defective contacts mechanism consisting of three components and a slotted screw (see photos). The clock retains its oscillating balance wheel (which provides the wonderful, almost silent, ticking sound you may have heard if you were lucky your clock ever worked), the four jeweled movement, and "gears," officially known as the "escape wheel assembly" and "transverse wheel assembly."

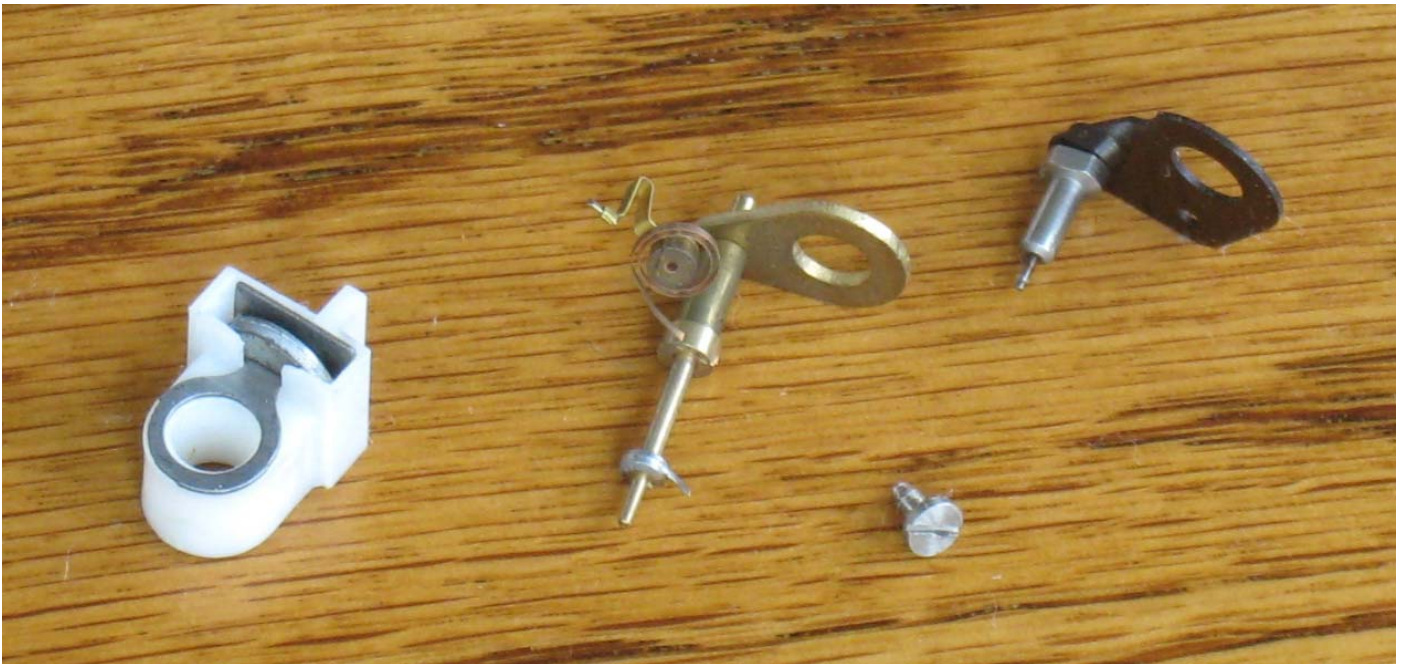
Thus, the weak links on these clocks were in A) the design of the contacts mechanism itself, and B) the mechanic working on the car. Therefore, when attempting to repair a Smiths clock, a solution to replace the contacts mechanism is imperative. Repairing the existing weak parts is impossible, as there are no new-old-stock components available, nor can they be rebuilt after the described burn-out, and, in any event, they are not reliable in the long run.

(7) The failed contacts and associated fittings—the weak link in the original Smiths clock. These are the parts replaced by the Clocks4Classics PCB board. Keep them if you ever wish to return to the original Smiths timepiece.

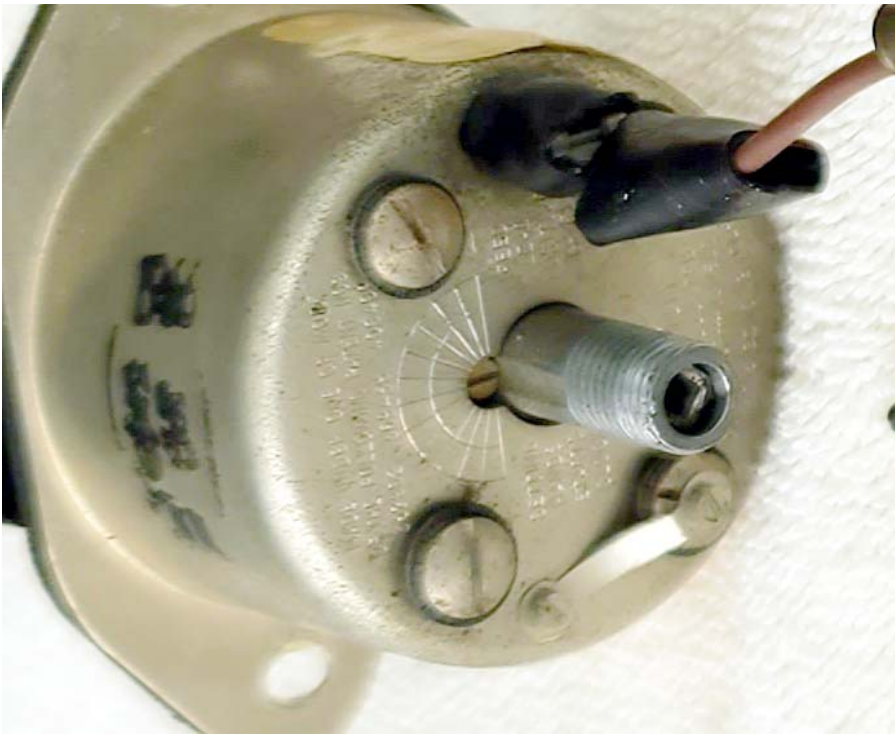
(8) Regulation (speed) adjuster is the slotted screw in center of the photo. Turning clockwise slows the clock, counterclockwise speeds it up.

The rebuild took precisely a week, which included four days to adjust the regulation (speed). It's prudent to wait 24 hours or so to check the accuracy and make adjustments, then wait another 24 hours and re-tweak as necessary.

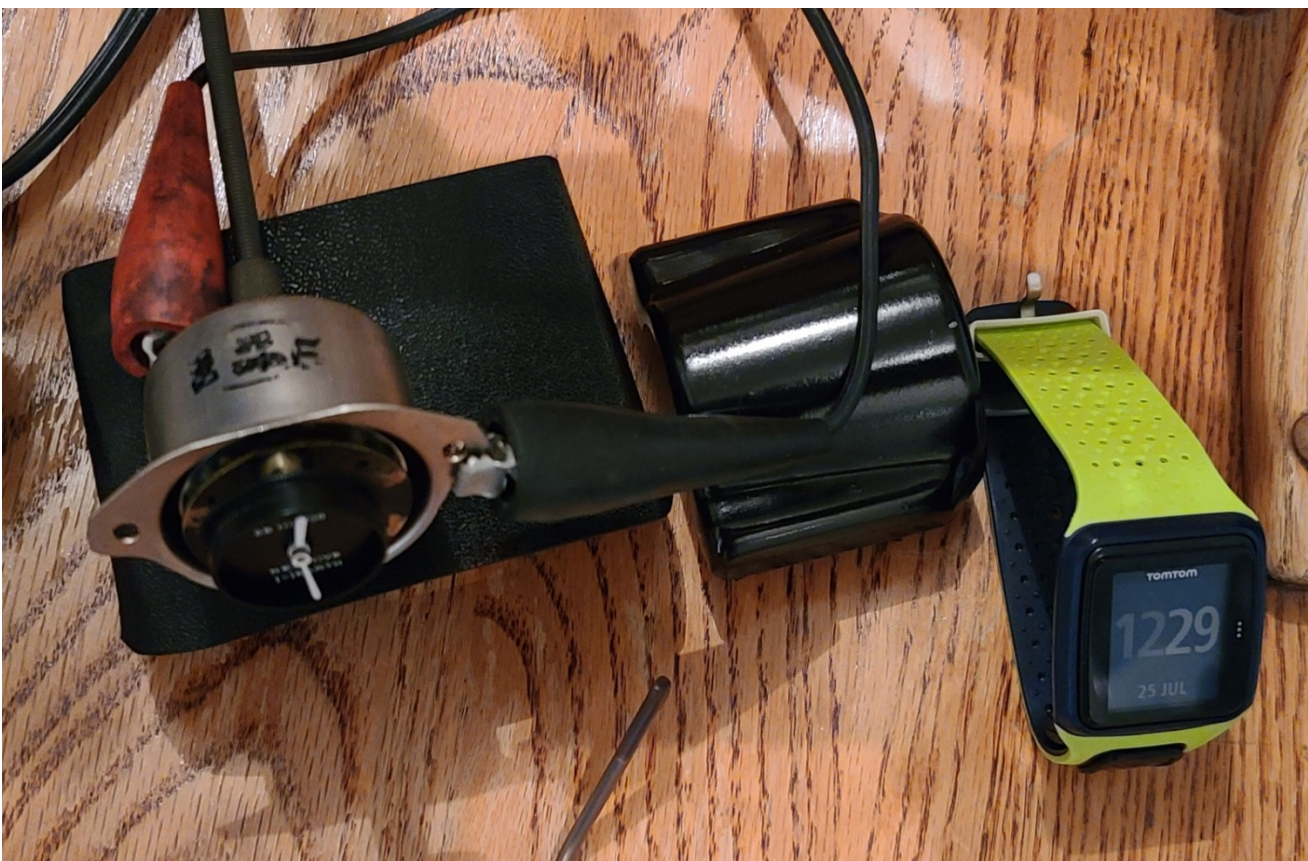
(9) Reassembled clock showing speed adjustment on the bench. Note alligator clips with power directly from the car battery.
