SUBJECT: Helene Permanent Repairs on NC 197 South, Yancey County, TIP# none,
WBS# 49082.2.13, PA# 24-11-0013, ER 25-4109

HISTORIC STRUCTURES SURVEY REPORT

Helene Permanent Repairs NC 197 South, Yancey County

WBS No. 49082.2.13 • Project No. 18313.1100997 • PA 24-11-0013

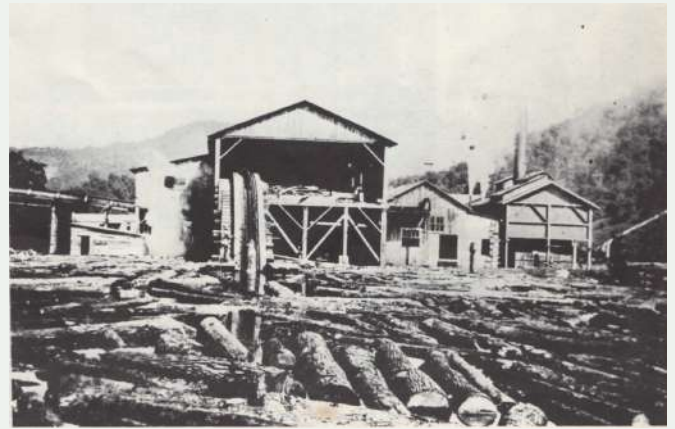
Figure 10. Carolina Spruce Band Mill at Pensacola. Logs are stored in the mill pond adjacent to the mill, waiting to be sawn. (*Common Times*, 1981)

Logging stripped mountain slopes of all but small clusters of trees, exposing thin soils to erosion. In 1913, sparks from Perley and Crockett's locomotives ignited brush fires on two separate occasions, destroying forest from Clingman's Peak to Mount Mitchell (Figure 8). Single-gauge railroads navigated steep hillsides, hauling timber to "log ponds" like those in Pensacola that held timber awaiting cutting (Figure 10). (Silver, 2003)

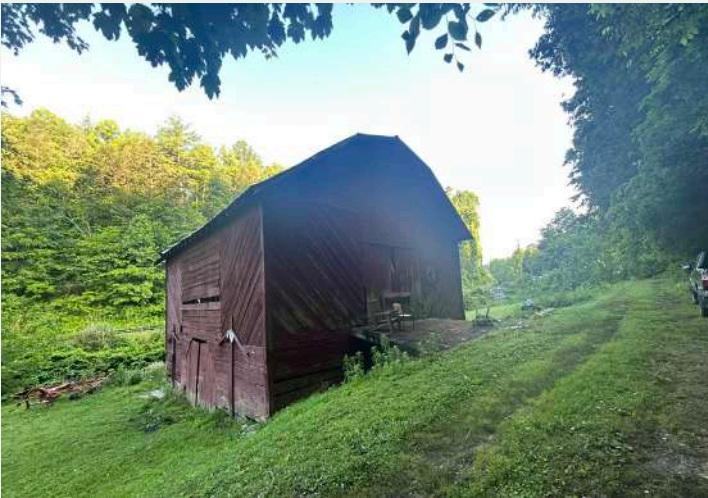
Figure 15. The barn at Hawkins Farm (MD0021; 12 Charles Blankenship Road, Marshall) is an example of a bank barn.

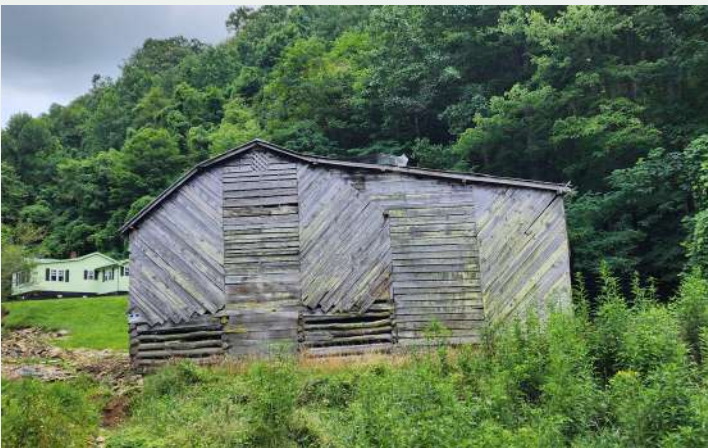
Figure 16. This barn on Hog Branch Road in Yancey County shows the evolution of barn design. The building rests on a log crib foundation with a post-1915 gambrel roof wood structure above. To the right side is a tobacco barn addition with a shallow roof slope that ties directly into the gambrel barn.

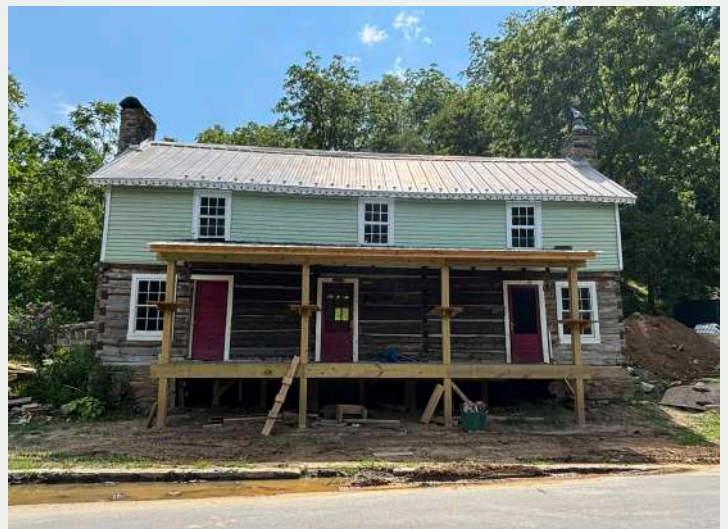
Figure 23. The Laus Peterson House (YC0177; 299 Toe River Road, Green Mountain) is an example of a nineteenth-century log cabin with an early twentieth century second-story addition, creating an I-house form.

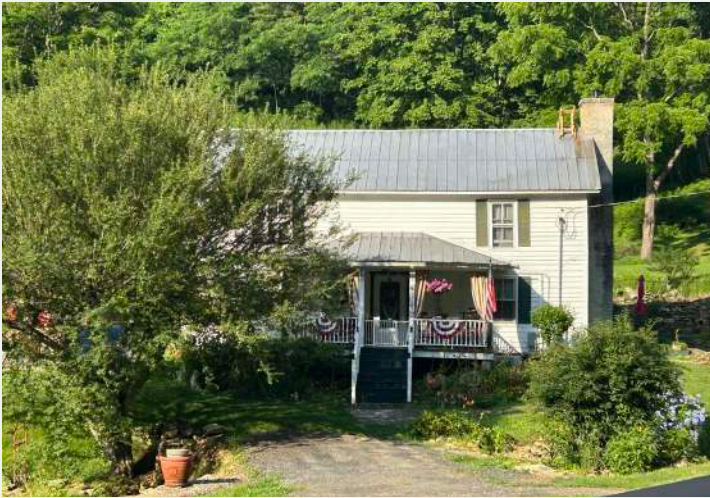
Figure 24. *Emphraim Honeycutt House (YC0050; 1533 Coxes Creek Road, Burnsville) is an example of a turn-of-the-twentieth-century center-hall I-house.*

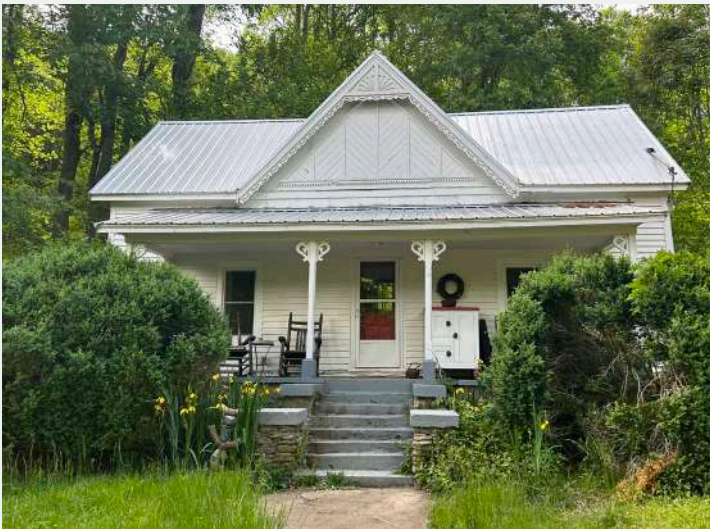
Figure 25. *The Hensley-Robertson House (YC0103; 78 Riverview Road, Burnsville) reflects the Triple-A form.*

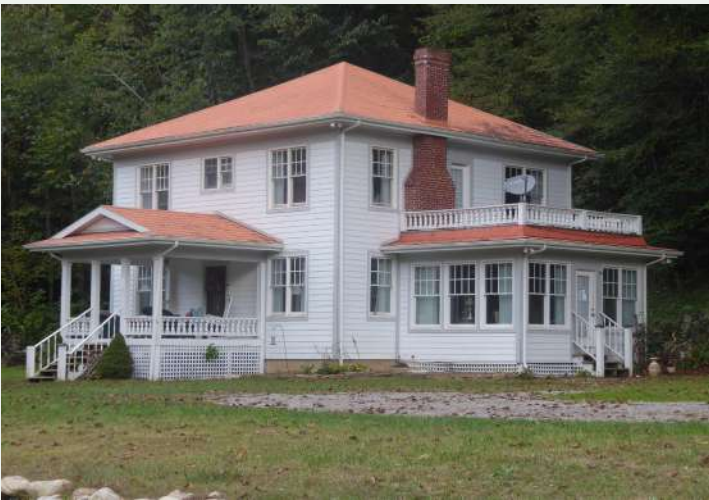
Figure 30. Brown-Wilson House (YC0267; 2475 Ewart Wilson Road).

Nationally, the American Foursquare gained popularity from the 1890s through the 1930s for its efficient, cost-effective design featuring a symmetrical square or rectangular façade and plan, often with a central entrance beneath pyramidal or hipped roof with a full, partial-width, or wraparound porch. Builders often added box bays and one-story wings subordinate to the principal massing, such as the sunporch wing on the Brown-Wilson House (Figure 30) (YC0267; 2475 Ewart Wilson Road,

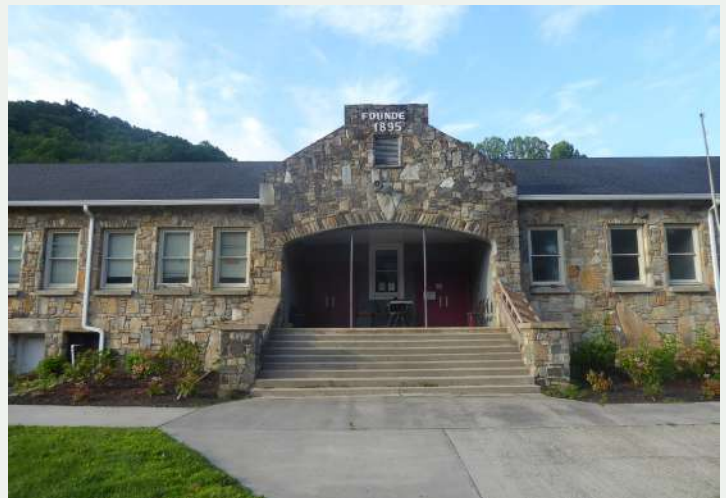
Figure 31. The Bald Creek School (YC0006; 100 Bald Creek School Road, Burnsville) reflects the WPA-era rustic revival style. Built as a high school in 1938, the building is now used as an elementary school.

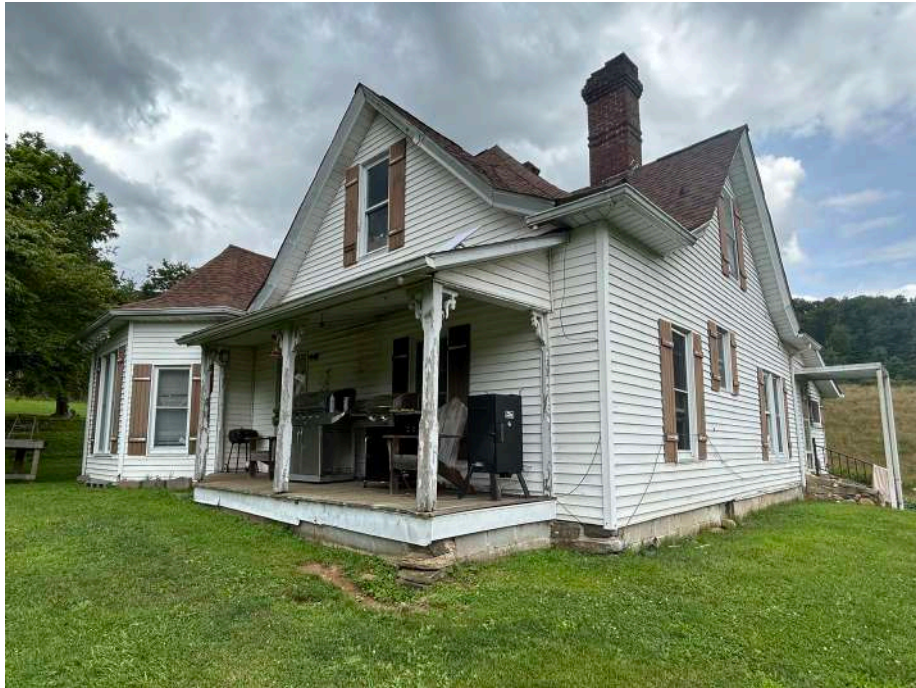
Figure 33. Oblique view of the north facade and west elevation of the David Dellinger House, looking southeast from front yard.

The David Dellinger House is a one-and-one-half story, double-pile house. A hipped roof covers the central square massing with projecting features, including gable wall dormers with flared eaves and a conical bay.

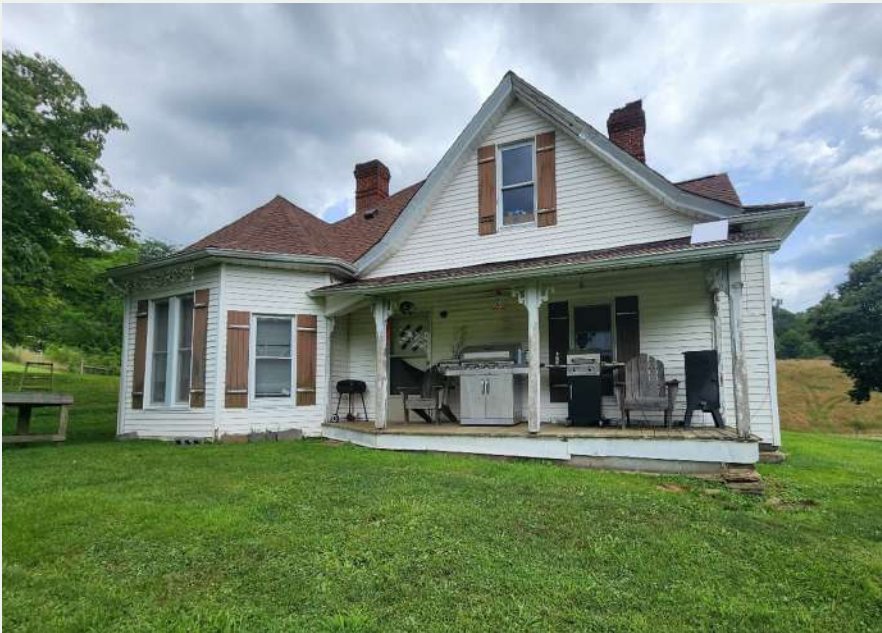
Figure 36. North facade of the house, looking south from front yard.

The north façade spans three bays and features a projecting cutaway bay with conical roof (Figure 36). Windows wrap three sides of the conical bay. A partial width front porch extends across the following two bays. Concrete block and stone piers support the porch floor while chamfered wood posts with decorative scrolled brackets support the shed roof. The main entry consists of a wood door with three diagonal lights and an aluminum screen door. A window is also located beneath the porch roof. A projecting gable wall dormer with flared eaves and a single window is centered above the porch.

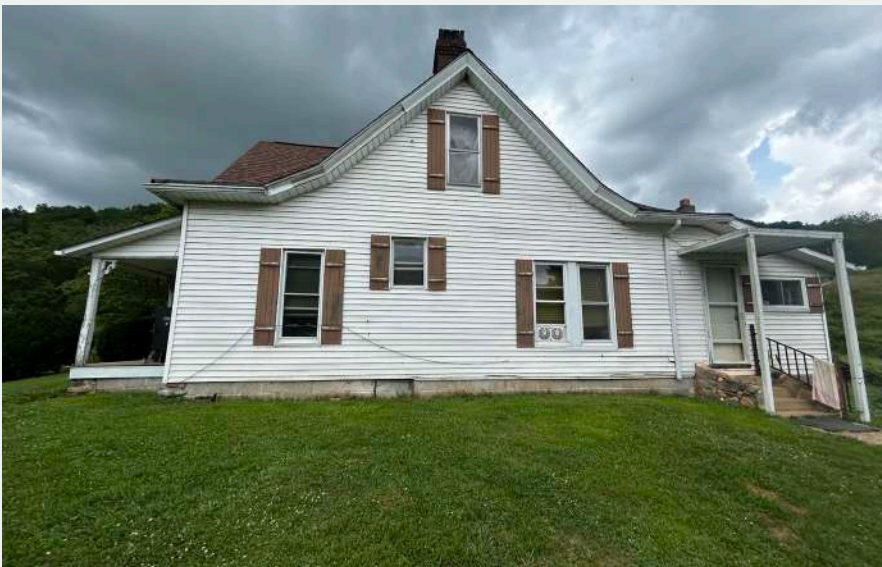
Figure 37. West elevation of the house, looking east from the yard.

northwest corner (Figure 37). Three concrete steps, flanked by stone wing walls, lead to an aluminum six-panel door and a three-part aluminum and glass storm door beneath an aluminum-framed flat-roof porch with corrugated metal roofing. A gable wall dormer with flared eaves projects from the

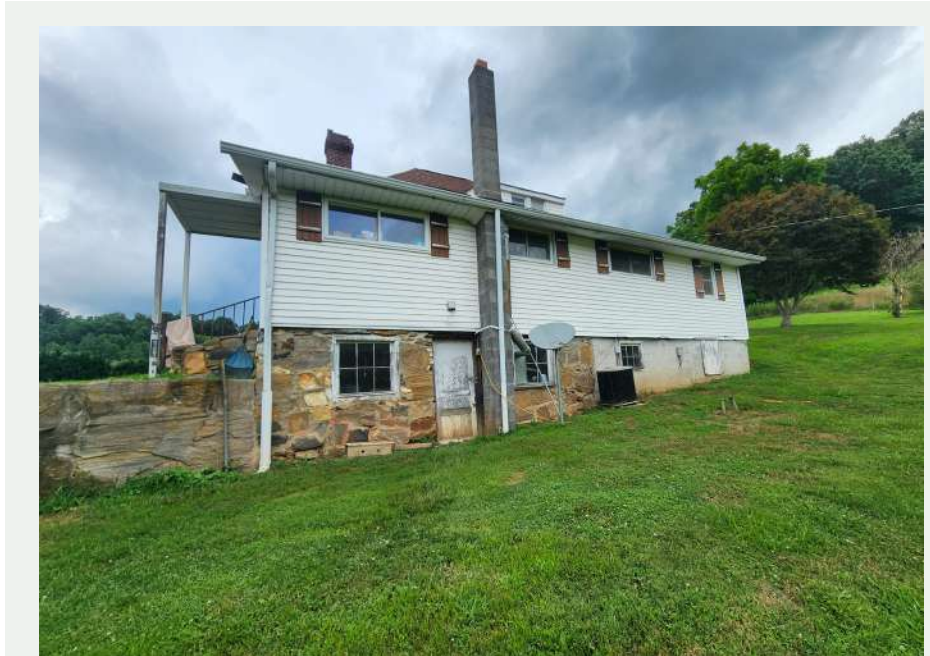
Figure 38. South elevation of the house, looking northeast from the yard.

The south elevation is an enclosed rear porch addition. The stone and concrete block foundation features three six-light wood windows, a historic two-paneled wood door, and a wood batten door (Figure 38). Three sliding windows and a one-over-one window line the wall of the main level beneath its shed roof. An off-center shed dormer with two double-hung windows projects from the hip roof above. An exterior concrete block chimney transitions to a stucco-concrete treatment with horizontal lines marking the courses as it breaks the eave of the shed roof.

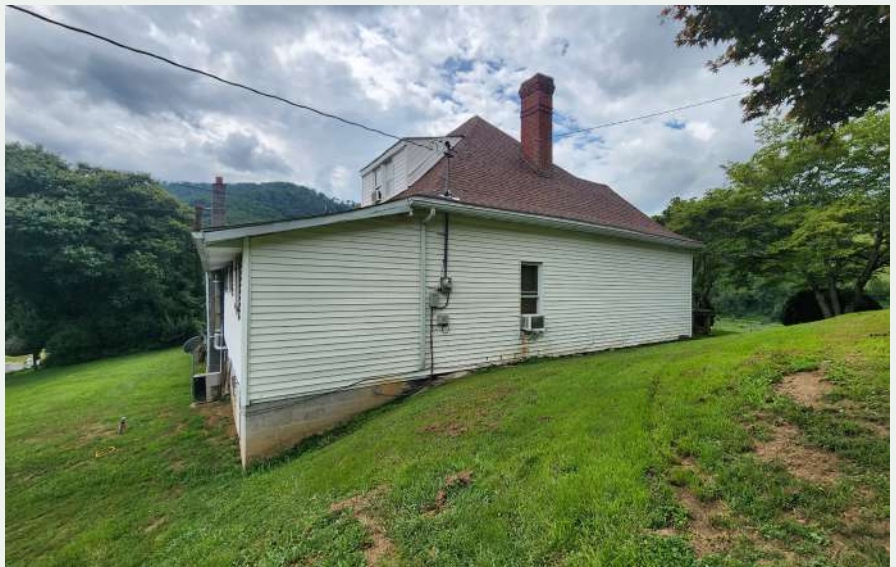
Figure 39. East elevation of the house, looking west from the yard.

The east elevation rests on the hillside as it slopes downhill to the south (Figure 39). The concrete block foundation beneath the enclosed porch addition wraps around this side from the south elevation. This elevation includes a one-over-one vinyl window beneath a second ornate red brick chimney, identical to the one on the west elevation.

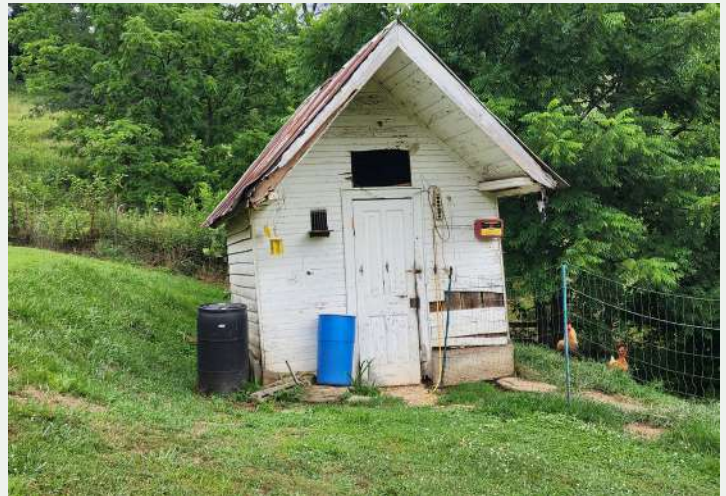
Figure 40. Apple house, looking east from the backyard.

A circa 1900 apple house, now repurposed as a chicken coop, sits on stone piers about 50 feet southeast of the house (Figures 35 and 40). This front-gabled structure has horizontal wood shiplap and weatherboard siding covering vertical interior wood planks. On the west elevation, a cantilevered gable roof with wood covered eaves shelters a historic four-panel wood door and a square opening covered by chicken wire above. A similar opening is in the rear gable where there is also a cut opening at the base accessing the chicken run surrounded by chain link and wire fencing. A historic standing seam metal roof covers the structure.

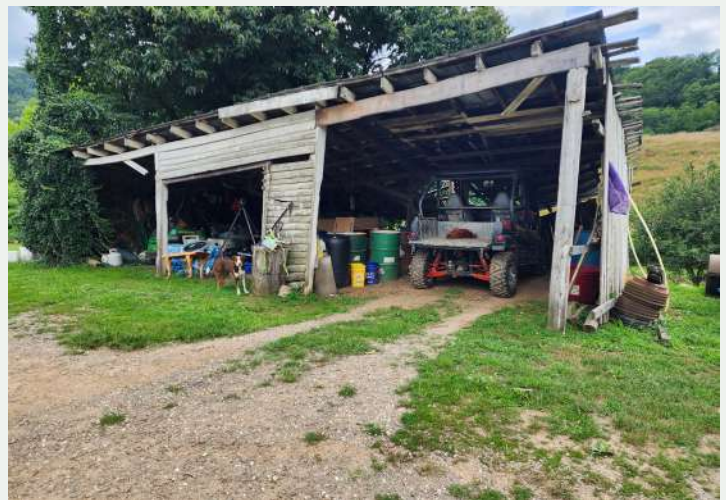
Figure 41. Three-bay garage, looking southeast from parking area.

A three-sided garage sits approximately 50 feet west of the house (Figure 35). It has dirt and gravel floor and features contemporary dimensional wood rafters supported by posts and beams of varying sizes and ages (Figure 41). The north elevation, facing the driveway, spans three bays. The front wall of the center bay likely dates to an earlier 1930s garage, based on its framed garage door opening and historic wood weatherboard siding. Vertical wood siding covers the later post-and-beam side bays, though overgrown vegetation obscures much of the east side. Standing seam metal covers the roof's exposed wood rafters and battens.

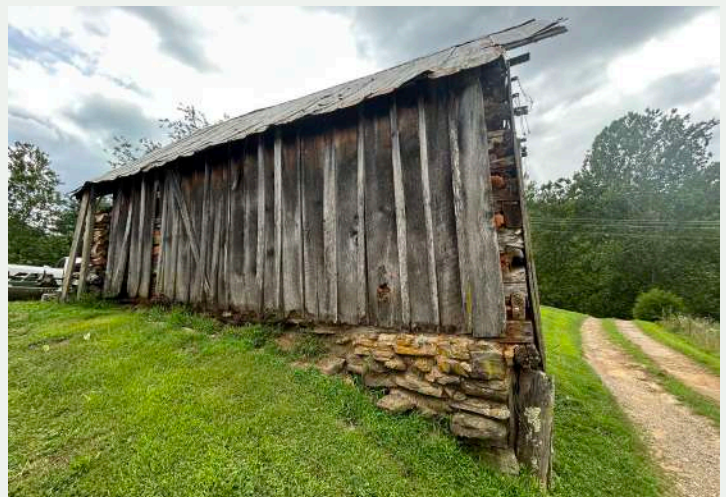
Figure 42. Smokehouse, looking southwest from driveway.

A smokehouse sits approximately 40 feet northwest of the garage, on the opposite side of the driveway (Figures 35 and 42). The log structure rests on a stacked stone foundation and faces south. Weatherboard siding fills the gable ends and board-and-batten siding covers the log structure of clay chinking and half-dovetail notching. Historic wood batten doors access the structure from the north, south, and east elevations. The north elevation features two rectangular framed openings, but no windows. Standing seam metal covers the gable roof that cantilevers over the south elevation. While its wood-sided log construction makes precise dating difficult, construction methods and site development history suggest David Dellinger likely built it before 1900.

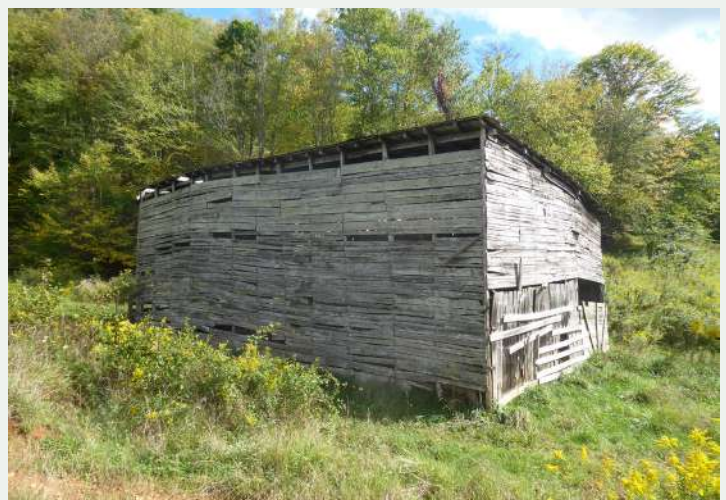
Figure 48. Tobacco barn, facing southeast in the pasture.

Hewn logs create a post-and-beam structured tobacco barn that sits approximately 215 feet southwest of the animal shelter (Figures 35 and 48). The rectangular-shaped barn is oriented west and has a dirt floor. Horizontal wood siding covers the exterior walls, with standing seam metal panel repairs on the south elevation. On the west elevation, two batten wood doors enter the building. Rows of siding have been removed from the east and west elevations and z-framed wood fence gates cover the openings between the poles. Standing seam metal covers the shed roof that slopes south. The style and design of the tobacco barn is simple, utilitarian, and common throughout the county, and Yancey County tax records suggest a 1940s construction date.

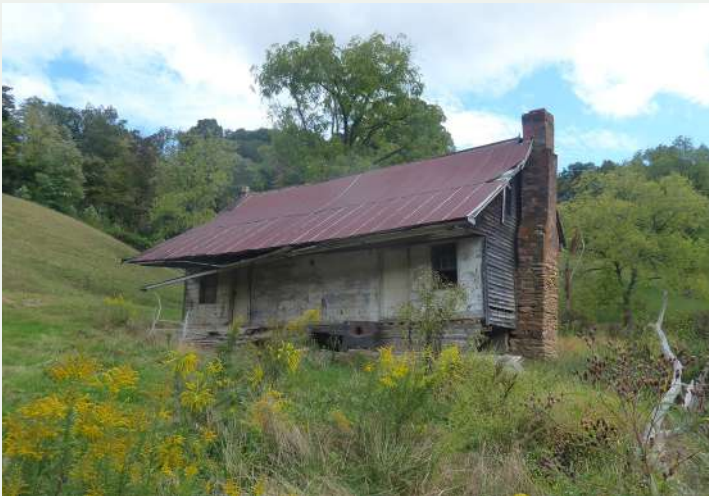
Figure 49. North façade of the tenant house, looking south from the pasture.

Approximately 300 feet south of the tobacco barn is a one-and-one-half story, symmetrical tenant house built before 1900 (Figures 35 and 49). The structure rests on stacked stone piers with a partial contemporary concrete block foundation. The house reflects the boxed construction method popular at the turn of the century. Weatherboard siding covers the exterior walls and shiplap covers the façade beneath the full-width front porch (Figure 49). The north façade features a collapsed full-width porch with a four-panel wood door and window for each "unit" (half of the house). The west elevation has a tapered stone wall chimney that transitions to red brick above the chimney box. A replacement concrete block chimney with terracotta flue is on the east elevation. A collapsed, partial-width, wood-framed rear addition on the south elevation has a concrete block foundation and board-and-batten

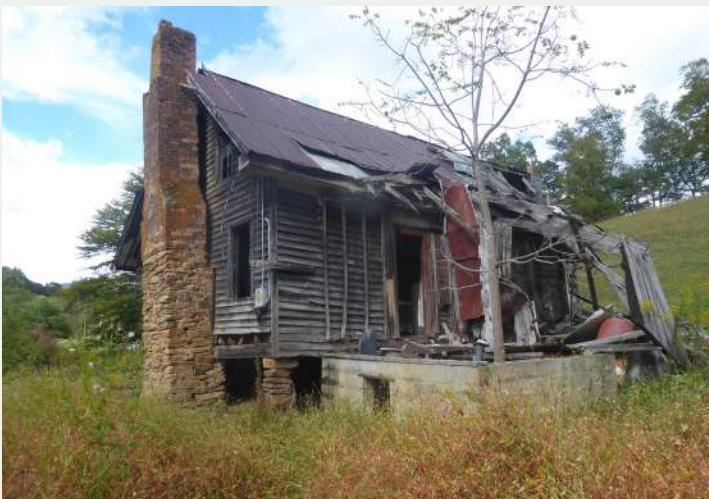
Figure 50. Oblique view of the west and south elevations of the tenant house, looking northeast from the pasture.

siding (Figure 50). Standing seam metal covers the roof. A capped concrete well is located approximately 25 feet behind the house.

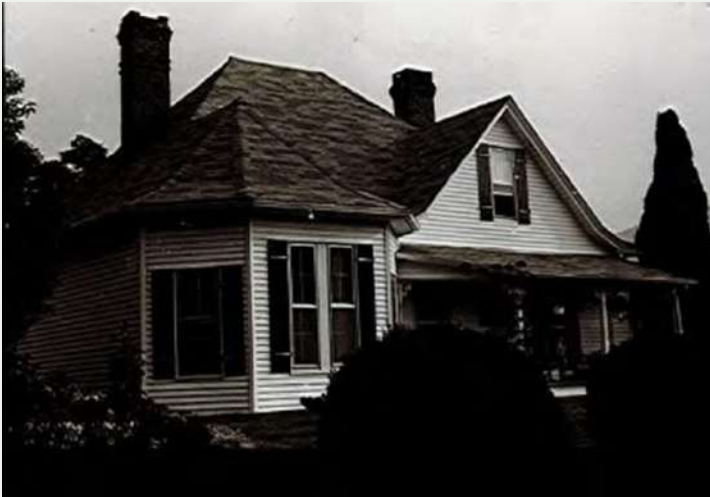
Figure 55. Oblique of the north facade and east elevation, 1983. (Presnell, 1983(a))

Photographs from the 1983 survey by Presnell show the house appeared similar to today, with asphalt shingle roofing, vinyl siding, decorative shutters, aluminum storm windows and doors, and enclosed porch addition (Figure 55). (Presnell, 1983(b))

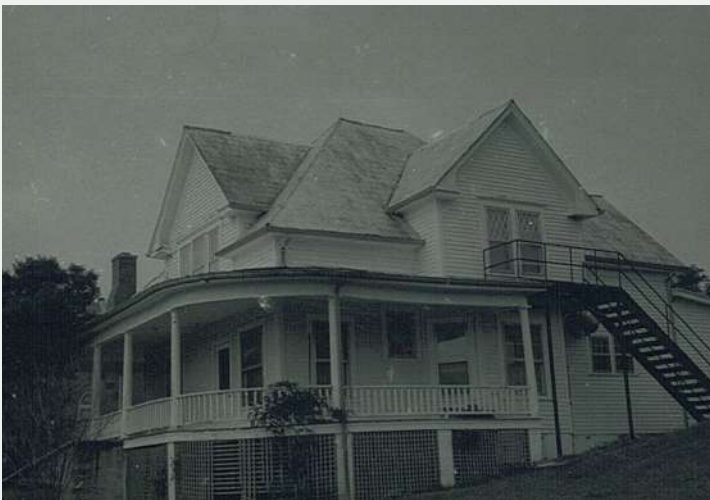
Figure 56. Justice House (YC0197). Photo dated August 9, 1985. (Humphries, 1985(b))

gables with cutaway corners and gabled wall dormers, a wraparound porch, and a later shed-roofed rear addition. The porch showcased a lattice skirt and turned posts and balustrades. The first floor featured one-over-one windows and half-light doors, while second floor windows had lattice-patterned top sashes. Pressed metal roof shingles covered the roof, and each gable included curved gable returns and plain rake boards. The Justice House occupied a town lot in Burnsville.

The now-demolished Justice House (YC0197; 105 North Main Street, Burnsville) reflected early twentieth century Queen Anne and American cottage styles (Figure 56). Built circa 1900, the two-story, double-pile, central-hall plan featured a hipped roof with projecting

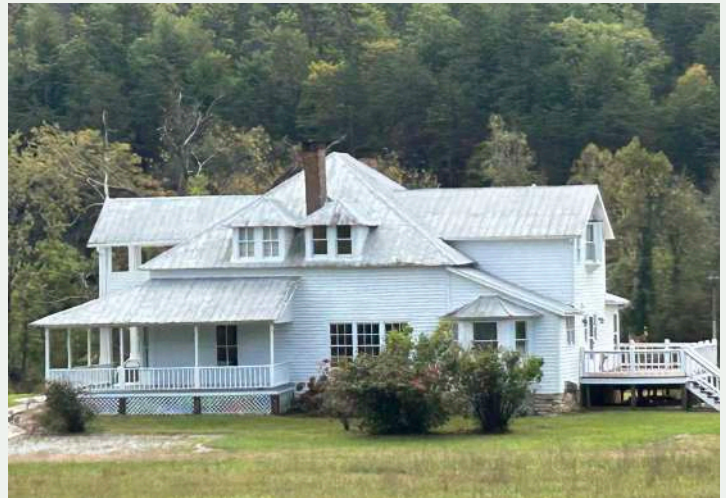
Figure 57. Farmhouse at the Henry Seawell and Mary Jane English Brown Farmstead (MC0089).

portico with triangular pedimented front gable, projecting window bays, and a mix of historic two-over-two and six-over-one wood windows (Figure 57). Hipped-roofed dormers with paired windows punctuate the hipped roof above the central mass. Outbuildings include a half-dovetailed log smokehouse and granary, a gable-front barn with mortice-and-tenon framed core, and a 1920s wood frame garage. (Brown, 2009)

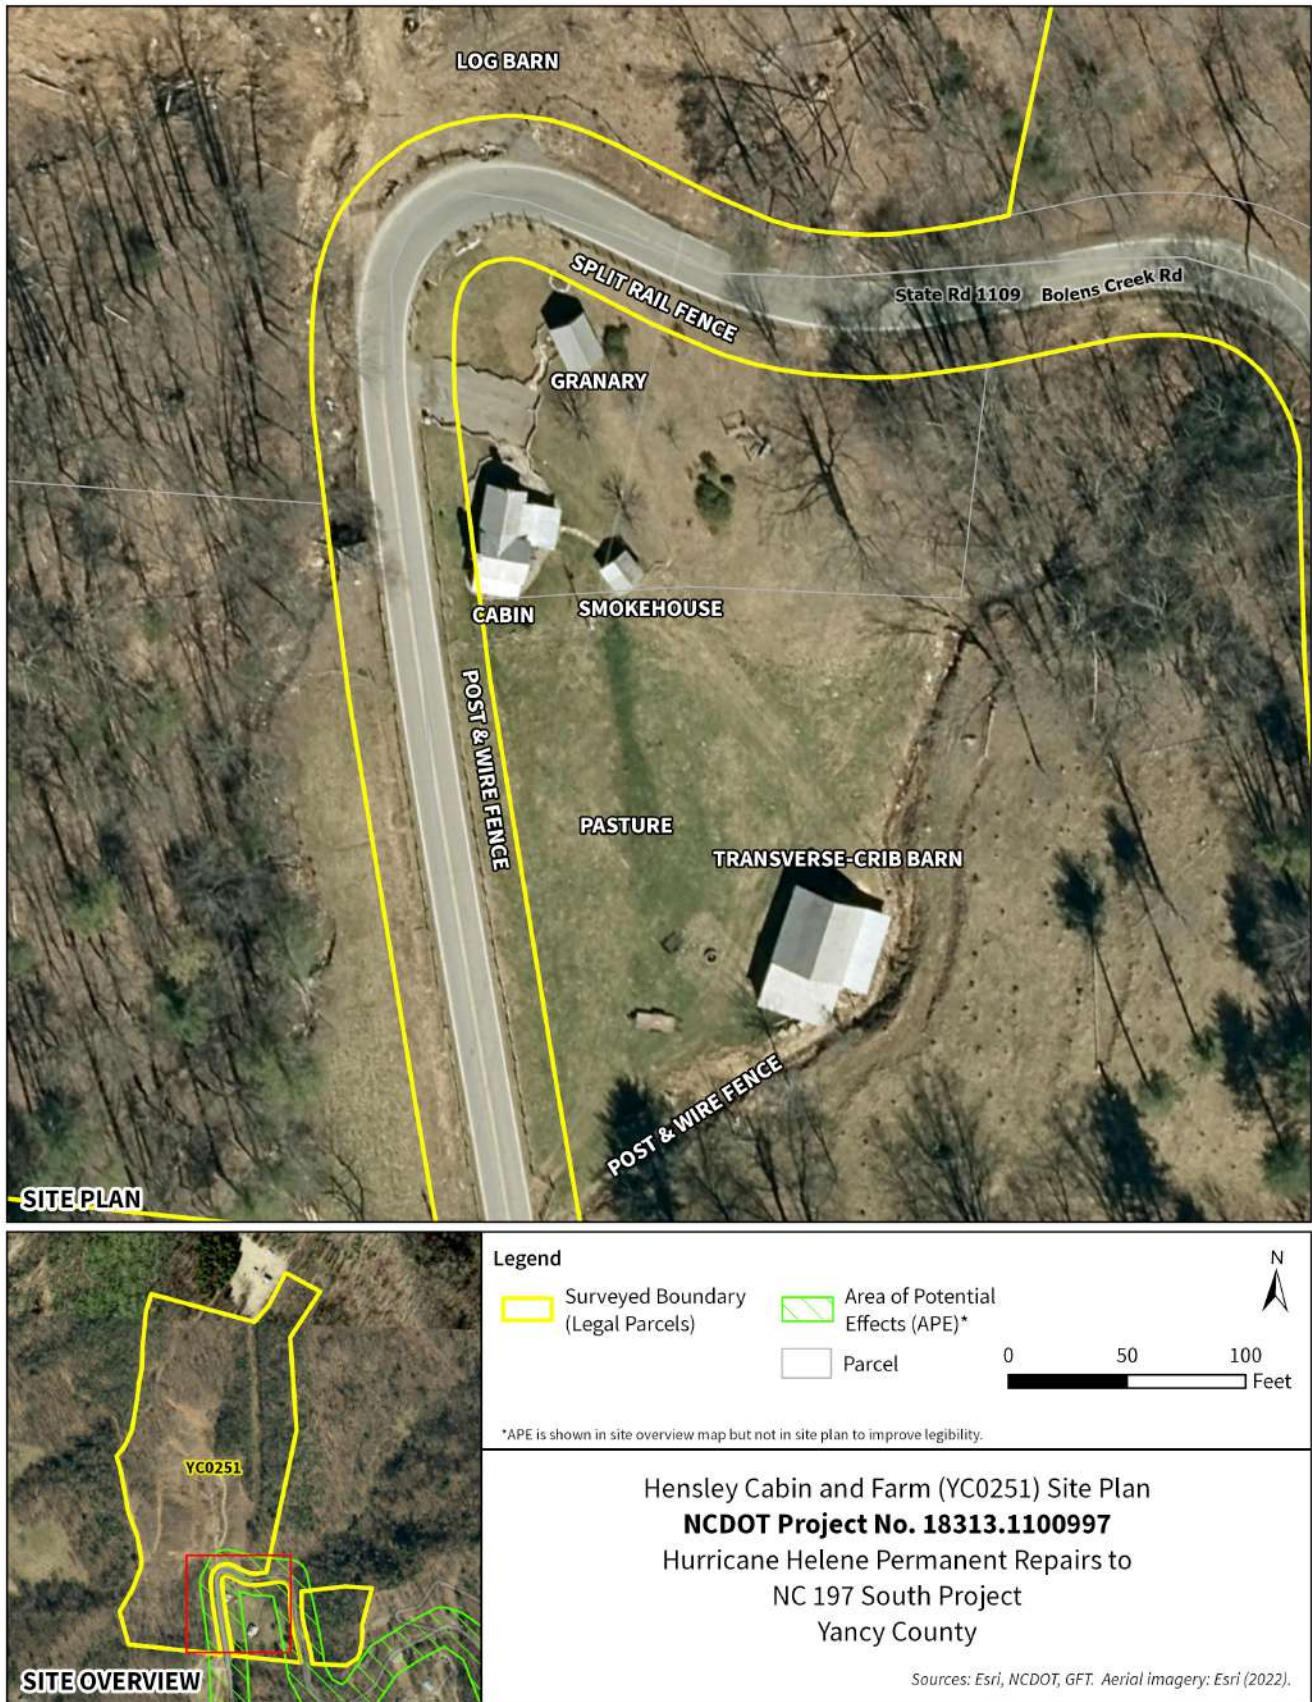
Figure 60. Hensley Cabin and Farm Site Plan.

The Hensley Cabin and Farm buildings cluster between an unnamed stream and Bolens Creek Road (Figure 60). The cabin sits approximately 20 feet from the edge of the road. A granary stands roughly 50 feet northeast of the cabin, and a

The Hensley Cabin and Farm (YC0251) sits in a curve on Bolens Creek Road, approximately one-half-mile northeast of its intersection with NC 197 South (Figures 1, 58, and 59). The farm spans approximately 45 acres across three parcels on the north, east, and south sides of Bolens Creek Road. Bee Branch Mountain stands to the north, and the terrain slopes generally southwest. The cabin and historic outbuildings cluster between Bolens Creek Road and an unnamed stream that flows southwest through the property towards the Cane River (Figure 60).

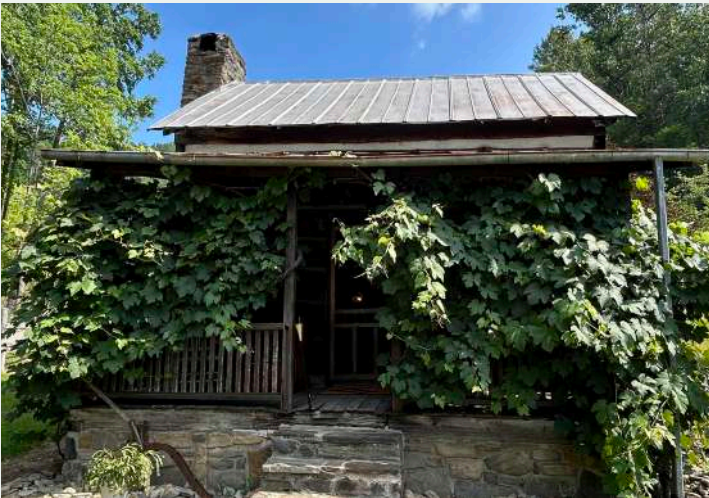
Figure 61. South facade of the cabin, looking north in the yard.

A full-width shed-roof porch shelters a centered doorway on the south façade. The porch rests on a stone veneer foundation with three stone steps leading to the central entrance (Figure 61). Reportedly constructed of redwood, the porch features wood decking, a railing on three sides, and square wood posts and joists supporting the roof. Ghost lines of earlier porch joists, now filled with cement chinking, are visible beneath the roof (Figure 62). Grapevines cover much of the porch.

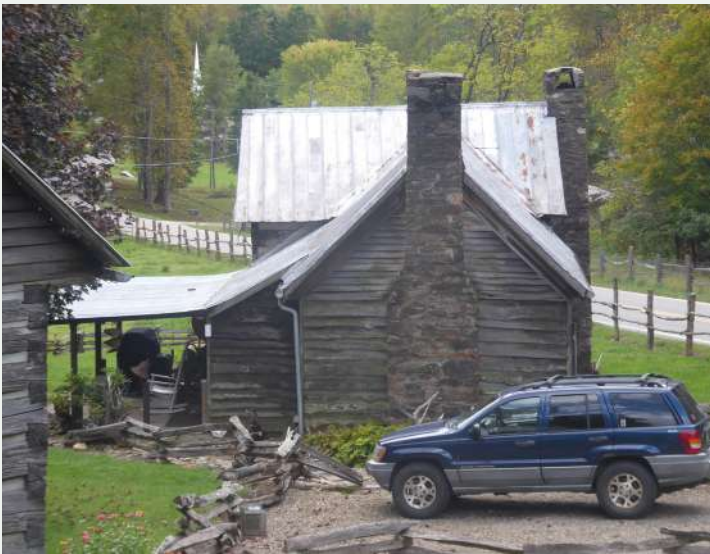
Figure 64. North elevation of the cabin, looking south from Bolens Creek Road. Note the enclosed porch addition to the left of the ell's gable end.

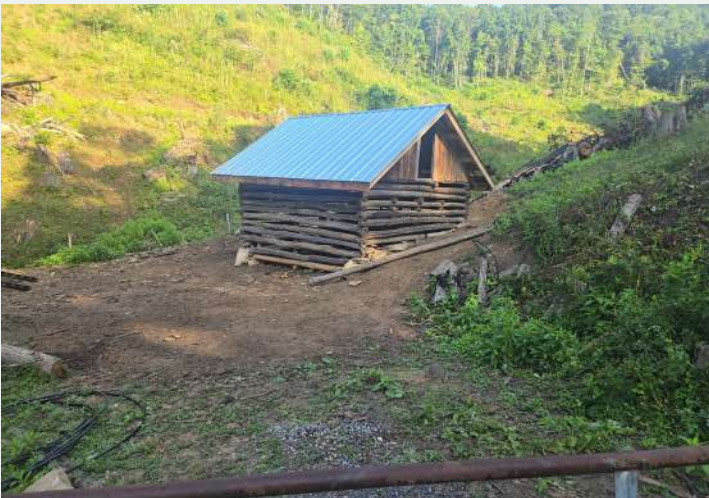
Figure 72. Log barn, looking northwest. (W. Hensley, 2025)

In 2025, Tim Hensley constructed the front-gable log barn to replace a circa 1910 tobacco barn destroyed by Hurricane Helene (Figures 60 and 72). The barn rests on a dry laid stone foundation and incorporates salvaged chestnut logs from the original structure. The log walls feature v-notched ends and no chinking. Vertical wood siding covers the gables, and a standing seam metal roof tops the structure.

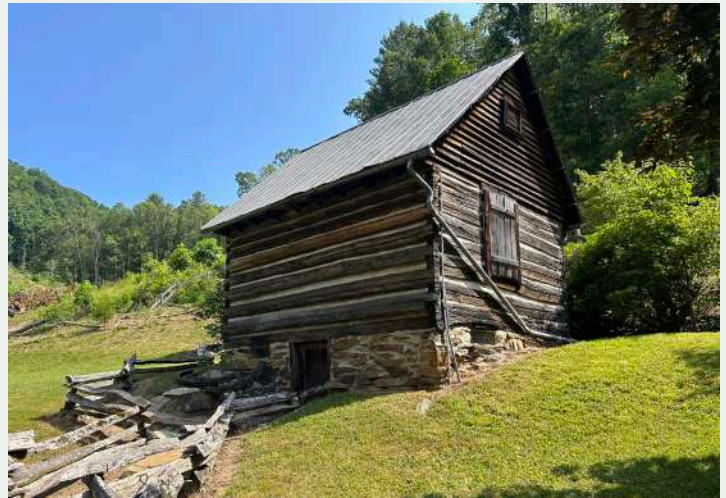
Figure 73. Granary with root cellar, c. 1812.

The circa 1812 granary is built into the hill northeast of the cabin (Figures 60 and 73). The one-and-one-half story front-gable log structure sits on a red clay mortared rubble stone foundation. Wire mesh covers rectangular vents in the foundation, and a wood board-and-batten door accesses the root cellar from the east elevation. The log walls of the structure have the same half-dovetail notching and cement chinking treatment as the cabin. A board-and-batten door leads into the granary on the north elevation, while an off-centered wood board-and-batten shutter protects a historic six-over-six double-hung wood window on the south elevation. Weatherboard siding covers the gable ends, which include wood vents. The roof is standing seam metal with contemporary gutters and

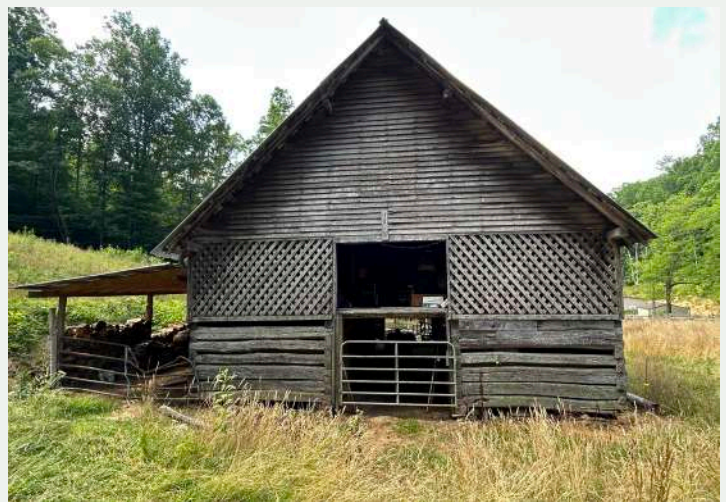
Figure 78. Transverse crib barn, looking southeast from pasture.

The two-story transverse crib barn is located southeast of the cabin, surrounded by pastures, and dates to the late nineteenth century (Figures 60 and 78). The gable-front barn rests on a rubble stone foundation and a center aisle runs northeast to southwest through the first floor. Log walls featuring half-dovetail and v-notch joinery form the first floor. Wood lattice covers the top half of the walls, ventilating the hayloft, and historic weatherboard clads the gables. A standing seam metal roof on open sheathing tops the barn.

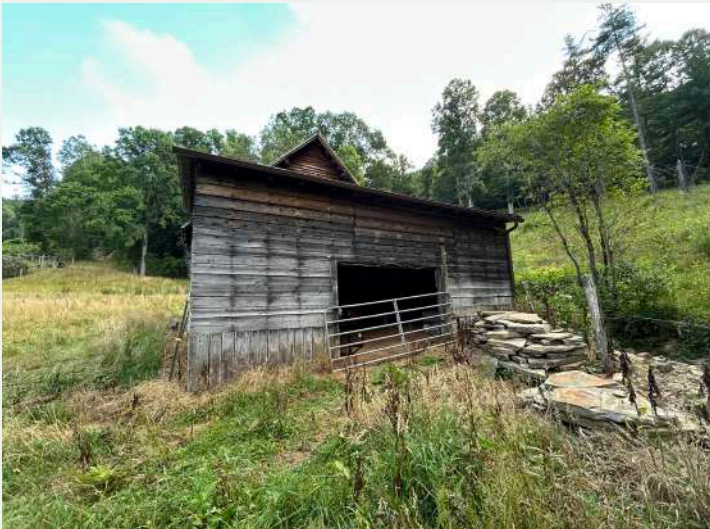
Figure 79. Tobacco barn addition, looking northeast from pasture.

In the 1980s, Wesley Hensley constructed the shed roof tobacco barn addition on the south elevation that continues the central aisle (Figure 79). It features vertical wood plank siding over a

concrete block foundation and horizontal wood plank siding above for airflow. In 2022, Tim Hensley built a shed roof lean-to on the east side, supported by rough-hewn log posts and a wood-framed roof. All roofs have standing seam metal.

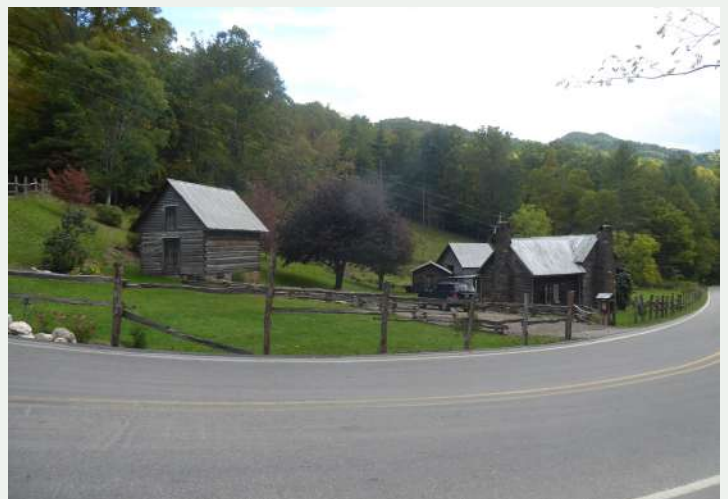
Figure 82. The granary, smokehouse, and cabin comprise the domestic zone, looking southeast from Bolens Creek Road.

Historic Appalachian farms often placed houses on hillsides overlooking fields and pastures. As farms grew, distinct work zones emerged—domestic areas near the house and agricultural zones closer to fields. The Hensley Farm reflects this development pattern: the granary and smokehouse cluster near the cabin, while barns sit further out in the pastures (Figure 82).

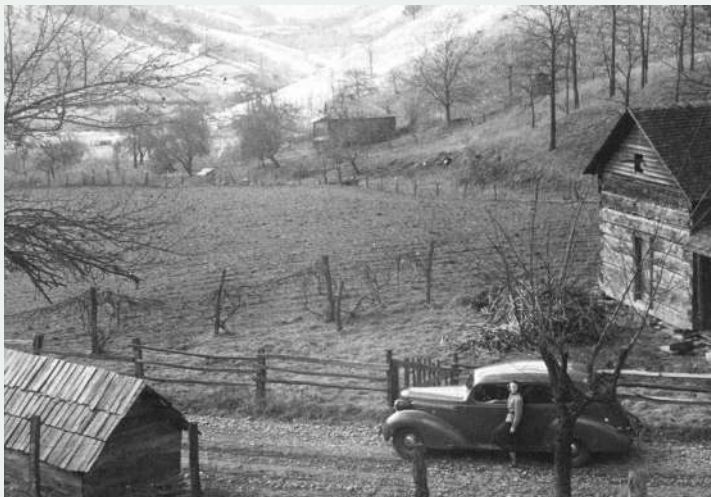
Figure 87. A circa January 1938 photograph of the Hensley Cabin, showing the road traveling on the east side of the cabin. Note the gabled structure in the lower left; the circa 1860 smokehouse replaced this building in the 1970s. (Sharpe, 1938)

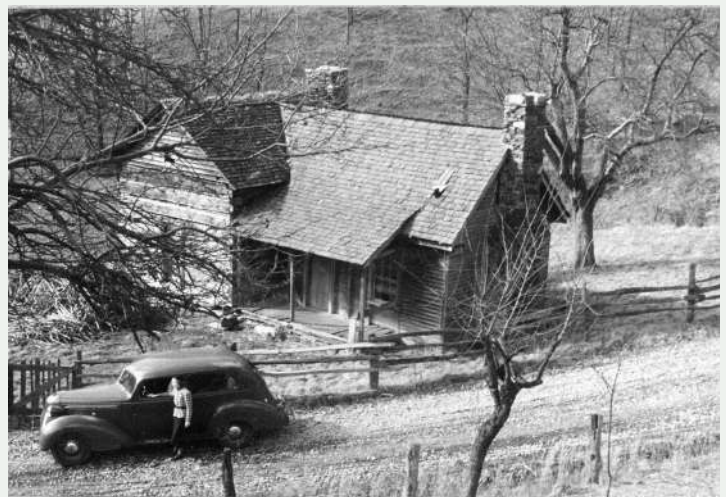
Figure 88. A circa January 1938 photograph of the Hensley Cabin, looking southwest. Note that the porch is not enclosed and the ell has narrow weatherboard siding. Split rail and post and wire fences line both sides of the road. (Sharpe, 1938)

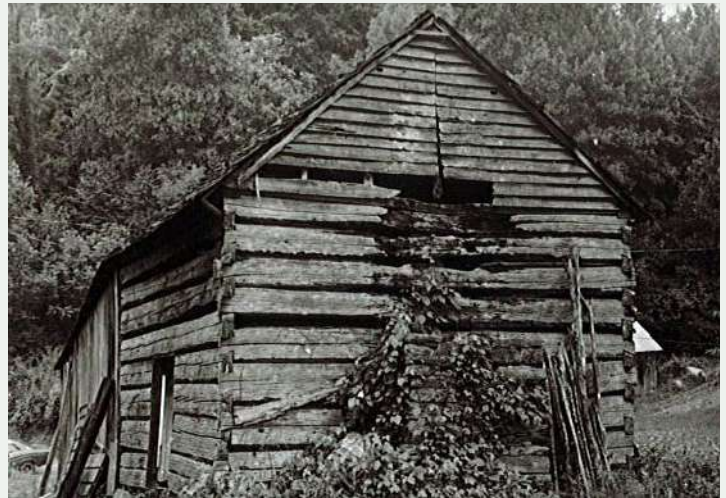
Figure 90. Oblique view of the now demolished Bennett Log Cabin (YC0141), (Presnell, 1983(h))

The now-demolished Bennett Log Cabin (YC0141; 600 Bennett Branch Road, Green Mountain) was a single-pen, half-dovetailed log structure dating to the early nineteenth century (Figure 90). The structure reflected the single-pen log cabin type with a rectangular plan (approximately twenty by eighteen feet), centered doorway, and one-shoulder stone gable-end chimney. The cabin had weatherboard gables, a cedar shake roof, and a lean-to addition clad in vertical wood siding. The cabin was in deteriorating condition at the time of the 1983 survey and has since been lost. (Presnell, 1983(h))

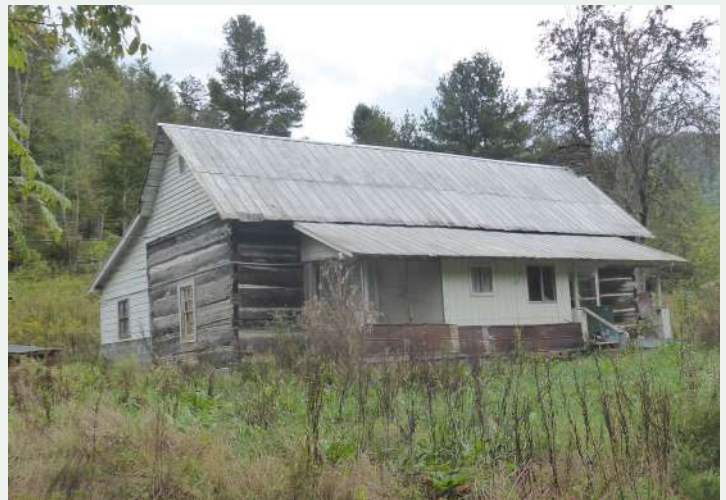
Figure 91. Oblique view of the south elevation and west façade of the Peterson-Arrowood Cabin (YC0045).

The Peterson-Arrowood Cabin (YC0045; 325 Gilders Creek Road, Burnsville), built around the turn of the twentieth century, features half-dovetail construction with concrete chinking, weatherboard-clad gables, six-over-six wood windows, and a one-shouldered stone chimney (Figure 91). Its one-and-one-half story, central-hall plan with partial-width front porch resembles popular frame house forms of the period. Several additions and modifications in the 1950s altered the cabin's form and compromised its integrity. Only minimal evidence of its farm use remains, including a historic one-story frame shed and a two-story tobacco barn. Due to these cumulative changes, it was determined ineligible for NRHP listing in 2013. (Griffith, 2013)

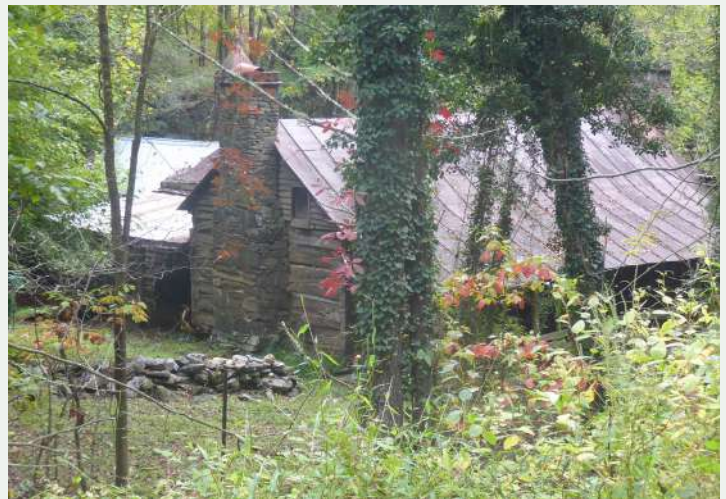
Figure 92. Oblique view of the north elevation and east facade of the Henry Willis Cabin (ML0002).

The Henry Willis Cabin (ML0002; 1132 Conley Ridge Road, Bakersville) was listed on the NRHP in 1988 under Criterion C for its architectural significance (Figure 92). Builders used chestnut logs with half-dovetail notching to construct the fifteen-foot-square, single-pen cabin around 1880. It features weatherboard gables, six-over-six wood windows, two opposing wood batten doors, and a one-shoulder stone

exterior end chimney. In 1890, a second single-cell log room was added to create a double-pen, followed by a full-width porch and kitchen ell in the early twentieth century. After 1930, owners constructed two additional expansions. These changes reflect the typical evolution of single-cell cabins as families adapted them over time. By the 1930s, owners had demolished most of the associated farm buildings, including the pig pen, spring house, woodshed, and “rag shop” building, leaving only stone foundations and a board and batten privy. (Humphries, 1988)

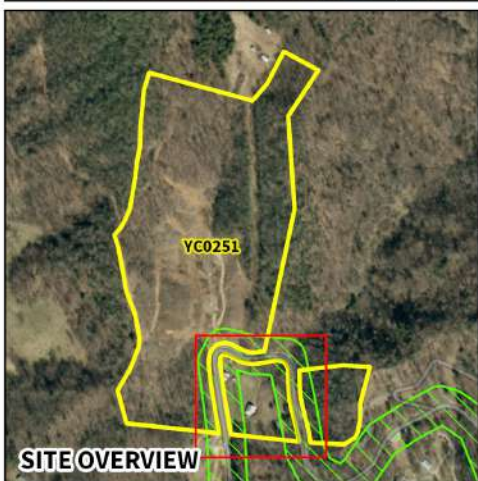
Figure 93. Map of Proposed NRHP Boundary for Hensley Cabin and Farm (YC0251)

The proposed NR-eligible boundary for the Hensley Cabin and Farm includes approximately 3.2 acres of the roughly 45-acre site (Figure 93). It covers all of the northeastern legal parcel (Yancey County PIN 072900415539000) and the portion of the southern parcel (Yancey County PIN 072900415366000) bordered by Bolens Creek Road to the north, west, and east. The southern boundary aligns with the legal parcel line, while the remainder follows the edge of the pavement as the historic cabin extends beyond the legal parcel and into the NCDOT right-of-way.

The boundary includes the homestead's historic buildings—the cabin, granary, smokehouse, and transverse crib barn—associated with the homestead, all circulation paths, and the surrounding pastures and woodlands that contribute to the resource's agricultural setting. This boundary excludes the parcel to the north of Bolens Creek Road (Yancey County PIN 072900423448000), which contains only the 2025 log barn and adjacent forested and pastured areas across Bolens Creek Road. This parcel no longer reflects its historic use (tobacco farming) and instead functions as an animal pasture and forest. While the Hensley property spans both sides of the road and the public road has historically served circulation with the property, the proposed NRHP-eligible boundary focuses solely on the historic core and excludes newer development.

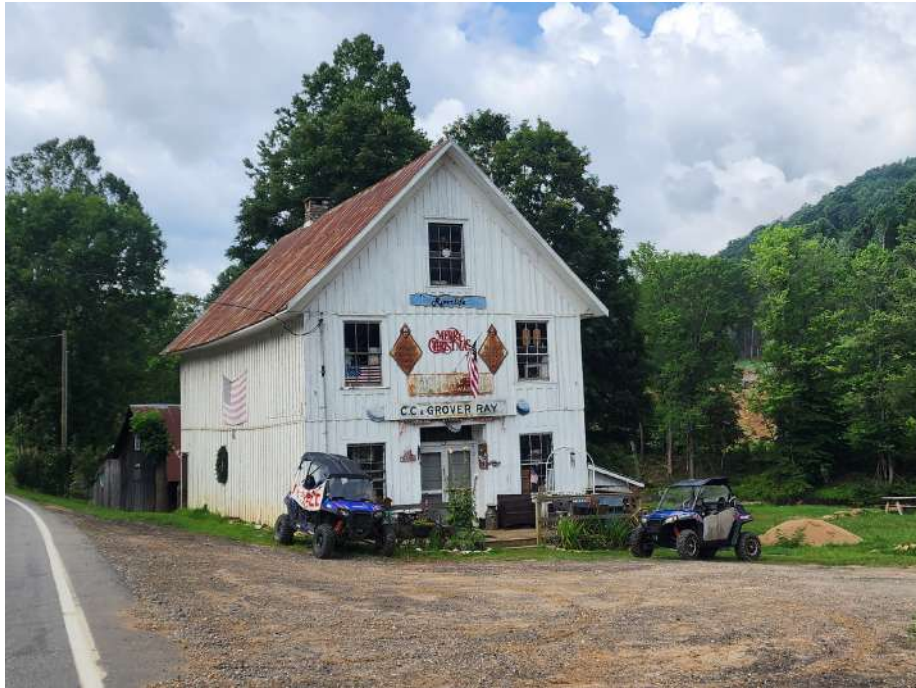
Figure 94. Oblique view of the north and east facades of the C.C. and Grover Ray Store, looking southwest from NC 197 South. Note the tenant house directly to the south.

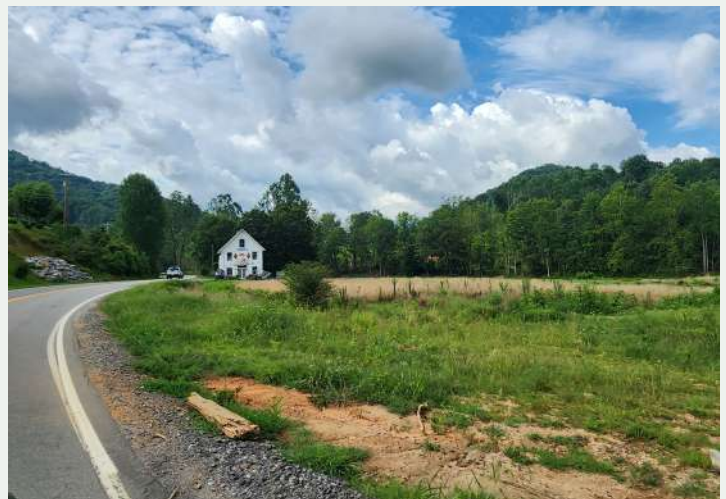
Figure 96. C.C. & Grover Ray Store, looking southwest from NC 197 South.

The C.C. and Grover Ray General Store is a substantially intact two-and-one-half story, wood-framed structure, oriented north (Figures 96 and 97). The store is rectangular in form and rests on a stacked stone basement foundation with two wood-framed window openings—now covered in plastic sheathing—centered on the west elevation. A historic concrete slab spans the façade, extended by a contemporary wood deck with simple posts and horizontal rails along the north edge. The slightly recessed central entrance features a historic ten-light transom, two five-panel wood doors, and wood and wire screen doors (Figure 98). Historic wood and metal signs decorate the façade, including a prominent “C.C. & Grover Ray” metal sign above the entrance. Stacked windows appear on the façade and rear (south) elevation, along with centered gable attic windows (Figures 98 and 99). Most windows are historic six-over-six wood windows except for historic six-over-one and one-over-one wood windows on the second level of the rear elevation (Figure 99). Built-to-fit wood frames with two rebar strands protect each sash in the first-floor windows. A historic wood batten door and similar screen door enters the southeast corner of the store and faces the highway (Figure 100). The exterior retains historic board-and-batten siding, with a subtle break in the pattern between floors. Standing seam metal panels clad the roof, which features boxed eaves.
