SUBJECT: Helene Permanent Repairs on NC 197 South, Yancey County, TIP# none,
WBS# 49082.2.13, PA# 24-11-0013, ER 25-4109

HISTORIC STRUCTURES SURVEY REPORT

Helene Permanent Repairs NC 197 South, Yancey County

WBS No. 49082.2.13 • Project No. 18313.1100997 • PA 24-11-0013

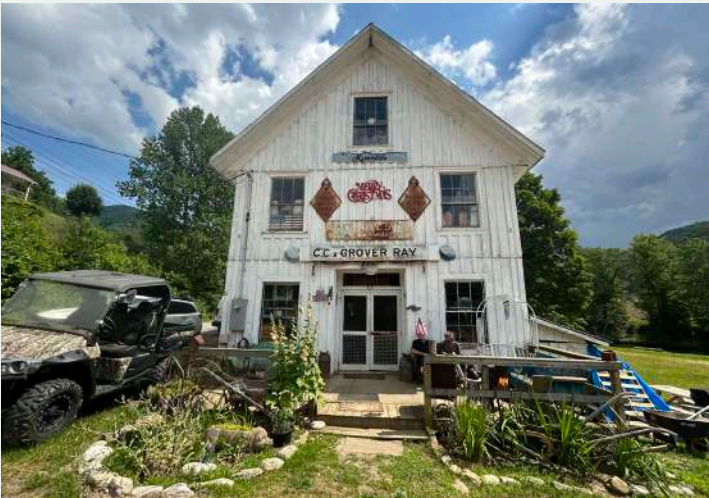
Figure 98. North facade of the store, looking south from yard.

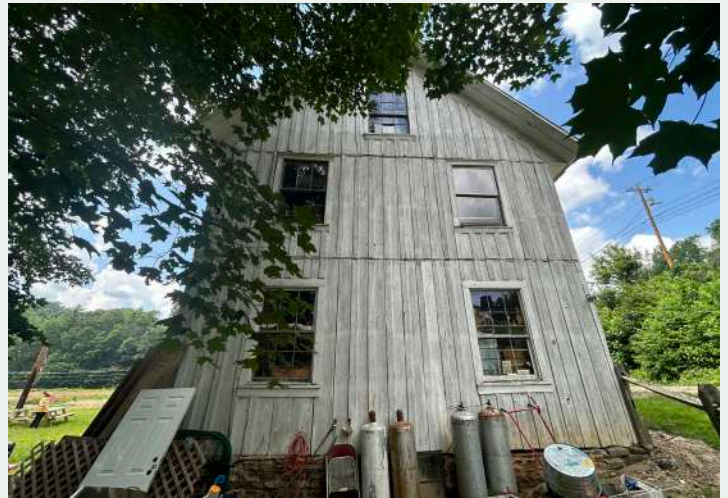
Figure 99. South elevation of the store, looking north from the yard.

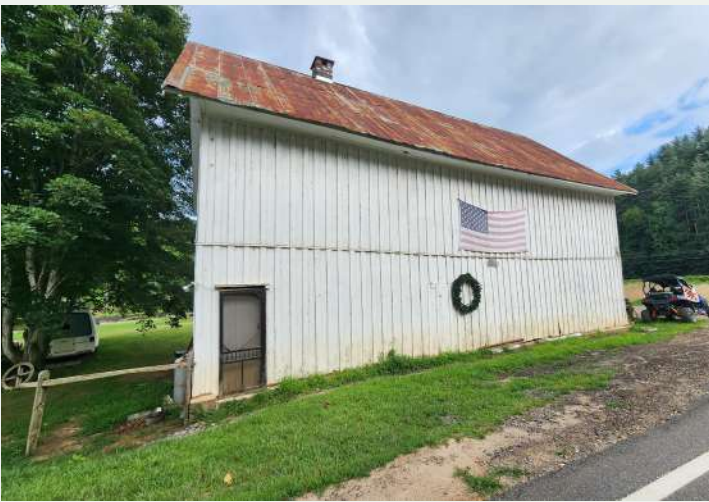
Figure 100. East elevation of store, looking northwest from NC 197 South.

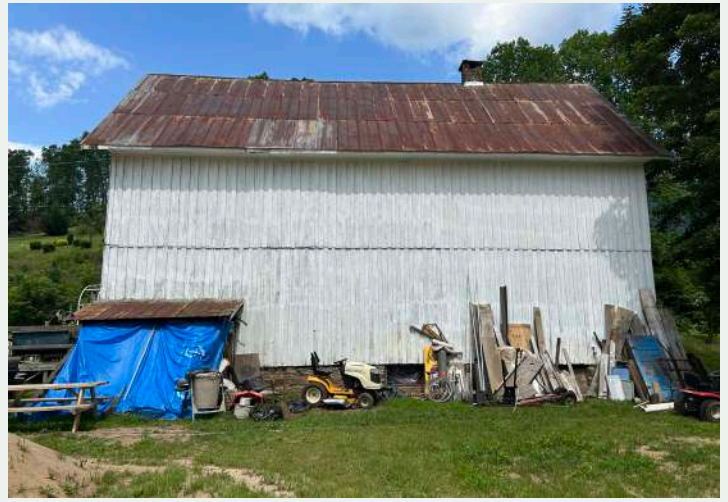
Figure 101. West elevation of the store, looking east from the yard. Note the lean-to shed addition covered by blue tarp at frame left.

A wood framed lean-to addition with stone and concrete foundation and pressed tin roof extends from the west elevation to protect concrete steps leading to the basement (Figure 101). The lean-to is clad with horizontal and vertical wood plank siding. A wood plank door that opens north enters the basement, which has a concrete floor and stone walls showing signs of past concrete repairs. Salvaged wood posts and beams along the east and west walls and hewn logs in the center of the room support the floors above (Figures 97, 102, and 103).

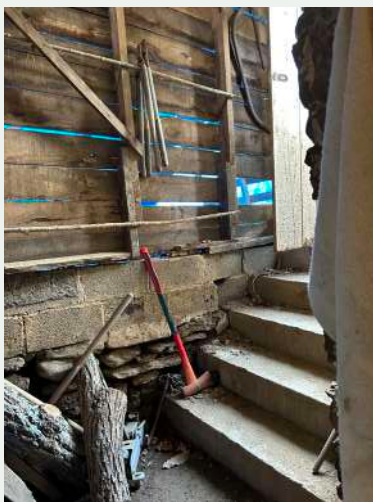
Figure 102. Enclosed exterior stairs of the addition, looking northwest from inside the basement.

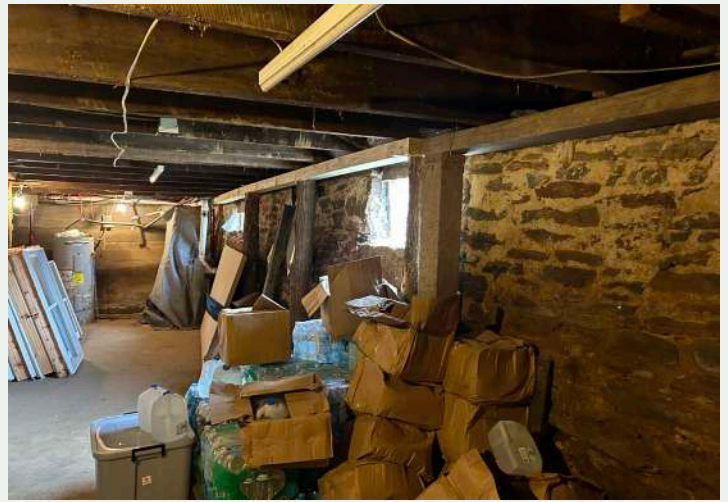
Figure 103. Basement of the store, looking southwest.

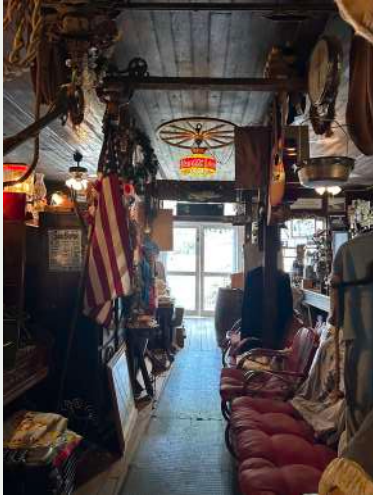
Figure 104. Interior of the store, looking north through the front doors.

and store counter run the length of the east wall in the main level, ending at an enclosed staircase in the southeast corner (Figures 104 and 105). The staircase includes a historic wood batten door with historic iron hinges and a latch (Figure 106). Historic wood shelving and display cases also fill the west wall and center of the store, and a second partitioned space with wood plank walls occupies the southwest corner (Figure 107). A red brick fireplace with historic wood mantle shelf divides the front and rear sections of the store and extends through the second and third floors, now used for storage (Figures 108 and 109). Exposed wood rafters and plank sheathing form the roof structure in the attic (third floor). Property owner Danny Hensley reported that the structure was framed with virgin chestnut.

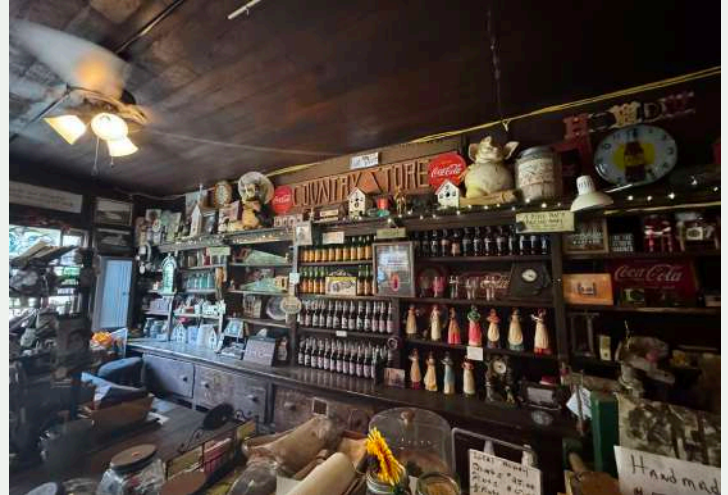
Figure 105. Historic shelving along the east wall of the store, looking northwest.

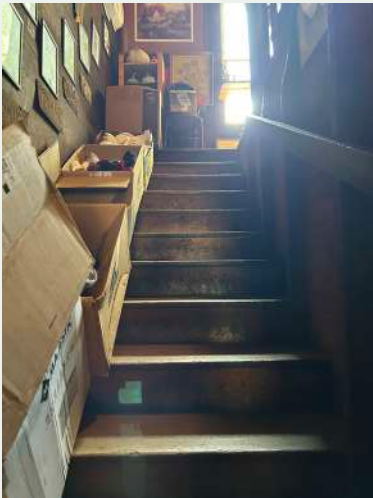
Figure 106. Historic wood stairs leading to the second level, looking south from the store.

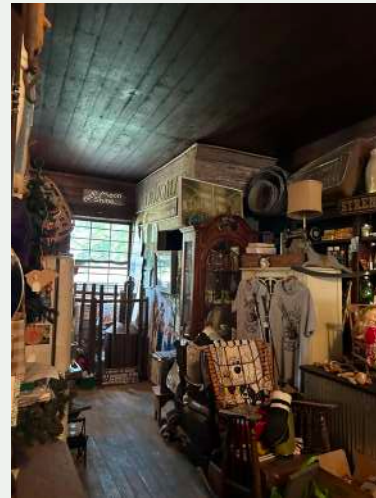
Figure 107. Interior of the store looking southwest. Note the partition in the corner.

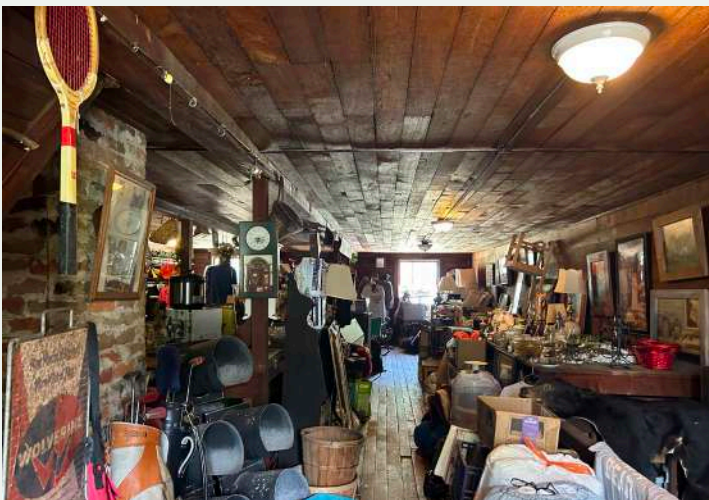
Figure 108. Second level of the store, looking north.

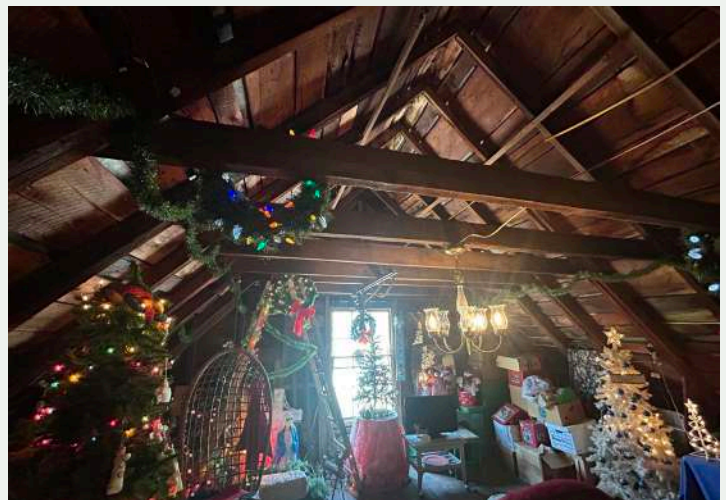
Figure 109. View of the attic, looking north.

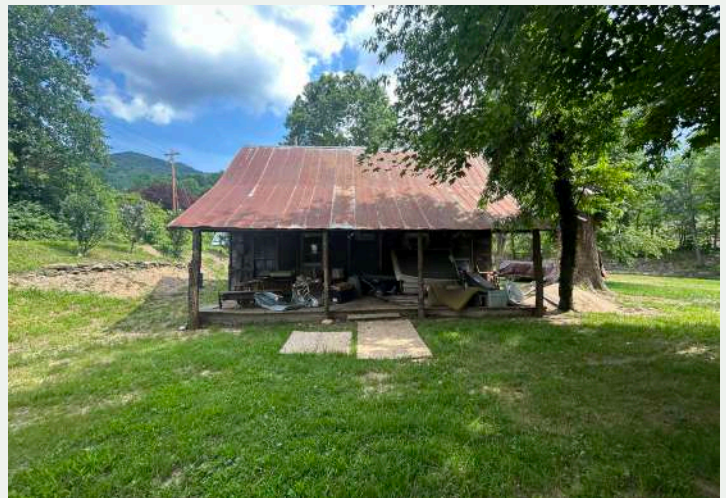
Figure 110. North facade of the tenant house, looking south from the yard.

The one-and-one-half story, side-gable house reflects early twentieth century boxed, or plank, construction. The house is three-bays wide and rests on a rubble stone foundation. It has a full-width front porch with unhewed log posts, a centered interior red brick chimney, and standing seam metal roof (Figure 110). On the façade, double-hung windows frame three centered entrances within each bay, each with a historic three-light wood paneled door. The center door is slightly wider, and a plywood patch covers a gap in the porch ceiling above it (Figure 111). The property owner shared that stairs leading from the porch to the loft had been removed. Historic wood four-over-four and one-over-one windows appear throughout, with three-over-two and one-over-one windows in the gables (Figures 112 and 113). A contemporary lean-to addition extends across its rear (south) elevation and includes a mix of salvaged vinyl four-over-one, one-over-one, picture windows, and an octagon-shaped window, along with a half-light leaded glass aluminum panel door (Figure 114). A metal stove pipe extends from the western third of the shed roof. Unpainted wood board-and-batten siding of varying widths clads the exterior of the house, and a patch beneath the window on the east elevation marks a later repair (Figure 113). Unfinished vertical wood siding clads the rear addition.

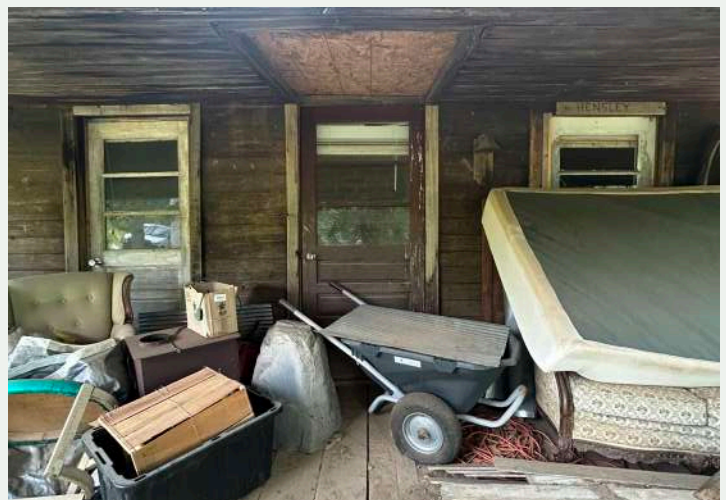
Figure 111. Three entrances across the tenant house's north facade. Note the plywood sheathing covering the opening above the central door.

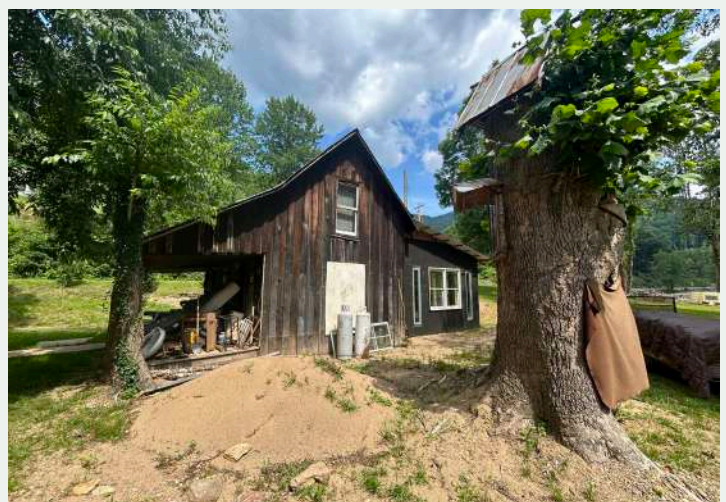
Figure 112. West elevation of the tenant house, looking southeast from the yard.

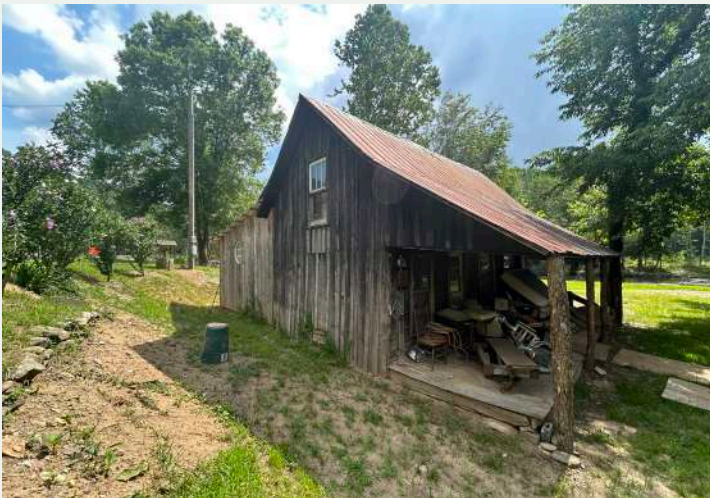
Figure 113. Oblique view of the east elevation and north façade of the tenant house, looking southeast from the yard.

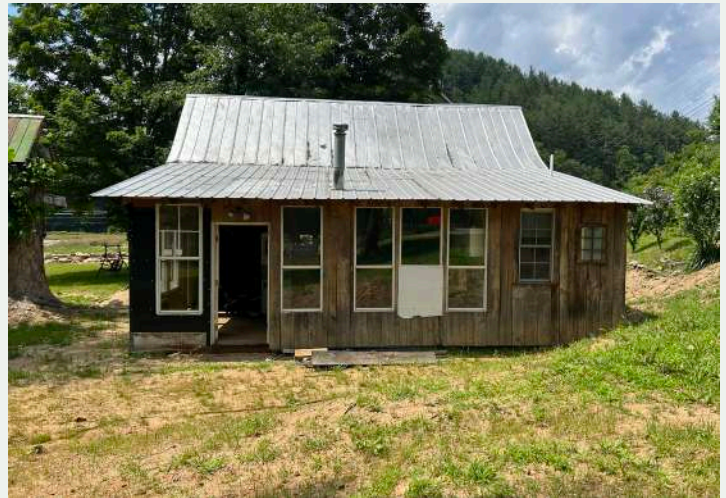
Figure 114. South elevation of the tenant house, looking north from the yard.

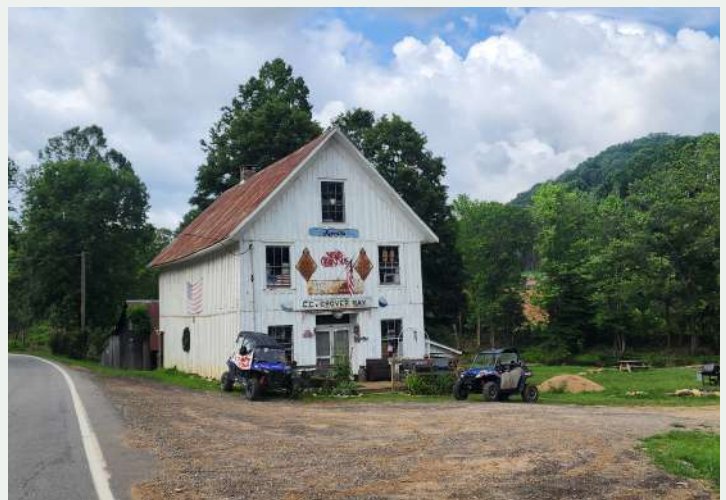
Figure 118. C.C. and Grover Ray General Store and tenant house, looking southwest from NC 197 S and the driveway.

The store and tenant house sit at the northern end of the parcel, between the tree-lined Cane River to the west and NC 197 South to the east. The NC 197 South roadbed rises about two feet above the elevation of the store and five feet above the tenant house (Figures 118 and 119).

A large gravel driveway north of the store provides site access, with parking areas to the north and east of the building (Figures 95 and 118). Stone-lined planting beds frame the store's facade. Although Hurricane Helene left sand across much of the site, grass had regrown around both buildings by the time of the field survey. Adjacent to the tenant house, remnants of a stacked stone wall line the sandy roadbed, bordered by Rose of Sharon bushes (Figure 120).

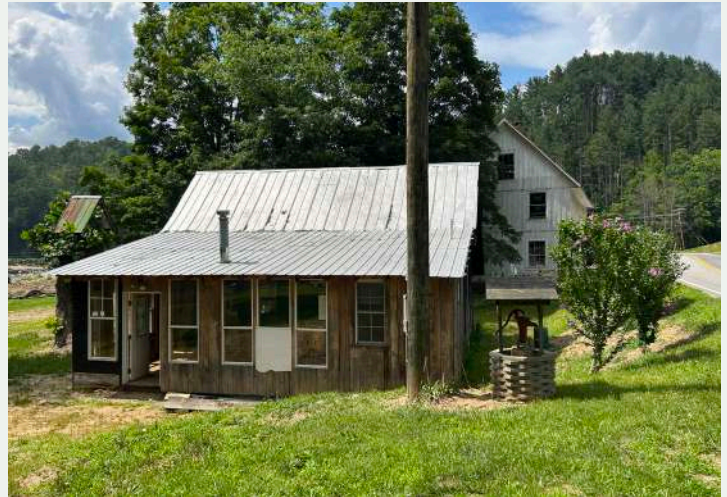
Figure 119. The store and tenant house, looking north from the yard.

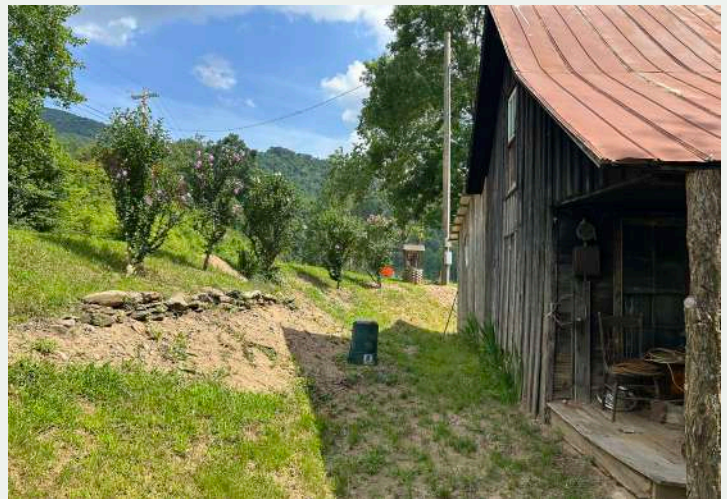
Figure 120. Remnants of a stacked stone wall and Rose of Sharon shrubs along slope of the road, looking south from the yard.

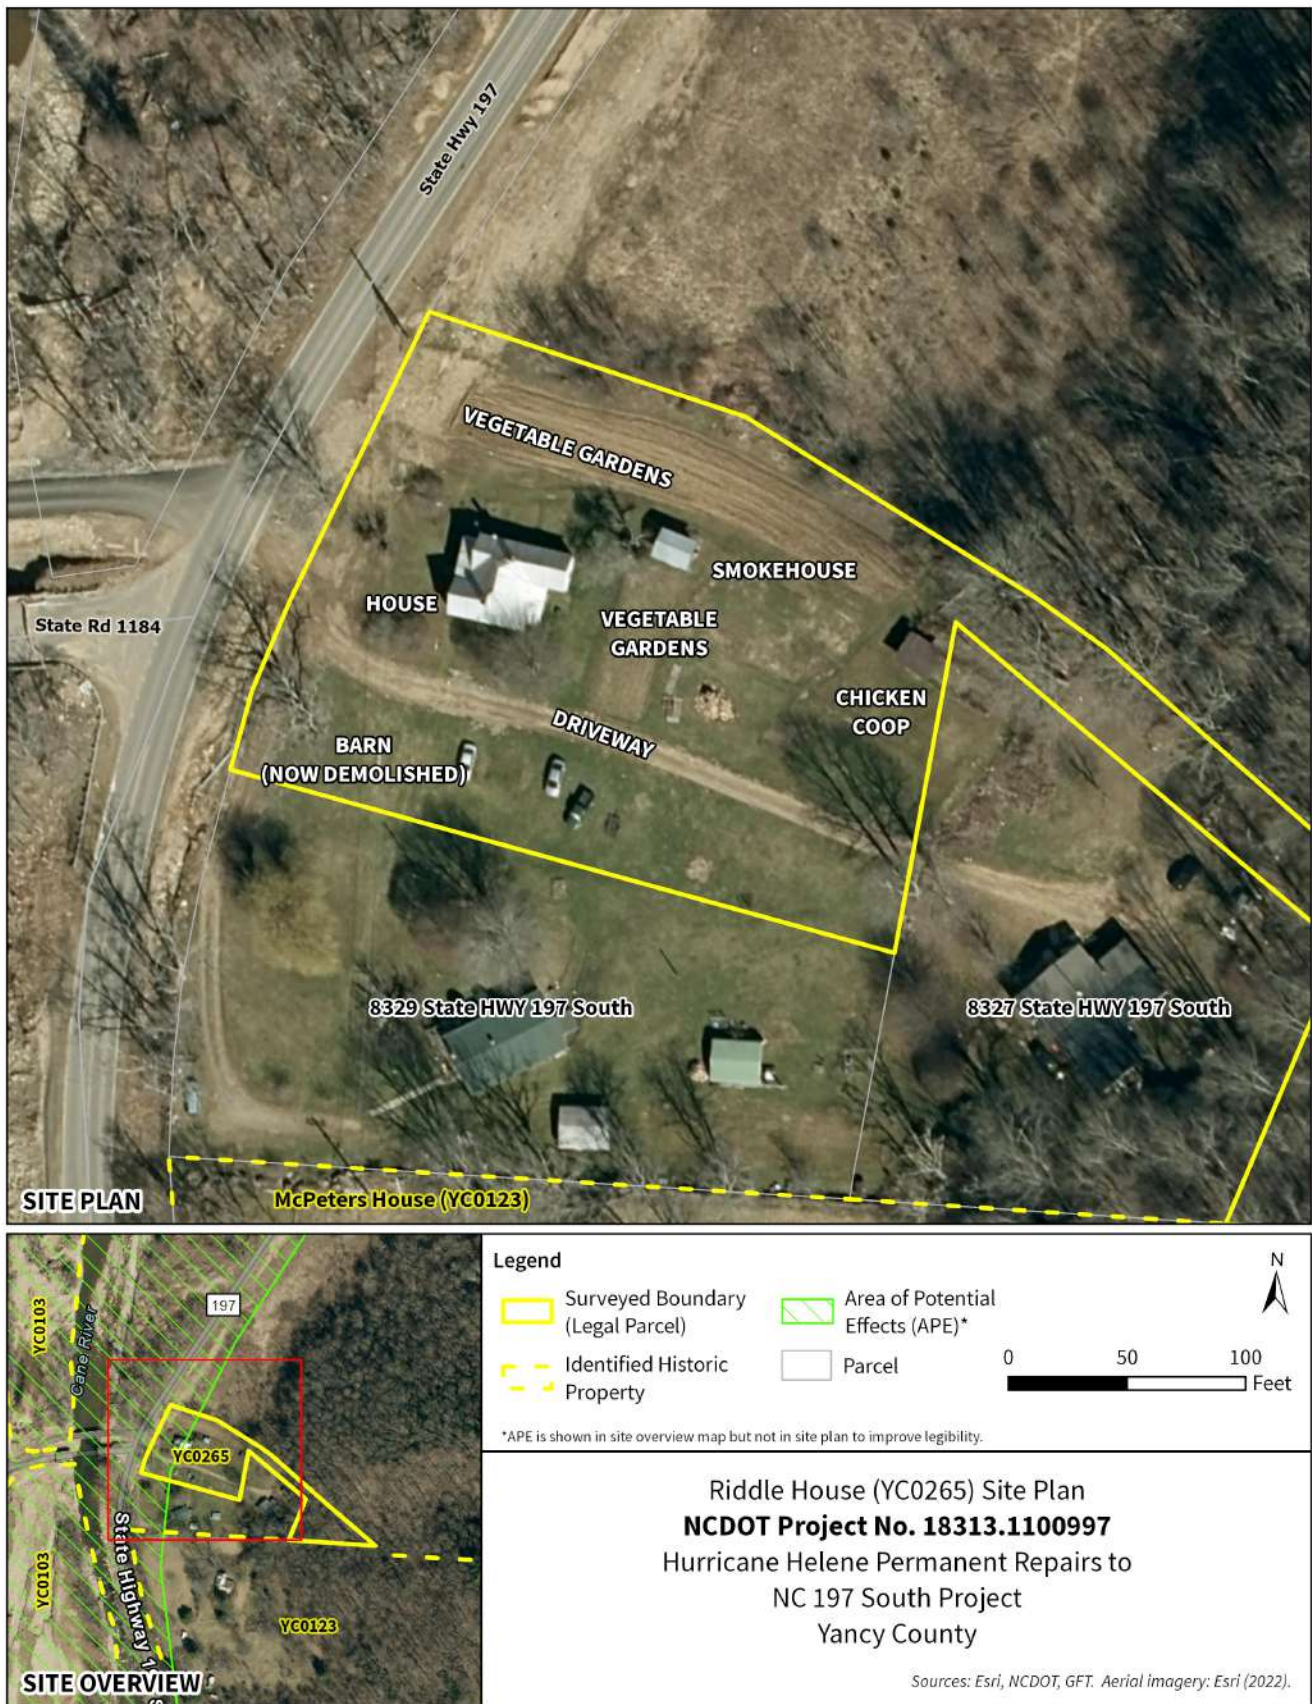
Figure 134. Riddle House Site Plan. Bobby Ray Riddle subdivided the 5-acre lot to create three parcels for his sons between 2016-2017, resulting in neighboring lots at 8329 and 8327 State Hwy 197 South.

The Riddle House is located in the western section of the lot approximately 60 feet east of the highway (Figure 134). A gravel driveway provides access on the south side of the house. The front yard was minimally landscaped with grass and groupings of shrubs and flower plantings. The parcel slopes gently uphill to the east and ends at a wooded hillside that borders Mount Mitchell State Park. Adjoining parcels include post-1970 residential development by the Riddle family.

A garden shed stands in the backyard, facing east on a concrete block foundation (Figures 134 and 139). Bobby Lee Riddle reported he constructed the hemlock-framed structure as a smokehouse in the 1970s. Unpainted, horizontal wood boards clad the exterior. A wood batten door opens on the southwest corner of the west elevation; a second door sits at the northeast corner. The roof has exposed rafter tails and standing seam metal roofing. Grapevines climb the east and south walls.

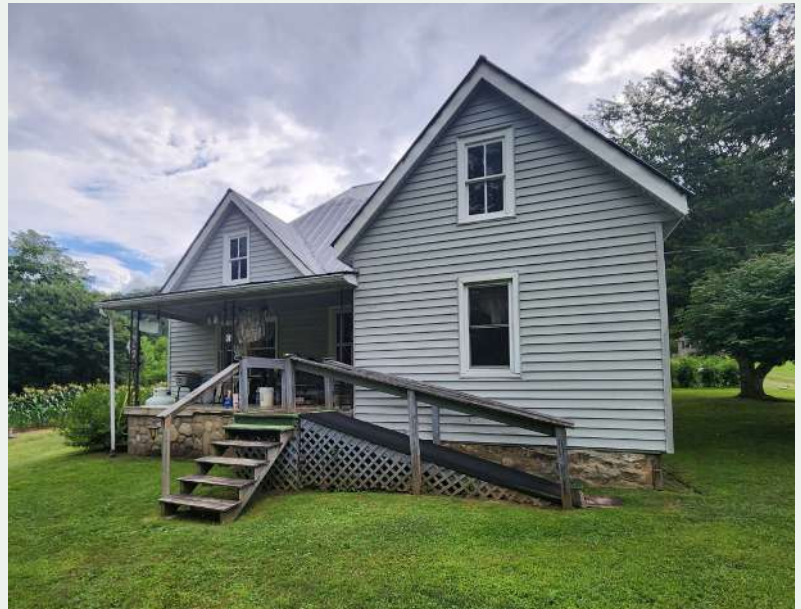
Figure 135. West façade, looking northeast from the front yard.

The Riddle House is a one-and-one-half-story double-pile plan with a hipped roof over a central, square massing with two projecting gable wings (Figures 133 and 135). The house sits on a mortared rubble stone foundation with visible concrete repairs. Vinyl siding clads the exterior walls, and the house features windows and doors of varying styles, ages, and materials. Two internal brick chimneys and an external concrete block chimney extend above the standing seam metal roof.

The L-shaped, three-bay façade includes a projecting gable wing that frames a partial-width front porch spanning the first two bays (Figures 133 and 135). The house cantilevers over the foundation in places, most notably at the southwest corner (Figure 135). The porch has a stone veneer skirt, open wood steps, and an accessibility ramp extending south. Both the stairs and ramp feature a lattice skirt and simple wood posts and handrail. Green and black outdoor carpeting covers the stair landing and ramp. The porch shelters a pair of historic three-over-one wood windows and a contemporary divided half-light aluminum storm door over a historic paneled wood door. Aluminum soffit panels cover the porch ceiling, which extends past the projecting gable wing. One vinyl one-over-one window is centered on the main level of the projecting gable wing. Historic two-over-two wood windows with historic wood surrounds are centered on each projecting gable of the second floor.

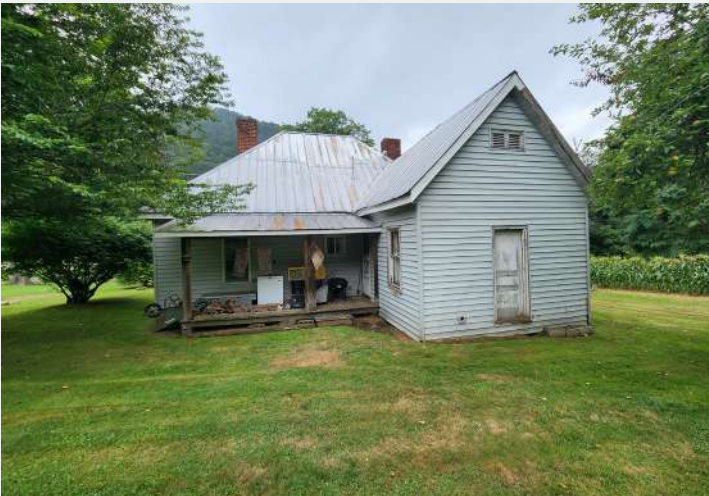
Figure 137. East elevation of the house, looking northwest from backyard.

On the east elevation, concrete blocks support the wood decking of the partial-width porch (Figure 137). Groupings of

two to three sistered wood posts support the porch's shed roof, which shelters a screened historic wood one-over-one window. Its projecting gable ell includes a historic three-paneled wood door centered beneath a historic wood attic vent. Missing aluminum cornice and soffit expose the unpainted wood cornice beneath.

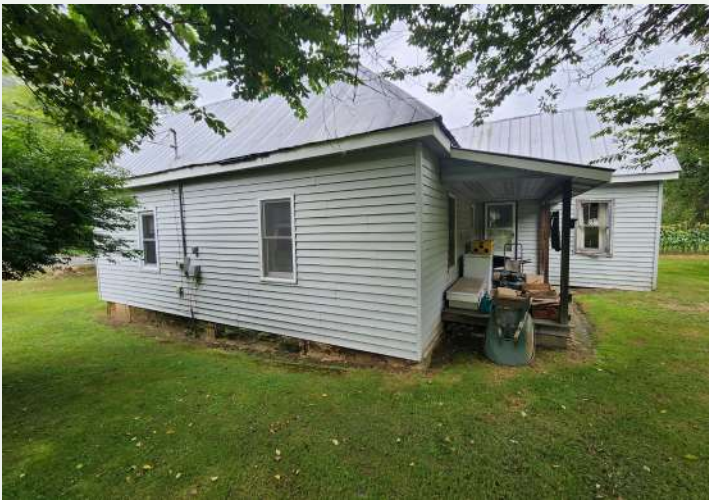
Figure 138. Oblique view of the south and east elevations of the house, looking northwest from yard.

The south elevation features two one-over-one vinyl windows with screened storm windows below the hipped roof (Figure 138). The projecting gable ell has a contemporary aluminum screen door over a historic half-light three-paneled wood door beneath the porch and a damaged historic three-over-one wood window. A deteriorating red brick chimney protrudes beneath the hipped roof's ridgeline.

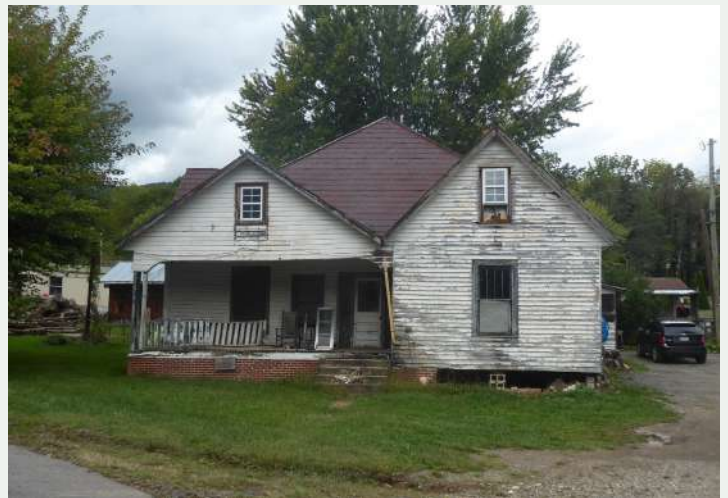
Figure 145. South façade of the Metcalfe House (YC0190).

The one-and-one-half story Metcalfe House (YC0190; 71 Azalea Lane, Burnsville) has a central hipped roof with projecting gables forming the partial-width front porch and ell (Figure 145). (The 1983 survey suggested the porch may be a later addition.) The house retains some historic features, including a central half-light door with sidelights, several wood four-over-one windows, wood clapboard siding, and pressed tin shingles. The Metcalfe House is in deteriorating condition and material alterations such as

the closed red brick foundation and replacement four-over-four vinyl windows on the second floor compromise its integrity. (Humphries, 1985(a))

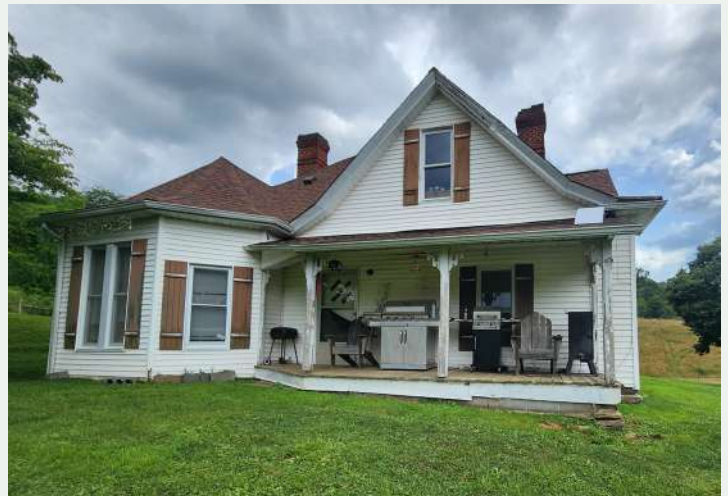
Figure 146. North façade of the David Dellinger House (YC0028).

The circa 1900 David Dellinger House (YC0028; 15 Dove Cove Road, Burnsville) also features a projecting gable above a partial-width front porch (Figure 146). The flared eaves of its gables and projecting conical bay on the facade are noteworthy features of its design though a rear shed-roofed addition detracts from its historic form. Alterations and material modifications including replacement doors and windows, decorative shutters, and foundation materials have eliminated or obscured historic materials.

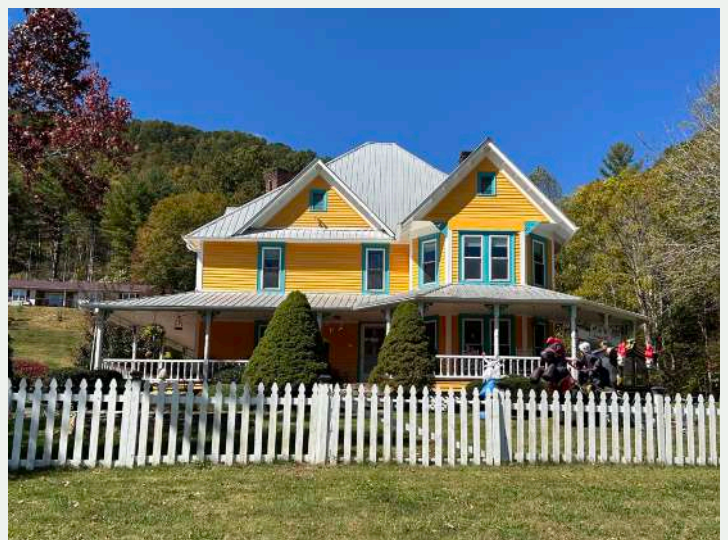
Figure 147. Southeast façade of the Dr. Peterson House (YC0091).

The 1890 Dr. Peterson House (YC0091; 32 Hortons Creek Road, Burnsville) offers a more ornate two-story variation of the house form (Figure 147). It features a central mass with hipped roof, gable wall dormer, and cutaways corners on the projecting gable ell of its façade. A two-sided wraparound front porch forms a six-sided octagon around the projecting wing. The house retains its historic integrity, preserving many cottage-style details such as scrolled corner brackets, wide frieze boards, turned porch posts and balustrades, and red brick chimneys with elaborate detailing.

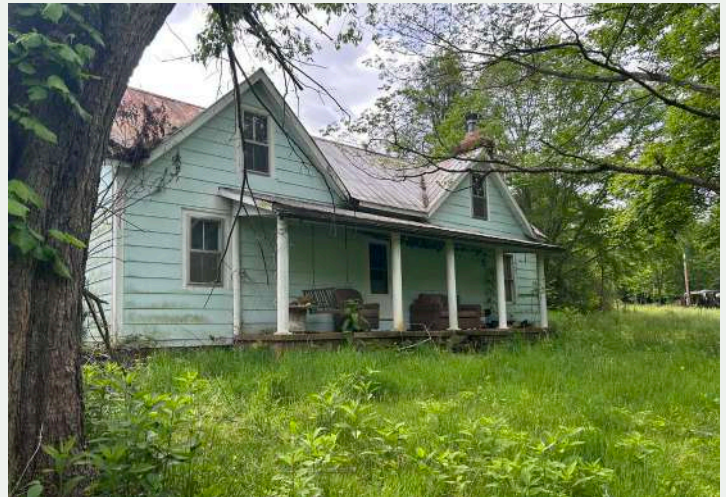
Figure 151. West façade of the house, looking northeast in the front yard.

The elongated central hall's west-facing façade has a partial width front porch (Figure 151). Stone veneer covers the porch skirt, and stone piers with concrete caps flank concrete steps that lead to the central entrance. Vinyl fluted columns on a concrete slab floor support its shed roof. The symmetrical façade includes two-over-two double-hung windows just outside of the porch, and an aluminum screen door protects a centered half-light, paneled wood door. Storm windows are present on all but the window to the south of the door.

The Joe McPeters House is a one-and-one-half story, side-gable, three-bay frame house with two gable wall dormers on the façade (Figures 149 and 151). The house sits on a rubble stone foundation and has a tapered stacked stone end chimney on the south elevation. A historic kitchen ell and 1970s shed-roof addition extend from the rear (east) elevation. Wood composite board and shingle siding clad the house. There are wood windows covered by aluminum storm windows and doors of varying styles throughout. Standing seam metal covers the roof of the historic house and later additions.

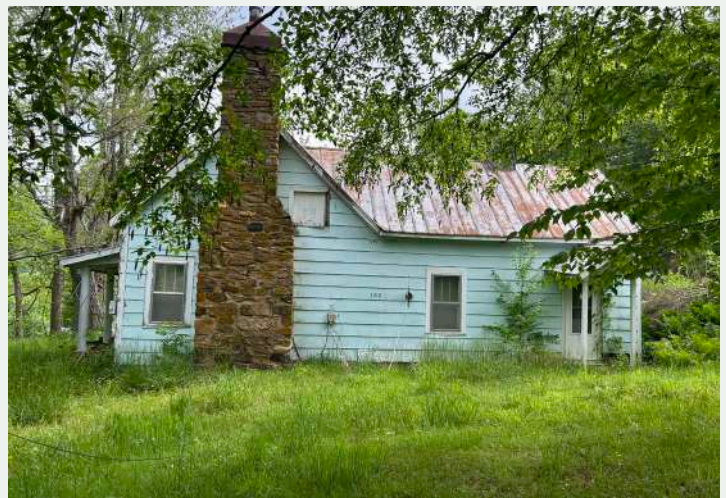
Figure 152. South elevation of the house, looking north from yard.

The south elevation reflects the historic form of a central hall with one-story rear ell (Figure 152). This elevation has three-over-one wood windows covered with aluminum storm windows on the main level. The side-gable has two square windows, one now boarded over, on either side of the tapered stacked stone end chimney. An interior stuccoed chimney extends from the midpoint of the ell's roof ridge and is associated with the interior kitchen space. A gabled overhang protects a side entrance with a contemporary door and aluminum screen door on the eastern half of the ell.

uncles built a new stone ranch house (not extant) on the southwest corner of the property (Figure 152) and added the stone end-chimney on the historic house in the 1970s, as well. The Hensleys stayed in the ranch house during the winter months because it was better insulated than the historic house they occupied in the summer.

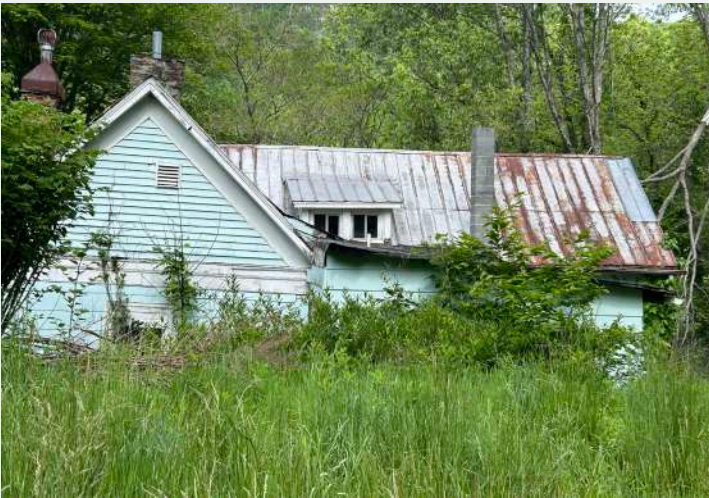
Figure 153. East elevation of the house, looking west from hillside.

The east elevation sits at the toe of the slope and was largely inaccessible due to the grade and vegetation (Figure 153). The ell's gable contains a single window. A 1970s shed roof addition extends from the ell across the back of the central hall form. The flatter shed roof of the addition was built up to meet the steep gable of the ell. The shed

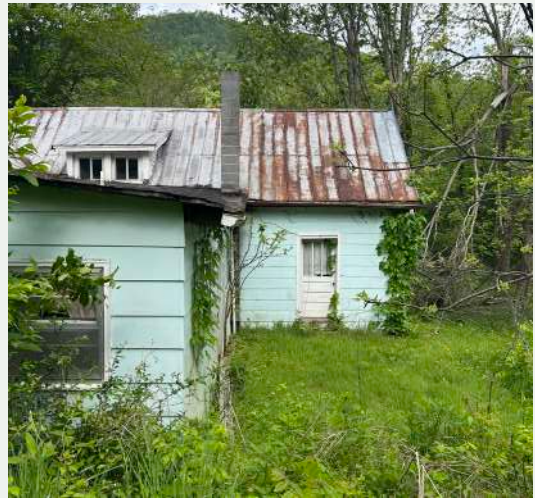
Figure 154. View of the 1970s addition (at left) and rear elevation of the central hall house, looking west from the backyard.

extension contains a single four-light wood window with aluminum storm window (Figure 154). A shed roof dormer protrudes from the center of the central hall's roof and contains two sliding vinyl windows. A half-light paneled wood door and concrete stoop enters the central hall at the north end of this elevation (Figure 154).

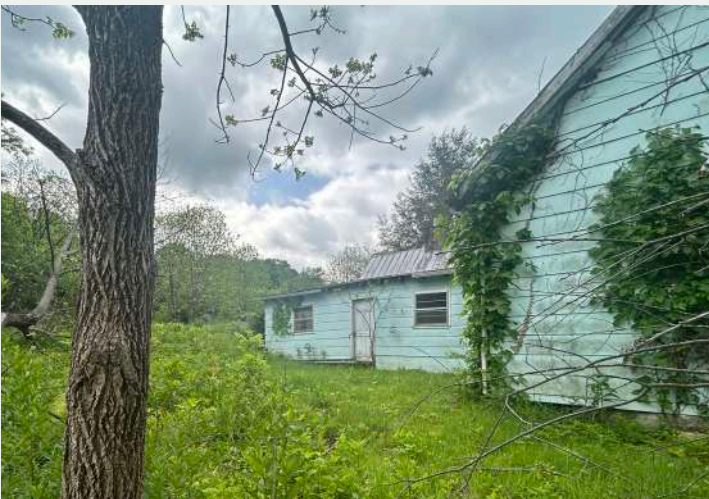
Figure 155. North elevation of the house, looking southeast from the side yard.

The north elevation of the addition rests on stone piers and includes single-hung four-light wood windows and an aluminum door (Figure 155). A concrete block chimney sits in the intersection of this addition and the central hall (Figure 156). A single four-light wood window with aluminum storm window is centered on the first floor under the gable end. Stone retaining walls flank stone stairs leading to a cellar beneath the northwest corner of the historic house (Figure 157).

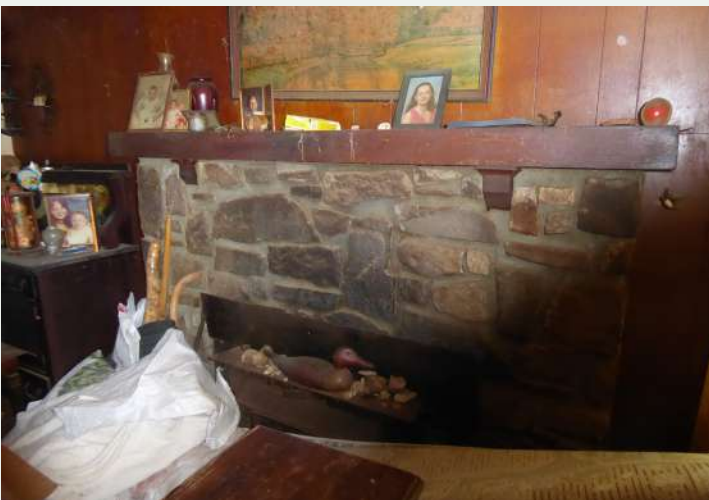
Figure 159. Blevins recalled that his uncles built this stone veneer chimney in the family room, likely in the 1970s-1980s.

built a stone veneer fireplace with wood mantle in the family room to the south of the hall (Figure 159) at about the same time as other additions to the house, circa 1970s-1980s. A wood paneled door on the east side of the family room leads to the rear ell and the 1970s addition. This addition contains the kitchen, bathroom, and a bedroom. GFT did not access this section of the house as the floor structure has collapsed.

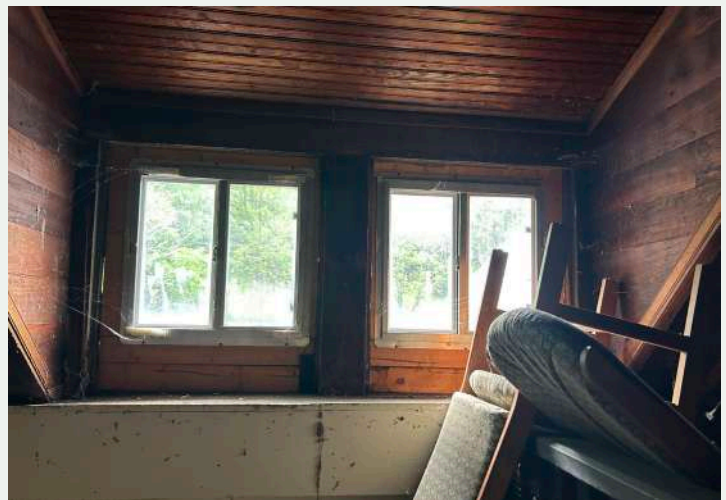
Figure 160. Shed dormer above staircase, looking east from the second floor central hall.

The upstairs plan matches the floor below with a central hall and two bedrooms. The east-facing dormer window over the stair landing and windows in the gable wall dormers light the upstairs rooms (Figures 160 and 161). Storage is built into the knee walls of the second-floor space.

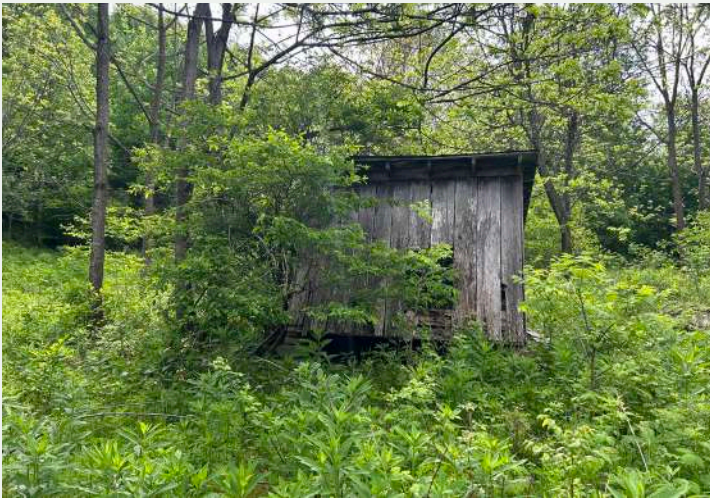
Figure 162. West elevation of the animal shelter, looking east from the hillside.

A side-gable wood frame animal shelter is located east and uphill of the house (Figures 150 and 162). The structure rests on stone piers. It has vertical wood board siding and an opening in the corner of the building, suggesting its prior use as a chicken coop. A collapsed barn or animal shelter is located southwest of this outbuilding (Figure 163).

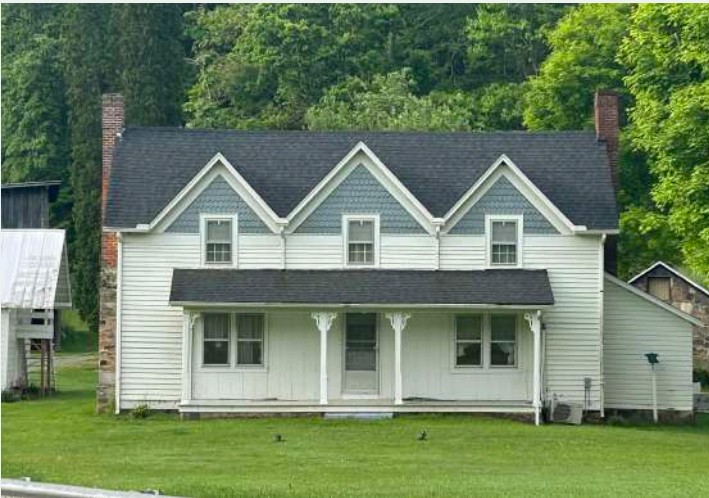
Figure 172. North facade of the Horton-McLaughrun House (YC0053).

The NRHP-eligible Horton Laughrun Farm (YC0053; 34 Gilders Creek Road, Burnsville) and the Bradley House (aka J.D. Bradshaw House, ML0083; 174 Relief Road Extension, Green Mountain) likewise utilize front gable dormers to light their second stories (Figures 172 and 173). Both homes retain a notable level of architectural ornamentation, including plain raking boards in the gable ends, a wide frieze band that divides the dormer windows, decorative moldings, and historic double-hung wood windows. The Horton-Laughrun Farm is eligible for listing in the NRHP under Criterion C for its architectural

significance and retains several historic features including chamfered wood porch posts, scrolled brackets, and wood fish scale shingles in its gabled dormers. The Bradley House, a contributing property to the Relief Historic District (ML00005), likewise retains architectural features such as turned wood porch posts, scrolled brackets, and a spindle balustrade. (Griffith, 2013)

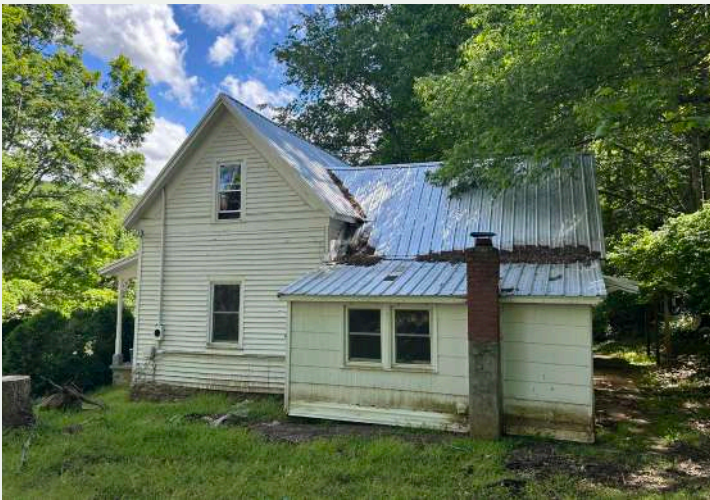
Figure 177. North elevation of the house, looking south from yard. The rear ell has been covered by Addition A, which projects to the north.

The Hensley-Robertson House is a one-and-one-half story, single-pile, central hall house with rear additions. The house has a central projecting gable above the partial width front porch, creating its Triple-A form (Figures 174 and 175). Later additions "A", "B", and "C" are attached to the historic rear ell (refer Figure 175). Weatherboard clads the exterior walls of the central hall and ell's gable and wavy shingle asbestos siding covers the later additions. Vinyl one-over-one windows of varying sizes are used throughout. Contemporary standing seam metal roofing covers the house and porch roofs.

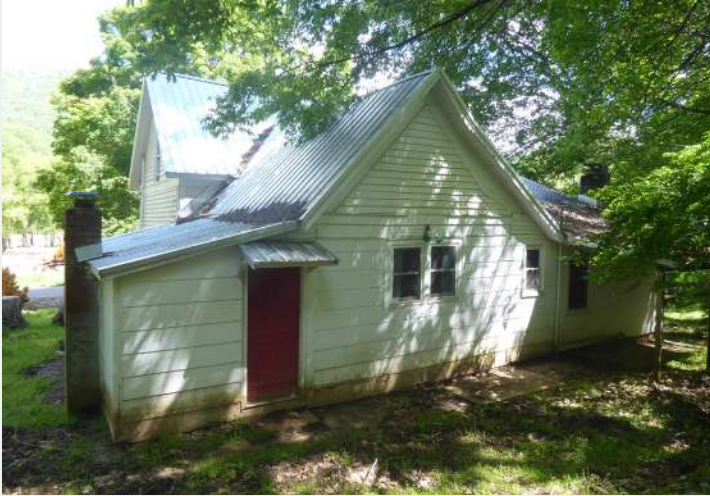
Figure 178. West elevation of the house, looking southwest from hillside. The gable of the rear ell is flanked additions A and B. Note the adjustment to the gable roof pitch on the right (south) slope of the ell and narrow weatherboard siding above Addition B's window (right).

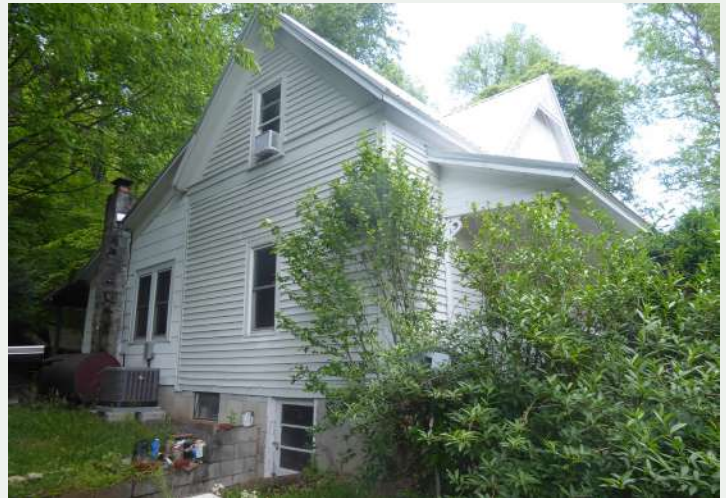
On the south elevation, the historic house and Addition C have a concrete block foundation that features a single two-light steel hopper window (Figure 179). Wood stairs flanked by concrete block retaining walls lead to the basement entrance beneath the side gable. A historic three-light, three-panel wood door sits at the bottom of these steps, slightly off-centered from the vinyl windows above (Figure 180). Stacked one-over-one vinyl windows are located on the north elevation of the central hall's side gable. Addition C extends to the west, containing an external red brick chimney covered in stucco and two vinyl windows (Figures 179 and 181).

Figure 179. Oblique view of the south elevation and east facade of the house, looking northwest from yard.

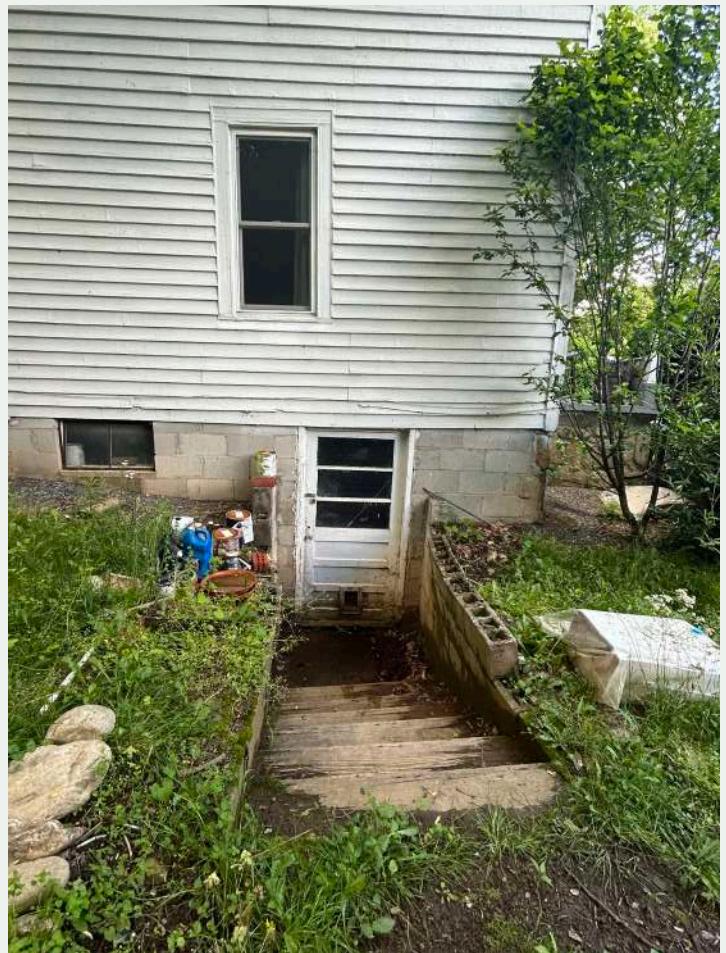
Figure 180. View of the basement entrance on the south elevation of the historic house, looking north from yard.

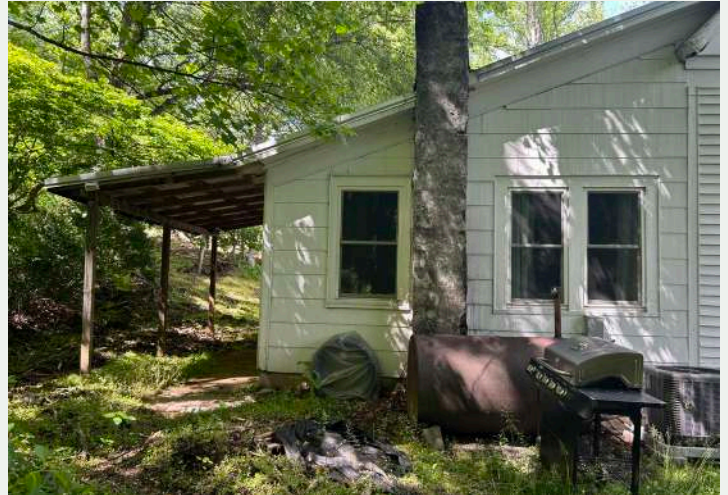
Figure 181. View of Addition C and covered patio on the south elevation, looking north from yard.

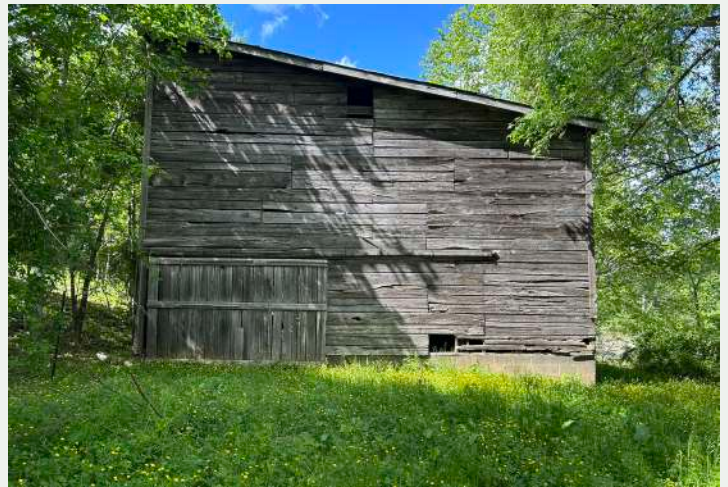
A circa 1950s wood frame, shed-roofed tobacco barn is located north and uphill of the house (Figure 176). The barn rests on a concrete block foundation, and horizontal boards of varying sizes clad the exterior. The south elevation has a square opening at the center of the wall, just beneath the roof eave, and a sliding barn door of vertical wood on its western half (Figure 182). The north elevation mirrors the south elevation's openings. The east side has no openings, and the west side was not accessible due to a locked gate. The style and design of the tobacco barn is simple, utilitarian, and common throughout the county.

Figure 182. South elevation of the tobacco barn, looking north from yard.

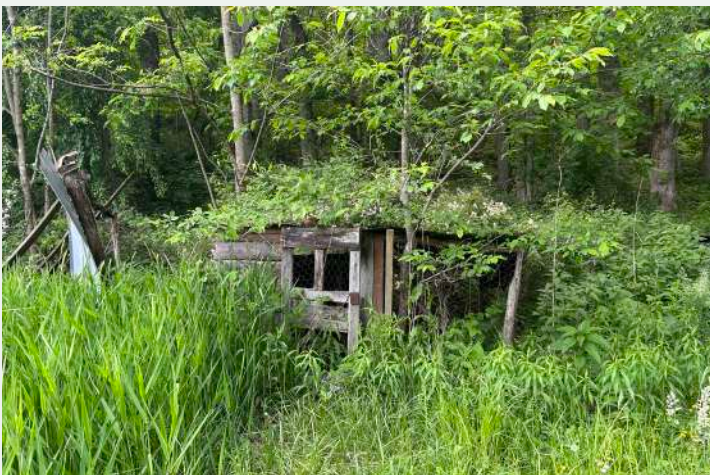
An abandoned chicken coop, likely from the 1950s, is covered by vegetation and located directly south of the house (Figures 176 and 183). The building has a wood framed door with chicken wire and a chicken run to the right (north) of the door. The shed roof, clad in standing seam metal like the house, appears to have collapsed and now rests on its side on the ground directly south of the building.

Figure 183. Oblique view of the north and east elevations of the chicken coop, looking southwest from yard. Note the standing seam metal roof structure laying to the side of the chicken coop.
