SUBJECT: Helene Permanent Repairs on NC 197 South, Yancey County, TIP# none,
WBS# 49082.2.13, PA# 24-11-0013, ER 25-4109

HISTORIC STRUCTURES SURVEY REPORT

Helene Permanent Repairs NC 197 South, Yancey County

WBS No. 49082.2.13 • Project No. 18313.1100997 • PA 24-11-0013

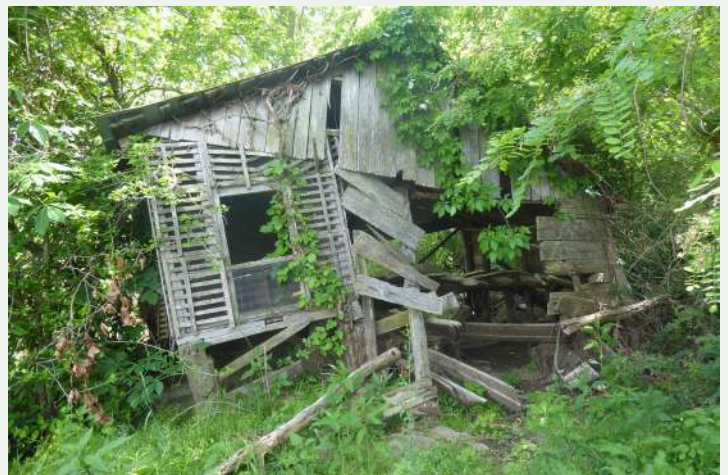
A corn crib-shed structure is located about 350 feet southeast of the house and on the east side of Riverview Road (Figures 176 and 184) and may date to the 1940s. Collapsed wood piers support the raised floor of the two-bay wide, front-gable structure. The east bay has wood slats covered with wire screening on the interior, indicative

Figure 184. North elevation of the corncrib-shed structure, looking southwest from the pasture.

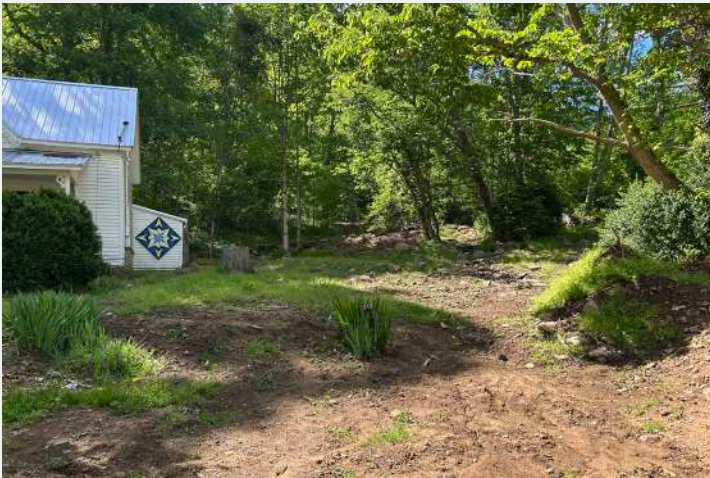
Figure 186. View of the driveway, looking west from the front yard.

A short dirt driveway provides access to the site just south of the Morning View Drive and Riverview Road intersection and ends before reaching the house (Figure 186). The driveway was severely damaged by Hurricane Helene. A section of curved concrete sidewalk extends southwest from the driveway to the front porch steps. Historically, a driveway connected the house to the barn to the north, but flooding from the hurricane washed out this section. A gravel driveway links the barn's north side to Morning View Drive. Pre-Helene aerial imagery shows that agricultural roads once connected the fields and pastures between Riverview Road and the Cane River, but the storm washed out these roads and surrounding pastures.

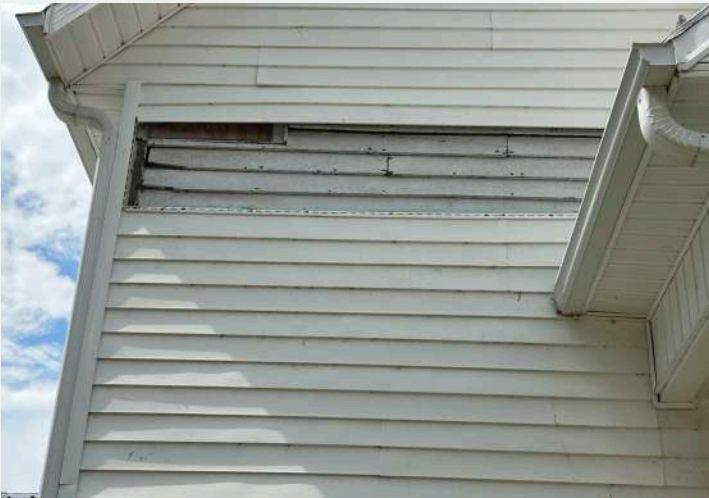
Figure 197. Historic wood siding hides beneath contemporary vinyl siding on the south facade.

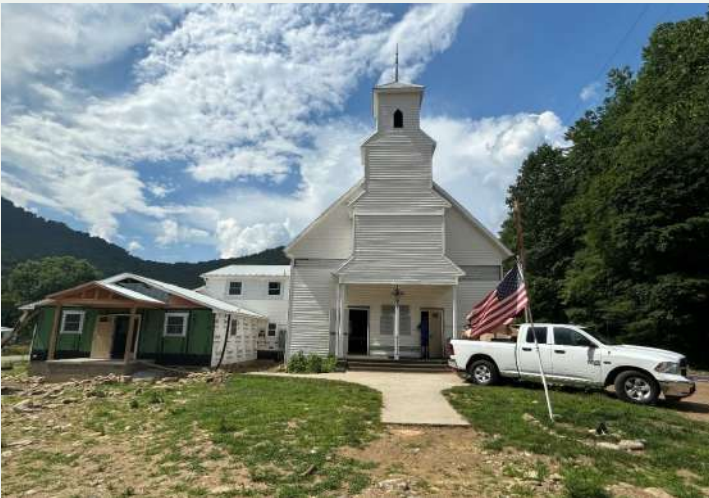
Figure 198. South façade of the church and Additions A and B to the west, looking north from the gravel parking area.

Additions B and C, both one-story and front-gabled, sit perpendicular to Addition A on a parged concrete block foundation. On the south façade, two wood posts support Addition B's projecting gable porch roof, which shelters a pair of six-panel steel doors matching those of the church (Figures 198 and 199). Two one-over-one vinyl windows flank the porch and another appears on the east elevation (Figure 199). Together Additions B and C span six bays on the west elevation (Figure 202). A wood deck with horizontal wood skirt, simple wood railing, and wood decking extends across bays four and five. Two steel half-light two-panel doors open onto the deck flanked by one-over-one vinyl windows. Addition A's side gable rises above the standing seam metal roof. On the north elevation, Addition C projects beyond the rear wall plane of the church and Addition A and has vinyl one-over-one windows on its east and south sides (Figure 199).

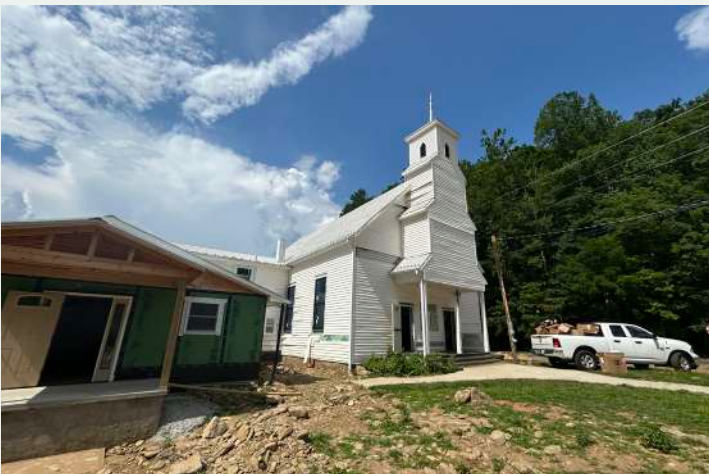
Figure 199. Oblique view of the south facade and west elevation of church, looking northeast from the front yard. Addition A covers the northern two bays of the church on this side.

The church features a rectangular plan and form, with a belltower on the south façade and sheltering the entrance. The building rests on a stone veneered foundation. The main entry is accessed by three concrete steps and composed of two contemporary four-paneled steel doors with arched lights. Three chamfered wood posts support the four-stage belltower. Each stage includes cascading shed roofs, and the final stage features a hipped roof topped with a decorative three-part wood spire (Figures 198-200). The east and west elevations span four bays, each with six-over-six vinyl replacement windows (Figures

199 and 200). Addition A covers the northern two bays of the church on the west elevation. The north elevation has a projecting bay window with two one-over-one vinyl windows (Figure 201).

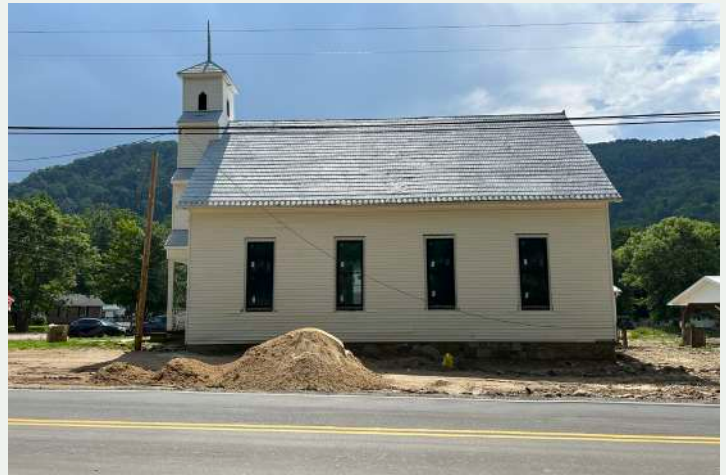
Figure 200. East elevation of the church, looking west from NC 197 South.

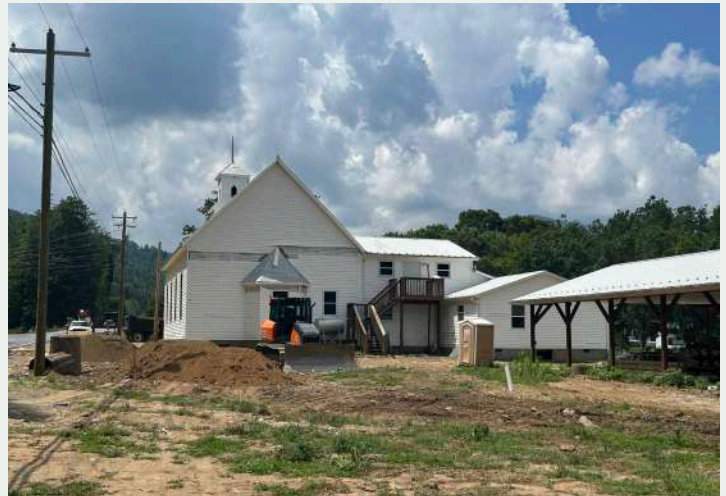
Figure 201. North elevation of the church and Additions A and C, looking southwest from the yard.

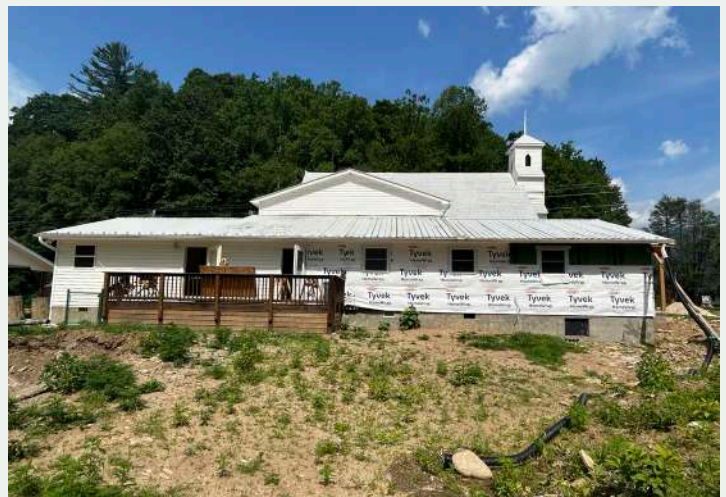
Figure 202. West elevation of Additions B (right) and C (left), looking east from the yard. The side gable of addition A extends above the ridge of Addition B.

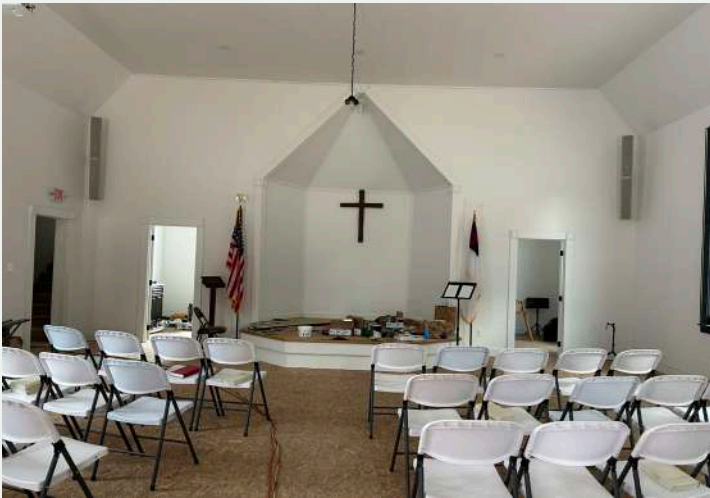
Both entrances on the church's façade open directly into the sanctuary, facing a trapezoidal apse on a raised altar centered on the north wall (Figure 203). Following Hurricane Helene, church members rebuilt the floor and installed a particle board subfloor by July 2025. Flooding destroyed most interior furnishings, including the wood pews. Walls and ceilings feature a mix of new and historic wood shiplap. Decorative square corner blocks accent the trim around two paneled wood doors flanking the apse and a third door on the left (west) wall leading to Addition A (Figure 203). Plain wood casings,

Figure 203. Interior of sanctuary, looking north. Note the particle board covering the reconstructed floor structure.

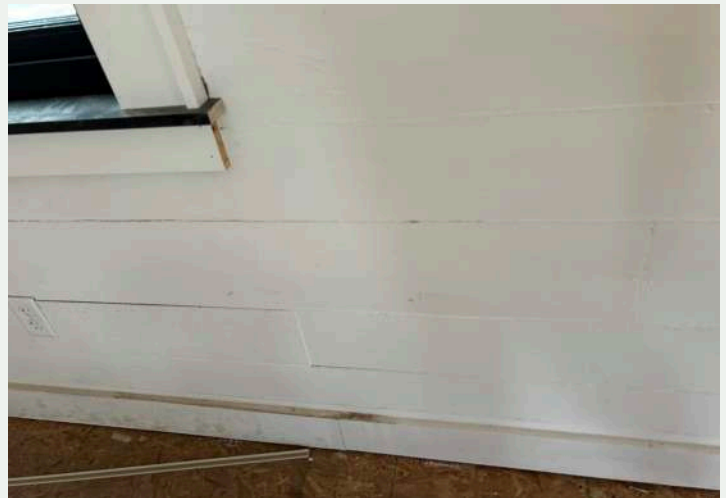
Figure 204. Shiplap covers the walls. Note the new casings and trim on the baseboard and surrounding the window.

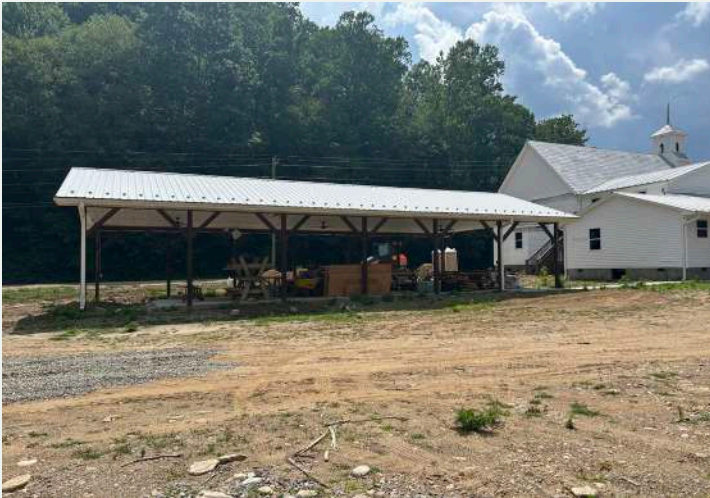
Figure 207. Pavillion, looking southeast from yard.

C and rests on a concrete slab foundation (Figure 207). Square wood posts with diagonal bracing support the standing seam metal roof, and aluminum panels cover the ceiling.

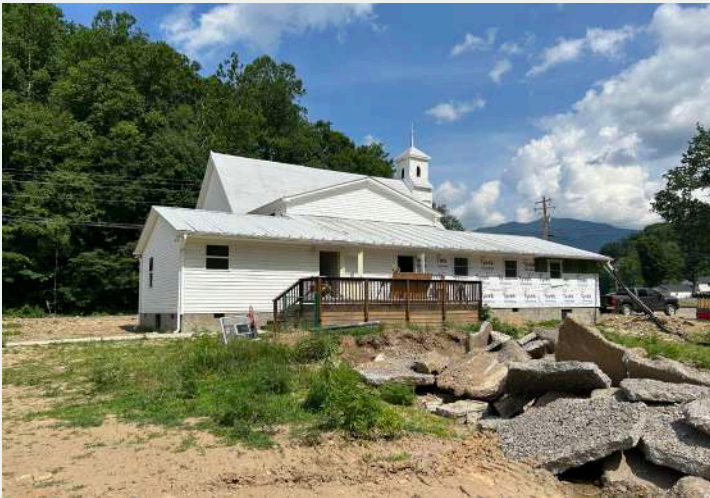
Figure 208. Sand, rock, and debris cover much of the site in summer 2025.

Hurricane Helene caused extensive damage to the site in September 2024. By summer 2025, church members and volunteers had cleared debris and re-graded the site (Figure 208). Dirt, sand, and piles of stone and broken asphalt covered much of the yard, except for a gravel parking area along Pensacola School Road and concrete sidewalks. Sidewalks connect the parking area to the church’s entrance and the wood deck north of the pavilion.

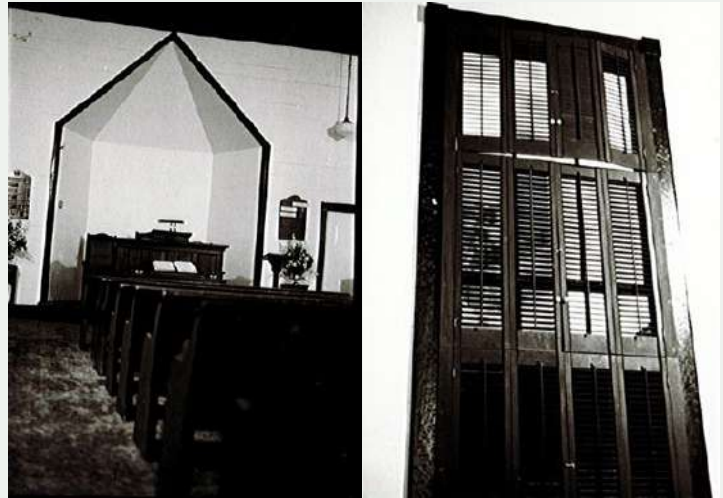
Figure 214. Interior photographs of the apse and window trim with corner block treatment, July 1983. (Presnell, 1983(c))

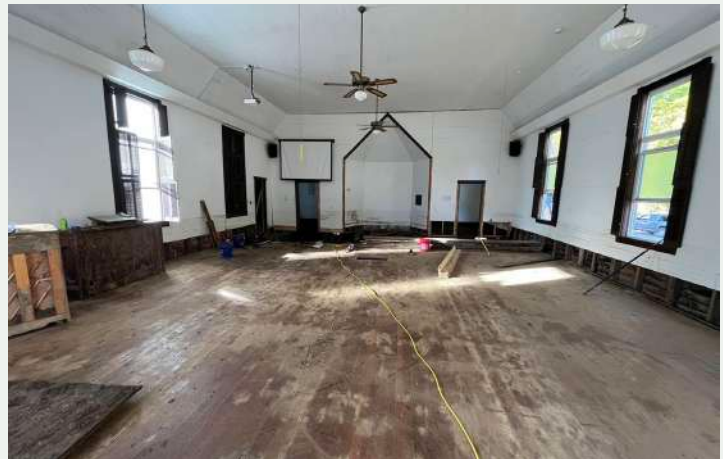
Hurricane Helene severely damaged the church and its additions. Floodwater collapsed the sanctuary's historic floor structure and destabilized Addition B's southwest corner, requiring new foundational footings and reconstruction of the front wall (Figures 215-218). Inside, volunteers removed damaged materials—including drywall, shiplap, and other finishes—exposing the wood wall and floor structures of the church and its additions. Reconstruction efforts included installing new drywall, windows, and doors. During GFT's July 2025 site visit, particle board covered newly installed floor joists, awaiting finish flooring in the sanctuary. Crews installed vinyl windows matching historic dimensions and cased them with new, plain wood moldings (Figure 219).

Figure 215. Interior of the church following Hurricane Helene. Note that shutters cover the historic window opening to the left of the side door accessing Addition A. (Laurel Branch Baptist Church, 2024)

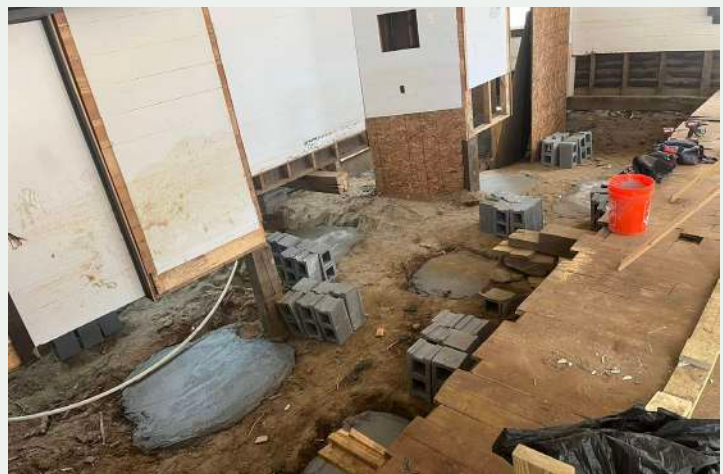
Figure 216. The historic wood floor had to be removed to pour new footings to support the altar. (Laurel Branch Baptist Church, 2025(a))

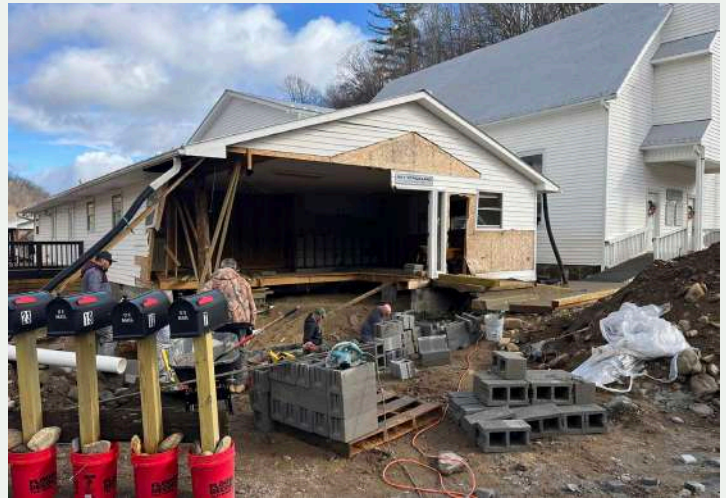
Figure 218. Hurricane Helene severely damaged the southwest corner of Addition B, requiring the Church to reconstruct a portion of its foundation, floor, and wall structure. (Laurel Branch Baptist Church, 2024(b))

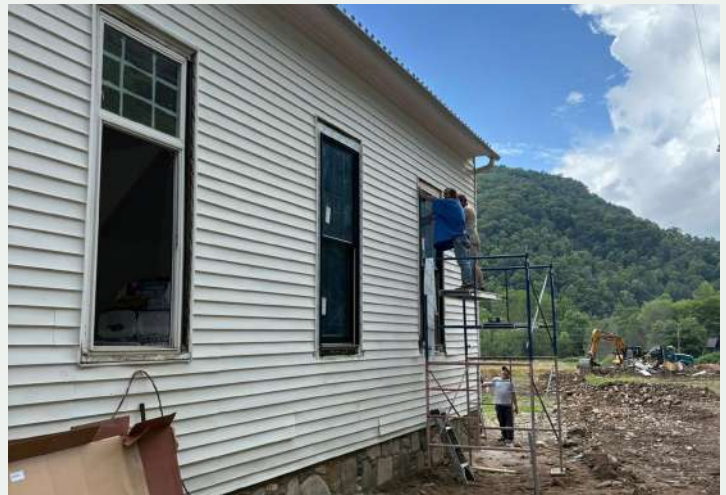
Figure 219. Church volunteers installing new windows. (Laurel Branch Baptist Church, 2025(d))

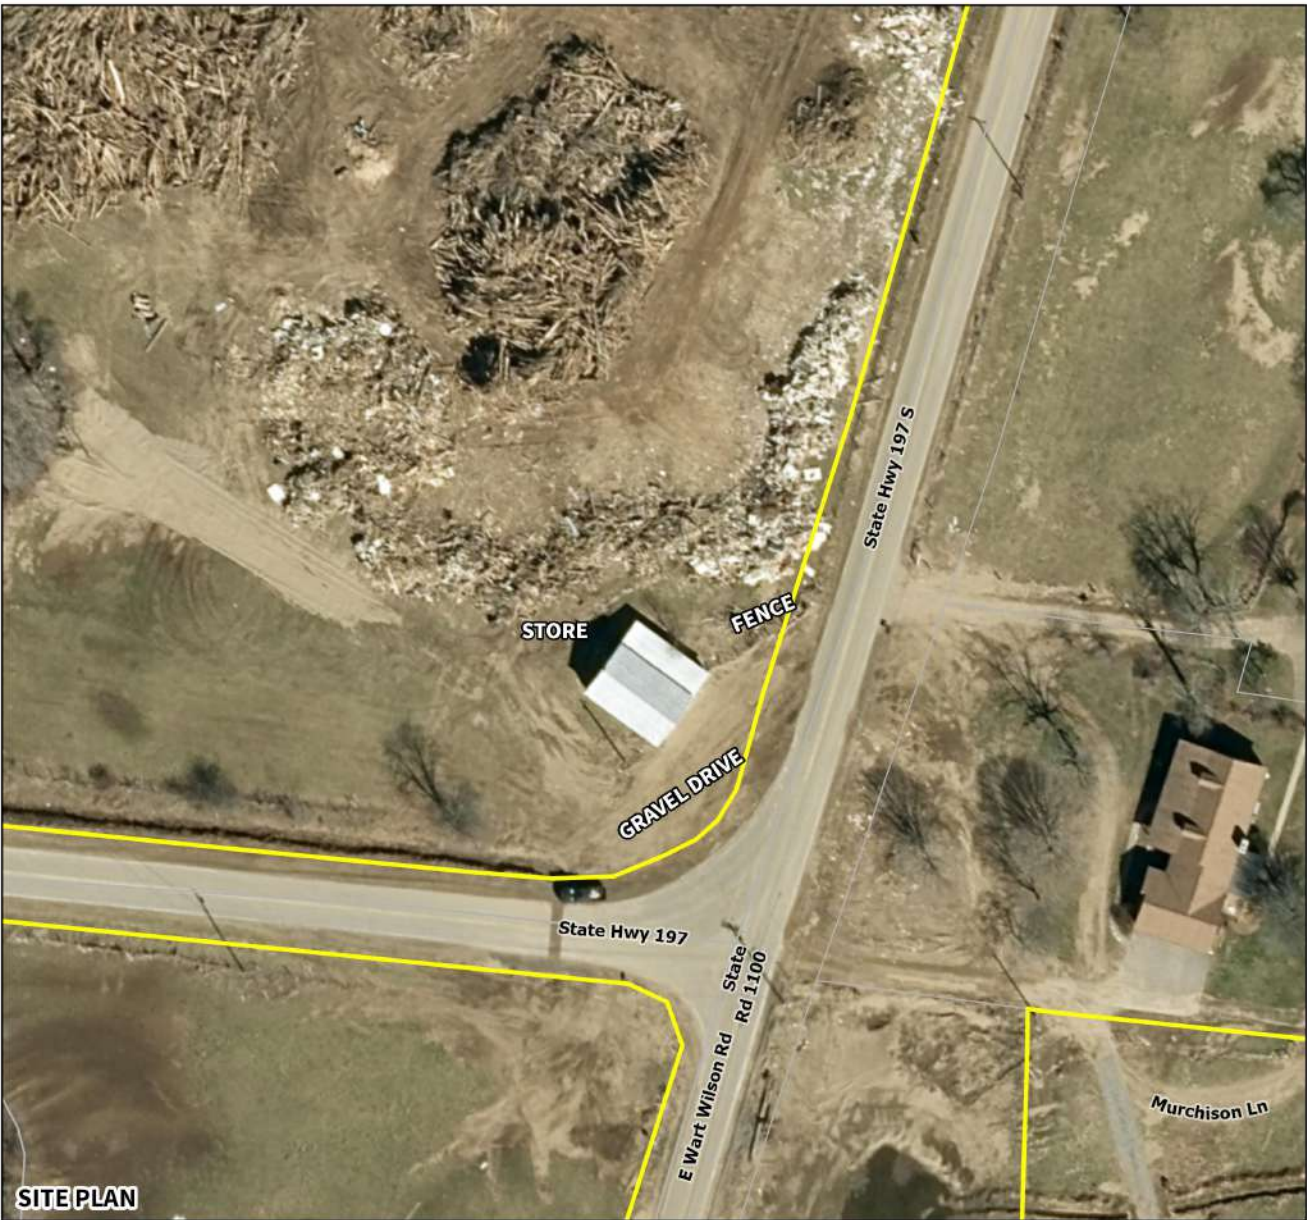
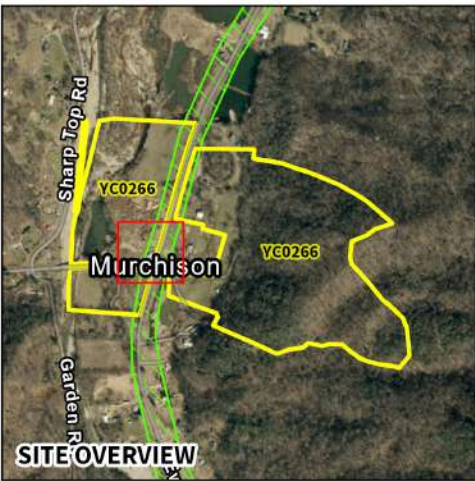
Figure 226. Murchison Store Site Plan.

The Murchison Store is currently associated with two adjacent legal parcels on both sides of NC 197 South by ownership (Figure 226). These parcels extend to the south and east of the store. The parcel south of NC 197 South and west of Ewart Wilson Road consists mostly of grass interspersed with tree lines east of the Cane River. The parcel east of NC 197 South contains a field with wood-frame sheds, barns, and a circa 1940 bungalow. These structures do not appear to be historically associated with the Murchison Store and are not included in this assessment.

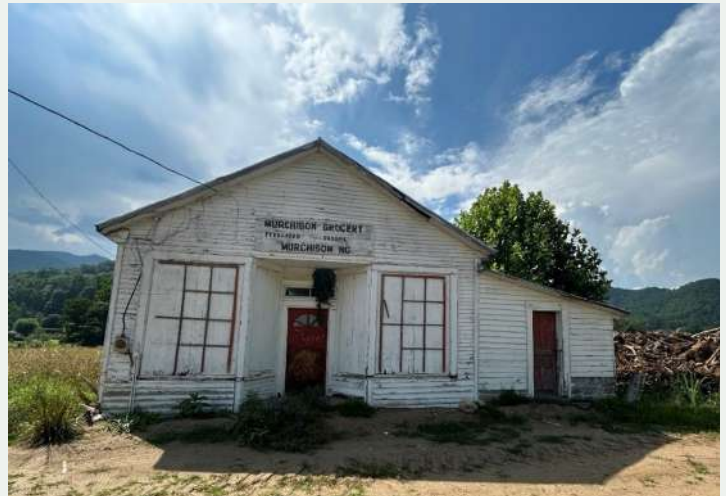
Figure 227. Southeast façade of the store, facing northeast from the front yard. Note the difference in the reveal of the weatherboard above and below the windows.

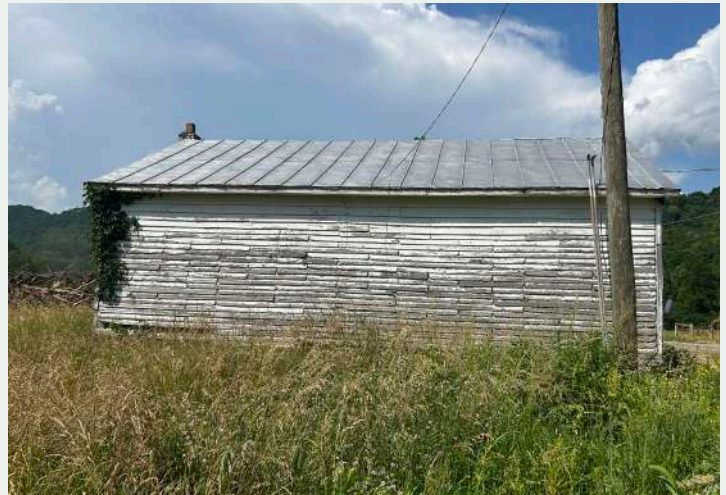
Figure 228. Southwest elevation of the store, standing on NC 197 South looking northeast.

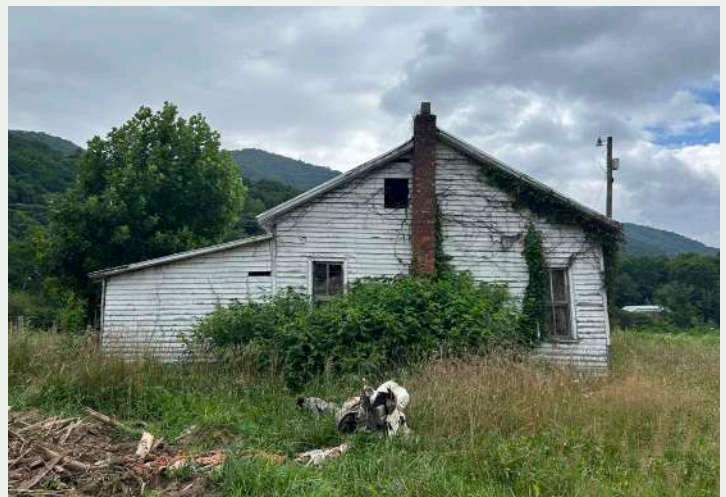
Figure 229. Northwest elevation of the store from the field behind the building, looking southeast.

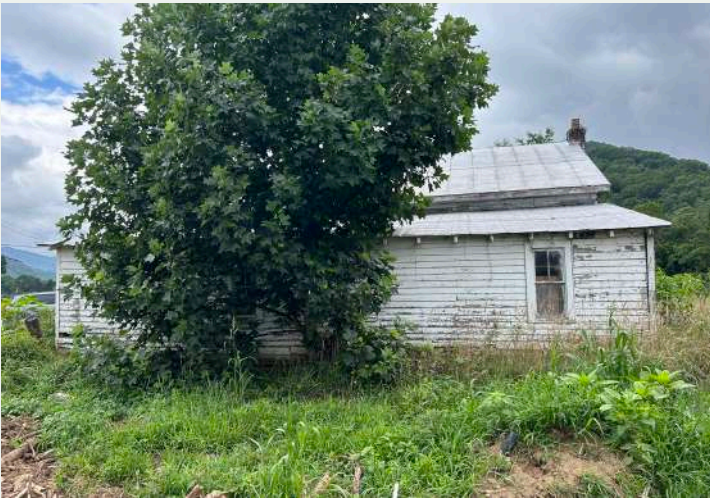
A shed roof addition meets the façade below the eave of the front gable. It features a slightly recessed, historic five-panel wood door on the façade and two historic four-over-four wood windows on the northeast elevation, all with wide, simple wood trim (Figures 227 and 230). The addition features weatherboard in a wider profile than the original store building and some drop board siding. Standing seam metal covers the shed roof's exposed rafter tails.

Figure 230. Northeast elevation of the store, looking southwest from the field adjacent to the building.

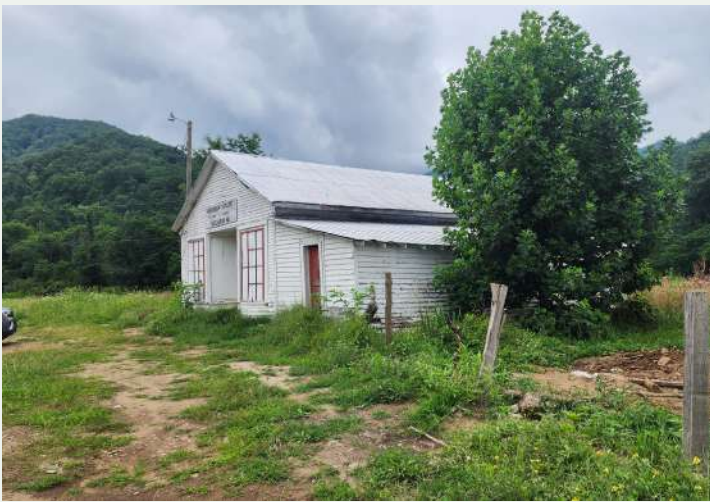
Figure 231. Oblique view of the southeast façade and northeast, looking south from the driveway.

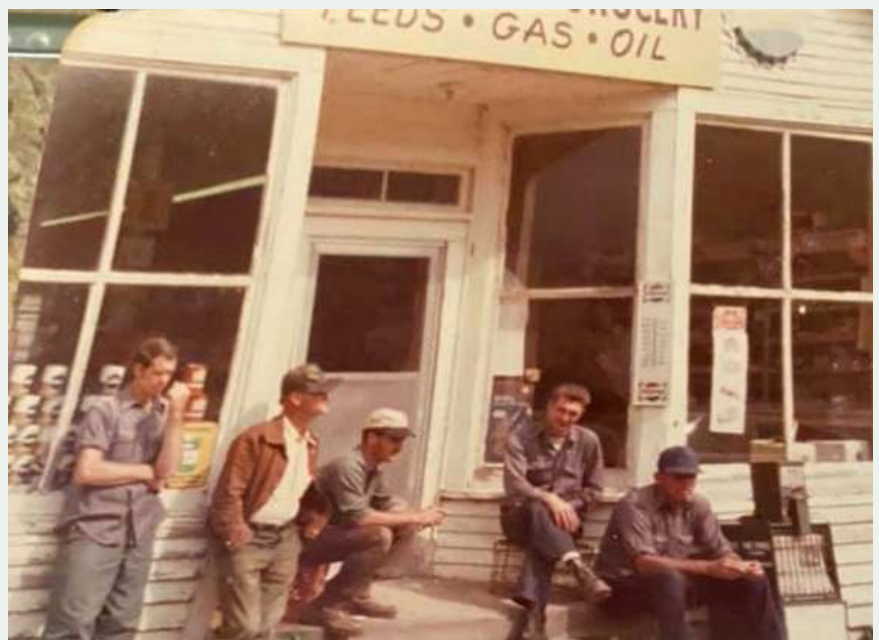
Figure 233. Men outside of the Murchison Store, 1970s. Note the change in the dimension of the reveal between the weatherboard siding above and below the windows. (Thomason, 2001)

Deterioration and later alterations have compromised the Murchison Store's integrity of the design, materials and workmanship. The building reflects a typical early twentieth century one-story, gable-front, wood-frame store with a shed-roofed side addition. It appears to retain historic features, including its stone pier foundation, weatherboard siding, two-over-two wood windows, red brick chimney, and standing seam metal roofing. However, alterations to the façade—such as the replacement steel door in the recessed entry and boarded storefront windows—detract from the historic fenestration pattern.

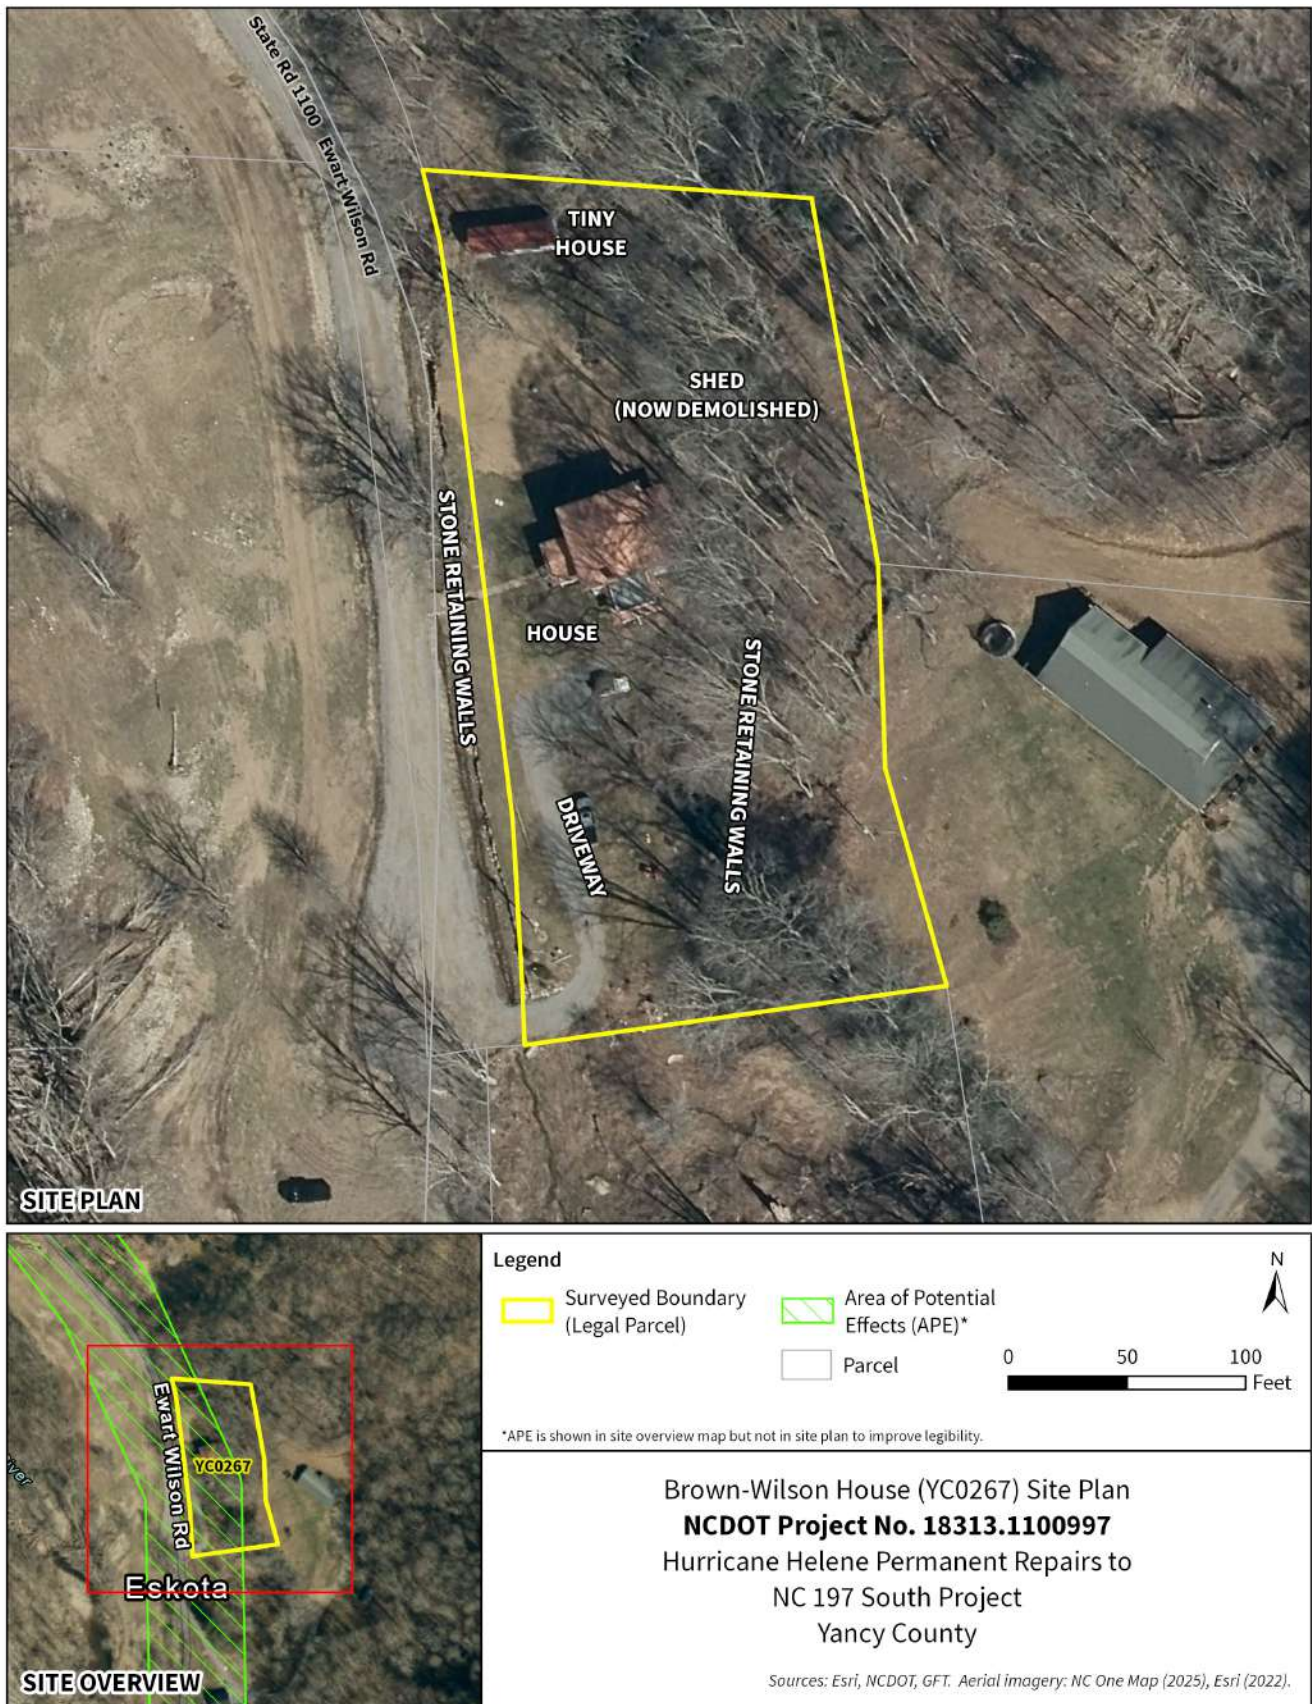
Figure 238. Brown-Wilson House Site Plan.

The Brown-Wilson House is located about 2.5 miles south of the intersection of NC 197 South and Ewart Wilson Road, in an area associated with the historic logging camp of Eskota (Figures 1, 236, and 237). The house sits on a 1.42-acre parcel approximately 50 feet east of Ewart Wilson Road and overlooks the Cane River to the west (Figure 238).

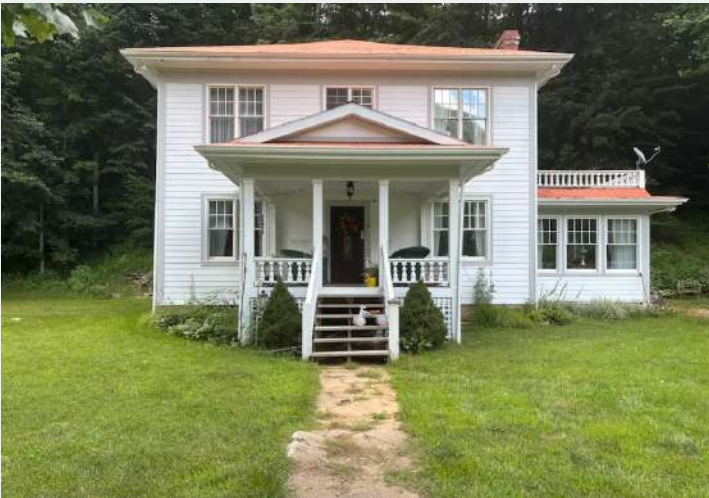
Figure 239. West facade, looking east from the front walkway.

The house rests on a board-formed concrete foundation (Figures 239 and 240). A concrete bulkhead with a steel door provides cellar access on the northeast corner. The front porch has a pedimented gable roof that shelters an aluminum paneled door with centered leaded glass panels. A one-story rear addition separates two open porches beneath a flat roof (Figure 241). The northern porch

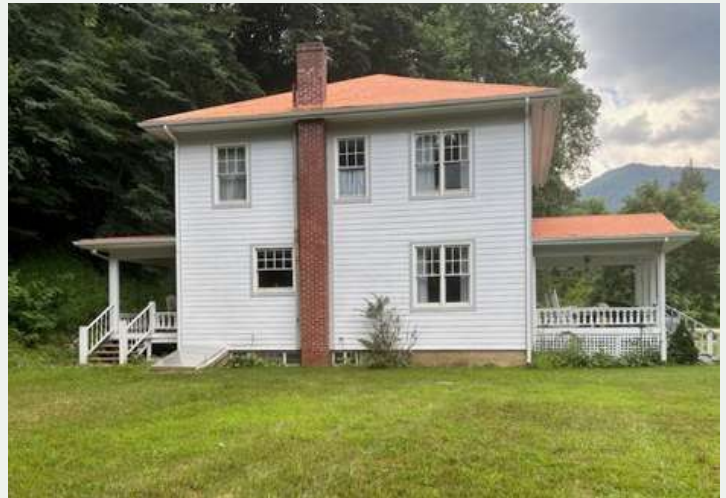
Figure 240. North elevation of the house, looking south from yard.

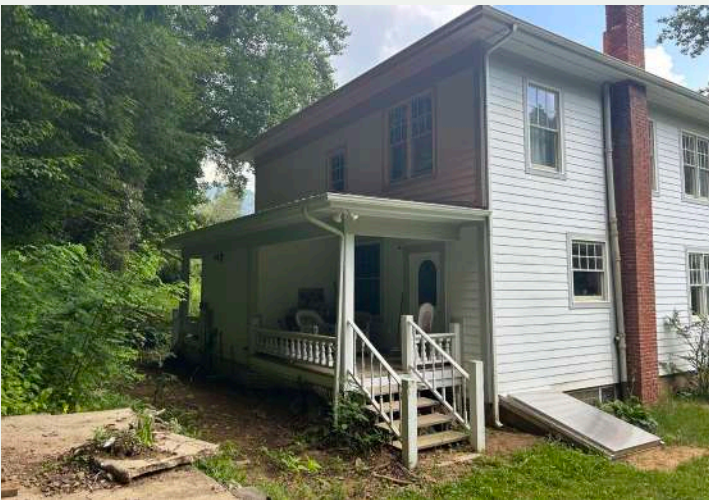
Figure 241. Oblique view of east and north elevations, looking southwest from the backyard.

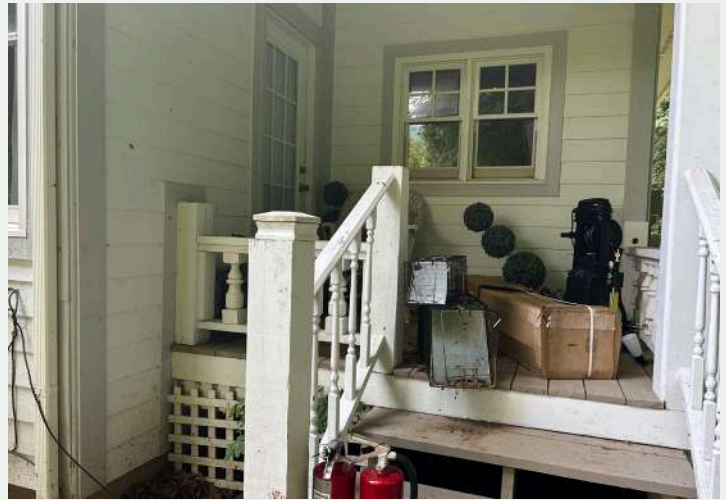
Figure 242. View of the rear porch from the south elevation, looking north from the stone patio.

includes an arched half-light aluminum door; the southern porch features a single French door (Figure 242). These porches share wood lattice skirts, wood steps with spindle railings and square newel posts, wood floors, low turned wood balustrades, classical square columns, and beadboard ceilings. Single and paired six-over-one vinyl windows are the most common treatment on the house with a few noted exceptions: paired four-over-four windows above the front porch, paired four-over-one wood windows beneath the southern rear porch, two sliding basement windows on the north elevation, and an eight-over-one window on the north elevation.

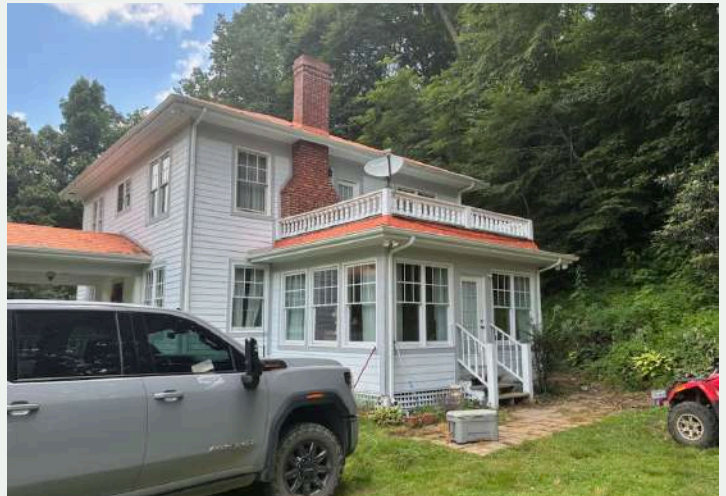
A one-story sun porch wing extends from the south elevation (Figure 243). Wood steps and railing, matching the other porches, lead to a centered single French door on the south elevation. Eight-over-one vinyl windows wrap the porch's west and east sides; six-over-one vinyl windows face south. The sunporch has a pressed tin mansard roof. Above, a low turned wood balustrade frames the second-level deck, accessed by a single French door east of the tapered brick chimney.

Figure 243. Oblique view of the west façade and south elevation of the house, looking northeast from the gravel parking area.

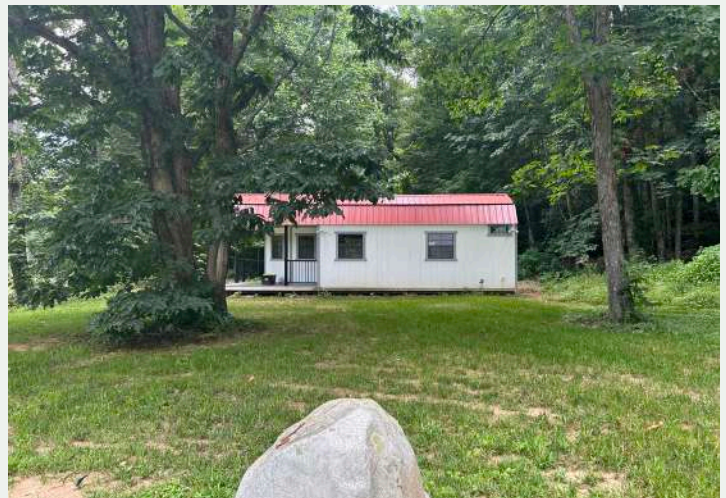
The Boones added a tiny house at the north end of the property in 2023 (Figure 244). The structure faces west and rests on a concrete block platform. It features a front porch, six-pane divided light windows, vertical wood siding, and a standing seam metal gambrel roof.

Figure 244. Tiny house, looking north from the yard.

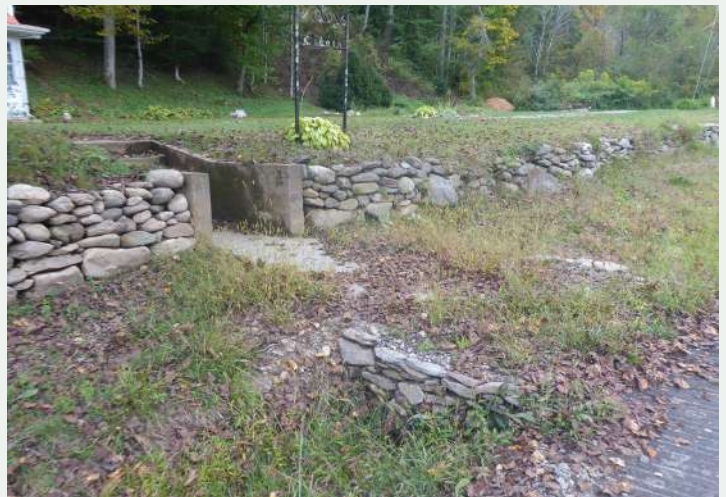
Figure 245. Stone retaining wall, concrete steps, and "Eskota" sign mark the front walkway, looking southeast along Ewart Wilson Road.

A stone pedestrian bridge and pipe span the roadside ditch, connecting the road to concrete steps framed by board-formed concrete retaining walls (Figure 245). In 2001, local blacksmith Johnny Thacker crafted the wrought iron “Eskota” sign adjacent to the gravel path to the front porch. Low stacked stone retaining walls, ranging from two to four feet in height, line the front yard. In the backyard, stone walls of the same height follow the base of the hillside, and remnants of a now-demolished historic shed’s stone foundation sit northeast of the house (Figure 246). (Boone, 2025)

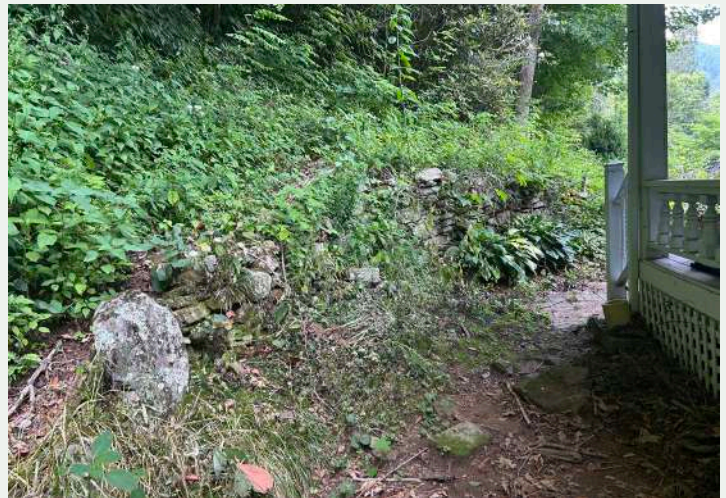
Figure 246. Stacked stone retaining walls behind the house, looking south from the backyard.

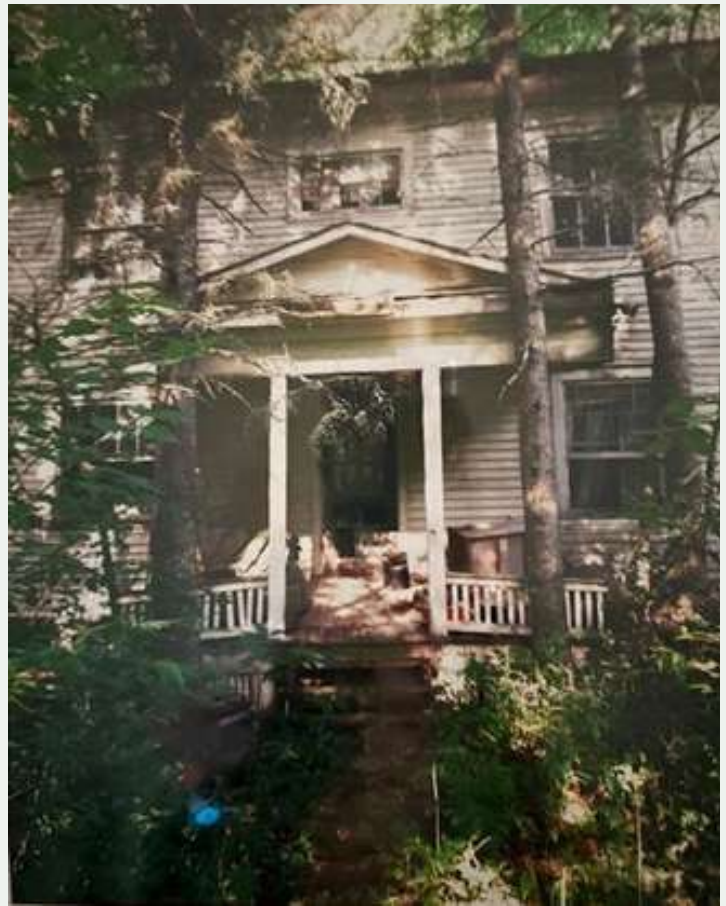
Figure 252. Front porch prior to 2001 restoration. The Boones reconstructed the porch using similar square posts but added a decorative balustrade. Note the eight-over-one windows and ten-light window above the pedimented gable. (Boone, 2025)

By 2001, the Brown-Wilson House was abandoned and obscured by overgrown vegetation (Figure 252). David and Elaine Boone began renovations that year, rebuilding walls and ceilings, and installing new building systems. They reconstructed the porches based on historic photographs and physical evidence, introduced decorative turned balustrades, and re-clad the house in custom-milled weatherboard. They modified fenestration patterns, replacing historic eight-over-one wood windows with paired six-over-one vinyl windows and installed new aluminum exterior doors (Figures 252-256). David Boone is Ewart Wilson's grandson; the Wilson family has owned the house for four generations. (Boone, 2025)

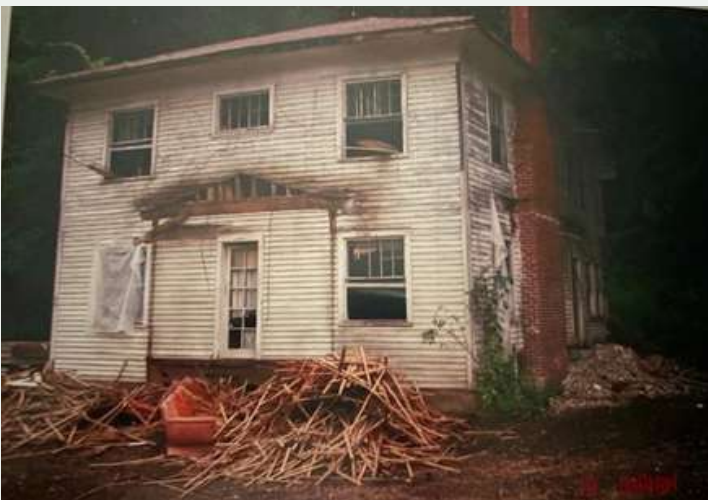
Figure 253. Southwest oblique of the house during the restoration. (Boone, 2025)

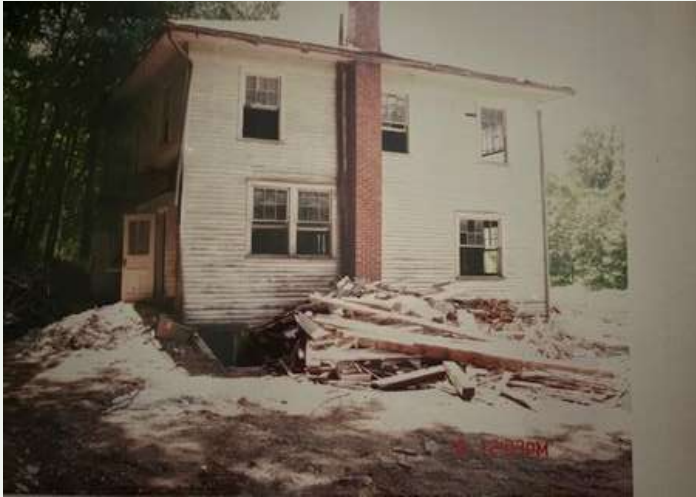
Figure 254. North elevation of the house during the 2001 restoration. (Boone, 2025)

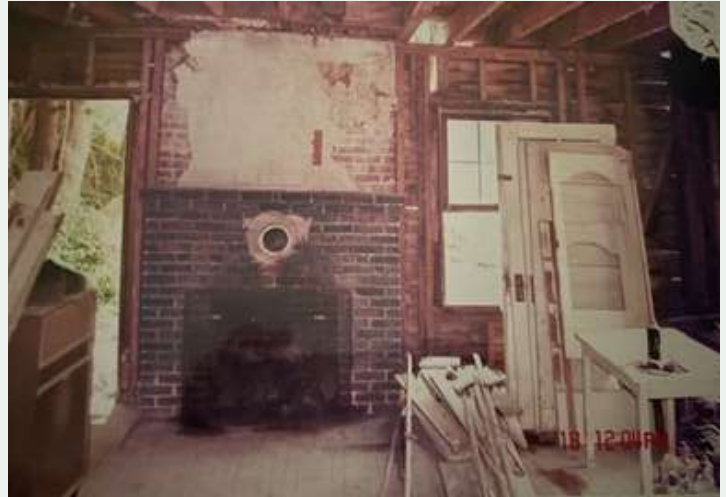
Figure 255. View of one of the brick fireplaces in the home. Mrs. Brown removed the mantles when she returned to Pennsylvania around 1920. Note the six-panel wood door stored in the corner. (Boone, 2025)

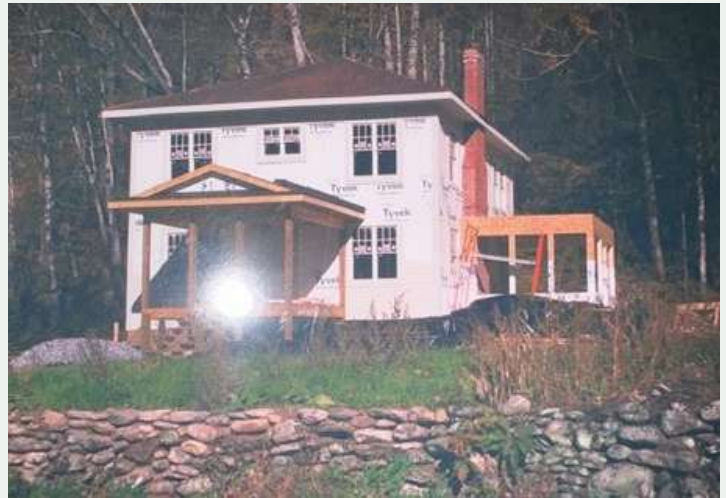
Figure 256. Reconstruction of the front porch and sunporch circa 2001. Note the new vinyl windows. (Boone 2025)
