THERMOGRAPHY AUDIT SCOPE OF WORKS

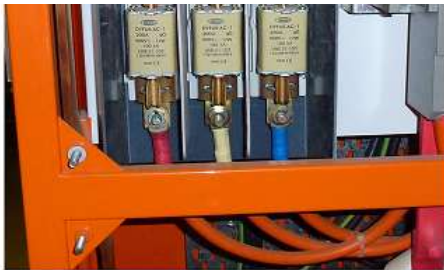
DIGITAL IMAGE - LOOKS NORMAL

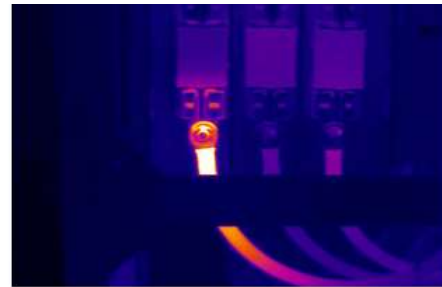
THERMAL IMAGE - HIGH TEMPERATURE FOUND IN RED PHASE

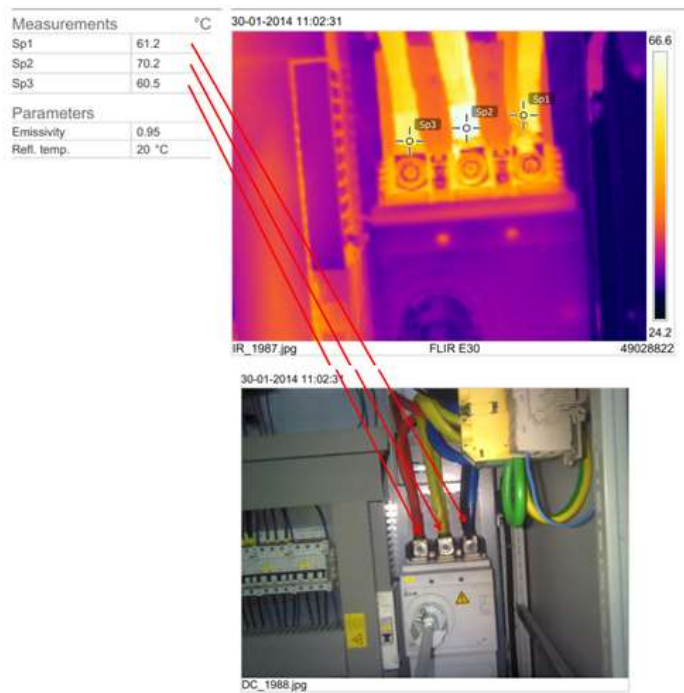
The below image is a Digital & IR image of a switch gear in Garment factory:
