Gaither Mtn Home Inspections LLC
(870) 416-5113

Home Inspection Report Harrison, AR 72601

Prepared For: Jim Naff
Inspected On Mon, Jul 29, 2024 at 9:20 AM

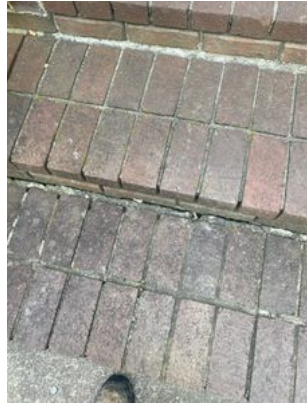
Brick steps on front of house show signs of setting

Recommend caulking cracks to keep water from getting in and freezing causing bigger cracks

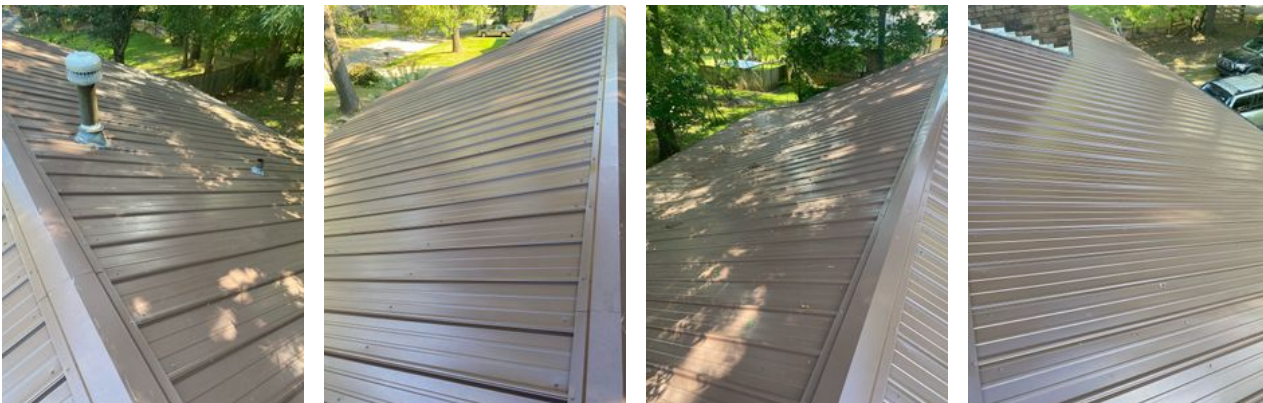
Comment 21

Screws are drilled in at an angle and then caulked (quite a few of them)

Recommend monitoring these areas for potential problems

Recommend putting screws in all hole found in the roof

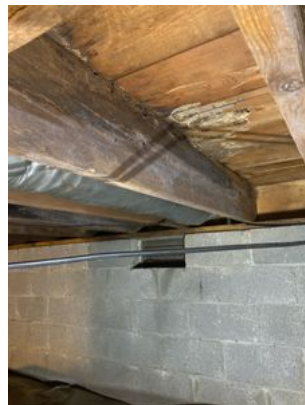
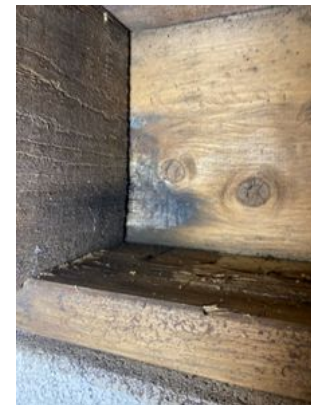
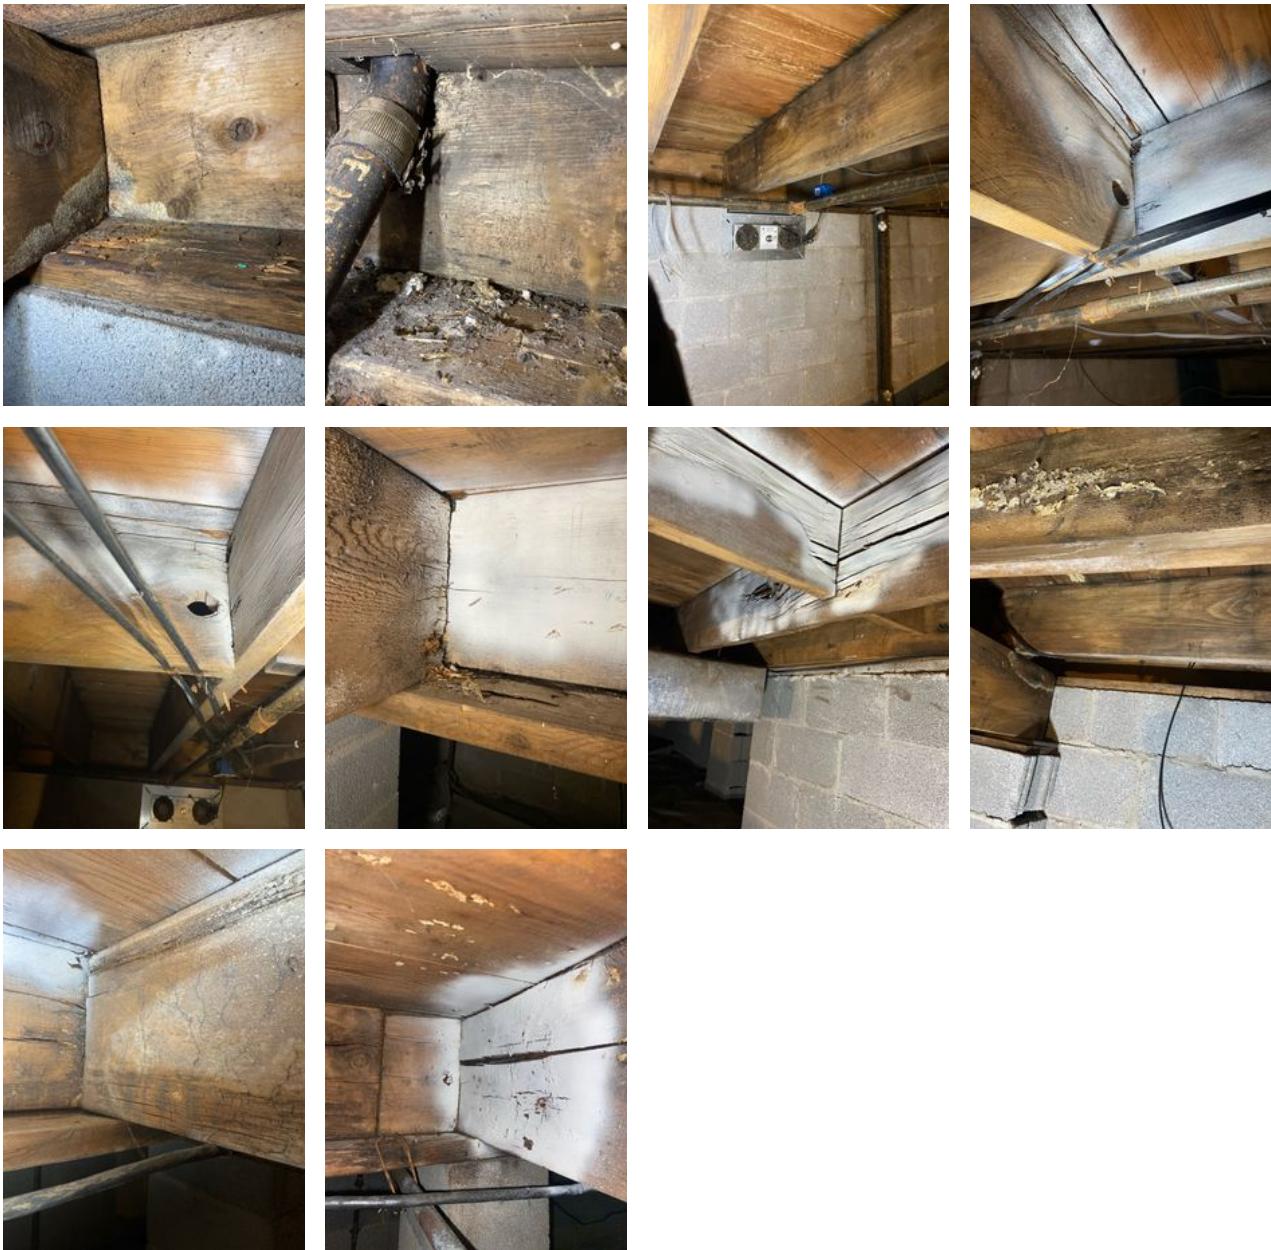
Deteriorating framing

Recommend replacing all deteriorating floor joists

Recommend replacing all deteriorating top seal plates

Recommend replacing deteriorating subfloor

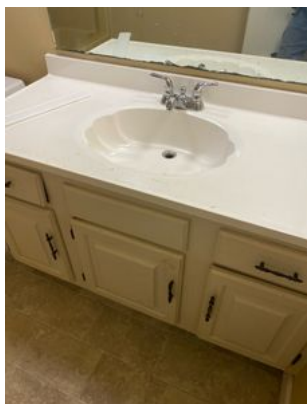
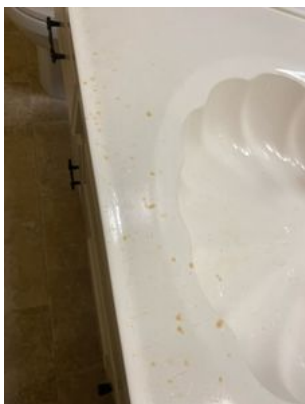
Comment 43

Drawers in vanity are broken

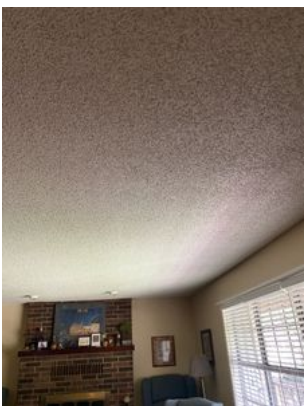
Comment 48

At time of the inspection part of the walls were covered up with large furniture and decorative items therefore the whole room could not be inspected properly Recommend fixing blemishes in drywall and paint

Recommend monitoring cracked area and if cracks become worse then bracing of the floor will be needed
