Report ID  
AP-736-000985

Inspection Date  
February 28, 2023 at 04:00 PM

**Type of building**  
Condominium

**Style of home**  
Low-Rise

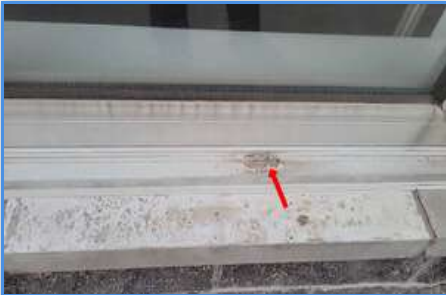
Location: REAR

At the time of inspection, caulk was missing, damaged or deteriorated in some areas around windows and doors, at siding seams or joints with trim, or at flashings/penetrations. This is a regular maintenance issue as caulk tends to shrivel and crack from weather. I recommend that the affected area(s) be evaluated and recaulked as needed by a qualified person.

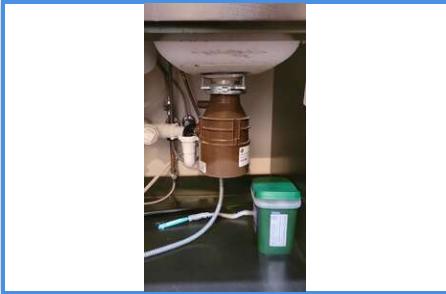
**Comment Location :** KITCHEN

The garbage disposal was inoperable. The unit should be repaired or replaced as needed by an appliance repair contractor.

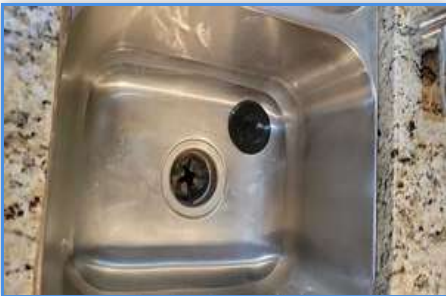
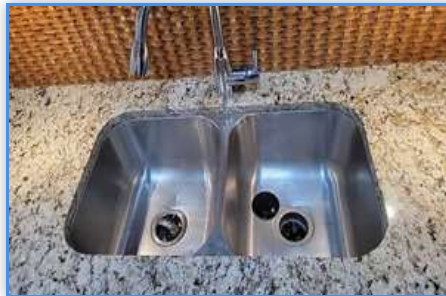
**Comment Location :** KITCHEN

At the time of inspection, the kitchen sink was slow to drain. The cause of a slow drain can range from a cleaning at trap to problems down line. I recommend further inspection and correction as needed by a qualified plumbing contractor.

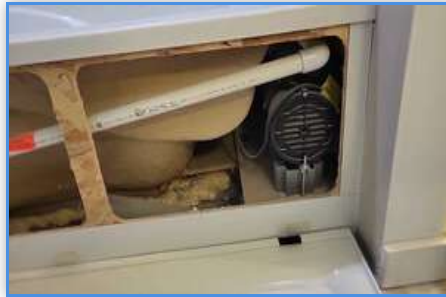
**Comment Location :** MASTER BATHROOM

There was an active leak at the connections under the tub when the jet tub was operated. I recommend having a qualified plumbing contractor repair as needed.

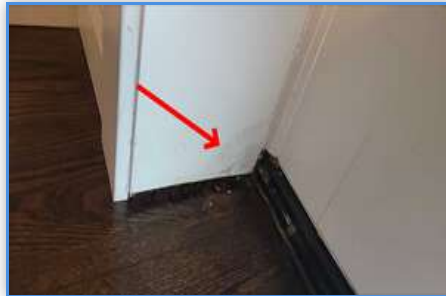
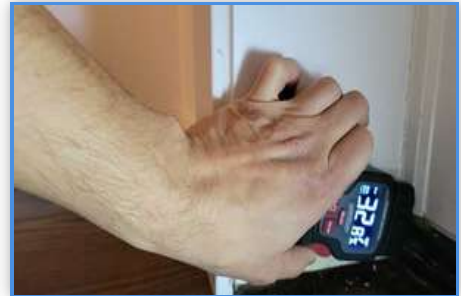
**Comment Location :** FRONT PATIO ENTRY

### 11.6.1 Active Moisture (Failed Exterior flashing)

At the time of the inspection active moisture was present near the exterior door. It appears the exterior flashing or other door components have failed to keep water from entering the home. I recommend having a qualified contractor further evaluate and repair as needed.

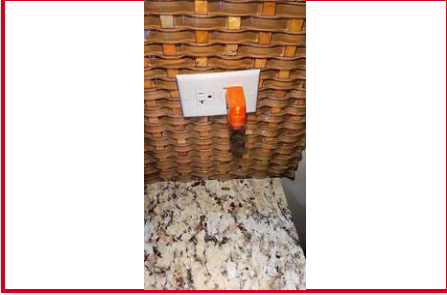
**Comment Location :** KITCHEN

The GFCI protected outlets did not trip off by using the test button on the unit. The outlets are defective and in need of replacement. They should be replaced by a professional electrical contractor.

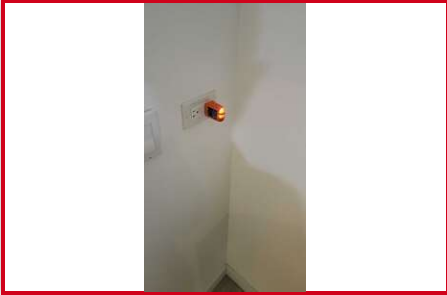
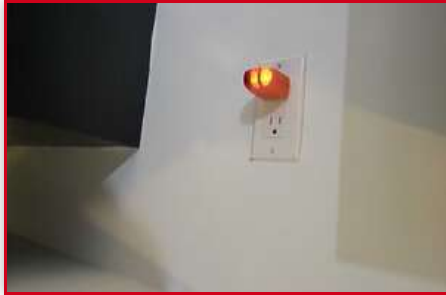
**Comment Location :** MASTER BATHROOM

### 6.1.1 Bathroom GFCI receptacle (Not tripping off)

At the time of inspection, the GFCI protected outlet did not trip off when it was tested. Recommended this is evaluated and corrected by a professional electrical contractor.

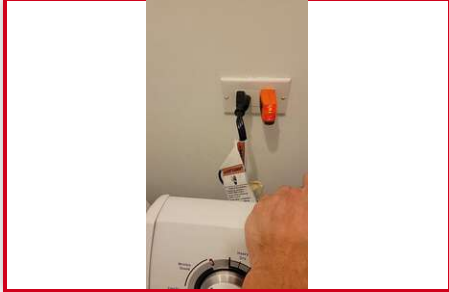
**Comment Location :** LAUNDRY ROOM

### 12.6.1 No GFCI

One or more receptacle(s) in the laundry room are not GFCI protected. It is recommended to have this receptacle switched/updated to a GFCI outlet for protection, to help prevent possibility of electrical shock. GFCI protection was required in laundry rooms or anywhere within 6 feet of a water source since 2005. All repairs involving wiring should be performed by a licensed electrical contractor.

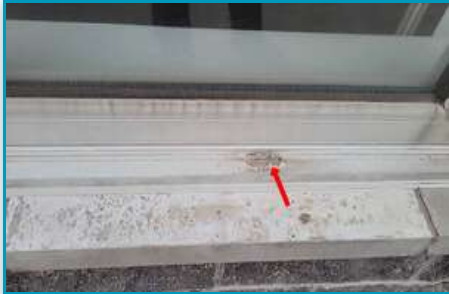
Location: REAR

At the time of inspection, caulk was missing, damaged or deteriorated in some areas around windows and doors, at siding seams or joints with trim, or at flashings/penetrations. This is a regular maintenance issue as caulk tends to shrivel and crack from weather. I recommend that the affected area(s) be evaluated and recaulked as needed by a qualified person.

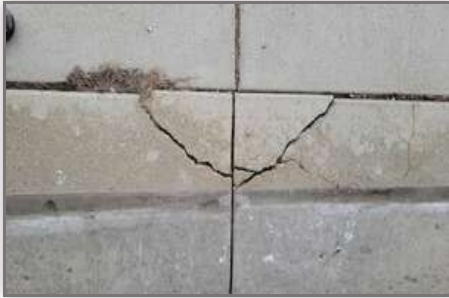
## 4.2.1 Floor, typical cracks

There were typical cracks identified throughout the garage floor. It is recommended to seal these cracks to prevent water penetration and expansion.

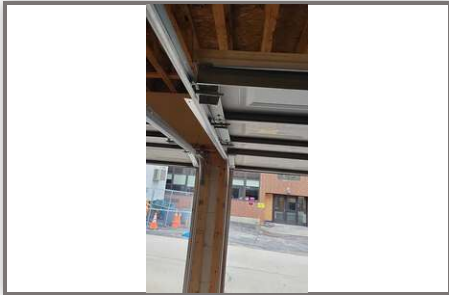
## 4.5.1 Lubricant needed

At the time of inspection, the garage door track hardly had any grease and made the door difficult to open or close/was noisy. I recommend correction as needed by a qualified person.

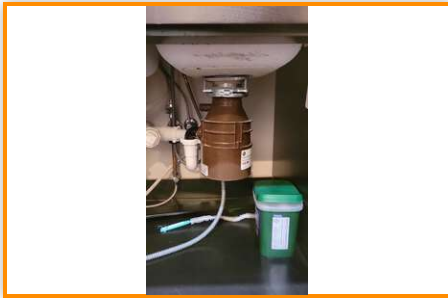
### 5.5.1 Garbage disposal-inoperable

The garbage disposal was inoperable. The unit should be repaired or replaced as needed by an appliance repair contractor.

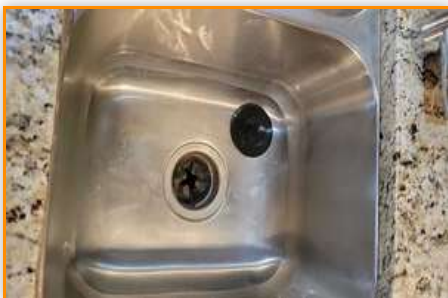
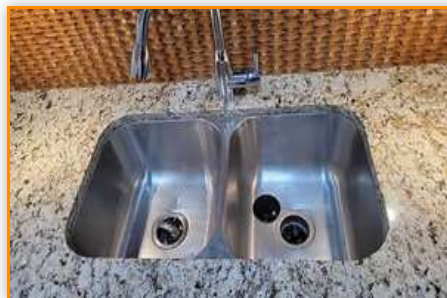
### 5.9.1 Slow drain

At the time of inspection, the kitchen sink was slow to drain. The cause of a slow drain can range from a cleaning at trap to problems down line. I recommend further inspection and correction as needed by a qualified plumbing contractor.

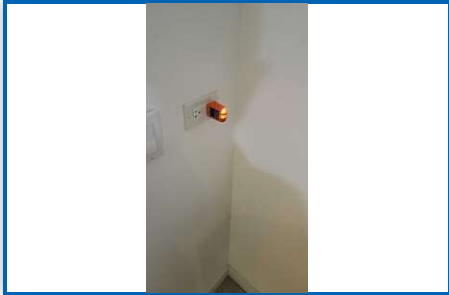
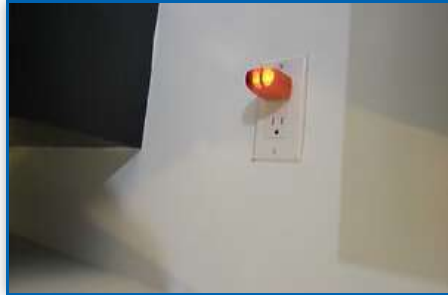
At the time of inspection, the GFCI protected outlet did not trip off when it was tested. Recommended this is evaluated and corrected by a professional electrical contractor.

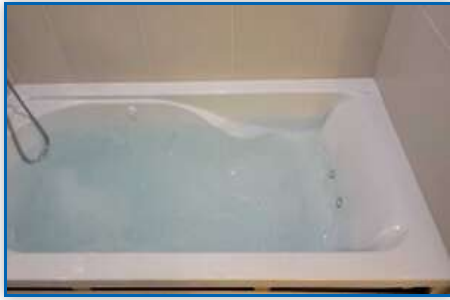
### 6.7.1 Weak jet response

There were one or more jets that were responding weakly. We recommend that the jets be evaluated and repaired as needed by a plumbing contractor.

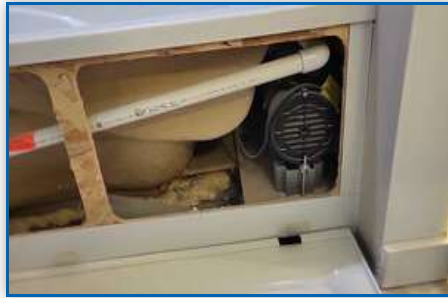
### 6.7.2 Jetted tub - Active Leak

There was an active leak at the connections under the tub when the jet tub was operated. I recommend having a qualified plumbing contractor repair as needed.

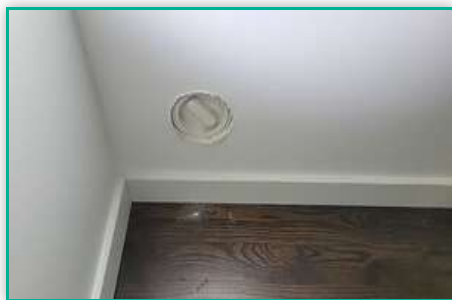
#### Comment Location - REAR CLOSET

The sewer clean-out is located in the home and is identified in the photo discription. It is not recommend to flush feminine hygiene products down a sanitary drain line or toilet. Materials can catch on tree roots or cracks creating a blockage and result in costly repairs to clean out the obstructions. It is also not recommended to dump cooking grease or oils down sinks or sanitary drains. Grease and oils have a tendency to cool and will collect creating a build-up and/or blockage in the main sewer line creating costly repairs.

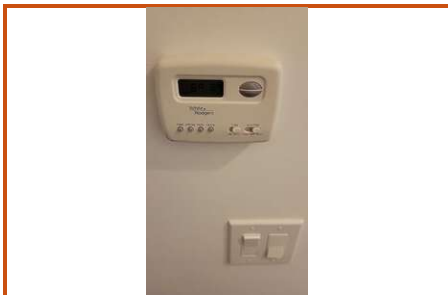
### Comment Location - HALLWAY

The thermostat location is identified in the photo below. This is for your information. To save energy, set your thermostat back at night or when you know your home will be unoccupied for an extended period of time (be mindful of different family schedules.) Savings can be as much as 1% of your heating bill for every degree lowered every 8 hours!

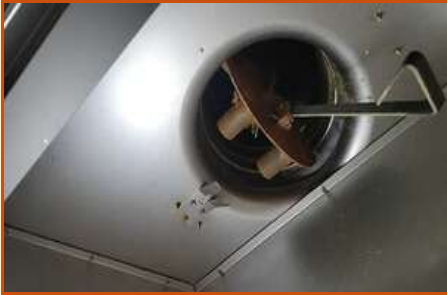
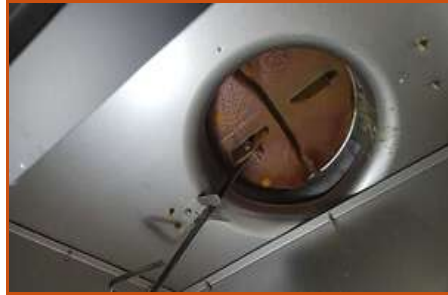
### Comment Location - LIVING ROOM

At the time of inspection, the damper of the homes gas fireplace was usable (closes and opens). Be aware a closed damper while using the fireplace allows toxic gasses to enter the living space.

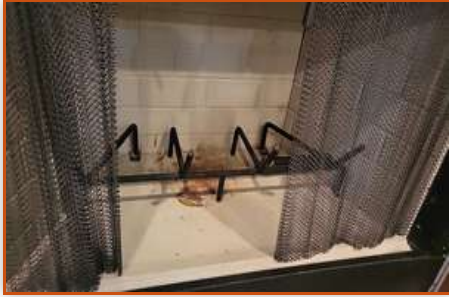
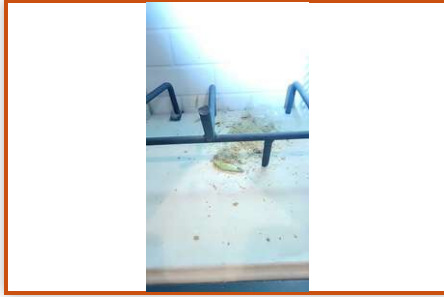
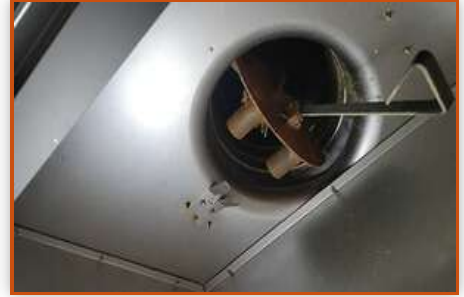
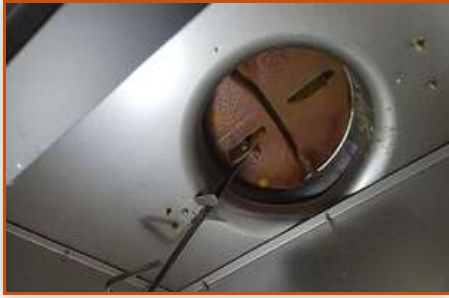
## Fireplaces not tested/operated

As per the Standards of Practice for both the National Association of Certified Home Inspectors (NACHI), the inspector does not light fireplaces, pilots, or operate gas valves during inspections. These appliances were only visually inspected and not fully evaluated or tested for function. It is recommended to get a full inspection of the fireplace and interior of the chimney flue before use.

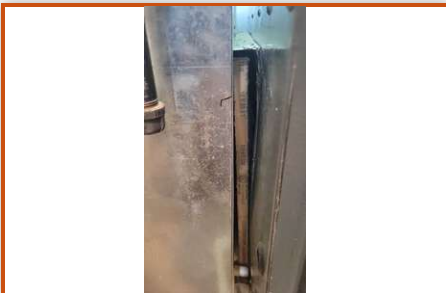
#### Comment Location - HALLWAY CLOSET

The furnace air filter is dirty and should be changed to avoid unhealthy indoor air conditions and damage to the furnace blower. The furnace air filter has a rating on the side of the filter. Depending on the one you buy it can be a 30, 60, or 90 day filter. You will need to change your filter according the filter rating on the package.

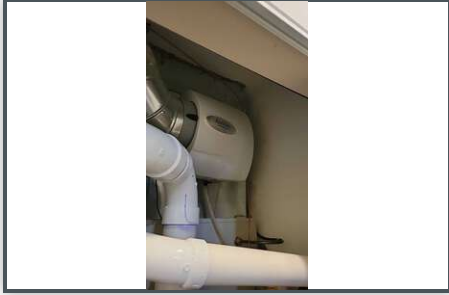
Note: There is a humidifier installed that can add comfort to the home during the heating season. These units are not inspected as they are outside the scope of this companies home inspection. Most units will require service annually.

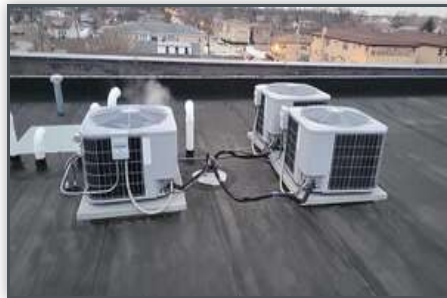
### Comment Location - ROOF

The outdoor air temperature was below 65 degrees Fahrenheit during the inspection. Air conditioning systems can be damaged if operated during such low temperatures. It is also impossible to determine if the HVAC system is cooling properly as even if no or low refrigerant is in the system, the air will still register at ambient exterior temperature. Client should be aware of this limitation when inspecting unit in cooler temperatures.

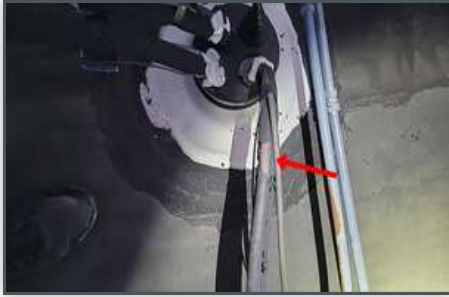
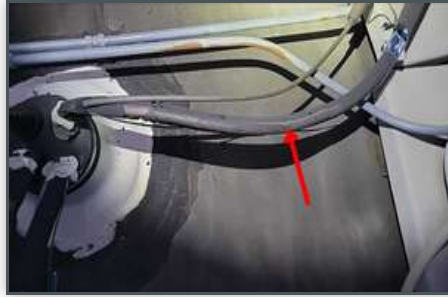
The foam sleeve on suction line, was missing foam sleeve or damaged in area(s) at outside AC unit. Missing foam on suction line can cause energy loss and condensation. I recommend the affected area(s) be replaced as needed by a qualified person.

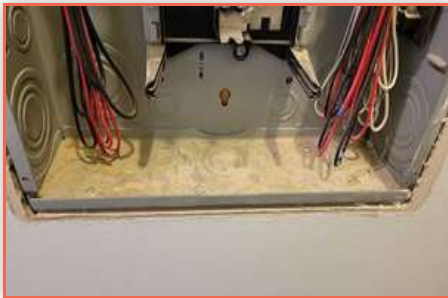
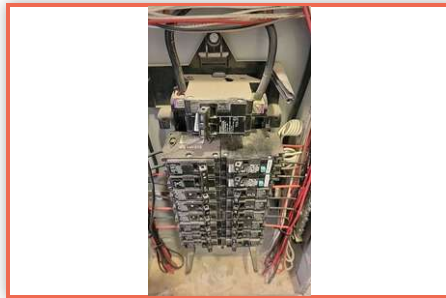
There was paint ,debris or other materials in the panel. I recommend that the panel be cleaned and and repaired as needed.

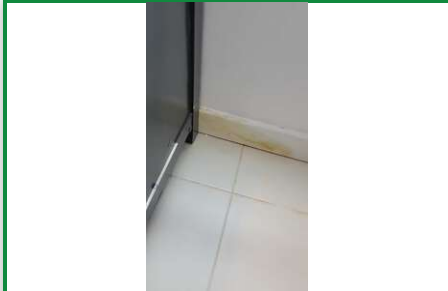
Location: HALLWAY BATHROOM

## 11.3.1 Walls (Past Moisture Stains)

There were stains or areas with signs of leakage in one or more areas. These area do not appear to be from recent water related problems. The inspector recommends asking the seller or sellers agent about this occurrence and how it was repaired. There will need to be minor repairs to the areas after verification that the leak has been mitigated.

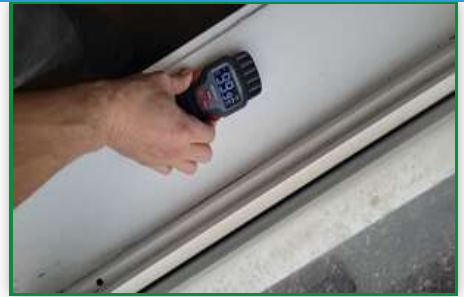
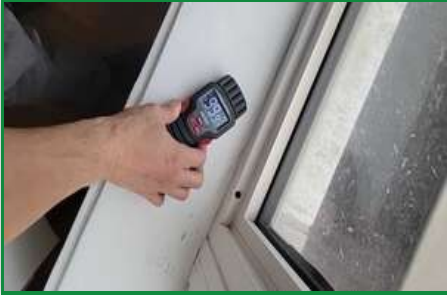
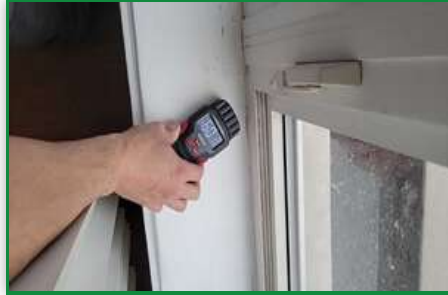
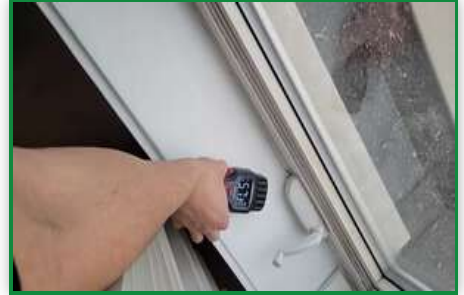
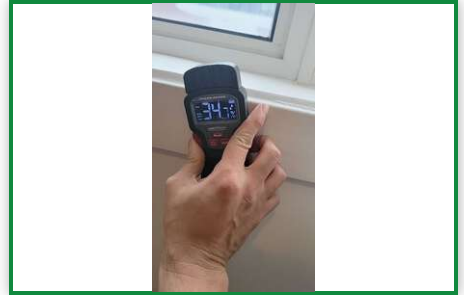
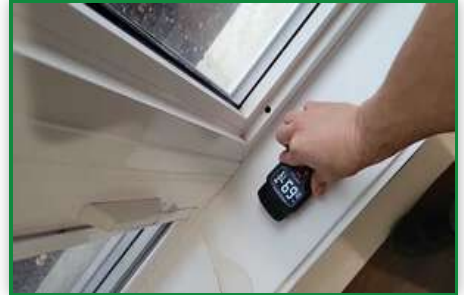
There were one or more areas around window openings that had signs of active moisture. A moisture meter was used and detected elevated levels of water intrusion behind the covering. I am unable to determine the extent of damage until the covering is removed. I recommend the affected areas be further evaluated to determine the source of water intrusion and have end it repaired by a qualified contractor. (Leaving windows open is a Possible cause)

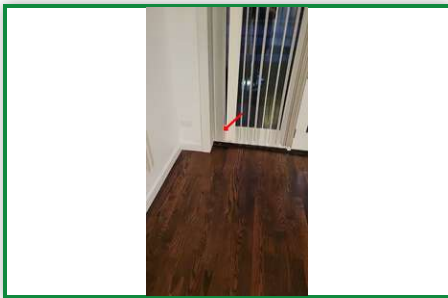
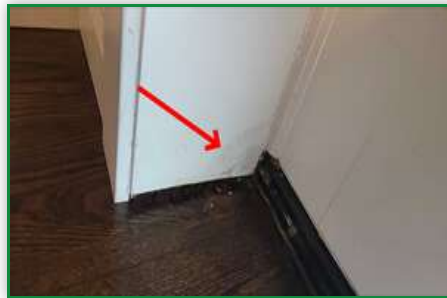
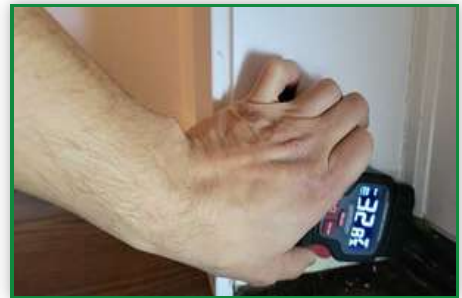
### 11.6.1 Active Moisture (Failed Exterior flashing)

At the time of the inspection active moisture was present near the exterior door. It appears the exterior flashing or other door components have failed to keep water from entering the home. I recommend having a qualified contractor further evaluate and repair as needed.

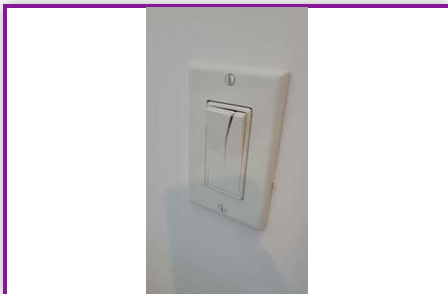
There was one or more damaged switches in the laundry room at the time of the inspection. We recommend that it be replaced as needed by a professional electrical contractor.

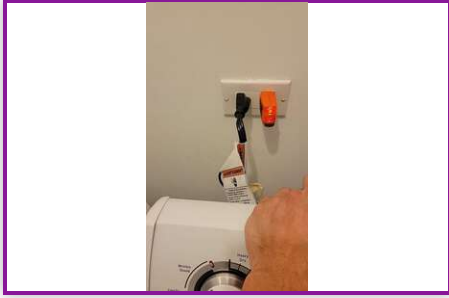
One or more receptacle(s) in the laundry room are not GFCI protected. It is recommended to have this receptacle switched/updated to a GFCI outlet for protection, to help prevent possibility of electrical shock. GFCI protection was required in laundry rooms or anywhere within 6 feet of a water source since 2005. All repairs involving wiring should be performed by a licensed electrical contractor.
