Inspection Report

AP-736-000930

10 [REDACTED] St [REDACTED]

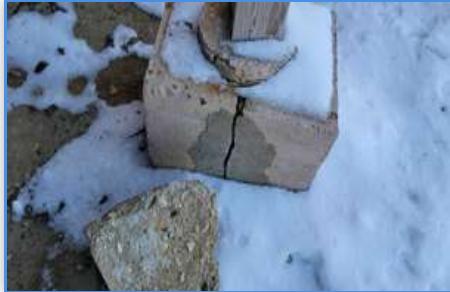
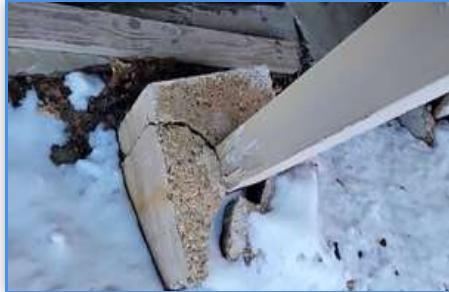
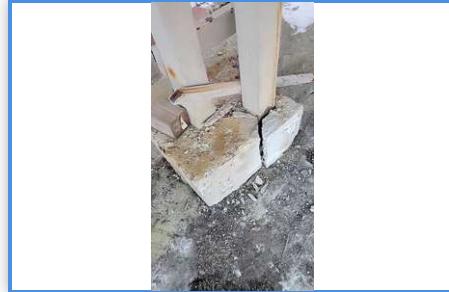
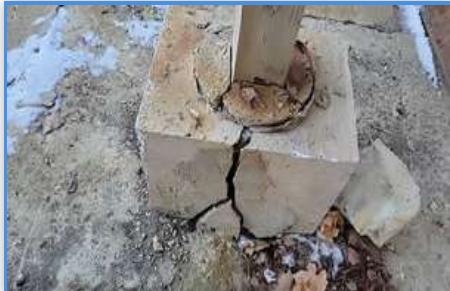
2.2.1 Damage and/or Deteriorated Deck Support Footing

Comment Location : REAR

At the time of inspection, one or more deck support footings were visibly cracked and/or deteriorated. I recommend repair or replacement by a professional contractor before further erosion occurs.

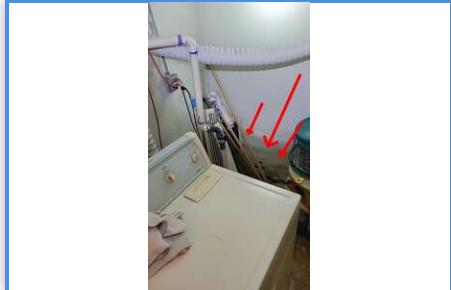
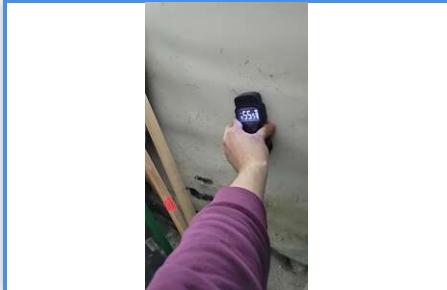
Comment Location : LAUNDRY ROOM

One or more visible sign(s) of water intrusion were present at the time of inspection. I am unable to determine extent or how often it may occur. If not corrected, a wet basement can lead to costly issues such as foundation problems, mold and deterioration of floor system. A qualified water infiltration specialist should further investigate and repair as needed. (See 18.5.2 for cause of moisture intrusion)

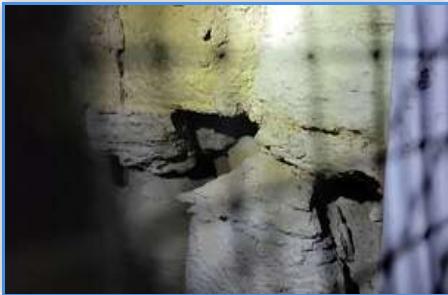
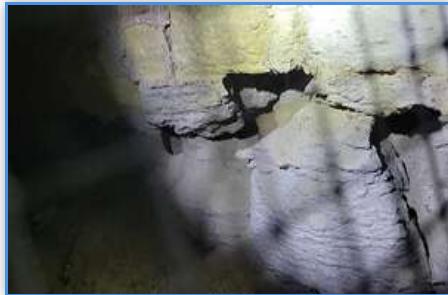
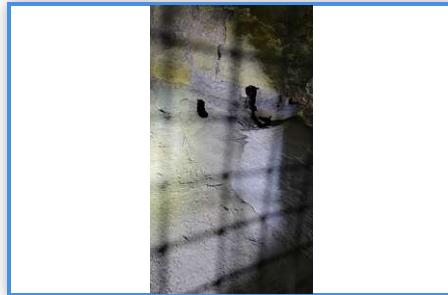
18.5.2 Damaged stone rubble foundation

There were damaged area found on the stone rubble foundation. The Inspector recommends that the affected area(s) is evaluated and repaired, as needed, by a professional contractor.

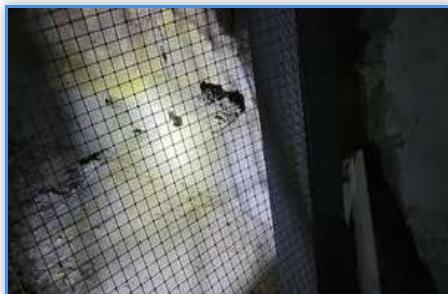
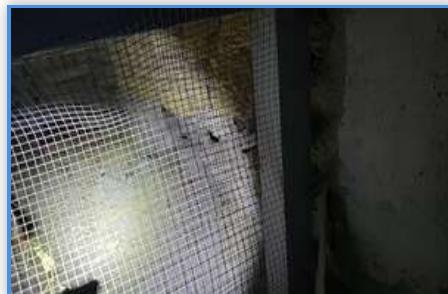
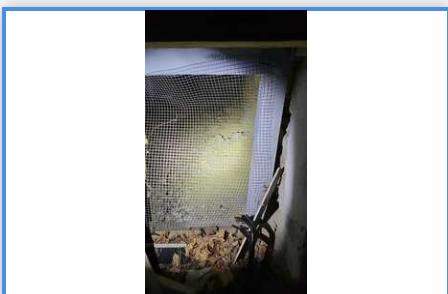
Comment Location : REAR RIGHT CORNER

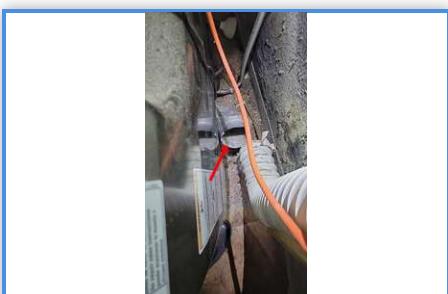
19.4.1 Broke/Disconnected Vent

Comment Location : LAUNDRY ROOM

The clothes dryer exhaust duct is broken or disconnected in one or more places. Clothes dryers produce large amounts of moisture, lint, which is highly flammable, and trace amounts of carbon monoxide which should not enter structure interiors. Damage to building components may result. A qualified person should evaluate and make permanent repairs as necessary.

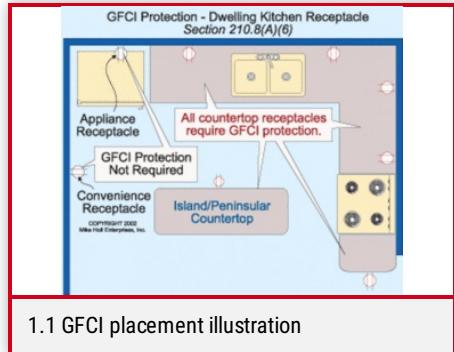
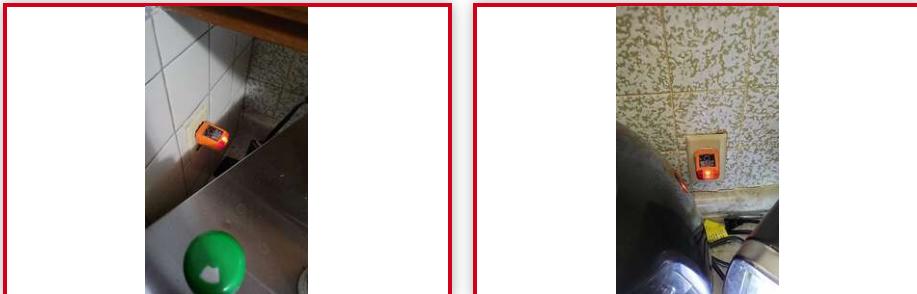
Kitchen electrical outlets were operable at the time of the inspection but no Ground Fault Circuit Interrupter (GFCI) protection were installed. GFCI protection should be installed for outlets within 6 feet of plumbing fixtures or on kitchen counters, as they were required in kitchens starting in 1987 by the NEC. Recommended this be done by a professional electrical contractor.

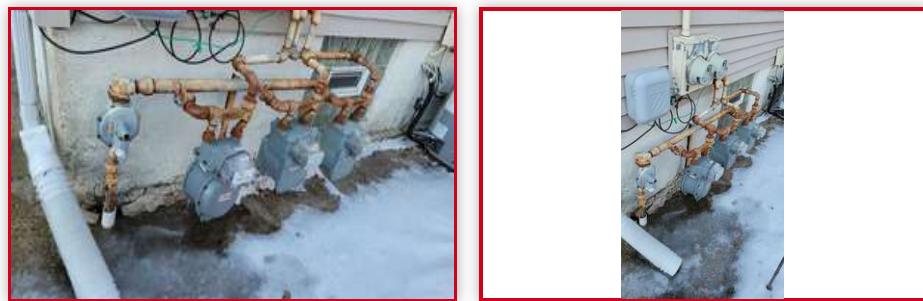
10.5.1 Meter gas pipe corrosion

The gas meter had one or more areas that were corroded. In time this can cause gas leaks. We recommend that the affected areas be repaired as needed by a the gas company.

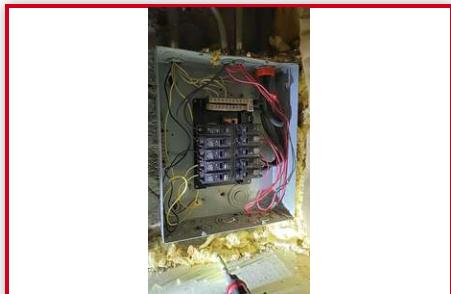
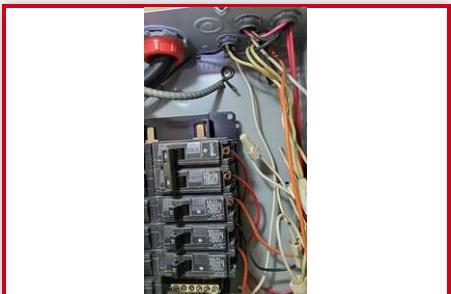
15.8.2 Missing bonding screw (Both Panels)

The panel neutral bus bar was missing it's green bonding screw or equivalent area identified on the installation method on manufactures data plate. I recommend the bonding screw be installed as required by a professional electrical contractor.

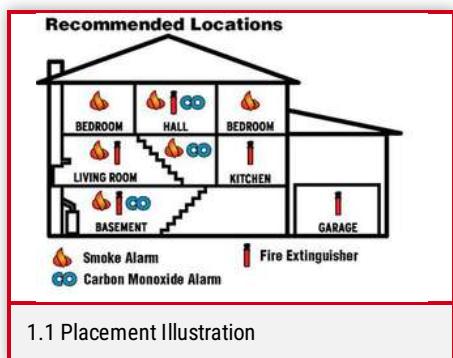
15.9.1 Smoke/CO Detector Missing

Smoke and carbon monoxide alarms were missing and/or not installed in one or more locations. Smoke and CO alarms should be installed per standard building practices (e.g. in hallways leading to bedrooms, in each bedroom, on each floor). I recommend installing photoelectric type combination alarms. Note: Homes built prior to 1992 were not required to have smoke detectors installed in each bedroom, only hallways. Regardless, calfire.ca.gov recommends installing smoke detectors in each bedroom for increased safety. Click here for more information.

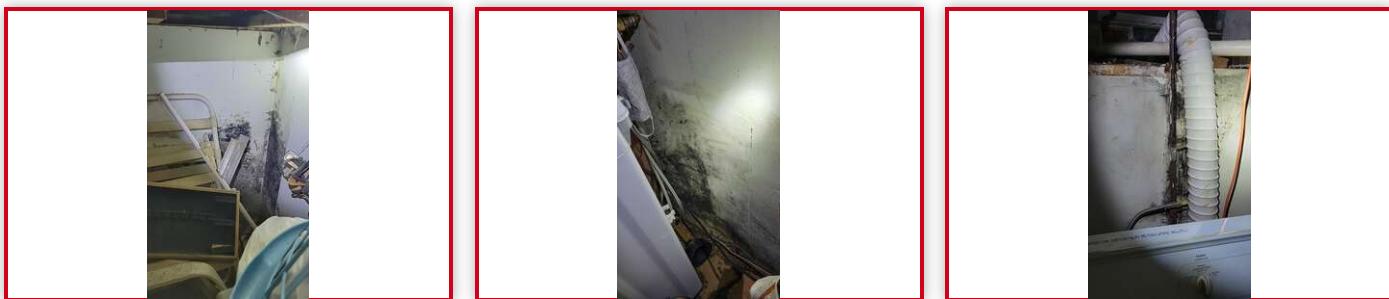
16.1.1 Microbial Growth

Microbial like growth or a musty odor was found at one or more locations. We did not test the substance through a lab so proper verification was not made. Growth is normally caused by moist conditions, plumbing or roof/exterior moisture issues, and issues with improper ventilation. I recommend that after the areas are verified as mold, the source of moisture should be found and the mitigation done by a professional contractor.

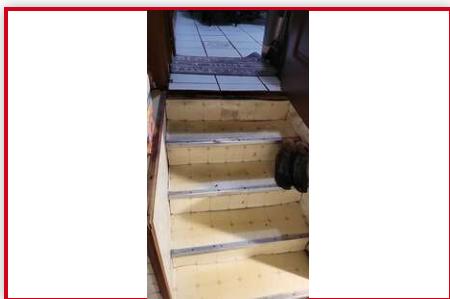
16.7.1 Handrails Missing

Staircase had no handrails. This is a safety hazard. I recommend a qualified handyman install a handrail per current standards.

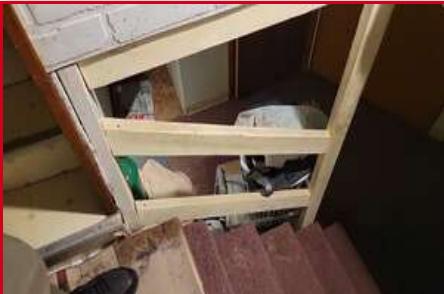
Comment Location : BASEMENT

One or more guardrails installed were climbable. The balusters were installed vertically instead of horizontally. This method is used in new construction quite frequently because it looks fabulous. As a result kids are able to climb the railings rendering them unsafe. We recommend that the guardrails be altered for safety.

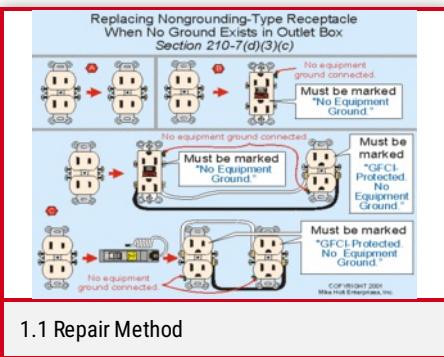
2 prong outlets rather than 3 prong grounded outlets were installed in one or more areas. These outlets are un-grounded and considered unsafe. There appliances that require a ground like computers or refrigerators as an example. Upgrading to grounded receptacles typically requires installing new wiring from the main service panel or sub-panel to the outlets. It is also industry standard for outlets to be replaced with GFCI protection as a repair, to use grounded appliances with them. I recommend a professional electrical contractor be hired to repair the affected outlets as needed.

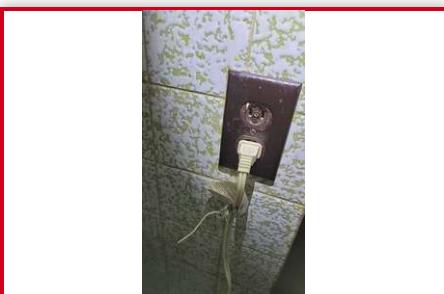
Comment Location : KITCHEN

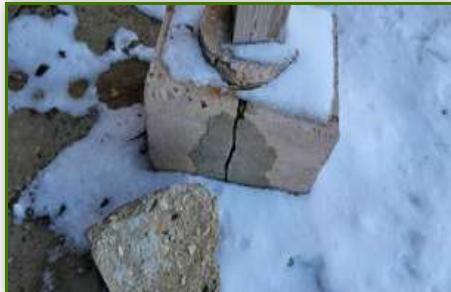
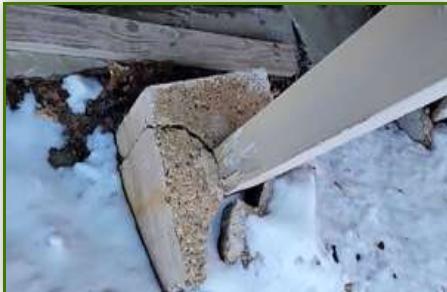
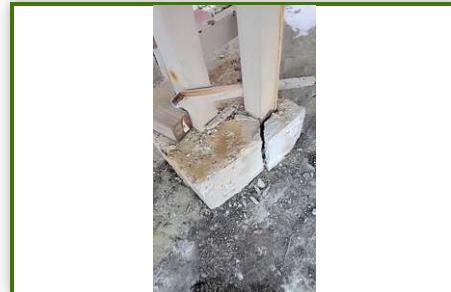
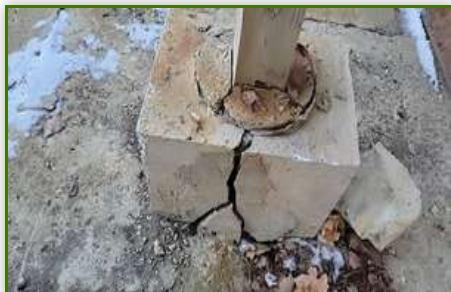
Comment Location - REAR

At the time of inspection, one or more deck support footings were visibly cracked and/or deteriorated. I recommend repair or replacement by a professional contractor before further erosion occurs.

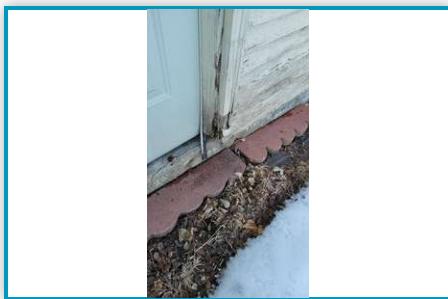
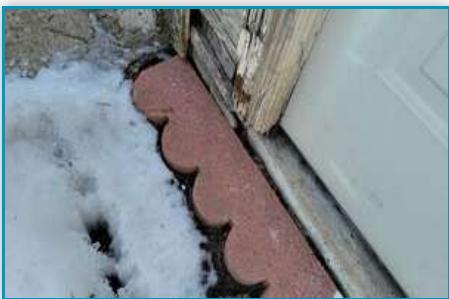
3.1.1 Damaged trim

The trim on this home was, cracked, deteriorated or damaged. I recommend the affected area(s) be evaluated and repaired or replaced as needed, by a professional contractor, to seal out moisture. Should you consider doing the repair yourself, see the DIY linked video to assist you in your decision.

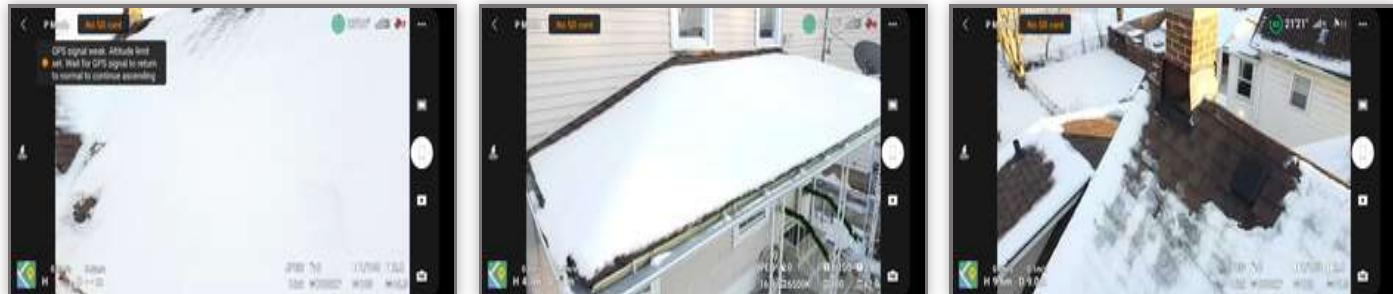
Snow on roof (Limited inspection)

At the time of inspection, snow covered the roof. The roof may have hidden defects covered by the snow.

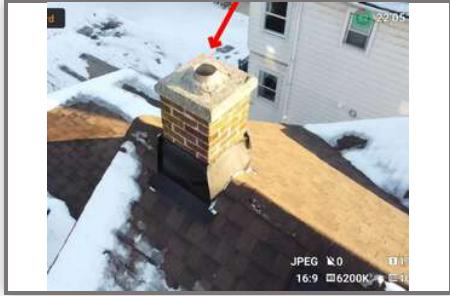
At the time of inspection, no metal rain cap was installed. A rain cap will help eliminate animals and moisture from entering the flue, as well as stop downdrafts. I recommend installation as needed by a professional contractor.

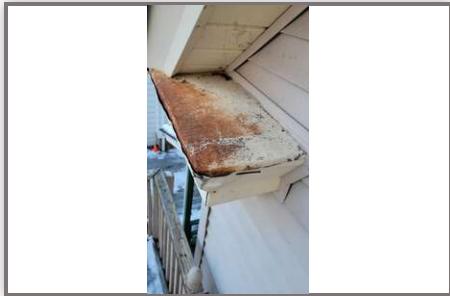
4.2.1 Corroded roof flashing (Minor)

There were one or more areas of the metal roof flashing had minor corrosion. The Inspector recommends that the affected area(s) be evaluated, replaced or repaired, as needed, by a professional contractor, to prevent moisture damage from areas corroded through.

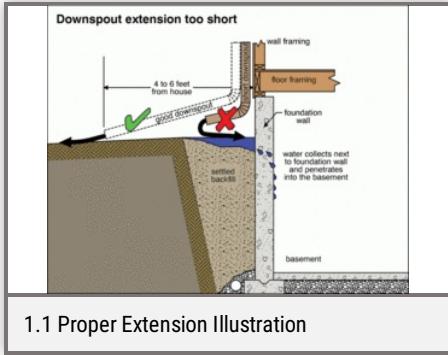
4.6.1 Downspout Extension (Short/None/Missing)

One or more downspouts were missing or too short around this the home, allowing roof drainage to discharge next to the foundation which can lead to further erosion, settlement, or water intrusion in these areas. I recommend proper extensions be installed by a qualified person.

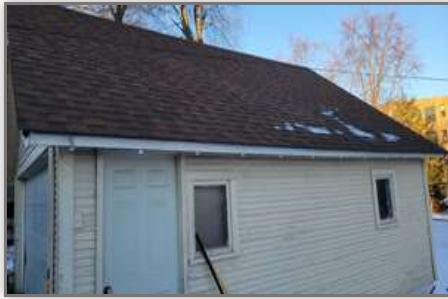
4.6.2 Gutters (Some Missing)

Roof drainage system is missing. Runoff can cause deterioration to fascia, roof edge and siding, water damage/intrusion, as well as foundation related problems. I recommend installation of gutters by a qualified contractor.

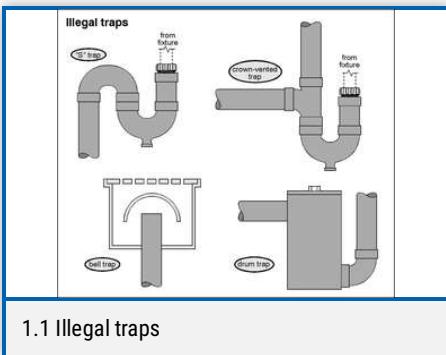
The kitchen sink drain uses an s-trap rather than a vented p-trap. Water seals (the water lying in the bottom of the u-shaped pipe) may be lost when discharges occur in the system, resulting in sewer gases entering the structure. Recommend having a professional plumber evaluate and replace s-traps with vented p-traps.

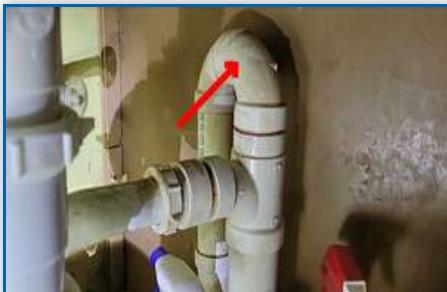
Comment Location - KITCHEN

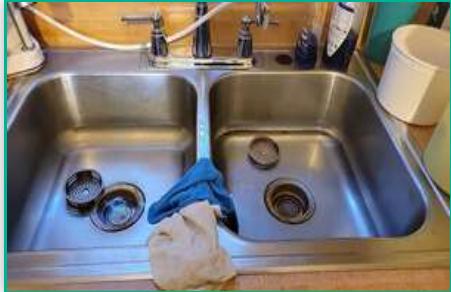
Comment Location - KITCHEN

At the time of inspection, the kitchen sink was slow to drain. The cause of a slow drain can range from a cleaning at trap to problems down line. I recommend further inspection and correction as needed by a qualified plumbing contractor.

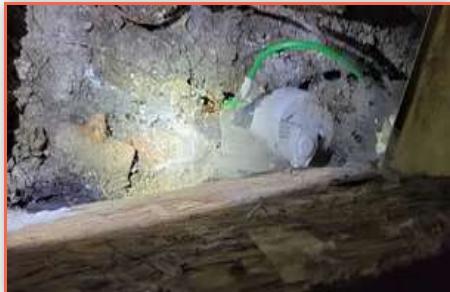
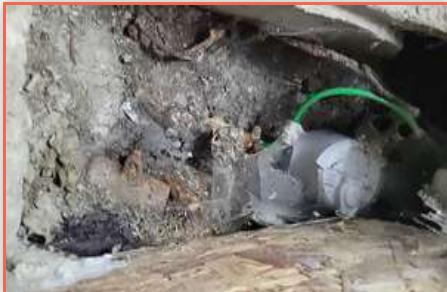
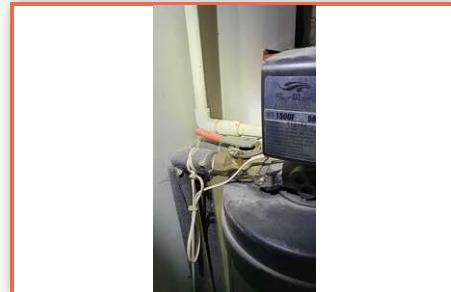
Comment Location - BASEMENT

The main water shut off location is in the description in the photo below. This is the area where you can shut off the water to your home if you need to do repairs or in an emergency.

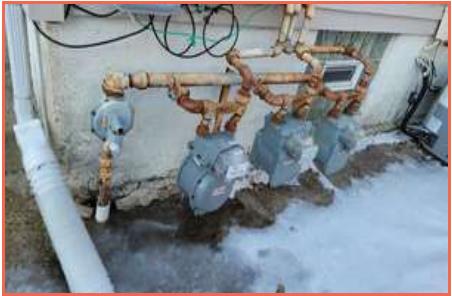
Comment Location - RIGHT SIDE FACING FRONT

The main fuel shut off is located on the gas meter. This is for your information.

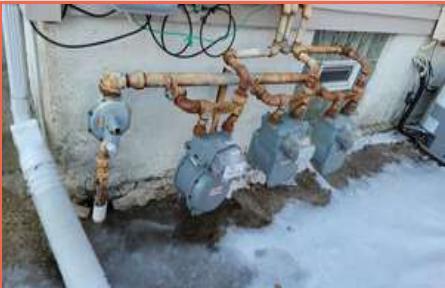
Comment Location - RIGHT SIDE FACING FRONT

The gas meter had one or more areas that were corroded. In time this can cause gas leaks. We recommend that the affected areas be repaired as needed by a the gas company.

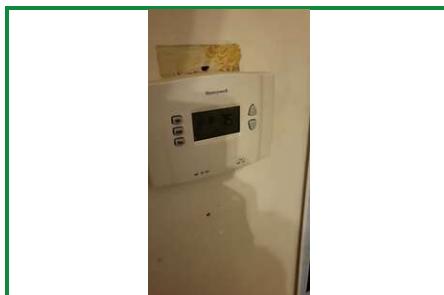
Thermostat location

Comment Location - DINING ROOM

The thermostat location is identified in the photo below. This is for your information. To save energy, set your thermostat back at night or when you know your home will be unoccupied for an extended period of time (be mindful of different family schedules.) Savings can be as much as 1% of your heating bill for every degree lowered every 8 hours!

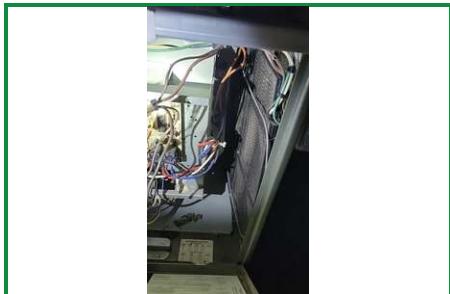
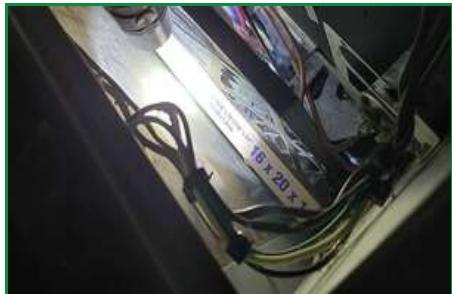
Comment Location - MECHANICAL ROOM

See photo below for where to change your filter. Typical recommendations range depending on your needs. A filter may last 30 days for cheaper fiberglass filters, to as long as 12 months for higher-end pleated filters. These estimates assume average use and depend on the type and size of your filter. A general rule of thumb is to check your filter every 30 to 90 days and replace as needed. As your filter traps more dirt, dust, and allergens from the air, the heating unit's efficiency decreases. This is considered a normal maintenance item. Cheaper 30 day filters allow more air to flow through your unit to make the blower motor work less hard. Higher end filters are good for catching dust and allergens. The choice is yours!

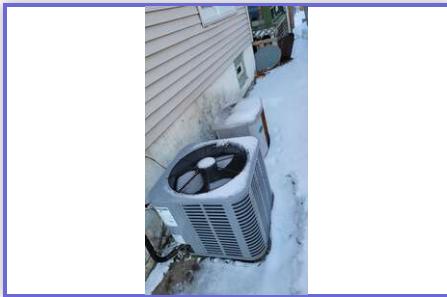
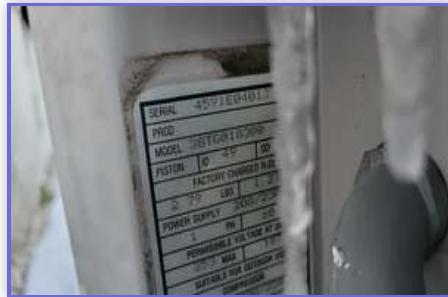
COOLING 1ST UNIT LIMITATION

A/C Not Tested / Temperature Under 65 F*

Comment Location - RIGHT SIDE FACING FRONT

The outdoor air temperature was below 65 degrees Fahrenheit during the inspection. Air conditioning systems can be damaged if operated during such low temperatures. It is also impossible to determine if the HVAC system is cooling properly as even if no or low refrigerant is in the system, the air will still register at ambient exterior temperature. Client should be aware of this limitation when inspecting unit in cooler temperatures.

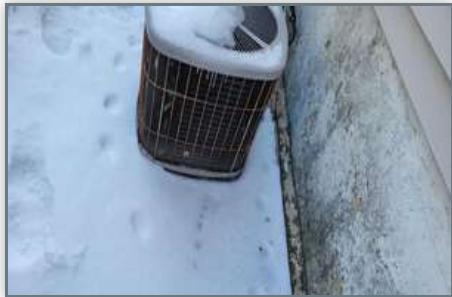
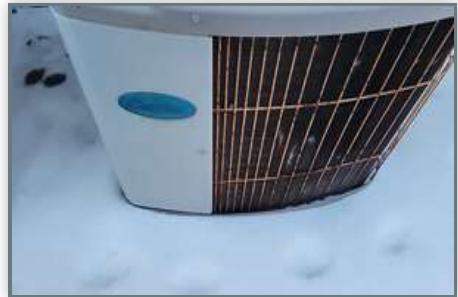
COOLING 2ND UNIT LIMITATION

A/C Not Tested / Temperature Under 65 F*

Comment Location - RIGHT SIDE FACING FRONT

The outdoor air temperature was below 65 degrees Fahrenheit during the inspection. Air conditioning systems can be damaged if operated during such low temperatures. It is also impossible to determine if the HVAC system is cooling properly as even if no or low refrigerant is in the system, the air will still register at ambient exterior temperature. Client should be aware of this limitation when inspecting unit in cooler temperatures.

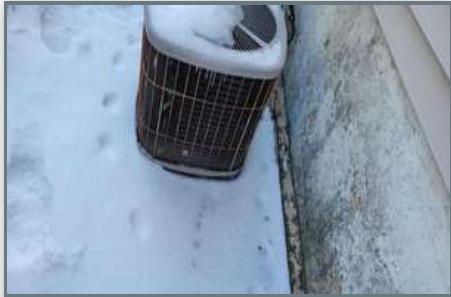
1.1 MFD in 1991

The useful life for most air conditioning condensing units is estimated at 15-20 years. This unit appeared to be near, at, or past this age and/or its useful lifespan and may need replacing or significant repairs at any time. I recommend budgeting for a near future replacement.

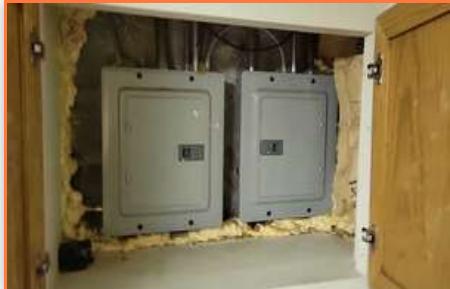
Comment Location - BASEMENT

The main electrical panel location is identified in the photo below. This is the area where you can shut off your electrical system at the main disconnect, in case of an emergency or need for service. All circuit breakers are much more reliable if they are exercised. Once a year you should exercise (shut them off and then turn them on) at your electrical panel including the main disconnect. Knowing if a circuit breaker is not functioning before a problem occurs can be a life saving event.

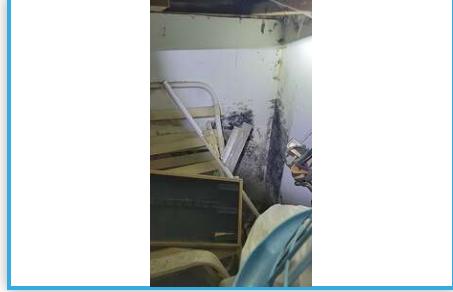
Microbial like growth or a musty odor was found at one or more locations. We did not test the substance through a lab so proper verification was not made. Growth is normally caused by moist conditions, plumbing or roof/exterior moisture issues, and issues with improper ventilation. I recommend that after the areas are verified as mold, the source of moisture should be found and the mitigation done by a professional contractor.

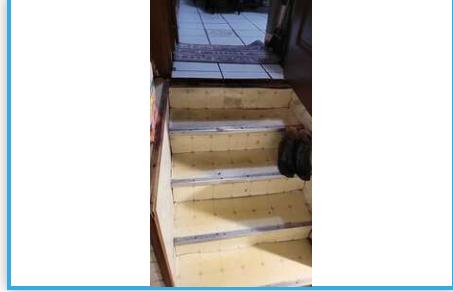
16.7.1 Handrails Missing

Staircase had no handrails. This is a safety hazard. I recommend a qualified handyman install a handrail per current standards.

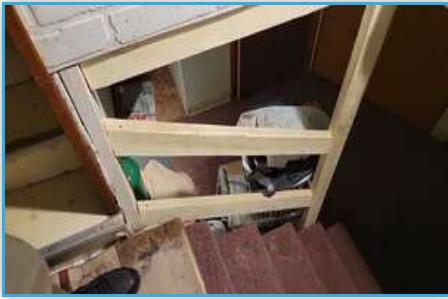
One or more guardrails installed were climbable. The balusters were installed vertically instead of horizontally. This method is used in new construction quite frequently because it looks fabulous. As a result kids are able to climb the railings rendering them unsafe. We recommend that the guardrails be altered for safety.

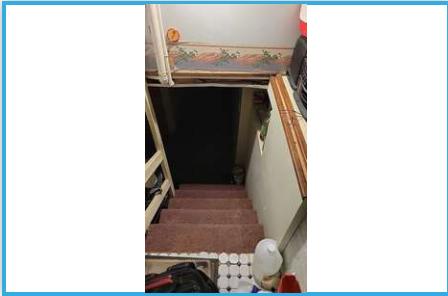
Safety Issues**Comment Location - BASEMENT**

The stairs to basement had no headroom. Clearance was less than 6 feet 6 inches. This is difficult to correct but at the very least, client should be aware to prevent injury.

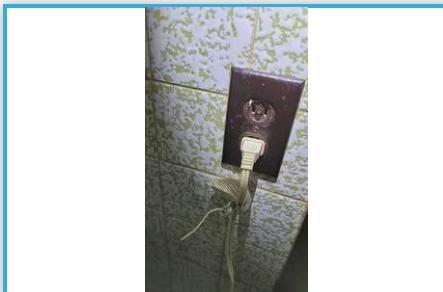
Safety Issues
Comment Location - KITCHEN

2 prong outlets rather than 3 prong grounded outlets were installed in one or more areas. These outlets are un-grounded and considered unsafe. There appliances that require a ground like computers or refrigerators as as example. Upgrading to grounded receptacles typically requires installing new wiring from the main service panel or sub-panel to the outlets. It is also industry standard for outlets to be replaced with GFCI protection as a repair, to use grounded appliances with them. I recommend a professional electrical contractor be hired to repair the affected outlets as needed.

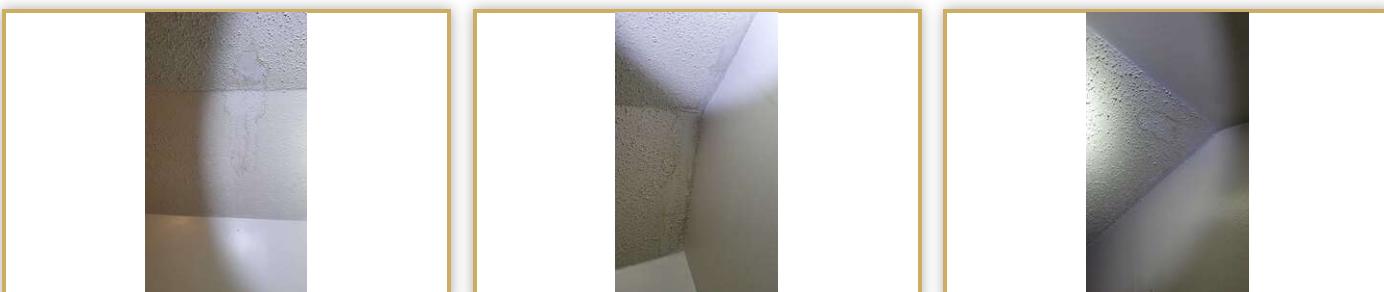
There were stains found but no moisture detected. I recommend asking the owner about the stains.

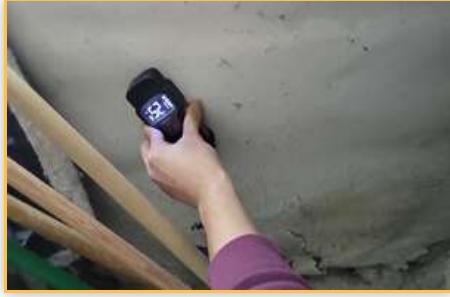
One or more visible sign(s) of water intrusion were present at the time of inspection. I am unable to determine extent or how often it may occur. If not corrected, a wet basement can lead to costly issues such as foundation problems, mold and deterioration of floor system. A qualified water infiltration specialist should further investigate and repair as needed. (See 18.5.2 for cause of moisture intrusion)

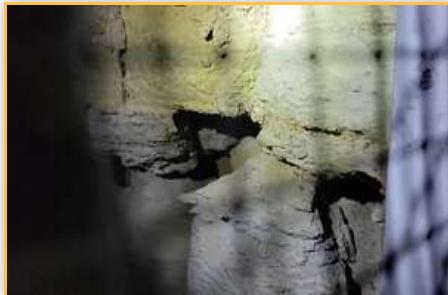
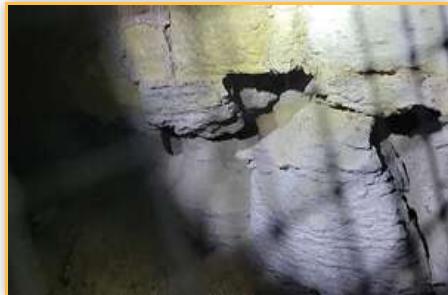
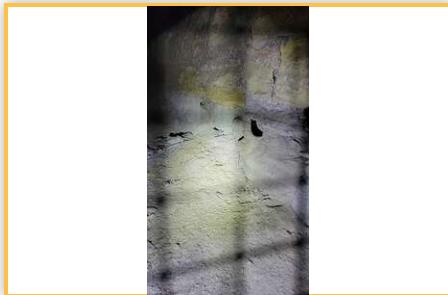
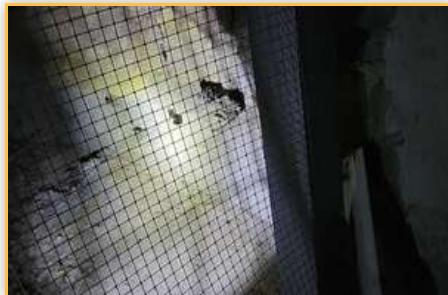
There were damaged area found on the stone rubble foundation. The Inspector recommends that the affected area(s) is evaluated and repaired, as needed, by a professional contractor.
