Inspection Report

## PROPERTY & INSPECTION INFORMATION

<b>Year Built</b> 1951	<b>Square Footage</b> 800
<b>Number of Units</b> 1 Unit	<b>Parties present (inspection attendance)</b> Buyer, Buyer's Agent	<b>Type of building</b> Single Family Detached (1 story)
<b>Style of home</b> Cape Cod	<b>Home faces</b> South	<b>Weather</b> Cloudy
<b>Temperature</b> Below 60 (F)

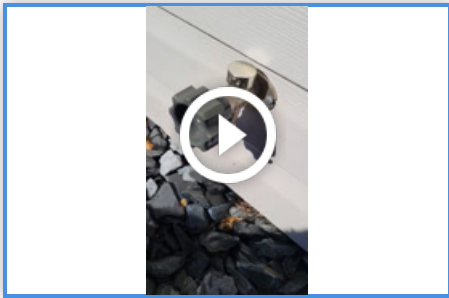
## 3.9.1 Leaking exterior faucet

**Comment Location :** FRONT

At the time of inspection, an exterior faucet was leaking constantly allowing water to accumulate next to the foundation. The Inspector recommends that the affected area(s) be evaluated, replaced or repaired, as needed, by a professional contractor.

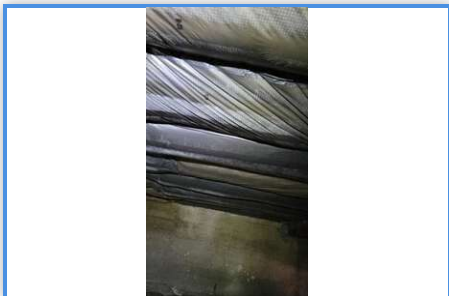
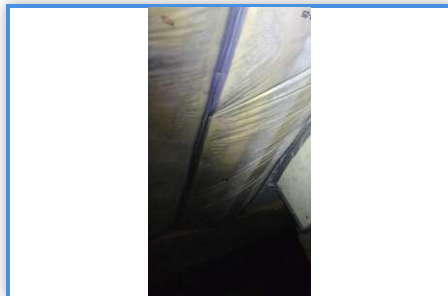
## 13.2.1 Plastic Cover

**Comment Location :** CRAWLSPACE

A plastic membrane was used to hold in blown-in insulation in the floors of the home which may cause moisture to accumulate causing mold. The Inspector recommends replacing the plastic with a "vapor-permeable" membrane that will allow moisture vapor to pass through by a professional contractor.

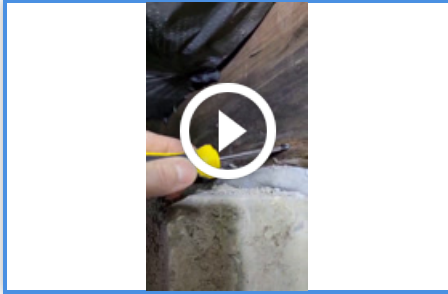
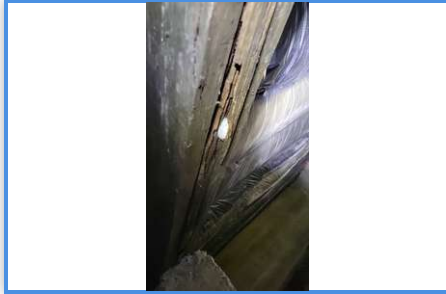
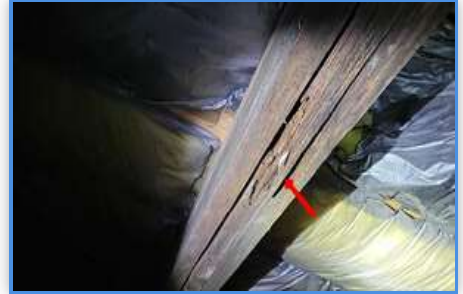
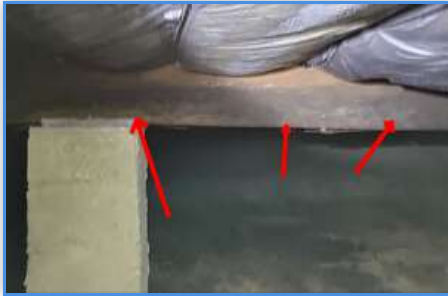
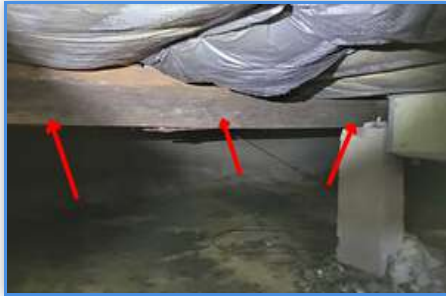
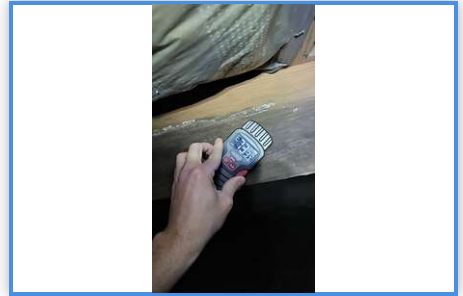
**Comment Location :** CRAWLSPACE

**1. DAMAGED WOOD (ACTIVE LEAKS)**

The homes wooden beam had water damage in areas from an active leak. The leak will need to be found and fixed by a plumbing contractor.

**2. WOOD BEAM (DAMAGED/ROTTED)**

The wood beam had areas that were damaged sagging, or rotted. I recommend that the beam be evaluated and repaired as needed by a professional contractor.

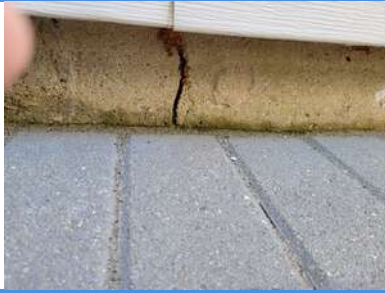
Location: RIGHT SIDE FACING FRONT

One or more areas of the exterior foundation walls had minor cracks visible. These cracks can be sealed and monitored to prevent further erosion from water intrusion. A contractor can seal these cracks with foundation approved sealant products.

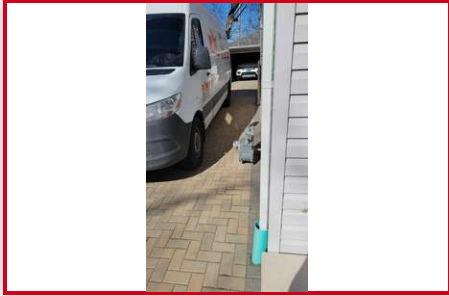
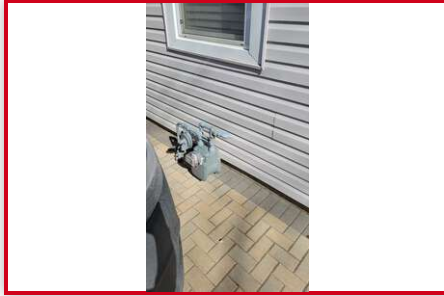
The gas meter and/or shut-off valve was located where it was subject to damage from vehicles. This is a potential explosion and fire hazard. I recommend a qualified contractor install a protective barrier per current standards.

Note: Some gas service providers will install protection at no charge.

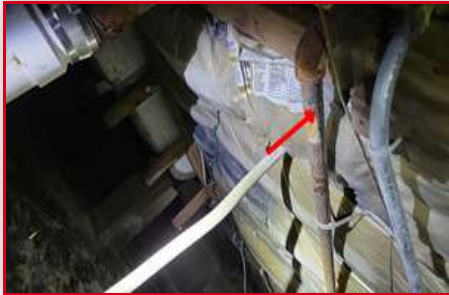
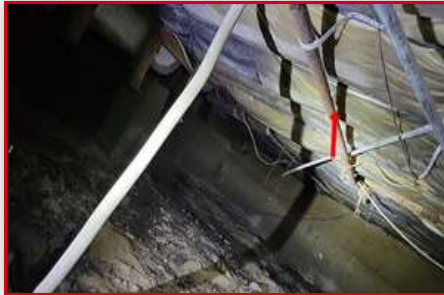
### 8.5.2 Gas Line Corroded

**Comment Location :** CRAWLSPACE

Some gas supply lines appeared to be rusted and/or deteriorated. I recommend repairs as needed by a qualified licensed plumbing contractor.

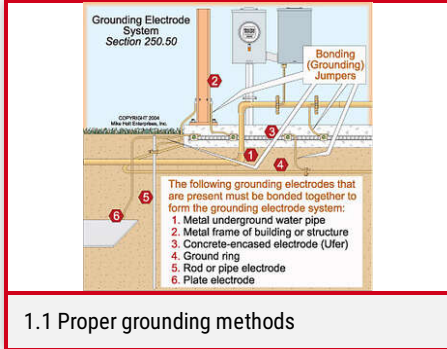
## 11.8.1 Panel not Grounded (No visible Electrode)

### Comment Location : REAR

Grounding of the metal panel enclosure was not visible/missing and/or improper. Grounding is done to ensure if the metal panel enclosure becomes energized, excess current has a way to escape to ground and prevent possible shock to anyone touching the metal pan box. I recommend repairs be made by a qualified electrician.

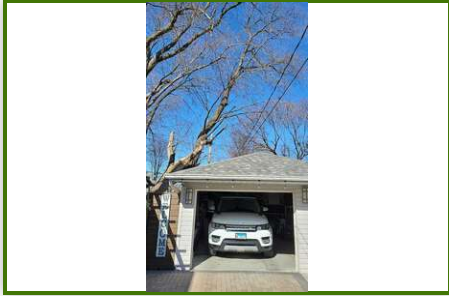
## 2.4.1 Overhanging limbs (Potential for damage)

### Comment Location - GARAGE

Large trees nearby have limbs that overhang the home. These branches have a potential to damage homes during storms or high wind situations. I recommend that the tree limbs be trimmed back or removed.

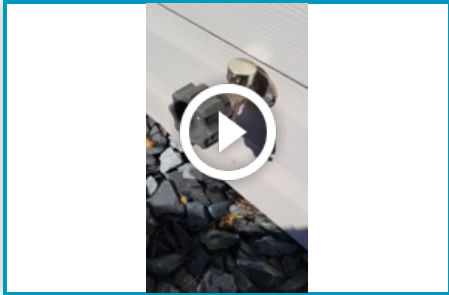
## 3.9.1 Leaking exterior faucet

Repair or Replace**Comment Location** - FRONT

At the time of inspection, an exterior faucet was leaking constantly allowing water to accumulate next to the foundation. The Inspector recommends that the affected area(s) be evaluated, replaced or repaired, as needed, by a professional contractor.

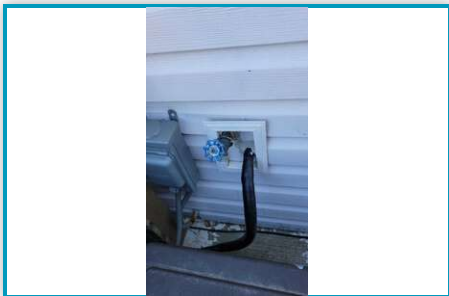
**Comment Location** - REAR

There were no anti-siphon devices installed on the exterior hose bibs. These are needed to help the pipe from freezing if a hose is attached and to prevent water from siphoning back into the house should the end of a hose be left in a pool of water. These can be purchased at most local hardware stores and screwed onto the hose bib.

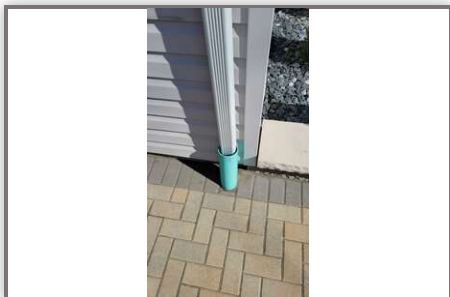
Note: Below ground drains noted, but not tested. They are not part of this inspection due to limited visibility. I am unable to determine if the drain lines are functioning properly.

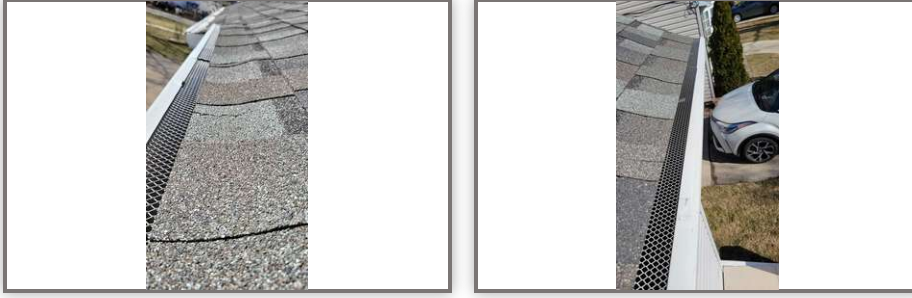
Note: The installed gutter topper system prevents clear views of the gutter system. Home inspections are not invasive and the gutter topper system is not removed during the inspection. The interior of the gutter is not viewed in these cases.

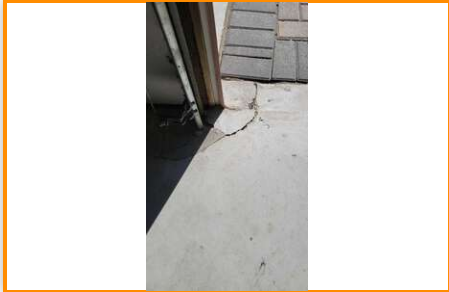
### 5.2.1 Floor, typical cracks

#### Comment Location - GARAGE

There were typical cracks identified throughout the garage floor. It is recommended to seal these cracks to prevent water penetration and expansion.

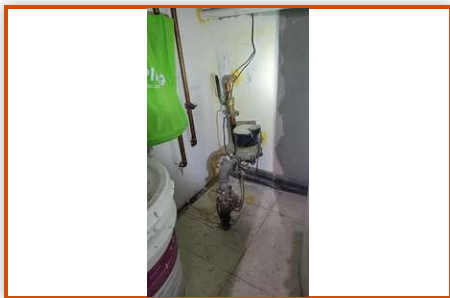
#### Comment Location - KITCHEN CLOSET

The main water shut off location is in the description in the photo below. This is the area where you can shut off the water to your home if you need to do repairs or in an emergency.

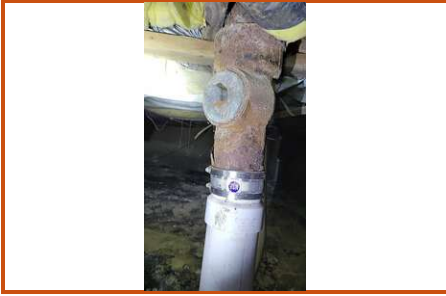
### Comment Location - CRAWLSPACE

The sewer clean-out is located in the home and is identified in the photo discription. It is not recommend to flush feminine hygiene products down a sanitary drain line or toilet. Materials can catch on tree roots or cracks creating a blockage and result in costly repairs to clean out the obstructions. It is also not recommended to dump cooking grease or oils down sinks or sanitary drains. Grease and oils have a tendency to cool and will collect creating a build-up and/or blockage in the main sewer line creating costly repairs.

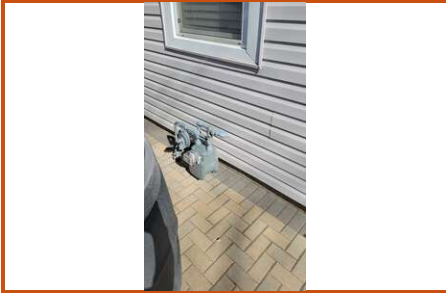
### Comment Location - LEFT SIDE FACING FRONT

The main fuel shut off is located on the gas meter. This is for your information.

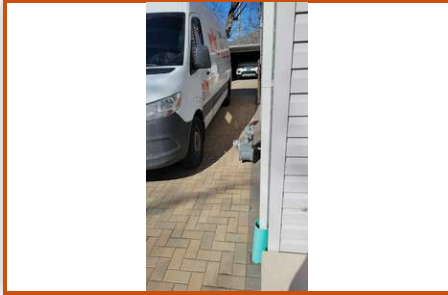
The gas meter and/or shut-off valve was located where it was subject to damage from vehicles. This is a potential explosion and fire hazard. I recommend a qualified contractor install a protective barrier per current standards.

Note: Some gas service providers will install protection at no charge.

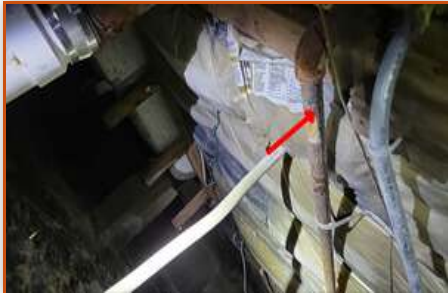
### 8.5.2 Gas Line Corroded

##### **Comment Location** - CRAWLSPACE

Some gas supply lines appeared to be rusted and/or deteriorated. I recommend repairs as needed by a qualified licensed plumbing contractor.

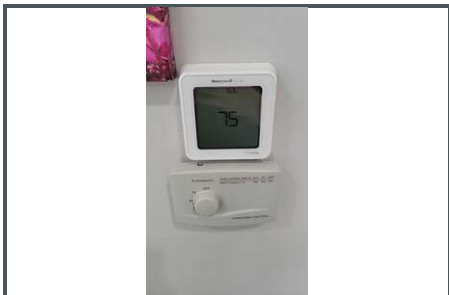
### Comment Location - LIVING ROOM

The thermostat location is identified in the photo below. This is for your information. To save energy, set your thermostat back at night or when you know your home will be unoccupied for an extended period of time (be mindful of different family schedules.) Savings can be as much as 1% of your heating bill for every degree lowered every 8 hours!

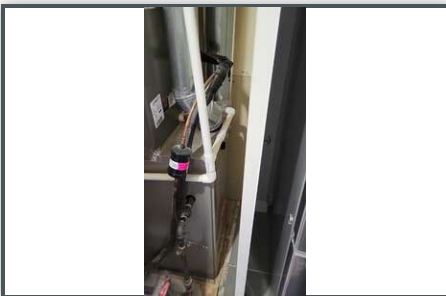
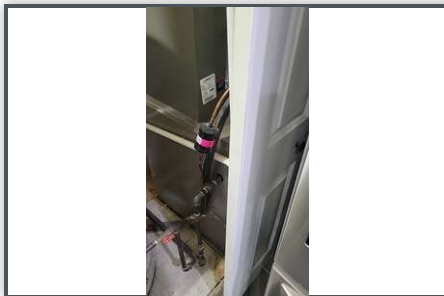
#### Comment Location - KITCHEN CLOSET

The furnace did not have sufficient clearance in front of the control side of the furnace for servicing. I recommend verification of manufacturer specifications and correction as desired.

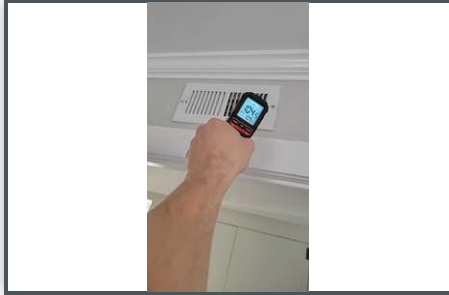
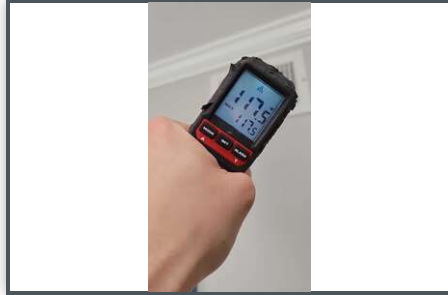
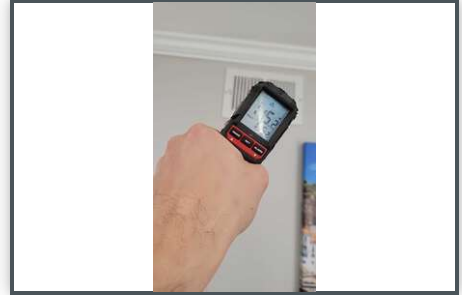
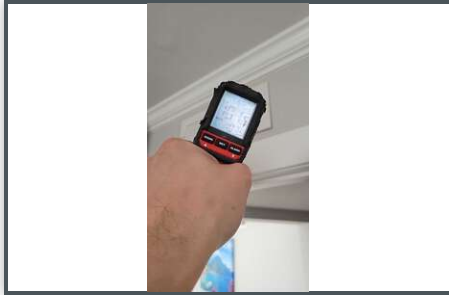
### 9.3.1 Heating ok

During the inspection we take a piece of paper and stick to the HVAC system air returns to ensure functionality. We then do a temperature read at the return to compare it to the heat or cooling being supplied to each room. There were no problems with the temperature splits, and all of the heat runs tested were functioning, unless noted in other areas in this report.

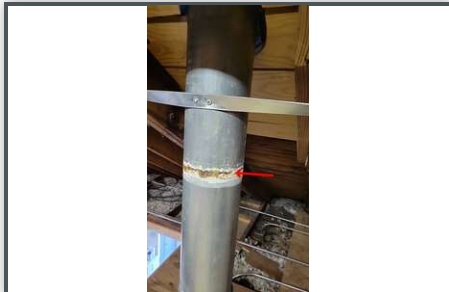
### 9.5.1 Furnace Flue (Corrosion)

#### Comment Location - ATTIC

The furnace flue had corrosion indicating it may have an issue causing condensation. I recommend the flue be repaired or replaced as needed by a qualified HVAC contractor.

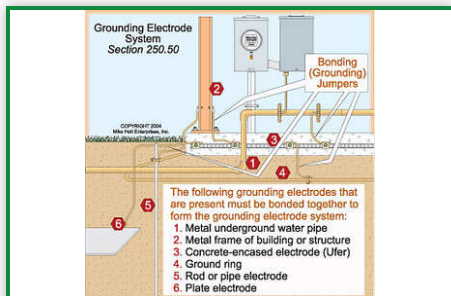
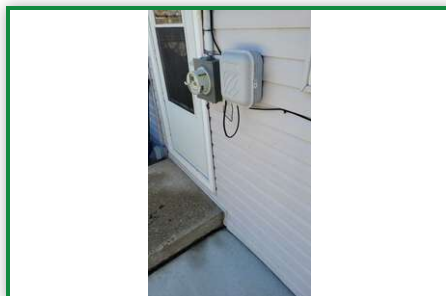
#### Comment Location - REAR

Grounding of the metal panel enclosure was not visible/missing and/or improper. Grounding is done to ensure if the metal panel enclosure becomes energized, excess current has a way to escape to ground and prevent possible shock to anyone touching the metal pan box. I recommend repairs be made by a qualified electrician.

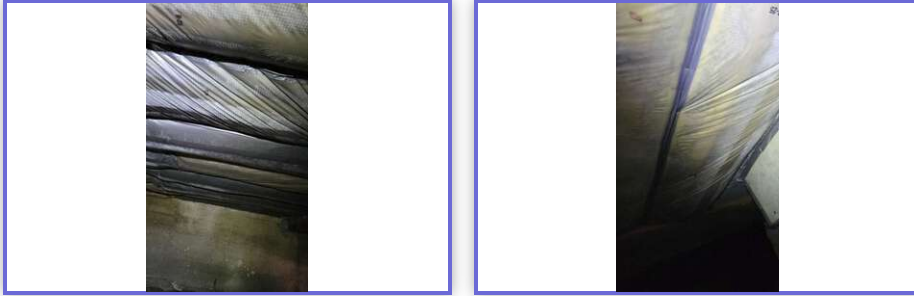
**Comment Location** - CRAWLSPACE

A plastic membrane was used to hold in blown-in insulation in the floors of the home which may cause moisture to accumulate causing mold. The Inspector recommends replacing the plastic with a "vapor-permeable" membrane that will allow moisture vapor to pass through by a professional contractor.

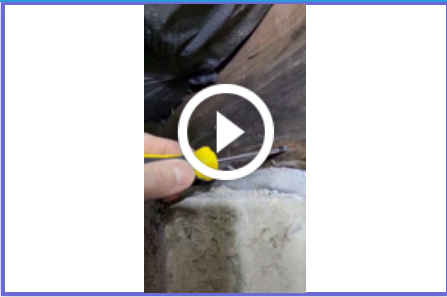
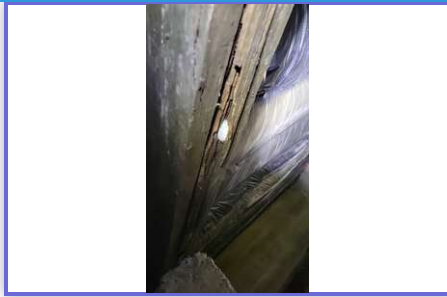
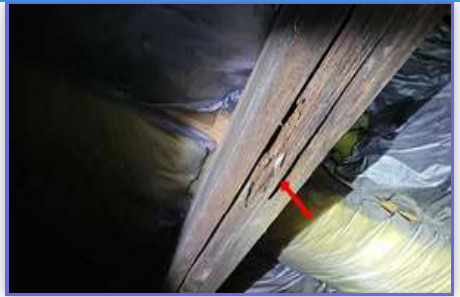
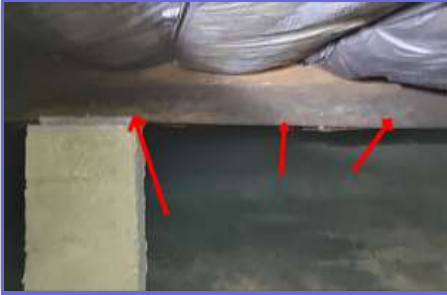
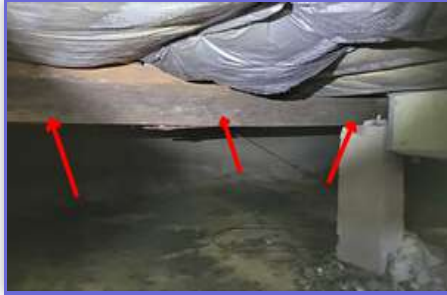
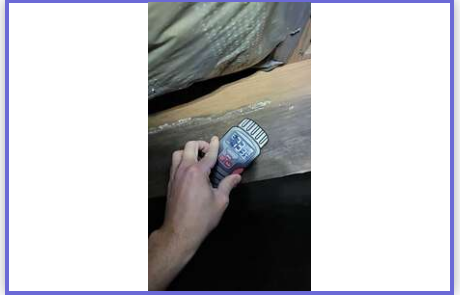
## 13.4.1 Columns, Piers And Beams(Multiple Defects)

## 2. WOOD BEAM (DAMAGED/ROTTED)

The wood beam had areas that were damaged sagging, or rotted. I recommend that the beam be evaluated and repaired as needed by a professional contractor.

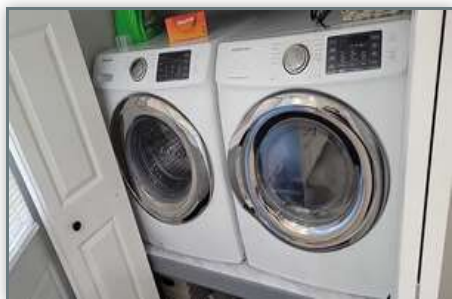
#### Comment Location - LAUNDRY ROOM

Note: The washer connections are not tested at the time of inspection. The connections and the wall around the area (when accessible or not blocked by the height of some washers) were visually inspected. There were no signs of stains or leaks noted at the time of inspection unless otherwise noted in the findings section below for further review or evaluation

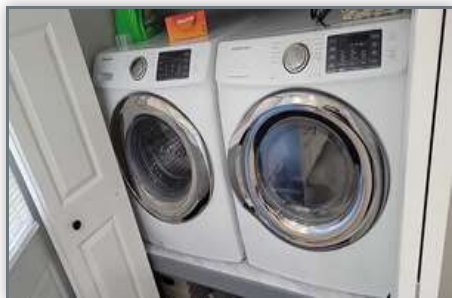
#### Comment Location - LAUNDRY ROOM

The washer and dryer were stacked at the time of inspection. This creates a limitation to inspection of supply lines, electrical service, and the dryer vent.

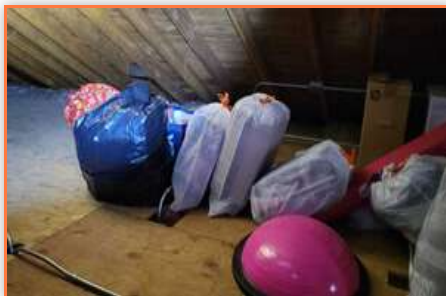
#### Comment Location - ATTIC

Stored items in the attic limited viewing of the attic to the access area or limited floored areas of the attic only.
