**This Report was Prepared Exclusively For:**  
**John Doe**  
**123 Fictional Street**  
**Katy, TX 77494**

# PROPERTY INSPECTION REPORT FORM

<u>John Doe</u> <i>Name of Client</i>	<u>06/08/2024</u> <i>Date of Inspection</i>
<u>123 Fictional Street, Katy, TX 77494</u> <i>Address of Inspected Property</i>	
<u>Barrett Neptune</u> <i>Name of Inspector</i>	<u>26288</u> <i>TREC License #</i>
<u> </u> <i>Name of Sponsor (if applicable)</i>	<u> </u> <i>TREC License #</i>

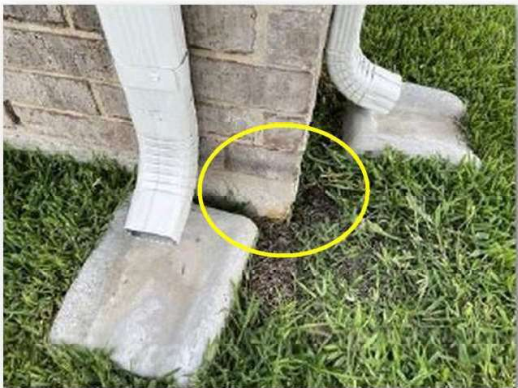
Corner cracks and / or missing concrete were found at corners of the foundation. This is a common condition found with this type of foundation and appears to have caused no structural problems.

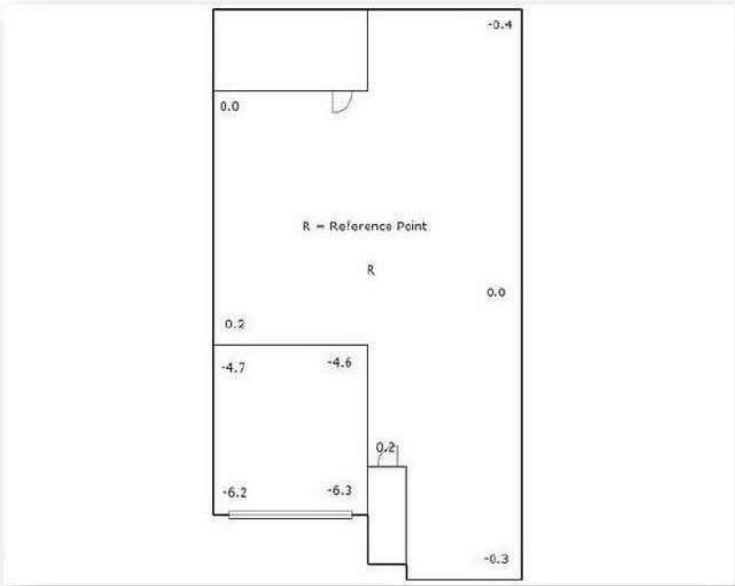
The below graph reflects measurements taken during the inspection to assist with determining the performance of the foundation. The outline / drawing is not to scale and does not accurately reflect every detail of the foundation walls.

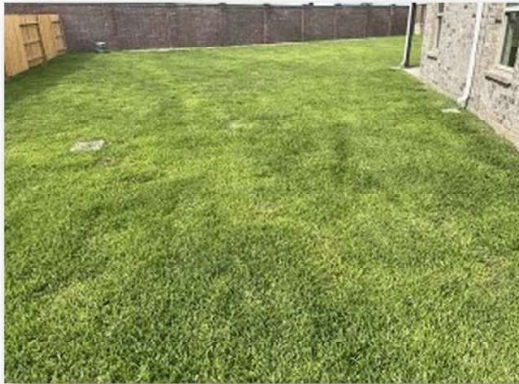
*Comments:*  
**Note:** Any area where the ground or grade does not slope away from the structure is to be considered an area of improper drainage. Six inches per 10 feet.  
**Items Damaged, Non-Functional, or Operating Improperly**  
Uneven / depressed grading was noted in the right side yard. This could be a tripping hazard. Recommend leveling the yard.

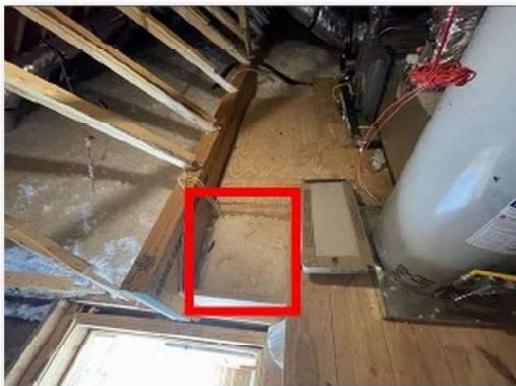
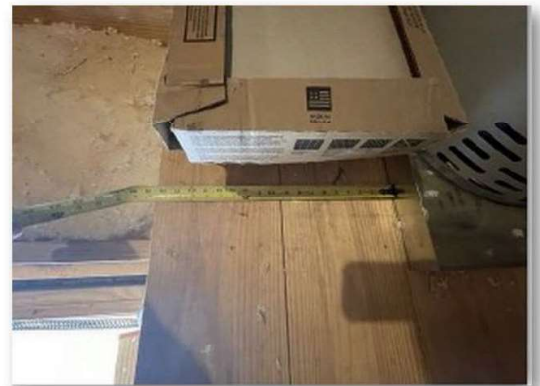
Walkway is not installed properly leading to mechanical systems in attic. - Safety Hazard

The walkway has not been installed properly leading to the mechanical system(s) in the attic.

Building codes require a walkway that 24" in width, unobstructed, and a minimum of 1/2" thick to be installed leading to all mechanical systems installed in attics.

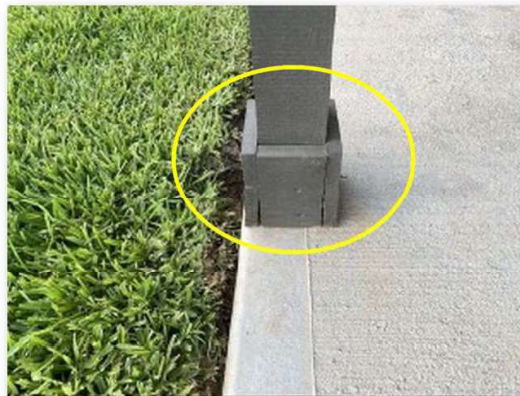
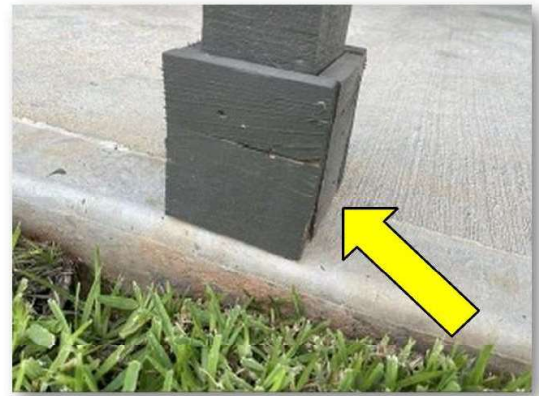
Damaged and / or missing trim were found on the exterior of the property. The damage was found at the following locations: Rear of Property

Areas where decay is present should be removed, exposing underlying materials for inspection prior to repair.

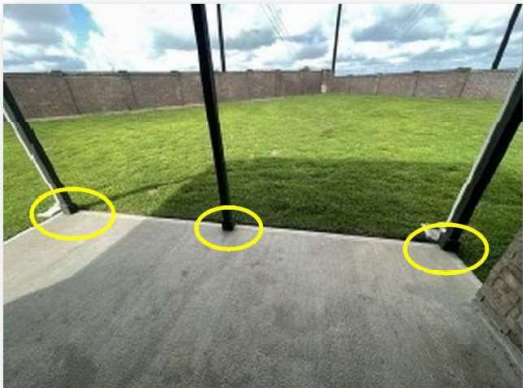
Damaged and missing sealant / caulking was found at joints, transitions, and voids on the exterior veneers. This material acts as a moisture barrier to prevent water from moving to the underlying wall cavity. The re-sealing of the exterior veneers should be considered.

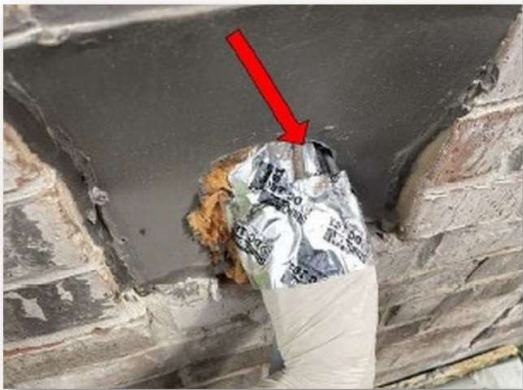
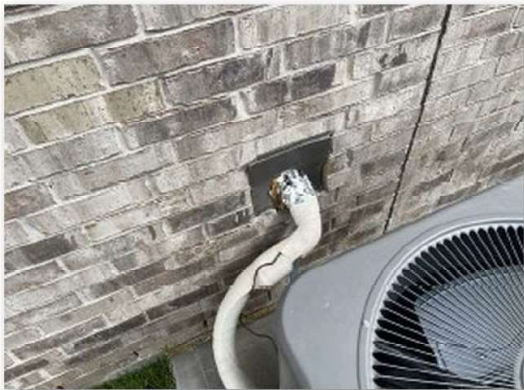
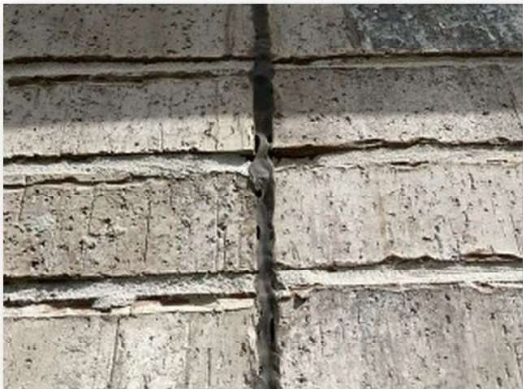
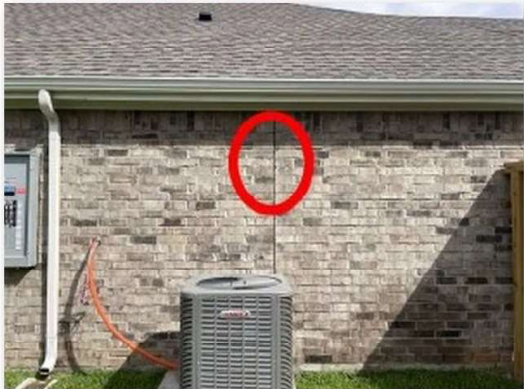
Evidence of insect (ants) activity was found around the perimeter of the structure on the exterior. Recommend improvements.

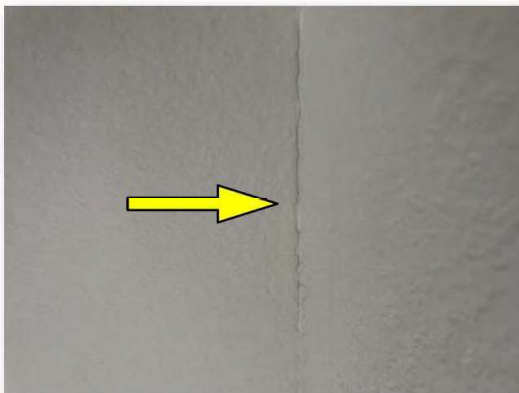
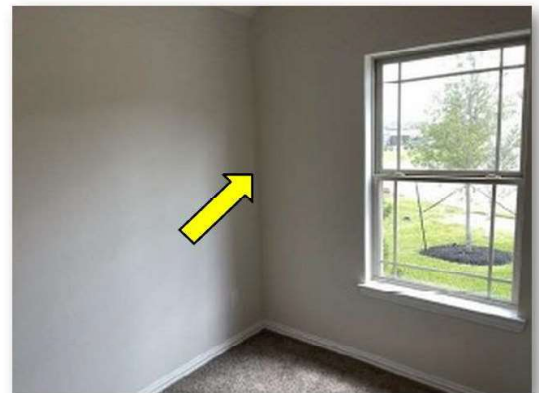
Hairline cracks were found on the interior of the property as evident of settlement.

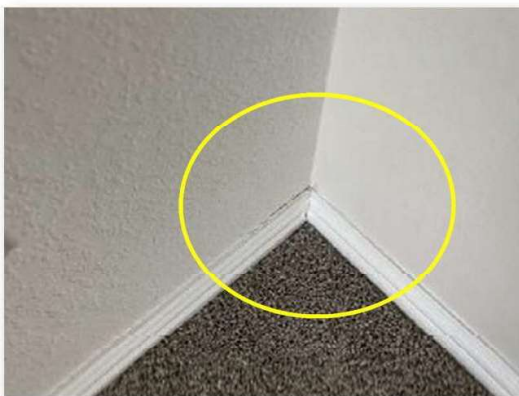
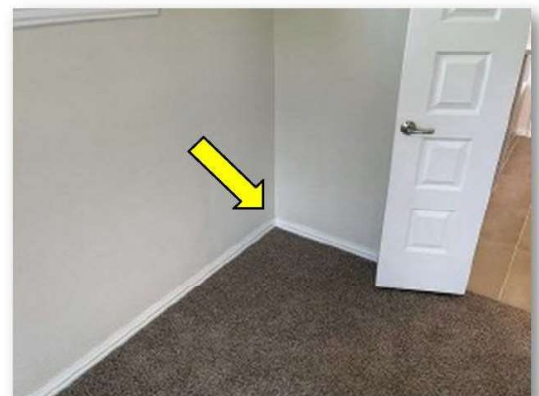
Many items at the property have not been completed at the time of the inspection. Missing paint, caulking, other items on the walls have not been completed for the inspection. The client is urged to perform a final walk-through prior to closing to insure all items have been completed satisfactorily.

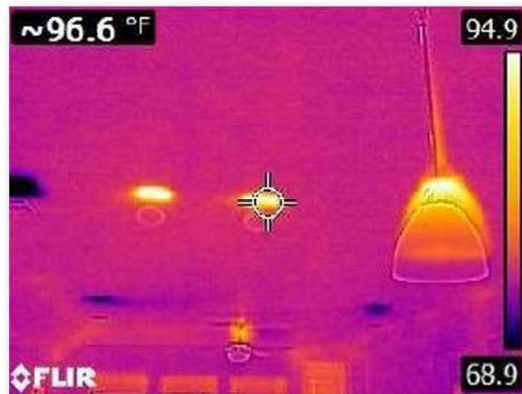
During the inspection of the ceilings on the interior of the structure with a infrared camera abnormalities were not noted. The picture(s) below are a sampling of some image(s) taken during the inspection.

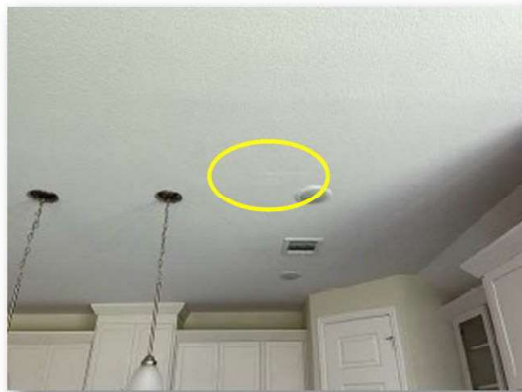
Evidence of patching was found at several sections of the ceilings in the home.

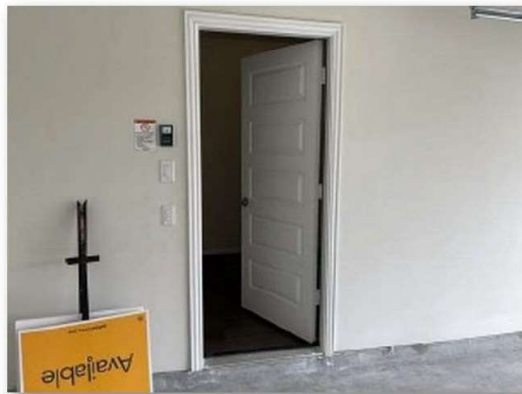
Self-closing device not functioning at the garage door leading into dwelling unit.

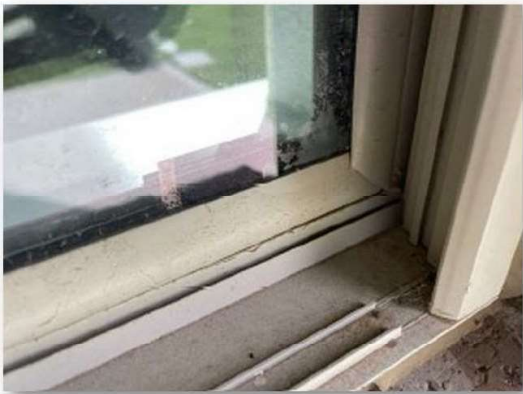
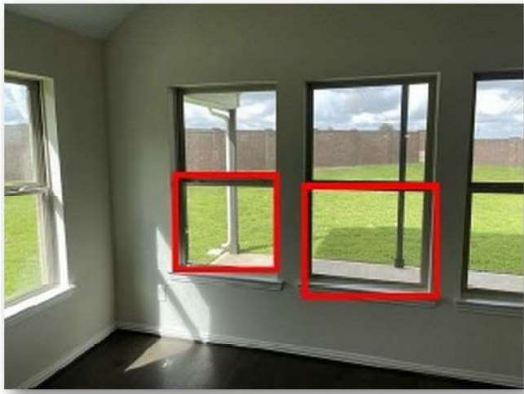
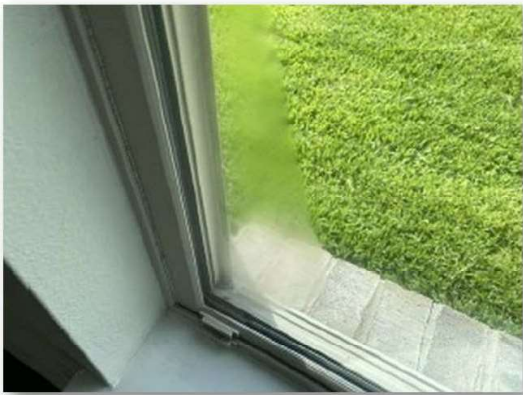
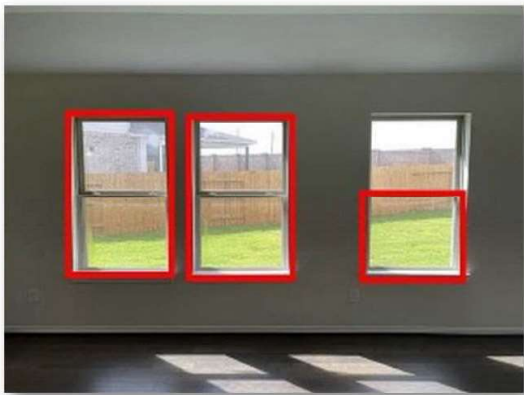
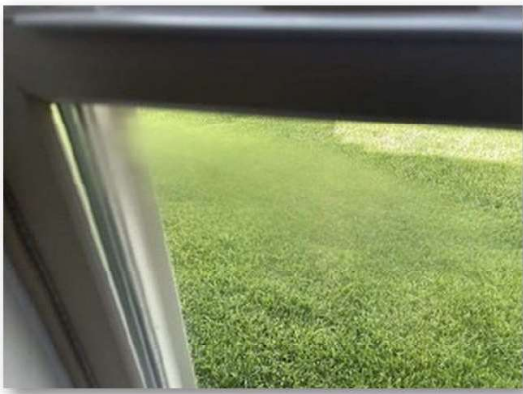
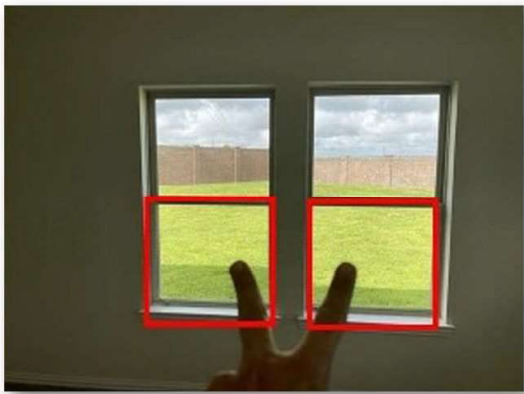
4. Laundry Room  
This was evident by the build up of condensation and / or discoloration between the two window panes. A qualified tradesman should be consulted to repair or replace the windows found deficient and evaluate the other windows in the property for additional lost seals.

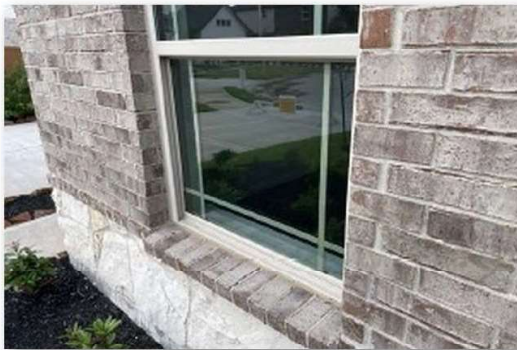
Missing window screens were noted at all of the windows. The builder should be consulted to determine if screens are normally installed with this home's windows.

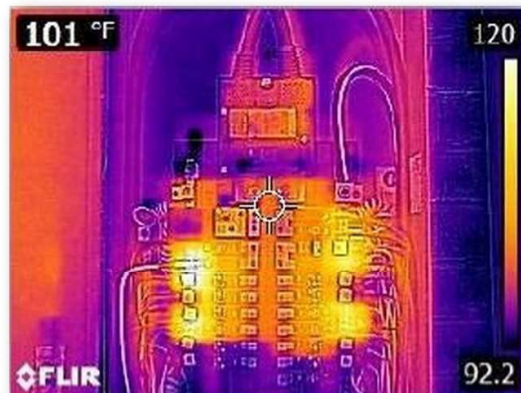
During the inspection of the electrical panel with a infrared camera significant abnormalities were not noted. The picture(s) below are a sampling of some image(s) taken during the inspection.

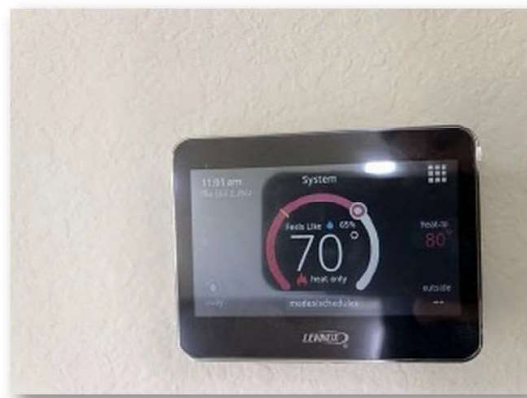
The gas heater (1) is not functioning as intended at the time of the inspection. The gas did not ignite properly during the inspection. A licensed HVAC technician should be consulted to completely evaluate the heater and make the necessary repairs.

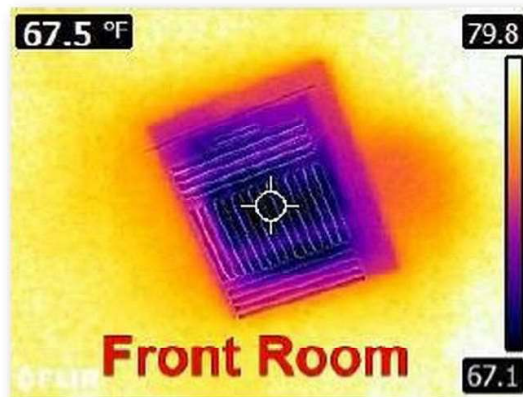
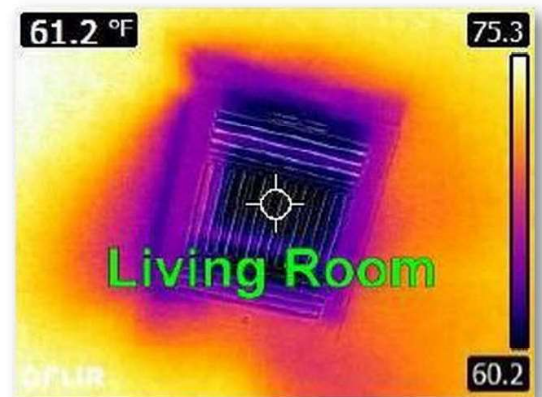
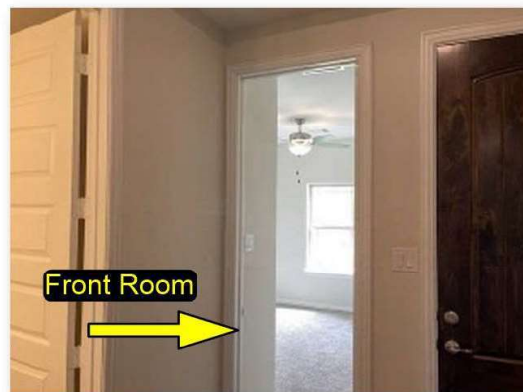
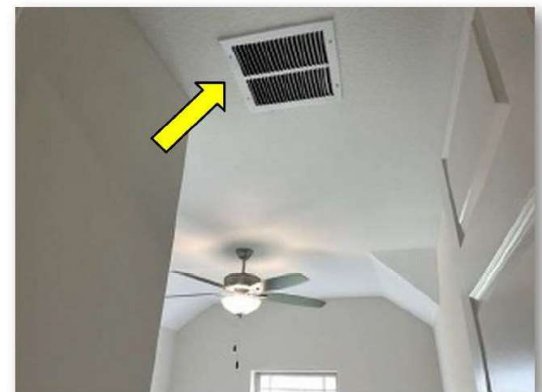
A temperature variance was measured between the front guest bedroom and the rest of the home in the property.. Improvements into the airflow and other solutions should be considered.

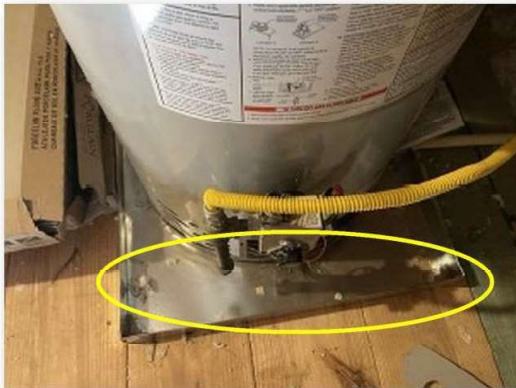
The emergency drain pan is in need of cleaning. The build up of debris in the pan could clog the drain line and cause water to easily overflow onto the ceiling.

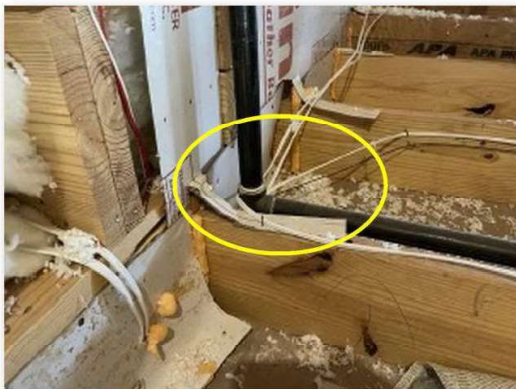
Conductors in contact with metal gas lines

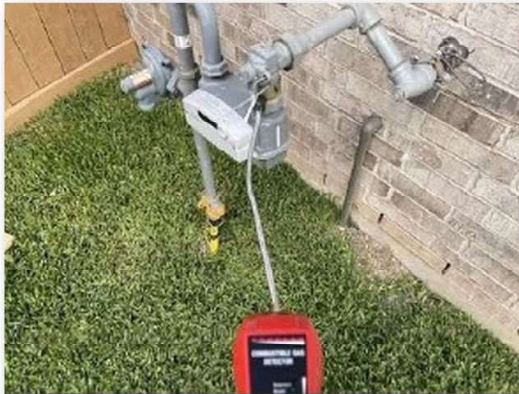
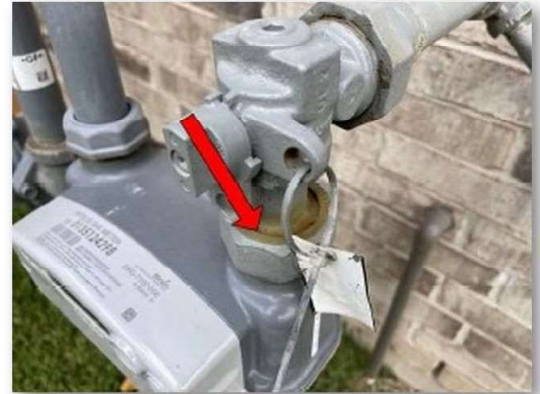
A gas leak was detected at meter. Recommend repairs by a contractor as soon as possible. This is a serious safety issue.

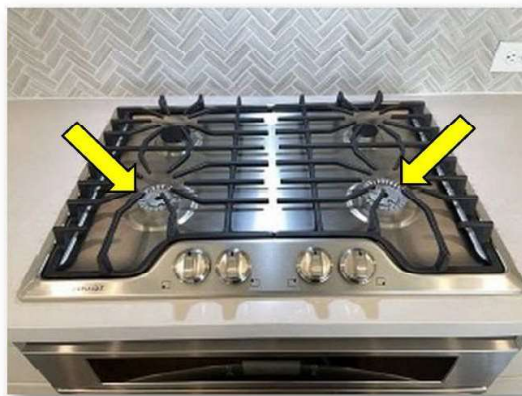
The cooktop burner covers are missing at the two front burners.
