Voliro LPS Sample Report Q2 2025

Project Information			
Project Name	Sample report	Report ID	Sample report
Inspection Date	2025-07-18	Report Date	2025-07-22
Report Version	1.0	Location	Europe

Asset Information			
Name	Vestas WTG XX	Material

Inspection Equipment - NDT			
Device Type	LPS	Manufacturer	Voliro
Model	Micro-Ohmmeter VG-BAT-150 special

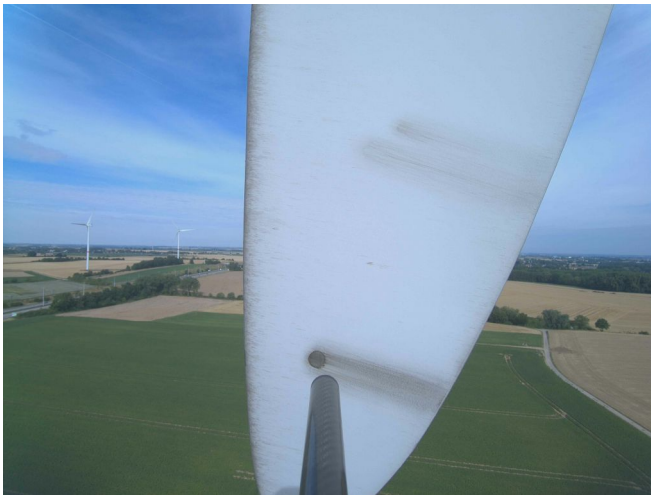
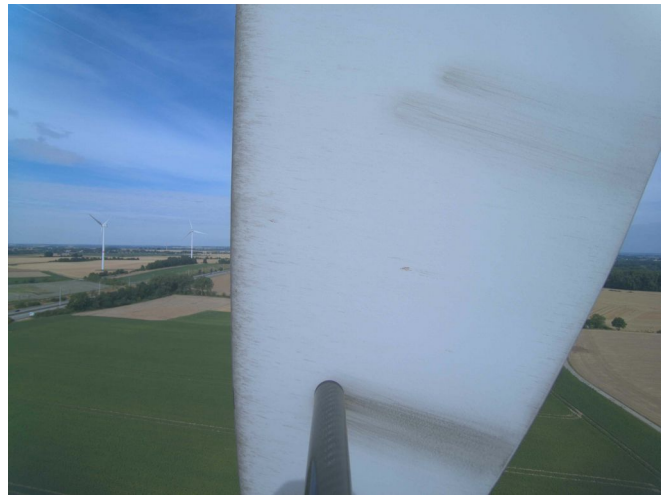
2.1.1 Inspection Point "Blade A - Pressure Side - 1"

Measured Value	3.257 Ω	Nominal Value	-
GPS Position	N/A	Local Position	-1.322m, 1.379m, 60.387m
Platform Orientation	-80°	Platform Inclination	0°
UTC Date & Time	2025-07-18, 09:57:27	Comment

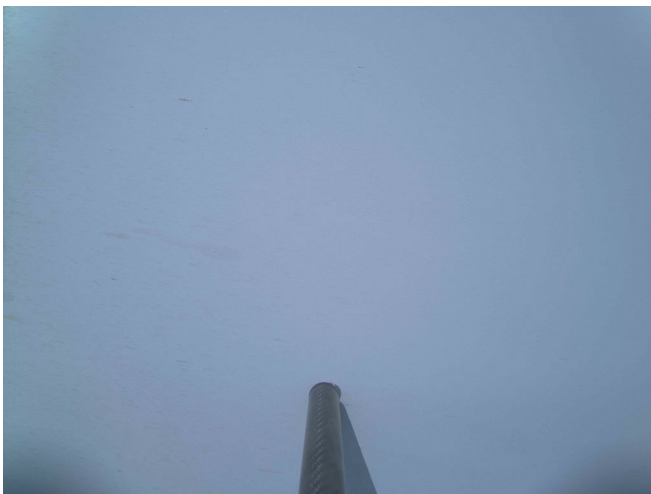
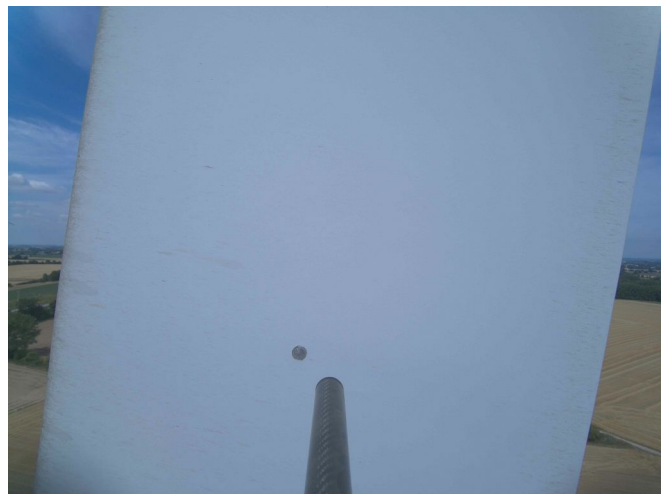
2.1.2 Inspection Point "Blade A - Pressure Side - 2"

Measured Value	3.499 Ω	Nominal Value	-
GPS Position	N/A	Local Position	-0.866m, 1.221m, 63.140m
Platform Orientation	-79°	Platform Inclination	0°
UTC Date & Time	2025-07-18, 09:56:38	Comment

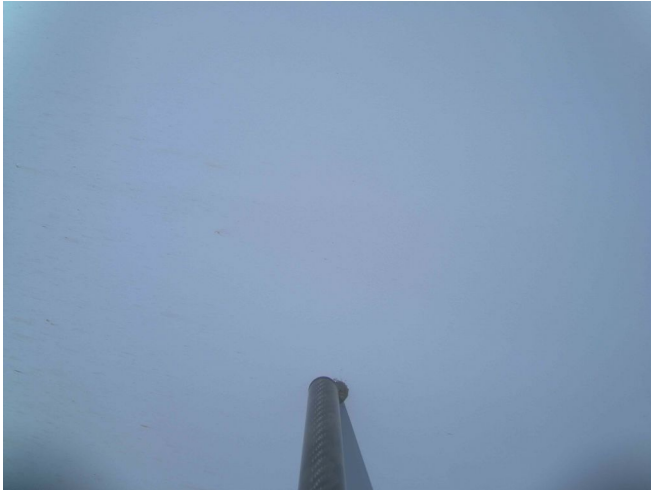
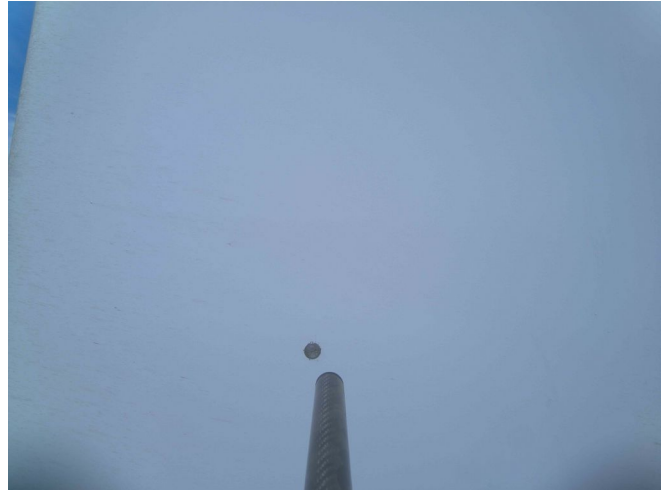
2.1.3 Inspection Point "Blade A - Pressure Side - 3"

Measured Value	3.270 Ω	Nominal Value	-
GPS Position	N/A	Local Position	-0.487m, 1.110m, 66.082m
Platform Orientation	-76°	Platform Inclination	-1°
UTC Date & Time	2025-07-18, 09:55:50	Comment

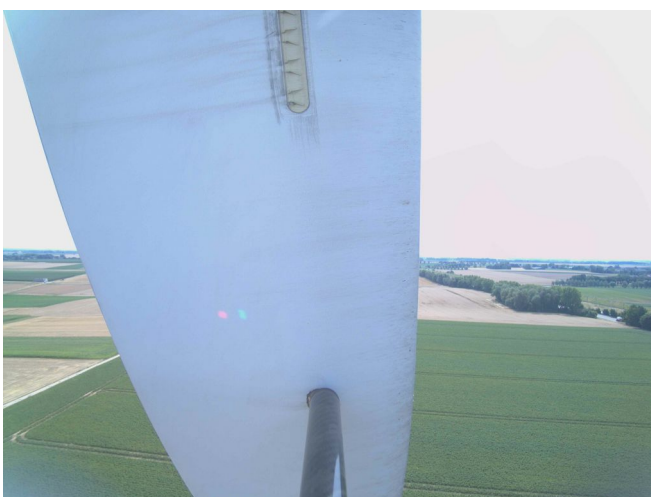
2.1.4 Inspection Point "Blade A - Suction Side - 1"

Measured Value	4.486 Ω	Nominal Value	-
GPS Position	N/A	Local Position	-1.079m, 2.293m, 60.365m
Platform Orientation	107°	Platform Inclination	0°
UTC Date & Time	2025-07-18, 09:51:56	Comment

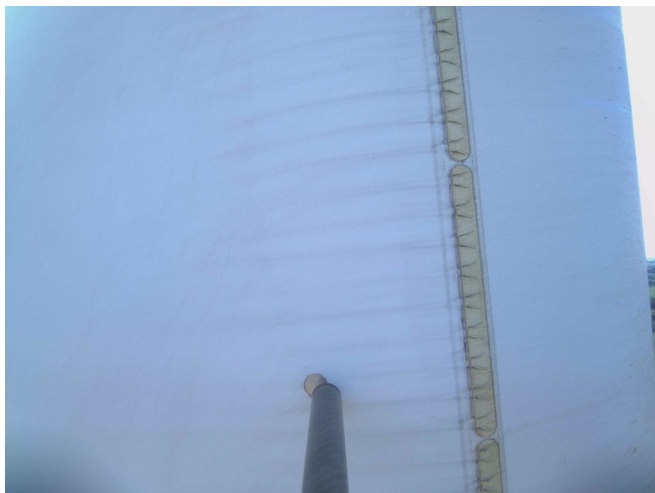
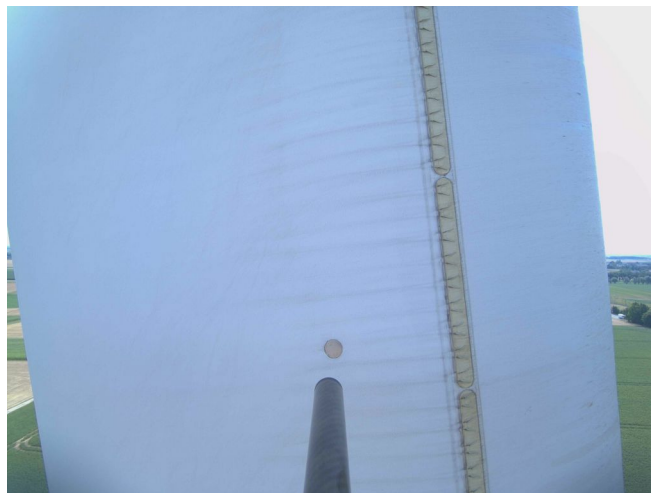
2.1.5 Inspection Point "Blade A - Suction Side - 2"

Measured Value	4.908 Ω	Nominal Value	-
GPS Position	N/A	Local Position	-0.585m, 2.233m, 63.136m
Platform Orientation	107°	Platform Inclination	0°
UTC Date & Time	2025-07-18, 09:53:11	Comment

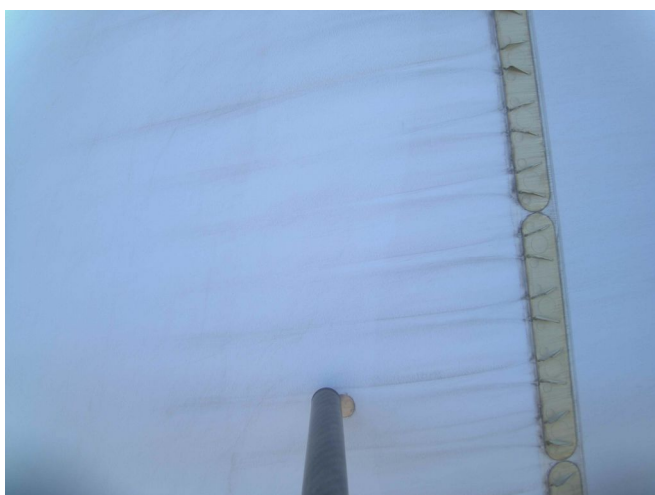
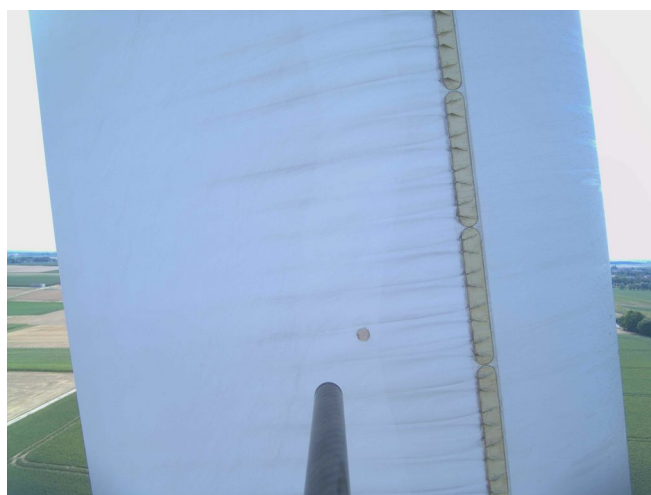
2.1.6 Inspection Point "Blade A - Suction Side - 3"

Measured Value	3.567 Ω	Nominal Value	-
GPS Position	N/A	Local Position	-0.161m, 2.119m, 66.103m
Platform Orientation	106°	Platform Inclination	0°
UTC Date & Time	2025-07-18, 09:53:58	Comment

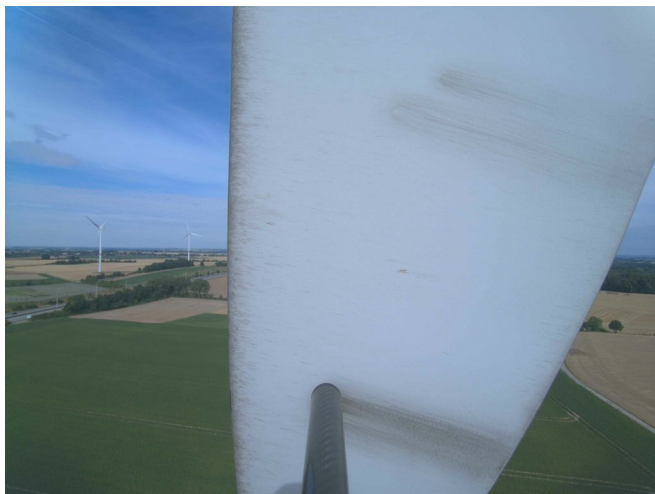
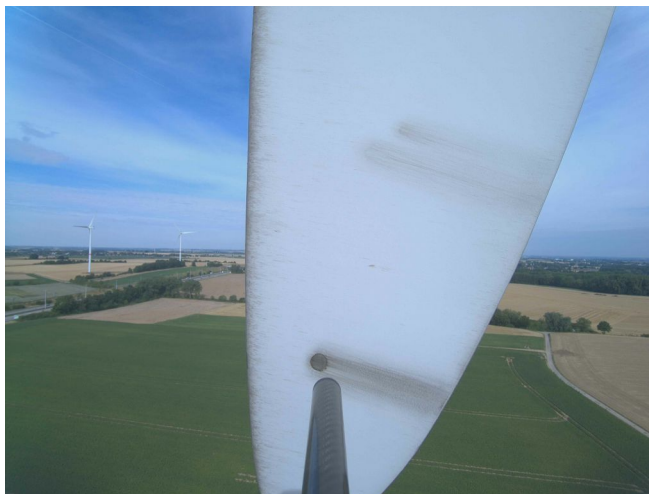
2.2.1 Inspection Point "Blade B - Pressure Side - 1"

Measured Value	1.956 Ω	Nominal Value	-
GPS Position	N/A	Local Position	-0.839m, 1.341m, 63.104m
Platform Orientation	-75°	Platform Inclination	0°
UTC Date & Time	2025-07-18, 09:29:24	Comment

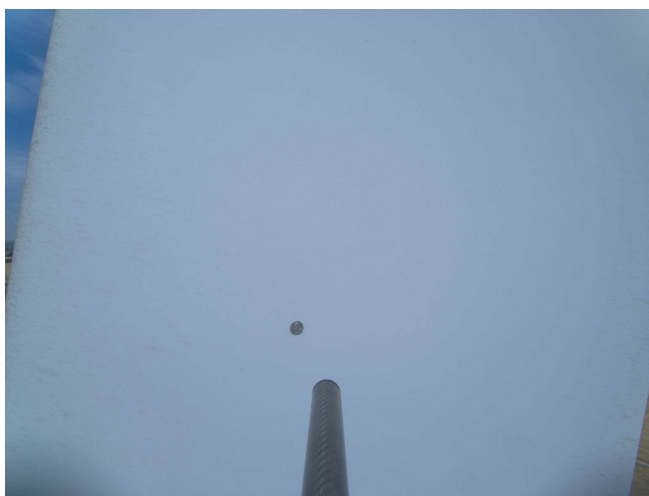
2.2.2 Inspection Point "Blade B - Pressure Side - 2"

Measured Value	2.887 Ω	Nominal Value	-
GPS Position	N/A	Local Position	-0.408m, 1.228m, 66.072m
Platform Orientation	-78°	Platform Inclination	0°
UTC Date & Time	2025-07-18, 09:28:03	Comment

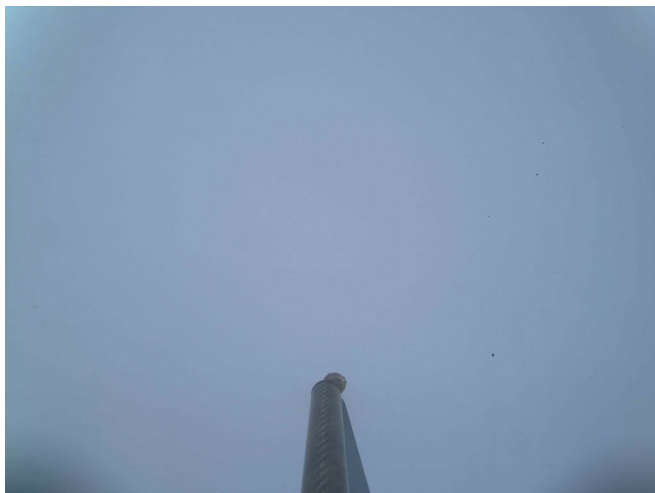
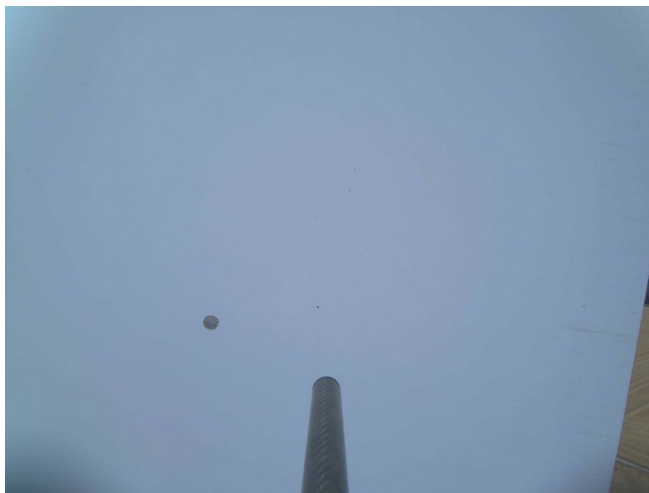
2.2.3 Inspection Point "Blade B - Pressure Side - 3"

Measured Value	2.883 Ω	Nominal Value	-
GPS Position	N/A	Local Position	0.120m, 1.069m, 70.018m
Platform Orientation	-76°	Platform Inclination	0°
UTC Date & Time	2025-07-18, 09:27:03	Comment

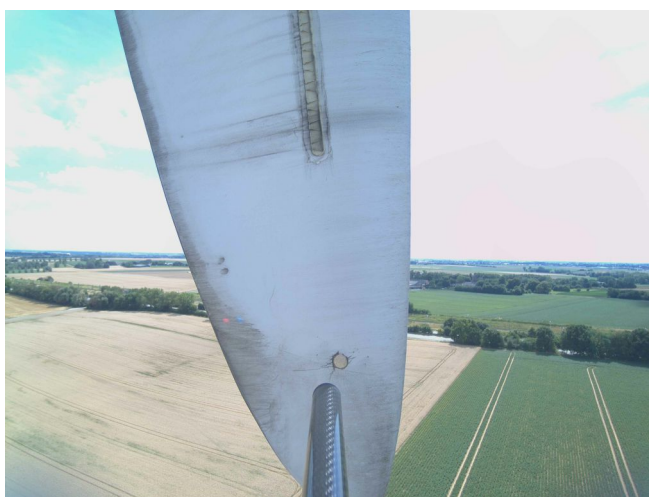
2.2.4 Inspection Point "Blade B - Suction Side - 1"

Measured Value	2.480 Ω	Nominal Value	-
GPS Position	N/A	Local Position	-0.549m, 2.321m, 63.045m
Platform Orientation	104°	Platform Inclination	0°
UTC Date & Time	2025-07-18, 09:31:38	Comment

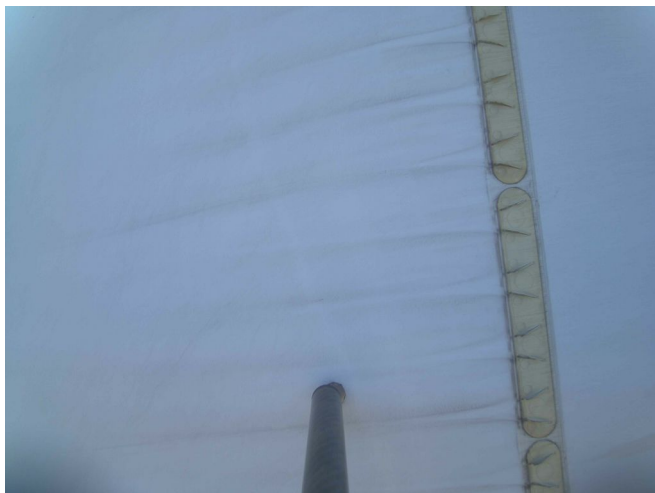
2.2.5 Inspection Point "Blade B - Suction Side - 2"

Measured Value	3.018 Ω	Nominal Value	-
GPS Position	N/A	Local Position	-0.136m, 2.229m, 66.025m
Platform Orientation	104°	Platform Inclination	0°
UTC Date & Time	2025-07-18, 09:32:32	Comment

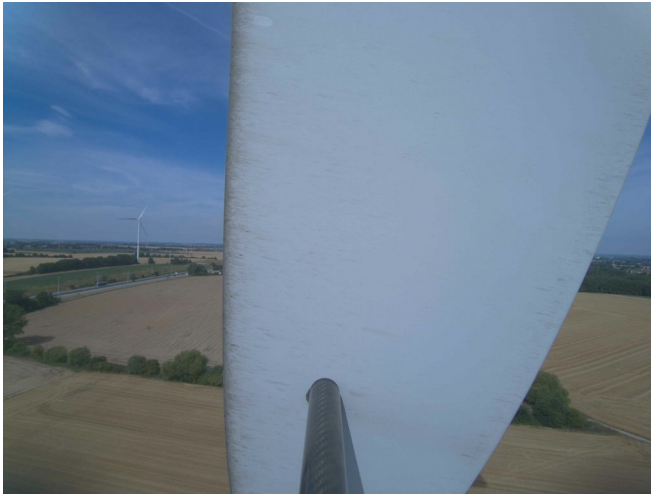
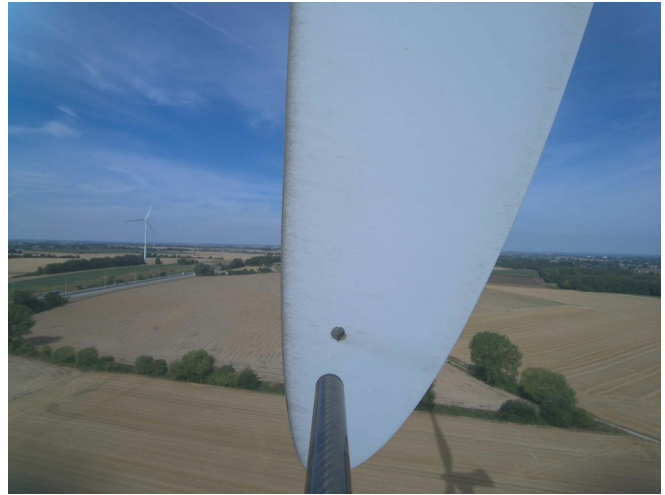
2.3.1 Inspection Point "Blade C - Pressure Side - 1"

Measured Value	2.745 Ω	Nominal Value	-
GPS Position	N/A	Local Position	-1.387m, 1.517m, 60.264m
Platform Orientation	-79°	Platform Inclination	0°
UTC Date & Time	2025-07-18, 09:04:34	Comment

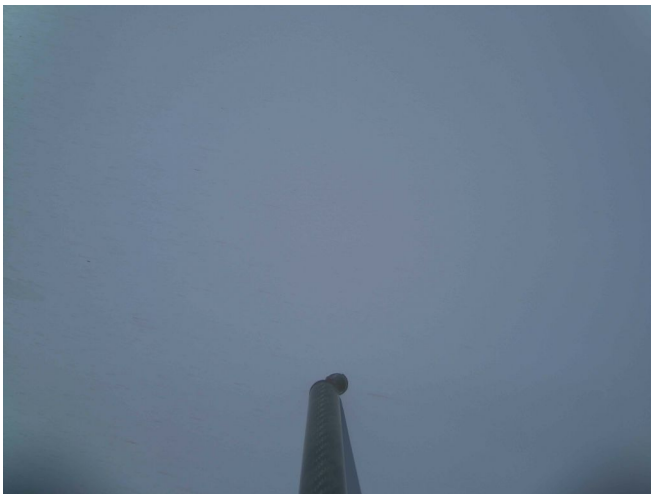
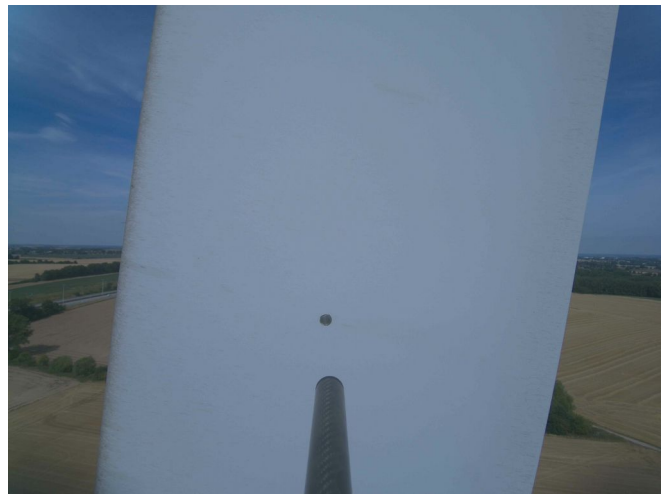
2.3.2 Inspection Point "Blade C - Pressure Side - 2"

Measured Value	1.737 Ω	Nominal Value	-
GPS Position	N/A	Local Position	-0.961m, 1.374m, 62.984m
Platform Orientation	-77°	Platform Inclination	0°
UTC Date & Time	2025-07-18, 09:03:41	Comment

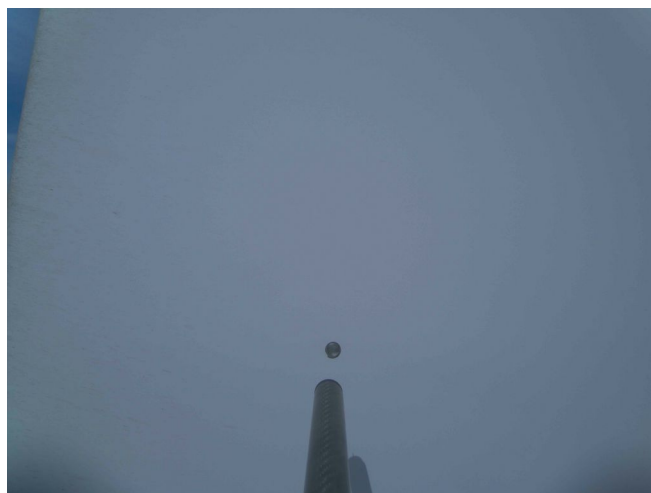
2.3.3 Inspection Point "Blade C - Pressure Side - 3"

Measured Value	1.735 Ω	Nominal Value	-
GPS Position	N/A	Local Position	-0.535m, 1.266m, 65.959m
Platform Orientation	-78°	Platform Inclination	0°
UTC Date & Time	2025-07-18, 09:02:46	Comment

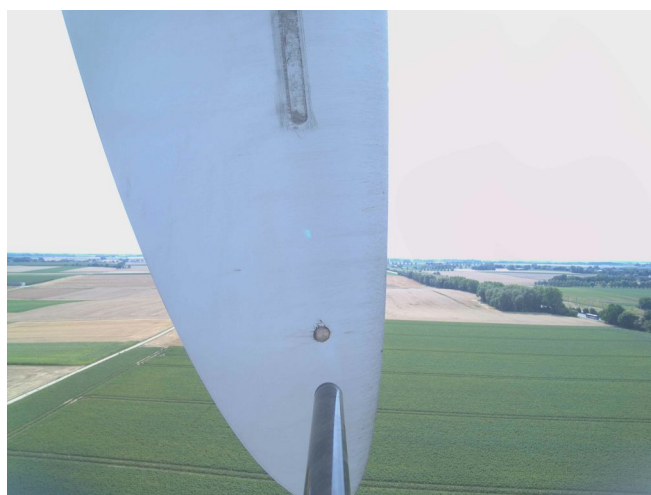
2.3.4 Inspection Point "Blade C - Suction Side - 1"

Measured Value	4.017 Ω	Nominal Value	-
GPS Position	N/A	Local Position	-1.130m, 2.422m, 60.240m
Platform Orientation	108°	Platform Inclination	0°
UTC Date & Time	2025-07-18, 08:58:15	Comment
