Année 2024 - 2025

Heritage inventory Chamberaud

Licence 3 –
Géographie et Aménagement :
Valorisation du Patrimoine et
Développement Territorial

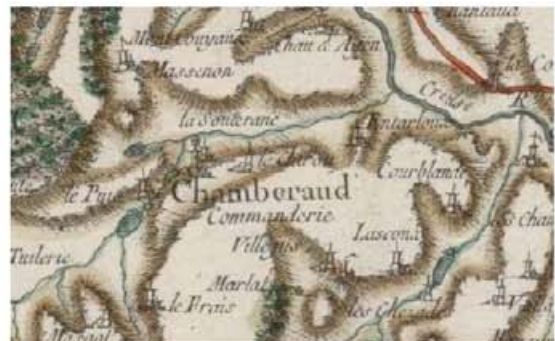
Source: Cassini map - Geoportal

This map shows the commandery, as well as three of the hamlets that make up the commune today: Le Puy, Le Chiron, and La Souterraine (or "La Souterane"). The other hamlets are not identified, perhaps due to lack of space, or perhaps those mentioned represent

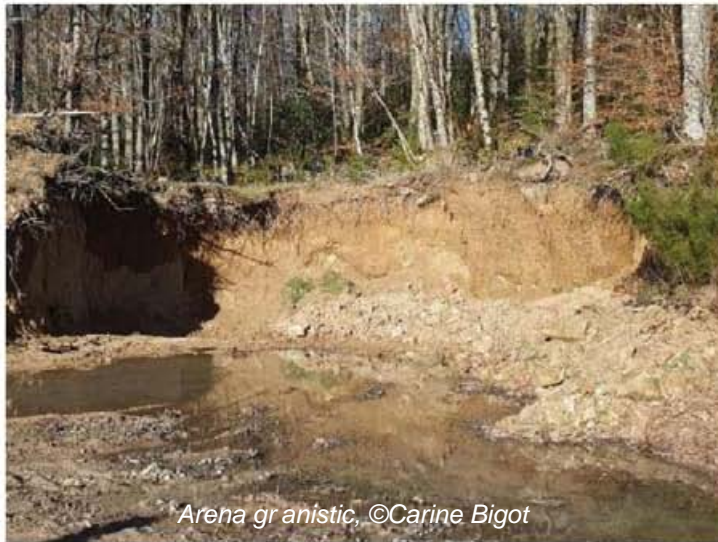
Arena granítica, ©Carine Bigot

Granitic sand, pictured on the left, is a coarse sand formed gradually over time through various erosion processes. Under the action of water that runs off and seeps into fissures (joints), the softer minerals in the **granite** (micas and feldspars) weather. Quartz, however, remains unaltered. The rock then loses its cohesion and disintegrates. Once **screened**, granitic sand is used as **aggregate** in **subgrade layers** under roads or buildings. It serves as a **drainage fill** or **filtering sub-base** because it is both stable and permeable. It remains a **useful, economical, and locally sourced material** for secondary layers or traditional finishes.

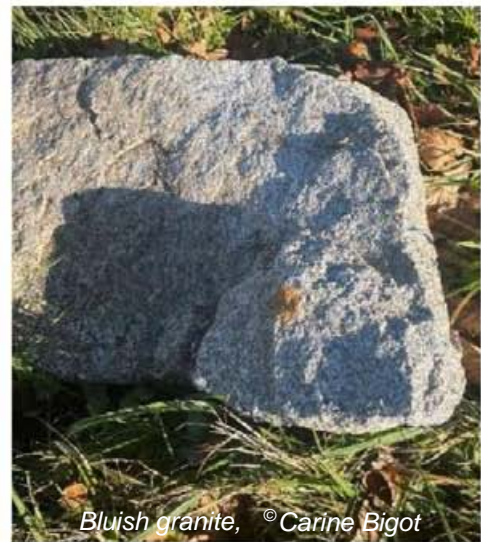
Bluish granite, ©Carine Bigot

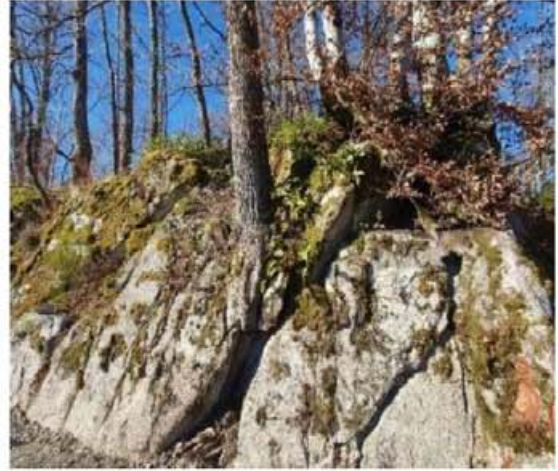
Granite chaos, ©Carine Bigot

Below is an example of granite **chaos** , a type of rock formation found extensively in Chamberaud. This chaotic landscape consists of a **disordered collection of granite blocks**, piled up or scattered across the slopes and plateaus. It is formed by the **deep spheroidal weathering of granite**, creating boulders within the rock mass, followed by the **disintegration of the granitic sand**. Erosion **eventually exposes** these **blocks**, creating a characteristic **landscape** surrounded.

known as "chaos." Within certain fissures in this landscape, we can observe tree species that have grown, illustrating remarkable adaptation to harsh conditions. Nutrients have become trapped there, providing the tree with an opportunity to thrive. The trees of Chamberaud are adaptable because the soils of Chamberaud are formed from the **dissolution and weathering of granite**. These soils are generally infertile, although their **properties** can vary depending on their **composition** and the **weathering** processes involved .

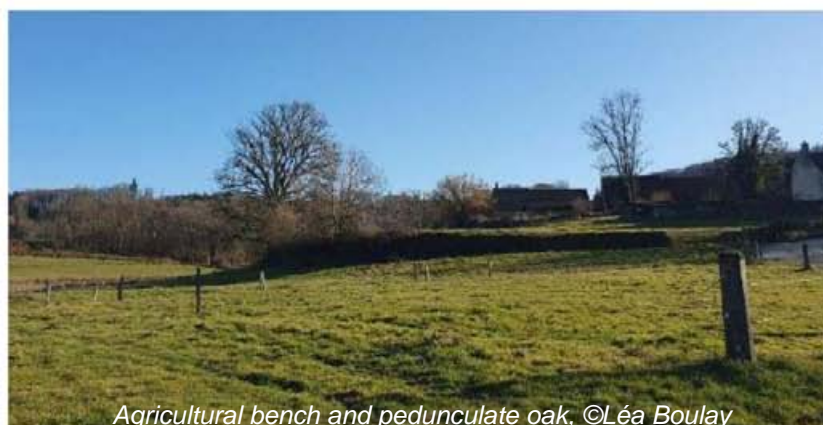
Agricultural bench and pedunculate oak, ©Léa Boulay

These terraces are strips of land with embankments, and they are a significant feature of the Chamberaud landscape. They are accumulations of sediments from past agricultural practices, which gave the soil a rich nutrient content. Above, a pedunculate oak was able to take root there, under the favorable conditions of the time. (See page 108)

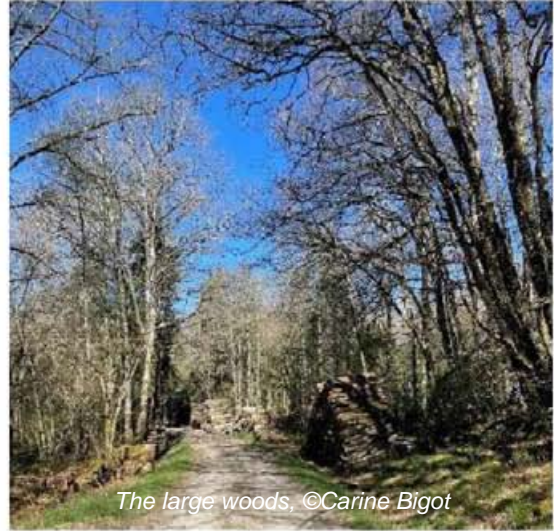
The large woods, ©Carine Bigot

But it is also a recreational area; the white path above, crossing the large woods, is a hiking trail, but it is also used by forestry vehicles. The large woods are divided into several private properties, each adhering to management plans.

The large wood is both a place of production and a place of recreation, the two coexist, but some corners of the path are rugged and damaged by the passage of large vehicles.

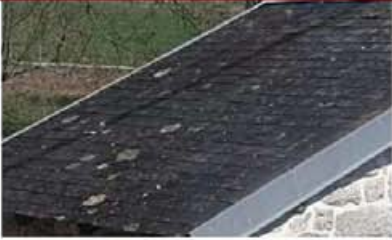
<i>21 The Chiron</i>	The Chiron
Mechanical tiles	Mechanical tiles are manufactured using machines that compress the raw material, concrete or terracotta, to then mold the tile and give it its shape.

Roofs			
Materials	Definition	Illustration	Main location(s)
Slate	Soft and flaky stone, schist, used in thin slabs for roofing.

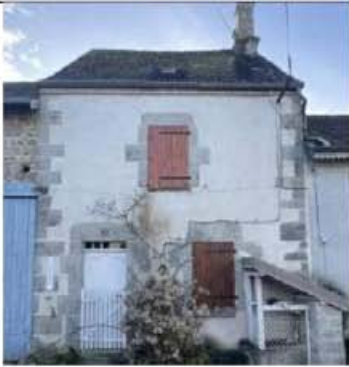
13 Le Puy	Le Puy There Commandery
Tyrolean plastering	Sprayed coating in one or more layers, from top to bottom, with a mechanical machine called a "tyrolean gun" (formerly manually with a broom) or with the aid of a pneumatic gun.

Le Puy	Le Puy
Lime plaster	Lime plaster completely covering the stone. Generally, the dressed stone corner quoins are visible.

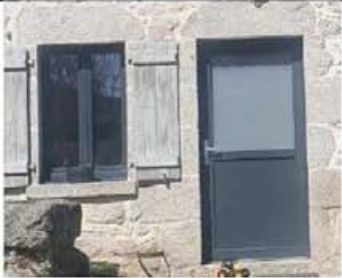
<p>21 The Chiron</p>	Non-specific

<p>1. The Chiron</p>	Non-specific
PVC	PVC became dominant in the building market in the 1980s.

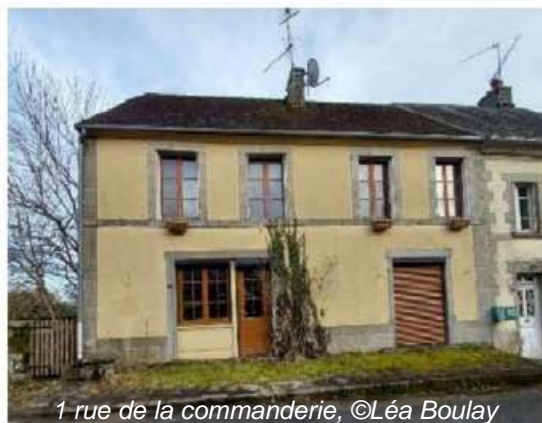
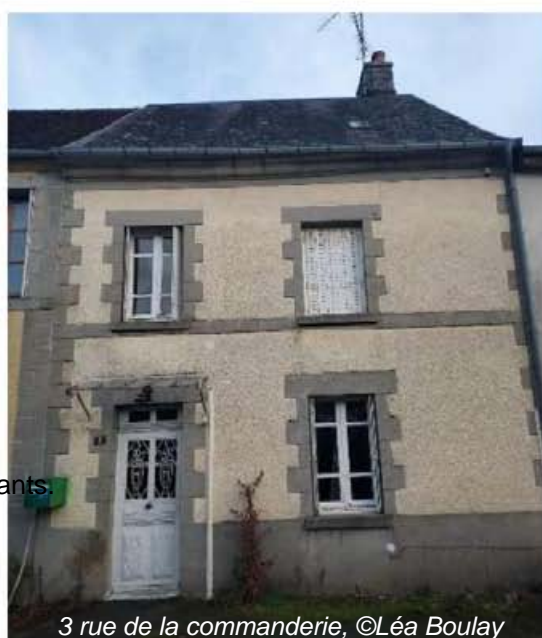
The house at 1 Rue de la Commanderie, for example, bears a striking resemblance to the houses built by returning migrants. Indeed, during their travels, these stonemasons from the Creuse region, particularly during the Haussmann era, had the opportunity to draw inspiration from these architectural innovations and bring them back to Chamberaud. This explains why, in the town centers and elsewhere, one can see facades with Tyrolean-style plasterwork, attempts at symmetry, and a continuous stringcourse running the length of the facade.

Although Chamberaud no longer has any shops or facilities, it was once a bustling hub of activity. These activities can leave their mark on the architecture, as is the case at 1 Rue de la Commanderie, where the frame of the former shop window is still visible. Indeed, this building once housed a grocery store, which also had a public telephone.

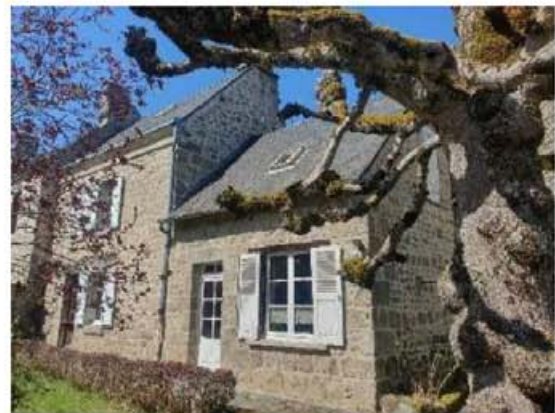
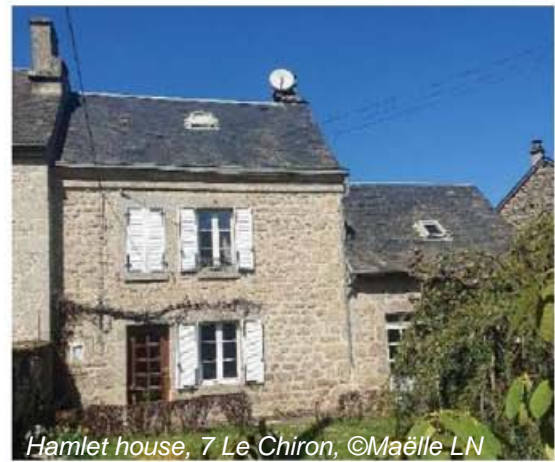
Hamlet house, 7 Le Chiron, ©Maëlle LN

For example, this house located at 7 Le Chiron is a hamlet house. (See page 217)

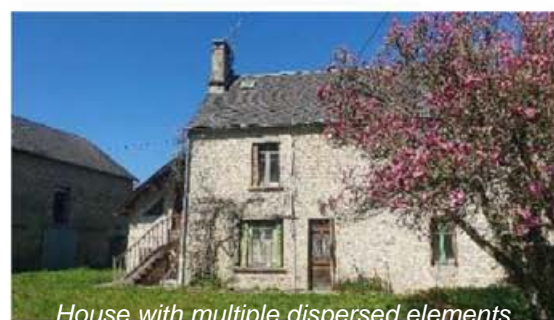
5 Le Chiron, ©Maëlle LN

House with multiple dispersed elements

For example, this house located at 5 le Chiron is a so-called house with multiple dispersed elements. Indeed, the barn section is not attached to the living quarters. (See page 215)

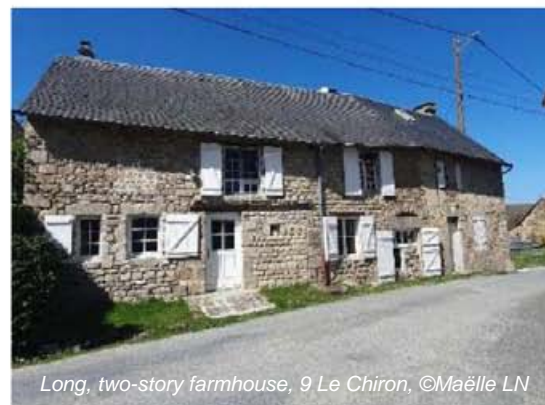
For example, the two-story farmhouse at 9 Le Chiron has been beautifully renovated and now possesses the characteristics mentioned above. (See page 219)

It is noticeable that the former living quarters may have initially been only the central section; the right-hand side could have been added later. The barn section was on the left of the image. The lintels and window and door frames are made of dressed stone, granite; the lintel above what may once have been a barn door is made of wood. There are numerous openings on the main facade, which faces southeast. The barn section conforms to the Limousin barn typology described below. Furthermore, according to the current owner, this building was once a café in Chiron.

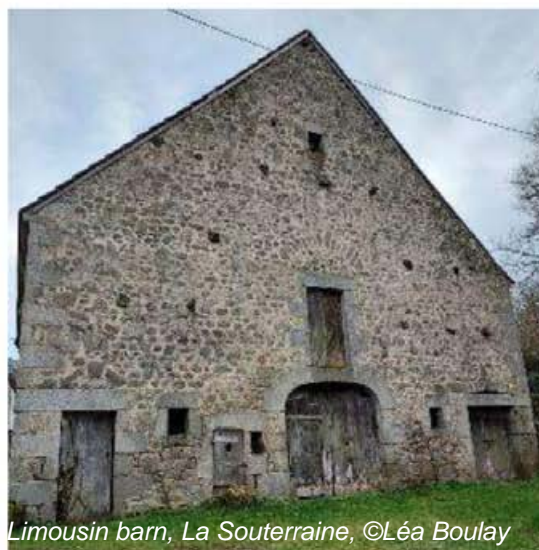
Limousin barn, La Souterraine, ©Léa Boulay

The Limousin barn is one of the typical barns of the Massif Central and more specifically of the Limousin.

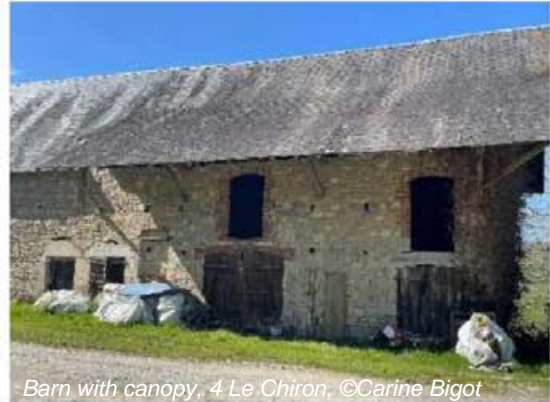
Barn with canopy, 4 Le Chiron, ©Carine Bigot

The canopy is a roof extension that extends well beyond the main facade. It serves, among other things, to protect from rain or sun the people who worked just in front of the barn (for example, threshing wheat, sorting, repairing tools, etc.), to shelter agricultural equipment (carts, tools, bales of hay, etc.) and to dry certain crops under cover.

In Chamberaud, these barns with overhanging roofs are often also Limousin barns or even longhouses. Like this building located at 4 Le Chiron, it combines the characteristics of a barn with an overhanging roof, a Limousin barn, and a two-story longhouse. (See page 213)

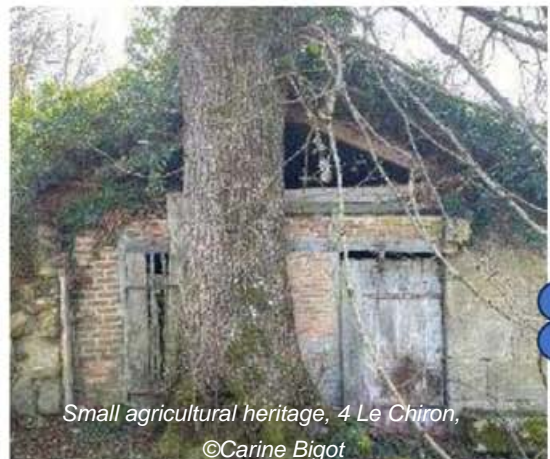
Small agricultural heritage, 4 Le Chiron, ©Carine Bigot

This property has a few noteworthy features. The small agricultural building on the property (perhaps a henhouse, pigsty, or something similar) is adorned with reused stones, a small column, and a Maltese cross (see page 214). The barn with its overhanging roof also features such stones, a Maltese cross, and the symbol of masons or Freemasons with the hammer and compass (the stones in question are hidden behind debris, so we don't have a picture to show).

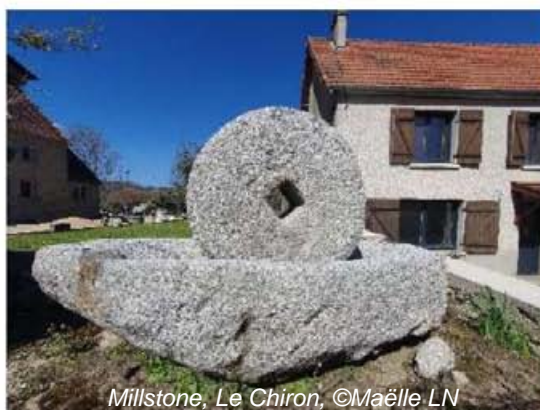
This mark is that of the millstone, which in Chamberaud was generally made of granite. These millstones could have been used by our farmers to grind grains such as oats or rye. Thanks to these millstones, flour could be made, for example. Clearly, in the photograph you can see a millstone that we believe to have been

It was used for flour, but it's possible it was also used for oil. However, over time the granite has worn away and the shapes that would have allowed this distinction have disappeared.

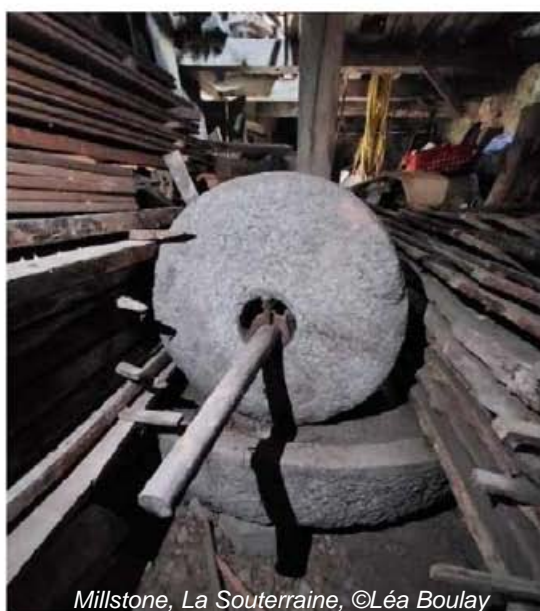
However, other types of millstones could be used with animal power, and this may be the case for the second type of millstone we encountered in the commune of Chamberaud. In the hamlet of La Souterraine, a millstone used for crushing fruit can be found.

including apples. This millstone, much wider than the previous one, still made of granite but with the iron axle still present, was used by turning, powered by an animal or a person, to make the pomace of the apples, from which the juice was subsequently pressed to make either fruit juice or cider. (See page 137)

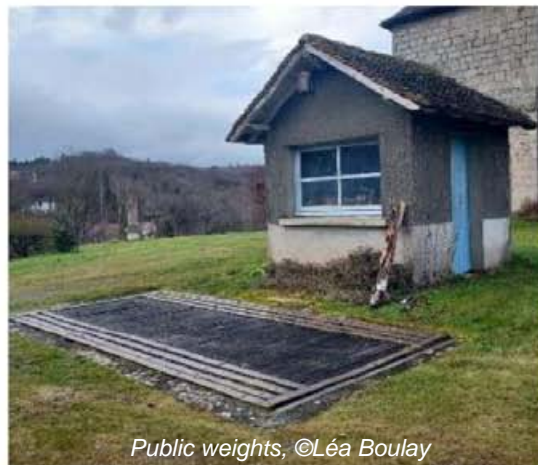
This building, located in front of the Saint Blaise church, was used to weigh animals but also materials.

It could be used during fairs and markets. The animal, or cart, would be brought to the platform in front of the weighbridge. The weight was then measured using instruments located inside the weighbridge. In Chamberaud, the public weighbridge remained in operation for a long time, until the 2000s.

Furthermore, the commune of Chamberaud was characterized by its crops, orchards, and also by its agricultural heritage. Indeed, livestock farming was present, primarily cattle, which could be raised for consumption. This livestock could be sold, and it was in this context that the public weighing scale was used. (See page 101)

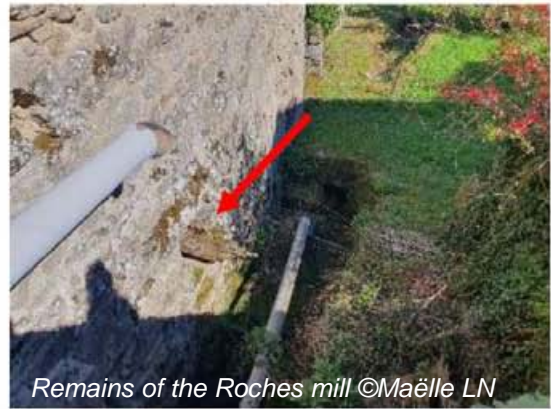
Remains of the Roches mill ©Maëlle LN

However, the remains of another mill can be found in the Rue des Roches.

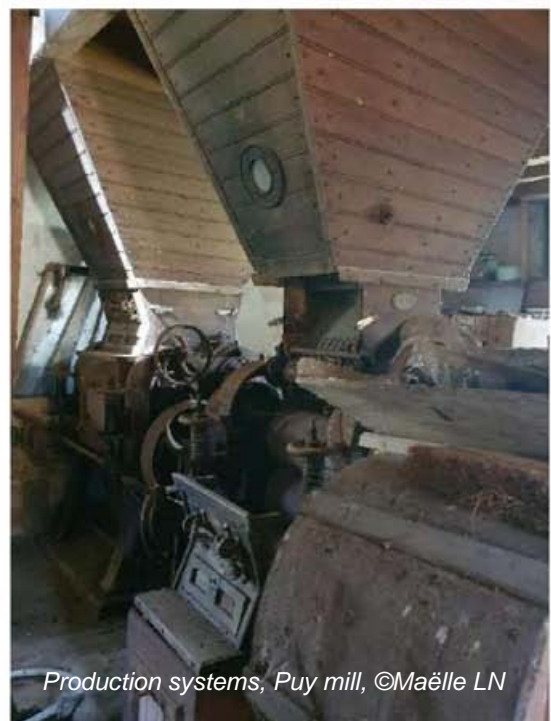
Production systems, Puy mill, ©Maëlle LN

Watermills are difficult to preserve because they are located in wetlands, unlike windmills. However, the one in Le Puy is quite well preserved; almost all of its mechanisms are still in place and mostly in good condition. Among other things, one can still find the bolting machine (a cylindrical sieve), the production systems mentioned earlier, the bucket elevators, the flour sacks, the mechanisms, and many other vestiges of its past activity. Today, all these elements have become essential to showcase, as there are only a few working watermills in France.

A project to enhance its value would therefore be worth studying in order to preserve it and perpetuate a part of this memory of Chamberaud.

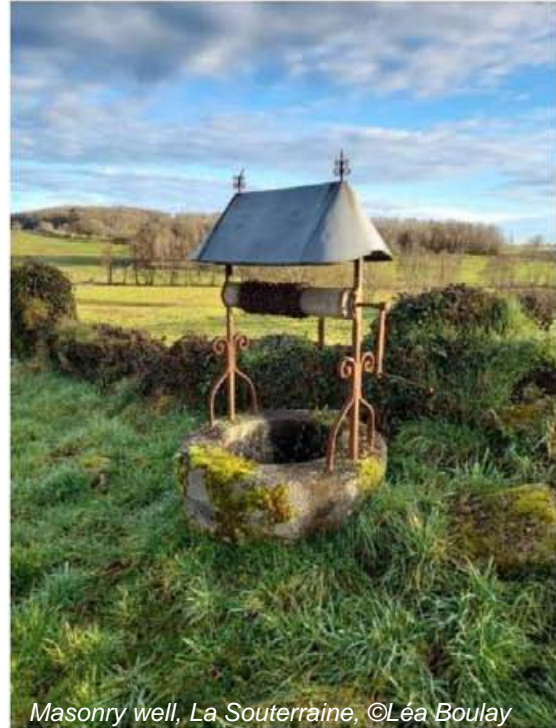
Masonry well, La Souterraine, ©Léa Boulay

For example, this masonry well located in La Souterraine, hamlet of Chamberaud, is well preserved and very representative although no longer in use. Indeed, we find the roof, here made of sheet metal, the wooden winch, the wrought-iron bracket and crank, and the granite curb. This well represents significant craftsmanship, judging by the scrolls adorning the roof and the bracket. Perhaps wells, like buildings, could thus affirm the social standing of their owners. (See page 136)

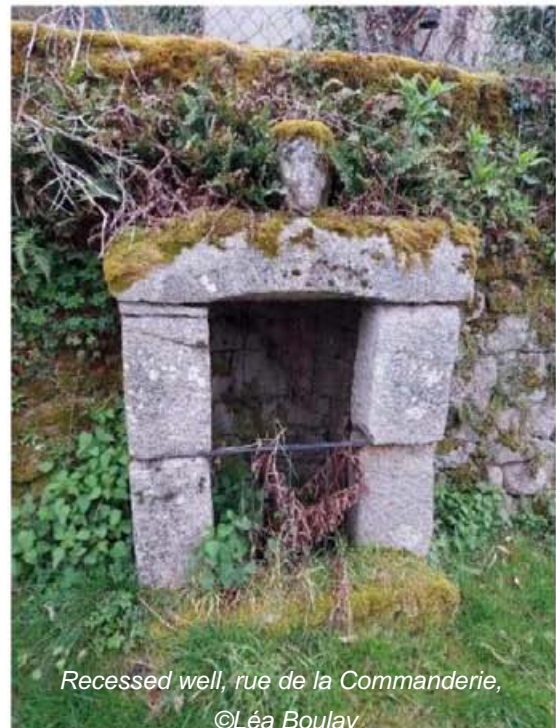
Recessed well, rue de la Commanderie, ©Léa Boulay

The materials usually found are: the stone coping (sometimes very discreet), the interior in masonry or dry stone, all often covered, with an integrated pumping system: pulley, bucket, or manual pump (piston, rocker...).

These wells were common in bourgeois houses, monasteries, old farms and castles. They served domestic purposes, maintaining a cool temperature (some were used as icehouses or coolers), and sometimes to conceal a private water source.

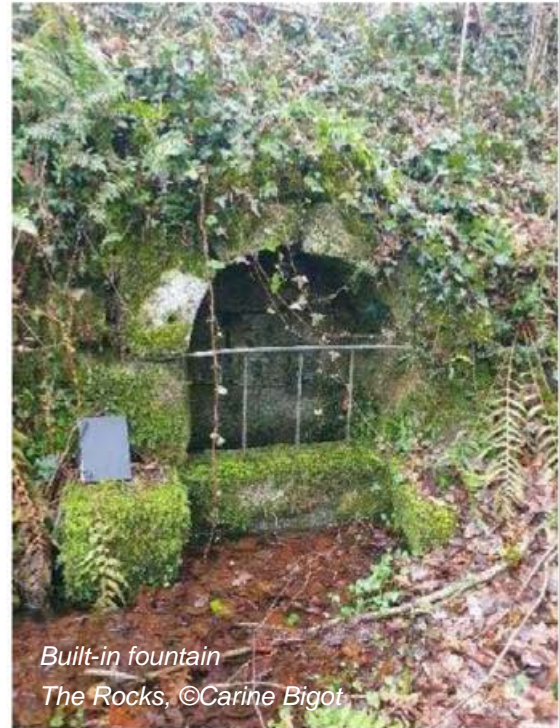
*Built-in fountain
The Rocks, ©Carine Bigot*

For example, this rather attractive built-in fountain is located in the undergrowth, beneath brambles and spontaneous vegetation. The surrounding area is becoming overgrown, but the fountain, made of dressed granite, remains quite visible. It stands on the path connecting the Commandery Church to the hamlet of Les Roches and its former numerous mills. This path was once paved, indicating its frequent use and thus highlighting the advantage of placing a fountain in this location. (See page 198)

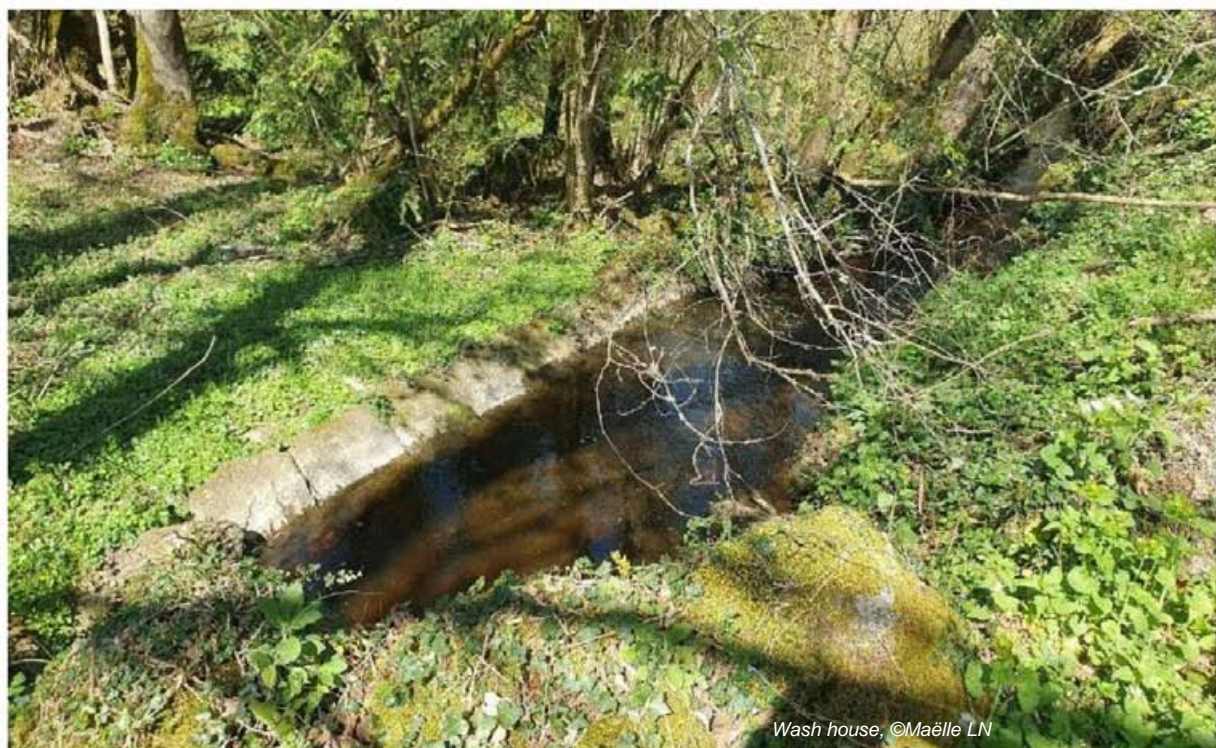
During our inventory, we were only able to discover one of the many wash houses that once existed in the town. Are they all still there somewhere, hidden and forgotten, or is this single wash house the last vestige of a rich past? It is located not far from the Puy mill and appears to have been restored, but no markings or maintenance measures are in place to ensure its continued existence. However, the water reservoir and the washing stones are still visible.

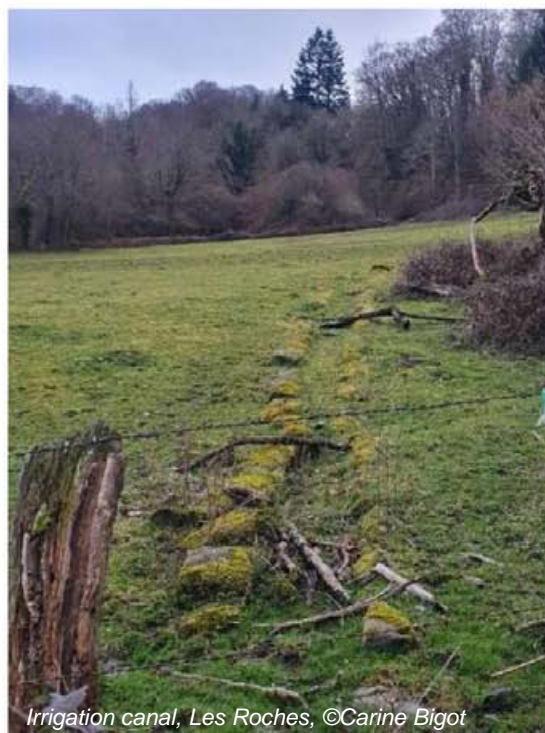
For example, we observed an irrigation canal on a plot of land by taking the path leading from the church to the hamlet of Roches.

This one is probably no longer in use today. It is slightly dug into the ground and surrounded by rubble stones. (See page 197)

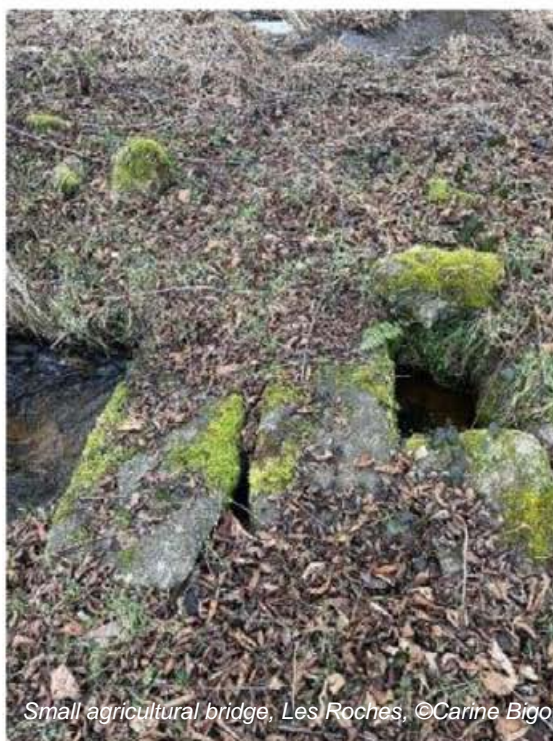
For example, this stone bridge is located along the same path as the irrigation canal seen previously. (See page 199)

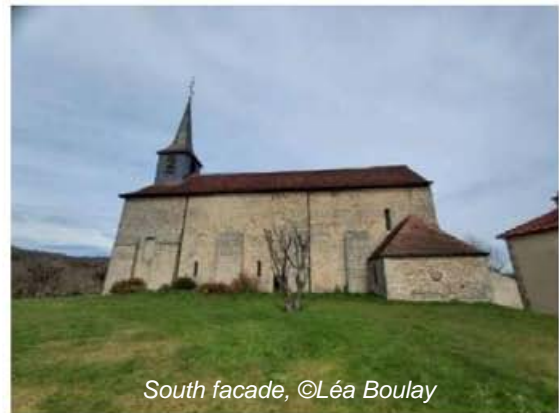
South facade, ©Léa Boulay

As observed while looking at the building, the windows are few, small, and some have been bricked up in order to limit the openings during attacks. Following this same logic, on the structure one can find low-density buttresses as well as traces

between 1337 and 1453. Furthermore, when examining the masonry, one quickly notices that the most altered elements are at the ends of the building, at the level of the porch tower, which underwent changes when the old commandery building was destroyed, consequently relocating the building's portal. Modifications are also found at the apse. Originally, on the east gable of the apse, which we will discuss in more detail later, was the sacristy, which is now located on the south facade. On this sacristy, one can find a keystone, a remnant of the old stone vaulting, which we will discuss later, depicting a carline thistle surrounded by its liernes. Also, to remind us that this church had a connection with the commandery, we can see two sundials on its facade, which must have been part of the former commandery. Furthermore, let's not forget that this is a place of worship, and for this reason, there is an opening on the side of the facade, now blocked, which served as an entrance for parishioners who did not enter through the main entrance. Inside the church, on either side of this blocked entrance, were holy water fountains.

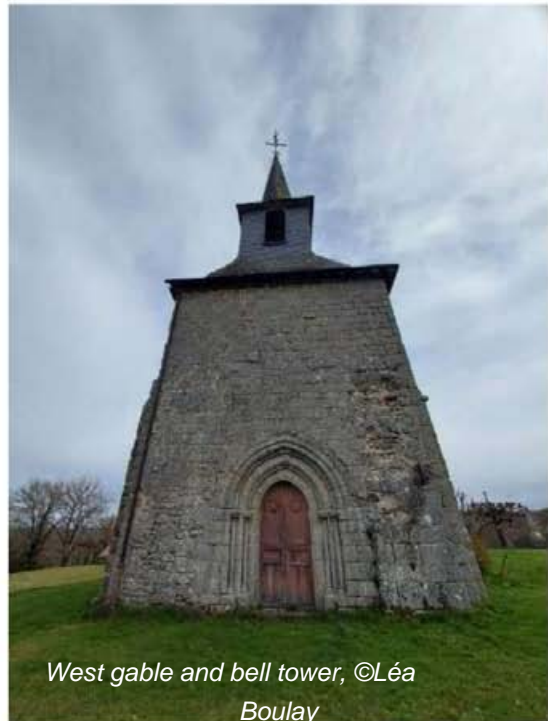
West gable and bell tower, ©Léa Boulay

Today, when one wants to enter the building, one finds oneself facing a very recent gable, crowned by a slate-covered bell tower, while the rest of the building has a tiled roof, since this entrance, as we have said previously, is not original; that is why the entrance is framed by a vault whose style is an imitation of Gothic, because it is much too recent (1879) to be considered Gothic art.

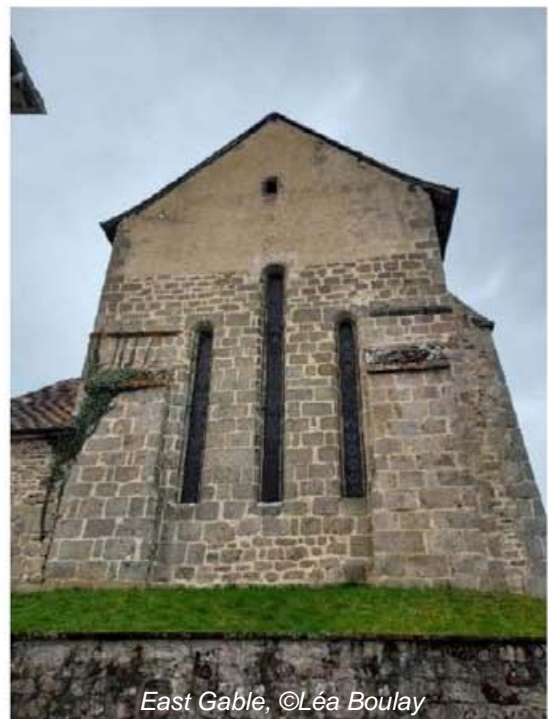
East Gable, ©Léa Boulay

Firstly, due to its height, the entire building was once shorter and even topped with a round tower. Secondly, the apse was opened up to accommodate the three long, narrow bays, into which stained-glass windows are set. Finally, as a last change to this section, one can

to note the presence of traces on the building due to former buttresses, higher up, which would have been removed later, possibly having become useless, since if there was indeed a round tower, these buttresses would have been used to support it but once it disappeared, they lost their usefulness.

Therefore, this building is indeed a heritage element to be preserved, as it is a trace of the origin of the town but which today is deteriorating due to a lack of resources.

Thus, this building, listed as a historical monument since 1991, needs funding for its restoration and enhancement. However, it is not the only trace of the Christian religious faith present in the town of Chamberaud.

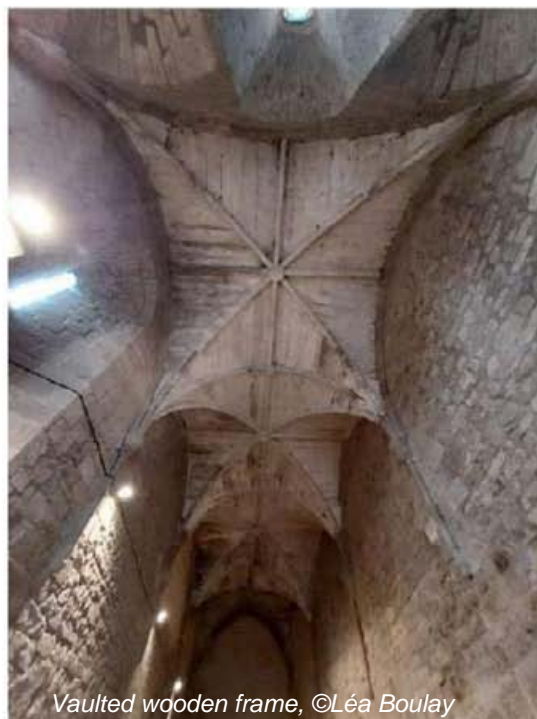
Vaulted wooden frame, ©Léa Boulay

Furthermore, today one can see a wooden, ogival-vaulted ceiling in this church, but this is not original and was likely added during the 18th century. Indeed, the church originally had a stone vault, which unfortunately collapsed. Nevertheless, the interior of the building retains traces of this former vaulting, as demonstrated by the stone columns supporting the roof structure, with polygonal capitals terminating in corbels that sometimes depict human faces.

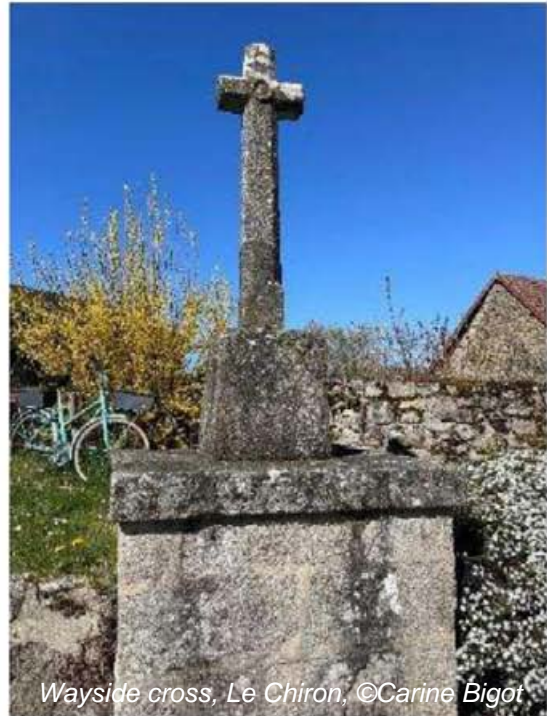
Wayside cross, Le Chiron, ©Carine Bigot

In the case of wayside crosses, they are located usually at an intersection, by the roadside. Its structure is made of granite, and consists of a base of cut granite, surmounted by another base this time of monolithic granite and topped by the cross.

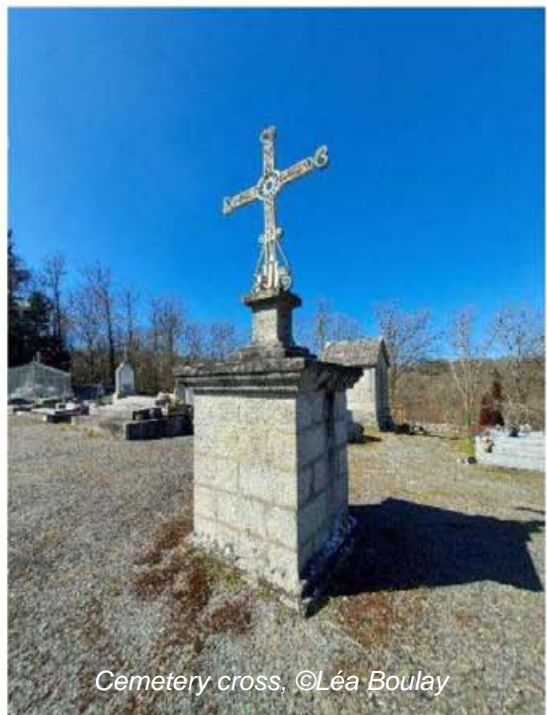
Cemetery cross, ©Léa Boulay

Furthermore, it is made of granite, but only its base and shaft; the rest is wrought ironwork, which is also highly symbolic because it features the shape of a heart, a reminder of what sustains human life. (See page 246)

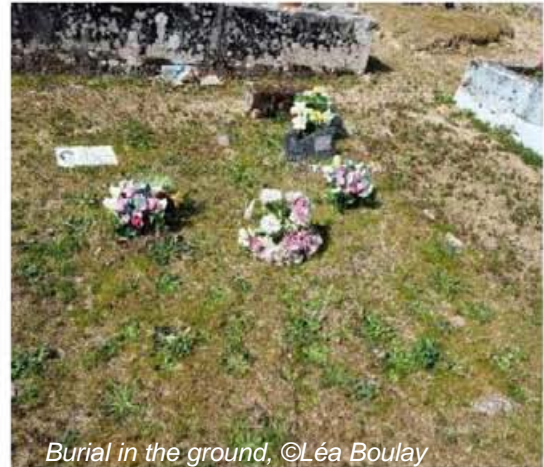
Burial in the ground, ©Léa Boulay

Burial directly into the ground is a fairly common burial practice in French cemeteries, and it can be found at Chamberaud. This particular burial is characterized by the complete absence of any surface structure; no headstone, base, tombstone, or foundation is present. It is recognizable as a burial site primarily thanks to the commemorative plaques that identify the individuals buried there. These plaques can be indicative of limited resources, as burial sites represent a significant investment. (See page 242)

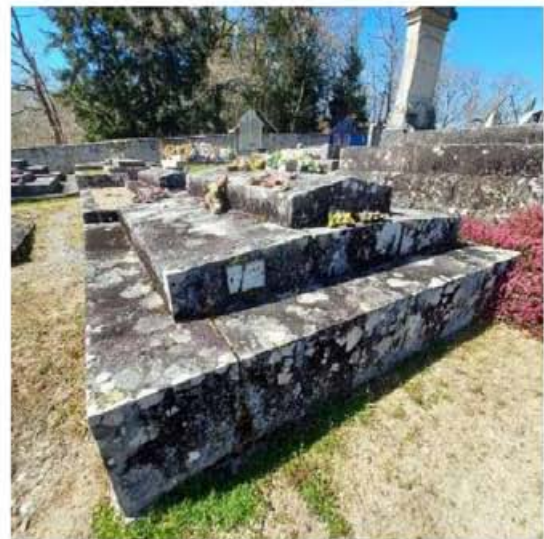
Communal tomb with multiple tombstones, ©Léa Boulay

This is the type of tomb that seems to be the most classic in Chamberaud, as this base is used for all types of burials when they involve exterior ornamentation. It consists of a stack of tombstones. Naturally, these tombstones are made of granite, a stone known for its durability.

It often happens that this type of tomb is not accompanied by a stele, as is the case in our attached example. (See page 243)

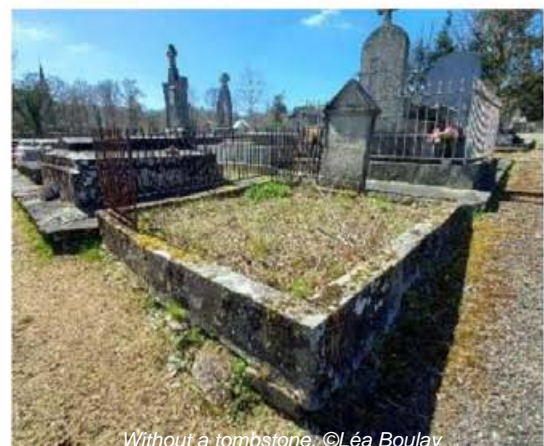
Without a tombstone, ©Léa Boulay

This type of grave marker is also very common in the Chamberaud cemetery; it consists of a simple pedestal, often surmounted at the head of the grave by a stele. This pedestal is a slab which will not be surmounted by a tombstone and which can either be a simple slab, carved from a single block of stone, or hollowed out to hold gravel so that the burial site can be decorated. The decorations can be flowers, commemorative plaques, or plants rooted in the grave, which has become a garden space. (See page 244)

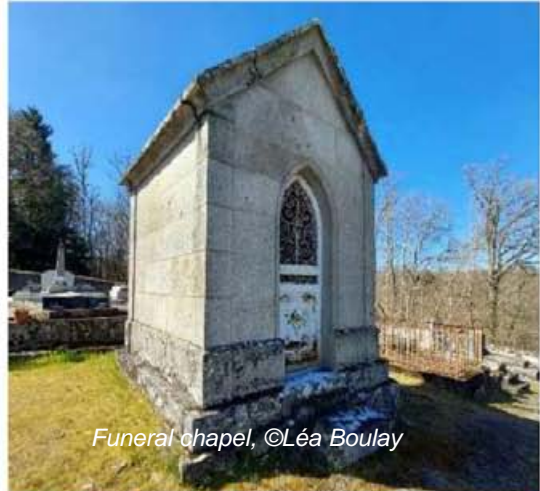
Funerary chapel, ©Léa Boulay

They are generally intended for wealthy populations. When this is the case, the funerary chapels will be monumental constructions, shaped like dwellings made of hewn granite, in which one can

find an altar. (See page 247)

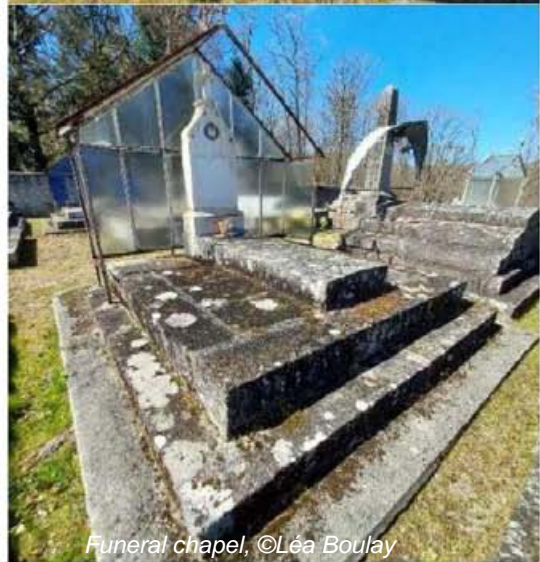
Funerary chapel, ©Léa Boulay

Naturally, this fashion became popular at all levels, but to make it accessible to other societal levels, chapels were transformed into structures that stand at the head of tombs and are generally made of glass and worked with iron. (See page 248)

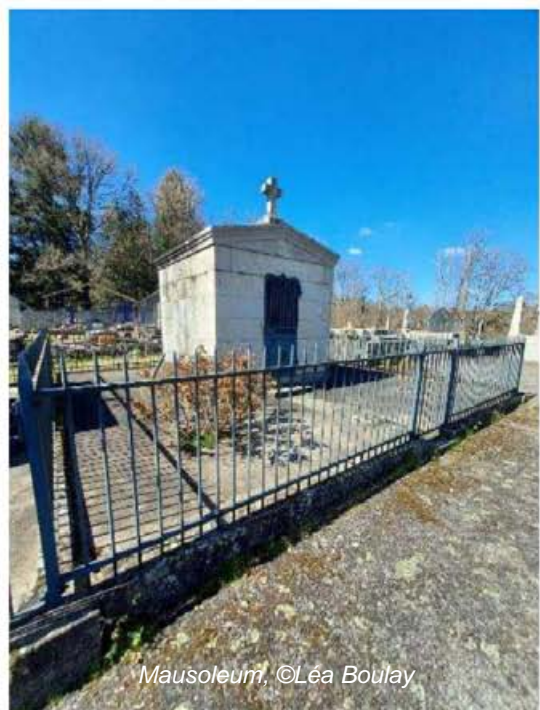
Mausoleum, ©Léa Boulay

Once again, the fashions of the Second Empire prevailed their traces in the cemetery, given that although the cemetery was created during the Third Republic, the methods that the previous regime must have. The popularization of this type of burial site spread as far as Chamberaud and it must have remained. Here, the mausoleum-type structure is actually a kind of vault, a collective tomb associated with a certain social standing due to its high cost. Also, although this type of burial is made of granite and can take the form of a small dwelling like a chapel, it is not a chapel. Indeed, what distinguishes it is the absence of an altar. As we have observed, on many plots the burial site may be surrounded by a barrier to mark its boundary, and this is often the case with this type of tomb, which is also positioned as close as possible to the main roads. (See page 250)

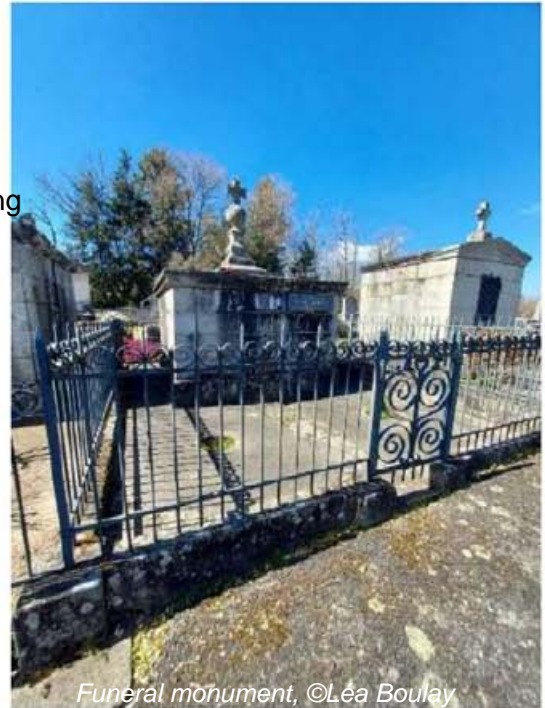
There is generally no access door, as it is a granite structure which, in the case of our example at Chamberaud, consists of a massive base of hewn granite, surmounted by a stele that extends vertically and is composed of several forms. (See page 251)

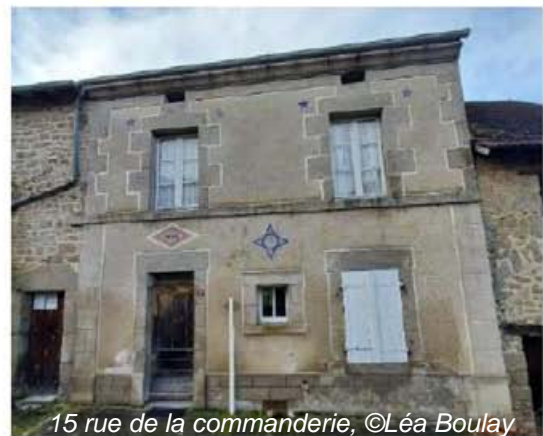
15 rue de la commanderie, ©Léa Boulay

During our research, observing certain facades, particularly that of 15 Rue de la Commanderie (see page 86), the symbols found there—namely, flowers and stars—led us to formulate a theory. This theory was further strengthened when we learned that the former 2 Rue de la Commanderie, a house that had been demolished, also featured these same symbols.

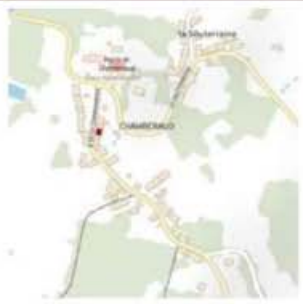
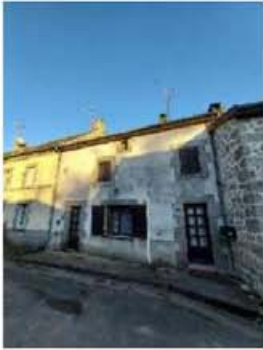
Built heritage		Typology		Home housing

46°02'56.4"N 2°02'43.4"E	Chamberaud	23,480	5 Commanderie Street
	Altitude	482.35m	Orientation	WEST
	Situation	On a plateau	Dimension	8m x 9m
	Accessibility	<input checked="" type="checkbox"/> Accessible <input type="checkbox"/> Limit <input type="checkbox"/> Not accessible	Current state of place	<input checked="" type="checkbox"/> Good condition <input type="checkbox"/> Average condition <input type="checkbox"/> Deteriorated <input type="checkbox"/> Abandoned

Description of materials			
	Element	Materials	Element	Materials
	Management berries	Cut granite and squared monolithic lintels	Roofing	Mechanical tile
	Joinery	Drink	Cornices	Wooden joist
	Walls	Coating zip line	Chimney	2 hewn granite stumps, joined with cement
	Foundations	Concrete		
Comments				
<p>Terraced house Gable roof</p> <p>The house rises over three levels, the overall design of which is not symmetrical:</p> <ul style="list-style-type: none"> - The first contains two entrance doors positioned on either side of the facade, and between the two openings a window with wooden shutters - The second level has two windows with wooden shutters, one of which is... The left side has a different lintel than the right side, as it does not extend beyond the jamb. - The top level has a light well whose lintel is cut by the roof slope. <p>The left-hand door has a chronogram on its lintel, indicating the date "1824," possibly representing the building's construction date. Also, on either side of this chronogram, are engraved letters "P" and "T," which could be the initials of the builder or owner.</p> <p>The frames have harp and satchel shaped jambs</p> <p>A stone sink surmounted by an oculus is visible next to the left door of the facade.</p> <p>A metal ring is attached to the facade to the left of the right-hand door; it was intended for tethering animals.</p>

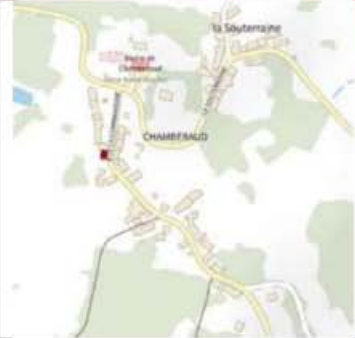
Built heritage		Typology		Limousin barn

46°02'56.1"N 2°02'42.8"E	Chamberaud	23,480	ZE 0165
	Altitude	481.89 m	Orientation	EAST
	Situation	On a plateau	Dimension	8m x 9m
	Accessibility	<input checked="" type="checkbox"/> Accessible <input type="checkbox"/> Limit <input type="checkbox"/> Not accessible	Current state of place	<input checked="" type="checkbox"/> Good condition <input type="checkbox"/> Average condition <input type="checkbox"/> Deteriorated <input type="checkbox"/> Abandoned

Description of materials			
	Element	Materials	Element	Materials
	Management berries	Cut granite, monolithic lintels and wooden lintels	Roofing	Mechanical tile
	Joinery	Drink	Cornices	Nothing
	Walls	Building blocks granite and lime mortar joints	Chimney	Nothing
	Foundations	Nothing		
Comments				
<p>A single-story, gabled barn in the Limousin style, featuring three openings. A double barn door allows entry for either animals or a farm vehicle. To the right of this door is a small window. Finally, to the right of this window is a doorway with a lintel surmounted by a relieving arch.</p> <p>This barn had another man's door to the left of the double-leaf barn door, of which one can still see the lintel, the jambs, but also an unblocked relieving arch, thus forming a baumadis which must have received a protective object.</p> <p>The corner chains and jambs are in harp and satchel shapes.</p> <p>The barn has annexes on either side of its gables: - North gable: garages - South gable: annex which was intended for the pig.</p>

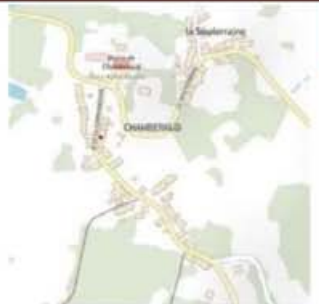
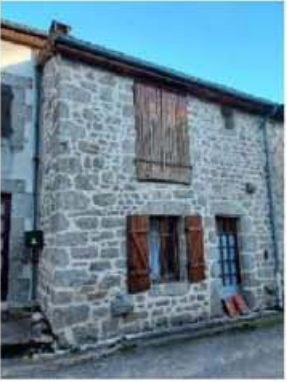
Built heritage		Typology		Home housing

46°02'56.4"N 2°02'43.4"E	Chamberaud	23,480	ZE 0129
	Altitude	482.04 m	Orientation	WEST
	Situation	On a plateau	Dimension	8 x 5.5m
	Accessibility	<input checked="" type="checkbox"/> Accessible <input type="checkbox"/> Limit <input type="checkbox"/> Not accessible	Current state of place	<input checked="" type="checkbox"/> Good condition <input type="checkbox"/> Average condition <input type="checkbox"/> Deteriorated <input type="checkbox"/> Abandoned

Description of materials			
	Element	Materials	Element	Materials
	Management berries	Cut granite and monolithic lintels	Roofing	Mechanical tile
	Joinery	Drink	Cornices	Wooden joist
	Walls	Granite rubble, lime mortar joint and granite rubble corner quoins	Chimney	Concrete and brick
	Foundations	Nothing		
Comments				
<p>Semi-detached house with two gable ends</p> <p>The house has two levels of elevation:</p> <ul style="list-style-type: none"> - The first level of elevation has a window on the left with wooden shutters and a door on the right. - The second level has, in line with the ground floor window, a window with wooden shutters. To the right of this window there is a light well. <p>The corner quoins and jambs are in the form of harps and saddlebags.</p> <p>The north edge is tiled. There is a stone sink to the right of the entrance door.</p>

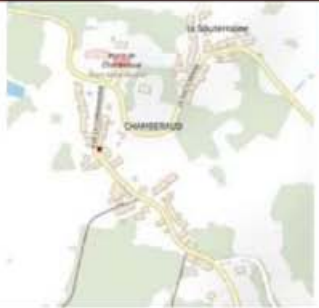
Built heritage		Typology		Limousin barn

46°04'88.3" N 2°04'53.7" E	Chamberaud	23,480	9 Rue de la commandery
	Altitude	481.16 m	Orientation	WEST
	Situation	On a plateau	Dimension	5.5 x 7 m
	Accessibility	<input checked="" type="checkbox"/> Accessible <input type="checkbox"/> Limit <input type="checkbox"/> Not accessible	Current state of the place	<input type="checkbox"/> Good condition <input checked="" type="checkbox"/> Average condition <input type="checkbox"/> Deteriorated <input type="checkbox"/> Abandoned

Description of materials			
	Element	Materials	Element	Materials
	Management berries	Cut granite, brick, wooden lintels	Roofing	Slate
	Joinery	Drink	Cornices	Nothing
	Walls	<u>Lower part:</u> Granite rubble wall, dry stone <u>Upper part:</u> Granite rubble, joined with lime mortar <u>Corner reinforcement:</u> concrete	Chimney	Nothing
	Foundations	Nothing		
Comments				
<p>Limousin barn with two sloping sides, adjoining.</p> <p>This barn has only one opening, a double-leaf door that is damaged, probably because of used motor oil which was previously applied to barn doors to protect them but which damaged them.</p> <p>On the lower part of the leaves, one can see the presence of ironwork whose end is in the shape of a fleur-de-lis.</p> <p>A dripstone carved in stone on the south gable of the house at 7 rue de la commanderie indicates the former presence of a thatched roof on this barn.</p>

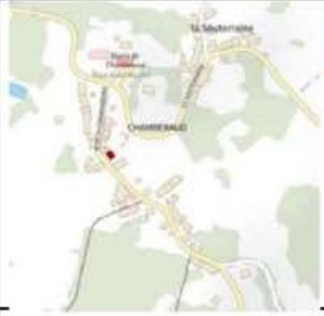
Built heritage		Typology		Home housing

46°04'89.7"N 2°04'60.8"E	Chamberaud	23,480	9 Commanderie Street
	Altitude	473.57 m	Orientation	SOUTHWEST
	Situation	On a plateau	Dimension	8 x 16 m
	Accessibility	<input checked="" type="checkbox"/> Accessible <input type="checkbox"/> Limit <input type="checkbox"/> Not accessible	Current state of place	<input checked="" type="checkbox"/> Good condition <input type="checkbox"/> Average condition <input type="checkbox"/> Deteriorated <input type="checkbox"/> Abandoned

Description of materials			
	Element	Materials	Element	Materials
	Window frames	Concrete support	Roofing	Mechanical tile
	Joinery	Wood, PVC	Cornices	Wooden joist
	Walls	<u>Lower section: granite</u> rubble covered with concrete <u>Upper part:</u> Concrete block with a concrete coating	Chimney	Concrete
	Foundations	Nothing		
Comments				
<p>Semi-detached house connected to the barn by a concrete block extension to the left of the building.</p> <p>The house has a hipped roof and two levels, each with six symmetrical openings: - The first level, the ground floor, has two windows to the right of which... I found the double-leaf folding wooden garage door. The second level consists of three openings: two windows divided into two bays and a third window, one bay wider than the first two, consistent with the width of the garage. These openings are covered by roller shutters.</p> <p>The front door of the house is accessed via a set of steps on the south gable end. Furthermore, the door is surmounted by a canopy which, through its glass and metal wall descending along the canopy, forms an entrance vestibule.</p>

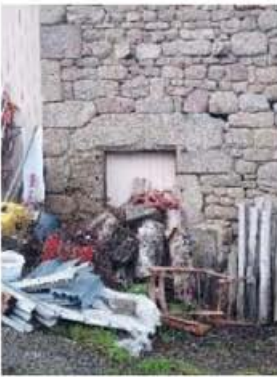
46°04'86.7"N 2°04'56.5"E	Chamberaud	23,480	
	Altitude	479.67 m	Orientation	SOUTH-EAST
	Situation	On a plateau	Dimension	8.5 m x 17.5 m
	Accessibility	<input checked="" type="checkbox"/> Accessible <input type="checkbox"/> Limit <input type="checkbox"/> Not accessible	Current state of place	<input checked="" type="checkbox"/> Good condition <input type="checkbox"/> Average condition <input type="checkbox"/> Deteriorated <input type="checkbox"/> Abandoned
Description of materials				
	Element	Materials	Element	Materials

Supervision of berries	<u>Home housing:</u> White-painted concrete, concrete lintels and other drink <u>Barn:</u> <u>Jamb:</u> cut granite and concrete <u>Lintels:</u> Granite monolithic carved wood	Roofing	Flat tile
	Joinery	Metal, wood	Cornices	Wooden joist
	Walls	<u>Home Residential:</u> Tyrolean plaster <u>Barn:</u> Some sections are made of granite rubble, dry stone, and others of granite joined with lime mortar.	Chimney	Home housing: Granite joined with concrete Barn: Coated concrete concrete
