Année 2024 - 2025

Heritage inventory Chamberaud

Licence 3 –
Géographie et Aménagement :
Valorisation du Patrimoine et
Développement Territorial

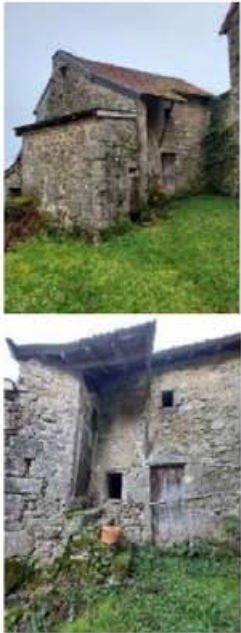
46°04'82.8"N 2°04'65.4"E	Chamberaud	23,480	ZE 0117
	Altitude	482.04 m	Orientation	SOUTHWEST
	Situation	On a plateau	Dimension	10 m x 8.5 m
	Accessibility	<input checked="" type="checkbox"/> Accessible <input type="checkbox"/> Limit <input type="checkbox"/> Not accessible	Current state of place	<input type="checkbox"/> Good condition <input checked="" type="checkbox"/> Average condition <input type="checkbox"/> Deteriorated <input checked="" type="checkbox"/> Abandoned

Description of materials			
	Element	Materials	Element	Materials
	Window frames	Lintels and hewn granite jambs, lintels and wooden jamb	Roofing	Mechanical tile
	Joinery	Drink	Cornices	?
	Walls	Granite rubble and lime mortar joint, corner quoins in dressed granite and rubble	Chimney	Nothing
	Foundations	Nothing		
Comments				
<p>Two-sided house, whose roof at the level of the facade extends on its left beyond the whole to form a canopy overhanging the staircase leading to a door on the left of the building which is surmounted by an opening whose frame is made of wood.</p> <p>The main facade consists of two bays, with two elevation levels:</p> <ul style="list-style-type: none"> - One on the right with a wooden door on the first level, blocked by a wooden stick. Above this doorway, a relieving arch can be seen, and higher up, there is an uncovered opening framed by granite. - The second bay, to the left of the first, has a bay window on the first level. wooden frames <p>The dwelling is attached to a wall. An extension appears to be attached to the left of the dwelling, containing another door. Opposite this is a woodshed, a place where wood is stored.</p> <p>The jambs and corner chains are in the form of harps and satchels.</p>

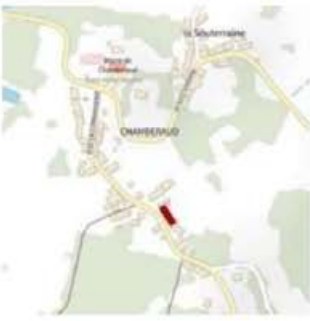
Long farmhouse with two stories

46°04'82.0"N 2°04'64.8"E	Chamberaud	23,480	19 Rue de la Commanderie
	Altitude	482.68 m	Orientation	SOUTHWEST
	Situation	On a plateau	Dimension	7m x 25m
	Accessibility	<input checked="" type="checkbox"/> Accessible <input type="checkbox"/> Limit <input type="checkbox"/> Not accessible	Current state of place	<input checked="" type="checkbox"/> Good condition <input type="checkbox"/> Average condition <input type="checkbox"/> Deteriorated <input type="checkbox"/> Abandoned
Description of materials				
Element		Materials	Element	Materials

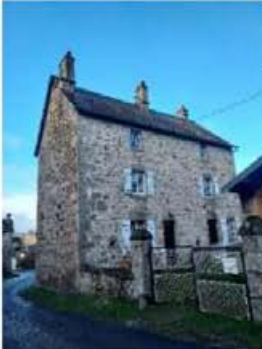
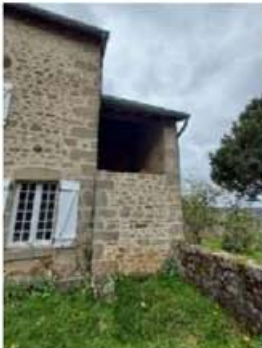
46°04'78.6"N 2°04'67.2"E	Chamberaud	23,480	21 Rue de la commandery
	Altitude	486.77 m	Orientation	SOUTH-EAST
	Situation	On a plateau	Dimension	6.5 m x 13 m
	Accessibility	<input checked="" type="checkbox"/> Accessible <input type="checkbox"/> Limit <input type="checkbox"/> Not accessible	Current state of the place	<input checked="" type="checkbox"/> Good condition <input type="checkbox"/> Average condition <input type="checkbox"/> Deteriorated <input type="checkbox"/> Abandoned
Description of materials

Element	Materials	Element	Materials
	Supervision of berries	Cut granite, monolithic lintels Northeast facade: Brick, cut granite, monolithic lintels	Roofing	Slate
	Joinery	Drink	Cornices	?
	Walls	Façade: Granite rubble stone with lime mortar joints, exposed stone finish, and dressed granite corner quoins Southwest gable: Granite rubble, dry stone Northeast facade: Granite rubble, dry stone.	Chimney	Cut granite cement joint

Foundations	Nothing		
Comments				
<p>First of all, when you want to enter the living space of this house, located at the corner of a road, you notice at the foot of the entrance the presence of a wheel guard, undoubtedly meaning that the former owner of this house had a link with the agricultural world and that is indeed the case.</p> <p>This house, built between the late 18th and early 19th centuries, belonged to an old local family whose owner was a wine merchant.</p> <p>To describe this building, we can divide the description into three parts: one on the main facade, another on the southwest gable, and another on the northeast facade. But before beginning the description, we can already mention that it has three stories, which is unusual for the town, where buildings, apart from those of wealthy people, generally do not exceed two stories. Therefore, we can assume that the family that</p>

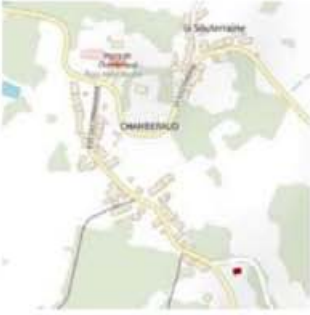
Built heritage		Typology		Residential house

46°04'74.5"N 2°04'76.8"E	Chamberaud	23,480	23 Rue de la commandery
	Altitude	485.38 m	Orientation	SOUTH-EAST
	Situation	On a plateau	Dimension	8m x 11m
	Accessibility	<input checked="" type="checkbox"/> Accessible <input type="checkbox"/> Limit <input type="checkbox"/> Not accessible	Current state of the place	<input type="checkbox"/> Good condition <input type="checkbox"/> Average condition <input checked="" type="checkbox"/> Deteriorated <input checked="" type="checkbox"/> Abandoned

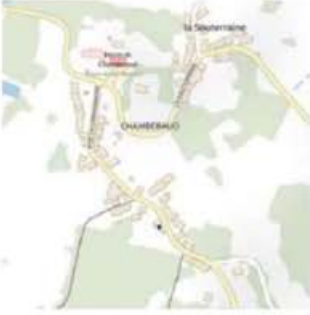
Water Heritage		Typology	Recessed well

46.047943° 2.046413°	Chamberaud	23,480	
	Altitude	486.88 m	Orientation	NORTHEAST
	Situation	At height	Dimension	Nothing
	Accessibility	<input checked="" type="checkbox"/> Easy access <input type="checkbox"/> Limit <input type="checkbox"/> Not accessible	Current state of place	<input checked="" type="checkbox"/> Good condition <input type="checkbox"/> Average condition <input type="checkbox"/> Deteriorated <input type="checkbox"/> Abandoned

Description of materials			
	Element	Materials		
	Management	Granite		
	Bottom	Granite		
	Barrier	Nothing		
Comments				
No longer in use.				
Author	Léa Boulay	Inventory date	27/01/2025

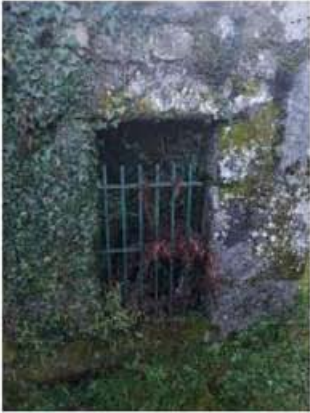
Water Heritage		Typology	Recessed well	
 	46.048371° 2.046579°	Chamberaud	23,480	
	Altitude	479.17 m	Orientation	NORTHEAST
	Situation	At height	Dimension	Nothing
	Accessibility	<input checked="" type="checkbox"/> Easy access <input type="checkbox"/> Limit <input type="checkbox"/> Not accessible	Current state of the place	<input checked="" type="checkbox"/> Good condition <input type="checkbox"/> Average condition <input type="checkbox"/> Deteriorated <input type="checkbox"/> Abandoned

Description of materials			
	Element	Materials		
	Management	Granite		
	Bottom	Granite		
	Barrier	Metal		
Comments				
No longer in use.				
Author	Léa Boulay	Inventory date	27/01/2025

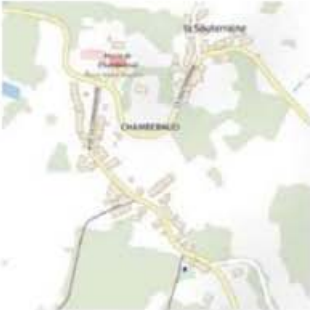
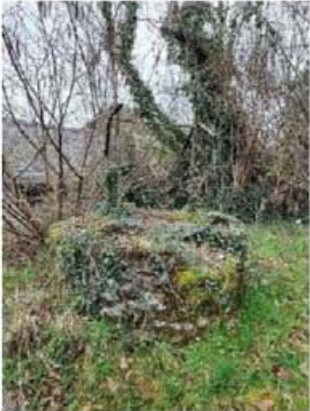
Water Heritage		Typology		Well

46.047509° 2.046876°	Chamberaud	23,480	21 Rue de la commanderie
	Altitude	490.25 m	Orientation	SOUTH-EAST
	Situation	At the height	Dimension	Nothing
	Accessibility	<input checked="" type="checkbox"/> Easy access <input type="checkbox"/> Limit <input type="checkbox"/> Not accessible	Current state of the place	<input type="checkbox"/> Good condition <input type="checkbox"/> Average condition <input checked="" type="checkbox"/> Deteriorated <input type="checkbox"/> Abandoned

Description of materials			
	Element	Materials	Element	Materials
	Awning	Nothing	Margelle	Granite
	Winch	Nothing		
	Gallows	Wrought iron		
Crank	Nothing			
Comments				
<p>This well was used until the 1970s to supply water to a large part of the rue de la commanderie; after that date, running water being available in homes, this well was no longer useful to the population.</p>				
Author	Léa Boulay	Inventory date	27/01/2025

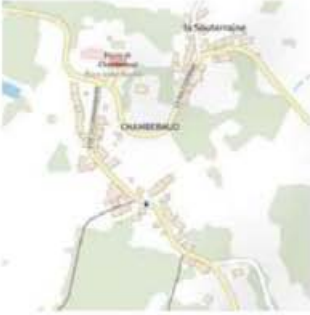
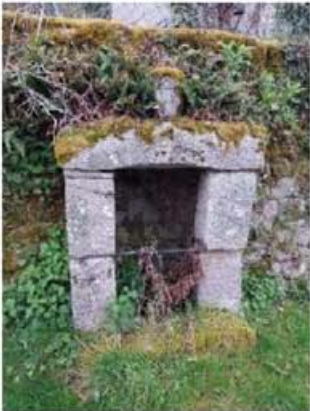
Water Heritage		Typology	Recessed well

46.048217° 2.046169°	Chamberaud	23,480	
	Altitude	482.06 m	Orientation	NORTH
	Situation	At height	Dimension	Nothing
	Accessibility	<input checked="" type="checkbox"/> Easy access <input type="checkbox"/> Limit <input type="checkbox"/> Not accessible	Current state of place	<input checked="" type="checkbox"/> Good condition <input type="checkbox"/> Average condition <input type="checkbox"/> Deteriorated <input type="checkbox"/> Abandoned

Description of materials			
	Element	Materials		
	Management	Granite		
	Bottom	Granite		
	Barrier	Wrought iron		
Comments				
<p>This well, located on a bend facing the road, was intended for community use and not for private purposes. Its lintel is decorated with what appears to be a representation of a human face, carved in granite.</p> <p>The face was certainly a corbel from the commandery.</p> <p>No longer in use.</p>

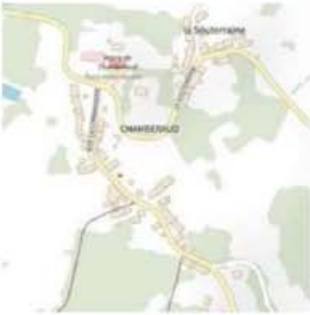
Craft heritage		Typology		Grinding wheel

46.048548° 2.045743°	Chamberaud	23,480	11 Rue de la commandery
	Altitude	480.04 m Orientation		NORTHEAST
	Situation	At height	Dimension	Nothing
	Accessibility	<input type="checkbox"/> Easy access <input type="checkbox"/> Limit <input checked="" type="checkbox"/> Not accessible	Current state of place	<input checked="" type="checkbox"/> Good condition <input type="checkbox"/> Average condition <input type="checkbox"/> Deteriorated <input type="checkbox"/> Abandoned

Description of materials			
	Element	Materials		
	Grinding wheel	Granite		
	Crusher/Press	Granite		
Comments				
Only the circular millstone is present. We doubt that the one in which the rotating millstone rests is the original stationary millstone.				
Author	Léa Boulay	Inventory date	06/04/2025

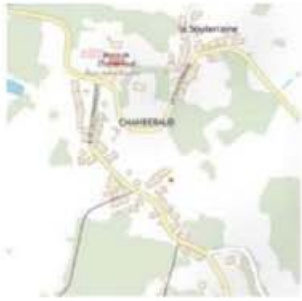
Craft heritage		Typology		Grinding wheel

46.048431° 2.046642°	Chamberaud	23,480	17 Rue de la commandery
	Altitude	477.46 m	Orientation	NORTHEAST
	Situation	At height	Dimension	Nothing
	Accessibility	<input type="checkbox"/> Easy access <input checked="" type="checkbox"/> Limit <input type="checkbox"/> Not accessible	Current state of place	<input checked="" type="checkbox"/> Good condition <input type="checkbox"/> Average condition <input type="checkbox"/> Deteriorated <input type="checkbox"/> Abandoned

Description of materials			
	Element	Materials		
	Grinding wheel	Granite		
	Crusher/Press	Granite		
Comments				
<p>Today this millstone is hidden among hydrangeas.</p> <p>Presence of a piece of wood in the axis of the rotating millstone, which helped to rotate the millstone.</p>				
Author	Léa Boulay	Inventory date	06/04/2025

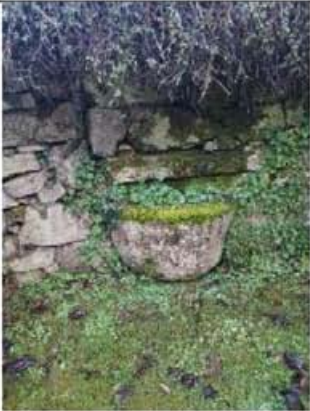
Description of materials			
	Element	Materials		
	Container	Granite		
Comments				
This washing machine is embedded in a wall. It was used for doing laundry.				
Author	Léa Boulay	Inventory date	06/04/2025

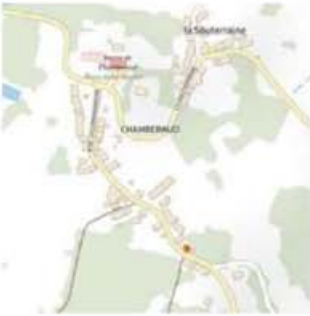
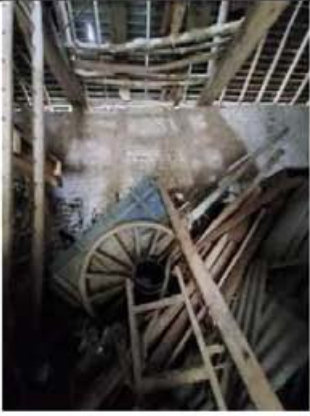
Craft heritage		Typology		Charette

Description of materials			
	Element	Materials		
	Box	Drink		
	Wheels	Drink		
Comments				
<p>It was pulled by horses.</p> <p>Made for storing manure that was going to be sold. It was unloaded by tipping it backwards.</p> <p>This type of construction is also called a "dump truck".</p>				
Author	Léa Boulay	Inventory date	06/04/2025

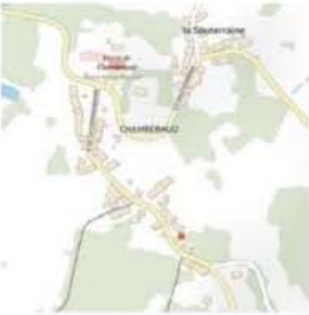
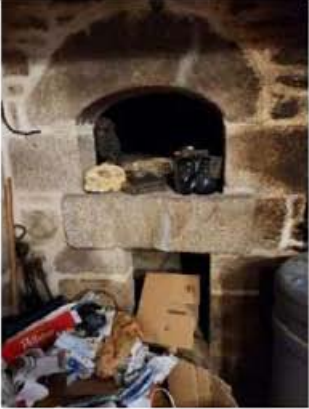
Craft heritage		Typology	Bread oven

Description of materials			
	Element	Materials		
	Management	Granite		
	Atre	Granite		
Comments				
<p>Large oven, a loaf of bread missing its door.</p> <p>The oven was used once or twice a month, either for the family or possibly others people.</p>				
Author	Léa Boulay	Inventory date	06/04/2025

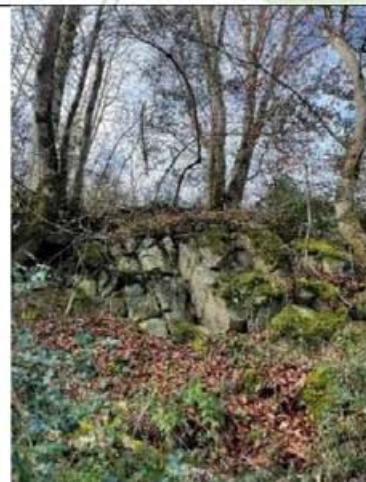
Natural Heritage		Typology	Geology

Description			
	State and threats		Site usage	
Comments				
<p>This photo illustrates a particular visual cross-section of granite: the bare soil reveals different strata, ranging from the thin organic layer where trees have shallow roots, standing on piles of granite rock. This is very common in the commune of Chamberaud, and more generally in the Creuse region. A true testament to the geology of Chamberaud.</p>				
Author	Carine Bigot	Inventory date	30/01/2025

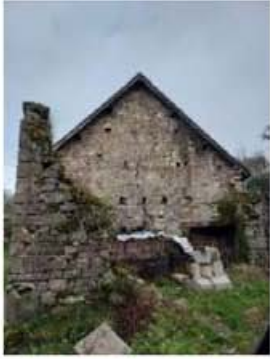
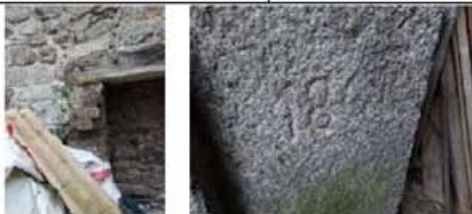
Description of materials			
	Element	Materials	Element	Materials
	Supervision of berries	Hewn granite, monolithic lintels	Roofing	Flat Tile
	Joinery	Drink	Chimney	Nothing
	Walls	Granite rubble in Dry stone and lime mortar joints create an exposed stone effect. Cut granite corner quoins	Cornices	<u>Northeast facade:</u> Nothing <u>Wall Gutters</u> <u>Southeast: Granite size</u>

Foundations	Nothing		
Comments				
<p>This now ruined house has a gabled roof, the rear of which is reminiscent of Alsatian-style roofs.</p> <p>We cannot say anything about the facade of the house, but we can see that the rear part remains, which is the attic, whose exterior wall contains putlog holes and inside we can find a cider millstone, because this building was a cider house that may have belonged to a blacksmith.</p> <p>On the jamb of the attic door, one can find an inscription of a chronogram, dating from 1861, which is the date of construction of the house.</p> <p>From the outside, the chimney is visible, its flue still exposed, descending to the hearth, whose lintel rests on a reused stone from the commandery, shaped like capitals with... rifle butts.</p>				
Author	Léa Boulay	Inventory date	27/01/2025

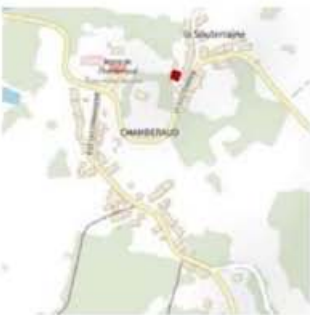
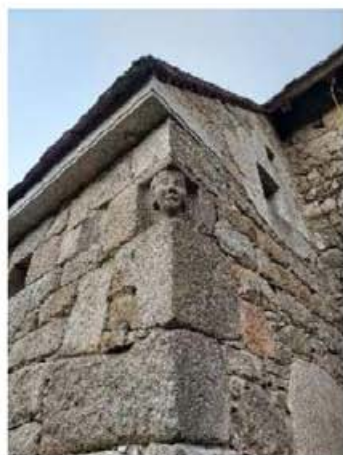
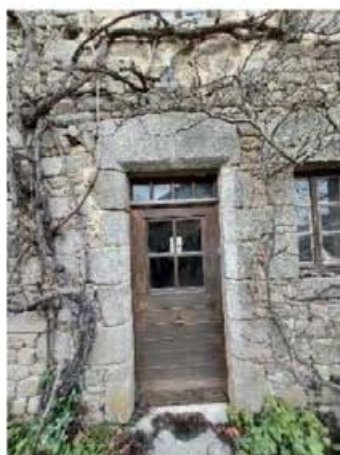
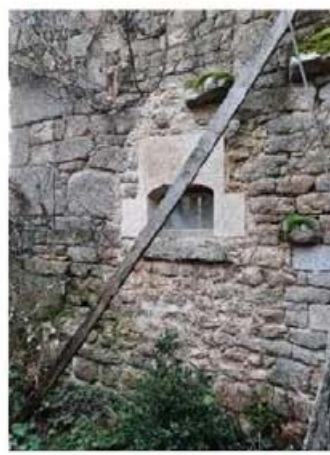
Built heritage		Typology		Home housing

Element	Materials	Element	Materials
	Management berries	Cut granite, lintels monolithic	Roofing	Flat Tile
	Joinery	Drink	Cornices	?
	Walls	Granite rubble stone in dry stone and lime mortar joints in exposed stone style. Cut granite corner chain	Chimney	Cut granite cemented
	Foundations	Nothing		
Comments				
<p>Gable roof, with a skylight and two chimney stacks, including a fascia board for the thatched roof and a step.</p> <p>The entire building has had to undergo several renovations due to the construction methods used, with traces of lime mortar joints.</p> <p>The dwelling can be divided into three parts because it appears to have undergone several stages of construction, as indicated by the corner quoins that separate them, from right to left:</p> <ul style="list-style-type: none"> - Part one consists of two bays: <ul style="list-style-type: none"> o Bay one: a window with a chronogram dated 1807 on the lintel o Bay two: an entrance door on the first level and a window on the second. - Part two, it contains three bays: <ul style="list-style-type: none"> o Bay one: what appears to be daylighting on the first and second levels o Bay two: an entrance door

A bakehouse was destroyed in the dwelling and replaced by a window. A salting tub and a washing-up area are still intact. A stone sink is present at the rear of the dwelling.

Harp and satchel style jambs and corner chain.

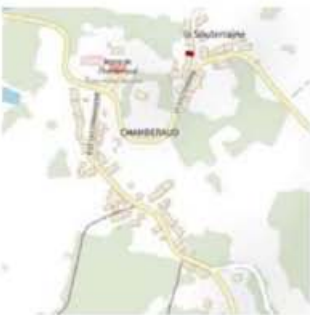
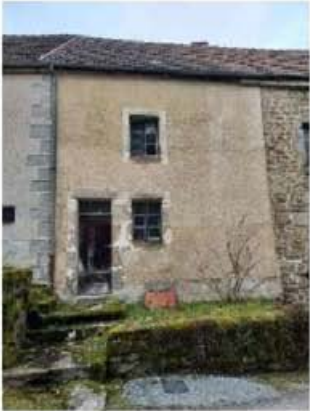
Built heritage		Typology		Home housing

Description of materials			
	Element	Materials	Element	Materials
	Management berries	Cut granite can be jointed with plaster	Roofing	Mechanical tile
	Joinery	Drink	Cornices	A hewn granite stone
	Walls	Coating zip line	Chimney	Nothing
	Foundations	Concrete, cut granite		
Comments				
<p>Gable roof</p> <p>Terraced house</p> <p>Two bays and two elevation levels:</p> <ul style="list-style-type: none"> - Bay one: an entrance door - Two bays: one window on the first level and another on the second

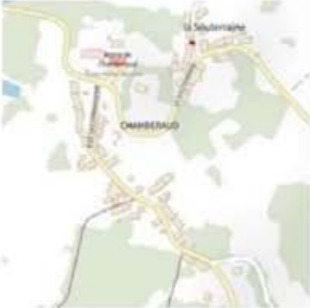
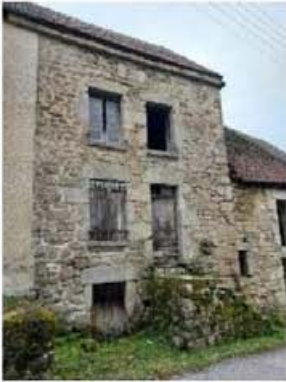
Built heritage		Typology		Home housing

Description of materials			
	Element	Materials	Element	Materials
	Management berries	Cut granite, lintels monolithic	Roofing	Mechanical tile
	Joinery	Wood, iron	Cornices	A hewn granite stone
	Walls	Granite rubble lime mortar joints, dressed granite corner quoins	Chimney	Nothing
	Foundations	Nothing		
Comments				
<p>Gable roof</p> <p>Adjoining</p> <p>Three levels of elevation (from left to right)</p> <ul style="list-style-type: none"> - Level one: a door, a granite staircase covered in moss - Level two: a window with wooden shutters, a wooden front door accessed via the stairs on the first level - Level three, two windows where the shutter hinges are still present, one of which no longer has any doors <p>Window sills carved</p> <p>Corner chain and harp and satchel jamb.</p>

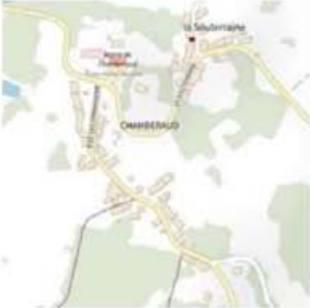
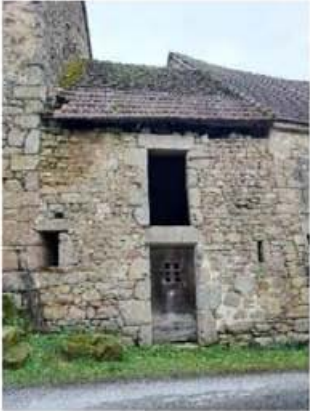
Built heritage		Typology		Home housing

Description of materials			
	Element	Materials	Element	Materials
	Management berries	Cut granite, lintels monolithic	Roofing	Mechanical tile, Flat tile
	Joinery	Drink	Cornices	Nothing
	Walls	Granite rubble stone, dry-stone construction with lime mortar joints	Chimney	Nothing
	Foundations	Nothing		
Comments				
<p>Gable roof</p> <p>Adjoining, but it is possible that it was wider at the time, as shown by the opening on the left of the dwelling whose jamb is cut by the adjacent dwelling.</p> <p>At the center of the building, on the first floor, is a doorway, likely not original given the traces of iron and the holes that suggest the presence of another door. Above this doorway is an opening that resembles a window, and the hinges for the shutters are still present.</p> <p>To the right of the entrance there is a small opening whose origin is unknown.</p> <p>Harp-shaped leg and satchel.</p>

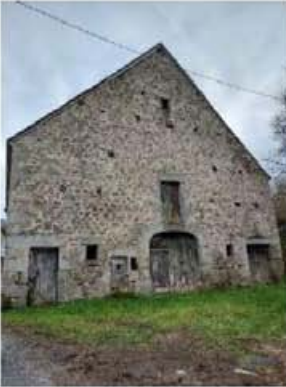
Description of materials			
	Element	Materials	Element	Materials
	Supervision of berries	Cut granite, monolithic lintels, keystone lintels	Roofing	Mechanical tile
	Joinery	Drink	Cornices	<u>North facade:</u> Nothing <u>Gutter wall</u> <u>East: Granite</u> size
	Walls	Granite rubble in Dry stone construction with lime mortar joints. Corner quoins in dressed granite.	Chimney	Nothing
	Foundations	Nothing

Comments				
<p>Gable roof. Semi-detached. Multiple projecting stones are visible on the gable end that forms the facade. Three bays are visible (from left to right): - Bay one: a doorway surmounted by a monolithic lintel and a relieving arch - Bay two (in the center): a double-leaf barn door with a keyed arched lintel</p> <p>Lowered. To the left of this door is the entrance to a well, then on either side of the barn door are openings that could be windows. Above the door, giving access to the attic, is a doorway surmounted by a monolithic lintel and a relieving arch. At the highest level, there is another window.</p> <p>- Bay three: a man's door surmounted by a monolithic lintel and an unblocked relieving arch, possibly suggesting the location of a baumadis for protective objects.</p> <p>Corner chain and harp and satchel jamb.</p>				
Author	Léa Boulay	Inventory date	27/01/2025

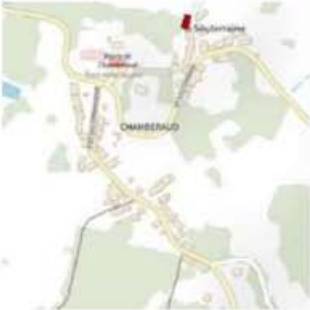
Built heritage		Typology		Limousin barn

Description of materials			
	Element	Materials	Element	Materials
	Window frames	Cut granite, lintels monolithic	Roofing	Slate
	Joinery	Drink	Cornices	Nothing
	Walls	Granite rubble built with dry stone and lime mortar joints. Corner chain in hewn granite	Chimney	Nothing
	Foundations	Nothing		
Comments				
<p>Gable roof with two skylights:</p> <p>An elevation level that includes (from left to right):</p> <ul style="list-style-type: none"> - A double-leaf wooden barn door - Two larger double-leaf wooden barn doors, whose lintels are cut, possibly due to a former thatched roof - One gives day - A man's door <p>A granite wheel guard on the left corner chain.</p> <p>Corner chain and harp-shaped jamb and satchel</p>

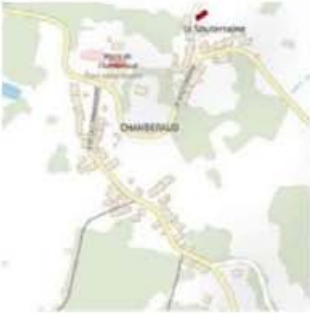
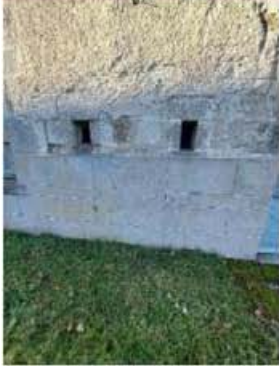
Built heritage		Typology		Residential house

Description of materials			
	Element	Materials	Element	Materials
	Management berries	Cut granite, lintels monolithic	Roofing	Slate
	Joinery	Drink	Cornices	Wrought iron frieze
	Walls	Concrete coating revealing some granite rubble, corner chain in cut granite	Chimney	Cut granite, brick
Foundations	Imitation concrete hewn stone			
Comments				
<p>A gabled roof, featuring two dormer windows and three chimney stacks with clay pots, suggests a house that was likely well-to-do. The ridge of the former three-part thatch roof is visible on the stacks. The structure appears to have been built in two sections, as indicated by the difference in roofing. This dwelling has two levels, on which we find (from left to right):</p> <ul style="list-style-type: none"> - Level 1: two windows, two skylights, an entrance door, a window with... <p style="padding-left: 40px;">wooden shutters, a basement window.</p> <ul style="list-style-type: none"> - Level 2: five windows, the last two of which are longer. <p>Extension to the left, with a lower roof, leading to a doorway. Bas-relief in the shape of a star is etched onto the concrete base, imitating cut stone. This eight-pointed star suggests a symbol of freethinkers. Jamb and corner quoins in the form of a harp and satchel.</p>

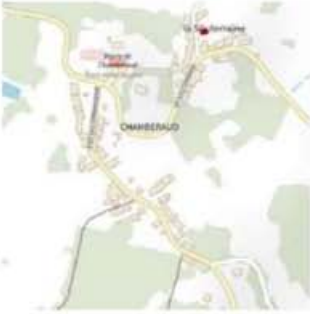
Built heritage		Typology		Limousin barn

Description of materials			
	Element	Materials	Element	Materials
	Window frames	Lintels in cut granite, wooden lintels	Roofing	Mechanical tile
	Joinery	Drink	Cornices	Nothing
	Walls	Concrete coating revealing some granite rubble, corner chain in cut granite	Chimney	Cut granite, brick
	Foundations	Concrete imitating cut stone		
Comments				
<p>Gable roof</p> <p>Adjoining</p> <p>Two bays and one elevation level:</p> <ul style="list-style-type: none"> - Bay one: a double-leaf barn door with a wooden lintel - Bay two: an opening that served as a man's door, with a monolithic lintel but which is filled in with bricks <p>Corner chain in the shape of a harp and satchel.</p>

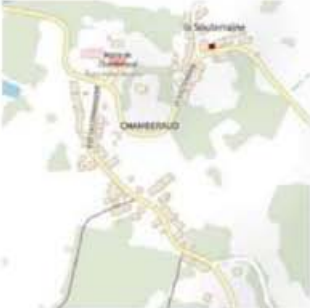
Built heritage		Typology		Home housing

Description of materials			
	Element	Materials	Element	Materials
	Management berries	Cut granite, Lintels monolithic	Roofing	Mechanical tile
	Joinery	Wood and wood painted blue	Cornices	Molded granite
	Walls	Concrete plaster, dressed granite corner quoins	Chimney	Cut granite
	Foundations	Nothing		
Comments				
<p>Gable roof, with a skylight. Semi-detached house reminiscent of certain houses in the town but also inspired by the type of return of migrants thanks to the band running between the two levels, but without symmetry it cannot be classified as such.</p> <p>Three bays:</p> <ul style="list-style-type: none"> - Bay 1: an entrance door with a flight of steps to reach it; to its right, a stone sink surmounted by an oculus. On the second level, there is a window with shutters. wooden. - Bay 2: a window with wooden shutters on level 1 - Bay 3: on each level there is a window with wooden shutters. Below level one, there is a basement window hidden by what appears to be ironwork. <p>Corner chain and harp and satchel jamb.</p>

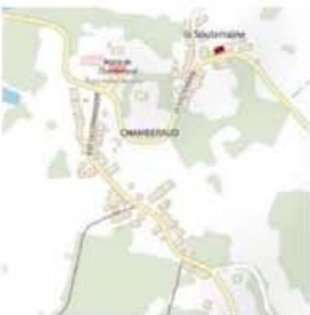
Built heritage		Typology		Barn Limousine

46°05'00.3"N 2°04'73.9"E	Chamberaud	23,480	ZE 0062
	Altitude	462.47 m	Orientation	SOUTH
	Situation	On a plateau, below	Dimension	8.75 m x 13 m
	Accessibility	<input checked="" type="checkbox"/> Accessible <input type="checkbox"/> Limit <input type="checkbox"/> Not accessible	Current state of place	<input type="checkbox"/> Good condition <input checked="" type="checkbox"/> Average condition <input type="checkbox"/> Deteriorated <input type="checkbox"/> Abandoned

Description of materials			
	Element	Materials	Element	Materials
	Management berries	Cut granite, wooden lintels	Roofing	Mechanical tile
	Joinery	Nothing	Cornices	Nothing
	Walls	Granite rubble built with dry stone and a few touches of lime mortar.	Chimney	Nothing
	Foundations	Nothing		
Comments				
<p>Gable roof. Semi-detached.</p> <p>4 bays:</p> <ul style="list-style-type: none"> - Bay one: on the far left, an opening for a man's door has been blocked, it had a wooden lintel and is slightly cut off by the adjoining building. Perhaps the barn was longer at one time. - Bay two: opening intended for a barn door, the top appears to be cut off by the roof. The barn was probably higher. - Bay three: Bay blocked with an OSB panel - Bay 4: opening intended for a barn door with a wooden lintel projecting onto the facade of the adjoining barn. Above, an opening that appears to be cut off, probably a door for a man to store the harvest in the attic. <p>Harp-shaped leg and satchel</p>

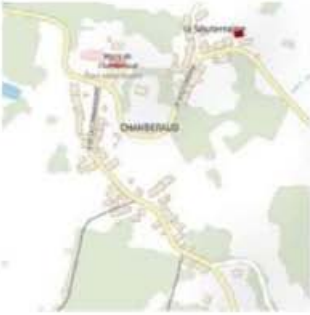
Built heritage		Typology		Barn Limousine

46°05'01.6"N 2°04'76.9"E	Chamberaud	23,480	13 The Underground
	Altitude	461.03 m	Orientation	SOUTH
	Situation	On a plateau, below	Dimension	9 m x 11.50 m
	Accessibility	<input checked="" type="checkbox"/> Accessible <input type="checkbox"/> Limit <input type="checkbox"/> Not accessible	Current state of place	<input checked="" type="checkbox"/> Good condition <input type="checkbox"/> Average condition <input type="checkbox"/> Deteriorated <input type="checkbox"/> Abandoned

Description of materials			
	Element	Materials	Element	Materials
	Management berries	Cut granite, wooden lintels and lintels monolithic	Roofing	Mechanical tile
	Joinery	Drink	Cornices	Nothing
	Walls	Granite rubble dry stone and granite rubble jointed with lime. Corner quoins in dressed and rough stone	Chimney	Nothing
	Foundations	Nothing		
Comments				
<p>Gable roof</p> <p>Three bays and one level of elevations</p> <ul style="list-style-type: none"> - Bay one: a blocked mansard door - Bay two: a double-leaf barn door with a wooden lintel. On either side of this door are light wells - Bay 3: a wooden man door <p>On the east side, there is a bench facing the rising sun.</p> <p>Corner chaining and harp-shaped jambs and satchel</p>

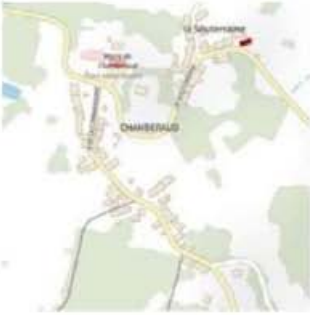
Built heritage		Typology		Residential house

46°05'00.6"N 2°04'78.4"E	Chamberaud	23,480	13 The Underground
	Altitude	460.03 m	Orientation	SOUTH
	Situation	On a plateau, below	Dimension	6.60 m x 17 m
	Accessibility	<input checked="" type="checkbox"/> Accessible <input type="checkbox"/> Limit <input type="checkbox"/> Not accessible	Current state of the place	<input checked="" type="checkbox"/> Good condition <input type="checkbox"/> Average condition <input type="checkbox"/> Deteriorated <input checked="" type="checkbox"/> Abandoned

Description of materials			
	Element	Materials	Element	Materials
	Management berries	Cut granite and lintels monolithic	Roofing	Slate
	Joinery	Drink	Cornices	Granite molding
	Walls	Granite rubble in Dry stone and granite rubble jointed with lime mortar. Corner quoins in dressed stone.	Carved granite fireplace	
Foundations	Nothing			
Comments				
<p>The roof is gabled except for the left extension, which has a single slope and two dormer windows. The thatched roof ridge at the chimney is still present, as is the chimney sweep's step. The house appears to be composed of three parts: the central section, which is the original house, and the side sections, which are extensions.</p> <p>The complex comprises 5 bays with two to three levels of elevation:</p> <ul style="list-style-type: none"> - Bays 1: a window on levels one and two, with a concrete sill; the one on level one has shutters. - Bays 2: a small opening is present above a sink stone - Bays 3 and 4, level 1: an entrance door on the left, a shuttered window on the right - Bays 3 and 4, levels 1 and 2: 4 windows with concrete sills, without shutters - Bay 5: one shuttered window on level 1, one window without shutters and with a concrete sill on level 2. Level -1, opening leading to a basement, surmounted by a relieving arch <p>Harp and satchel style jambs and corner chain.</p>

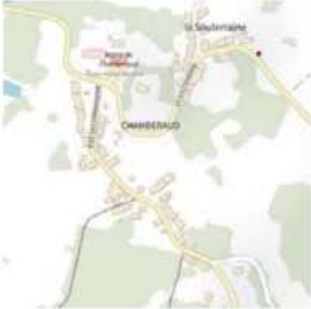
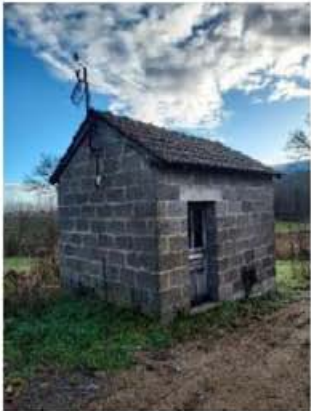
Built heritage		Typology		Home housing

46°05'00.6"N 2°04'78.4"E	Chamberaud	23,480	13 The Underground
	Altitude	460.03 m	Orientation	SOUTH
	Situation	On a plateau, below	Dimension	6.60 m x 17 m
	Accessibility	<input checked="" type="checkbox"/> Accessible <input type="checkbox"/> Limit <input type="checkbox"/> Not accessible	Current state of place	<input checked="" type="checkbox"/> Good condition <input type="checkbox"/> Average condition <input type="checkbox"/> Deteriorated <input checked="" type="checkbox"/> Abandoned
Description of materials

Element	Materials	Element	Materials
	Management berries	Concrete blocks and lintels armed	Roofing	Mechanical tile
	Joinery	Drink	Cornices	Nothing
	Walls	Concrete block joined with lime mortar	Chimney	Nothing
	Foundations	Granite rubble lime mortar and cement mortar		
Comments				
Two-sided roofed house This dwelling was a place where a person practiced the trade of clog maker.

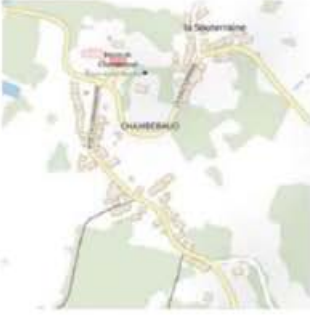
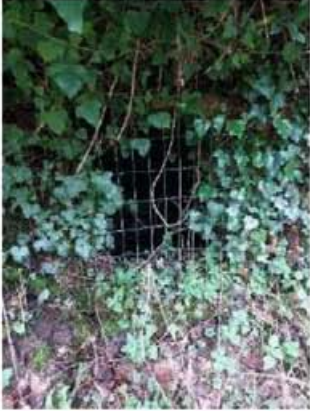
Water Heritage		Typology	Recessed well

46.049687° 2.046223°	Chamberaud	23,480	
	Altitude	469.78 m	Orientation	NORTH
	Situation	On a plateau, below	Dimension	Nothing
	Accessibility	<input checked="" type="checkbox"/> Easy access <input type="checkbox"/> Limit <input type="checkbox"/> Not accessible	Current state of the place	<input type="checkbox"/> Good condition <input checked="" type="checkbox"/> Average condition <input type="checkbox"/> Deteriorated <input type="checkbox"/> Abandoned

Description of materials			
	Element	Materials		
	Management	Granite		
	Bottom	Granite		
	Barrier	Wire mesh		
Comments				
<p>It is located in a path or otherwise called a "gratou" leading towards the 3rd Underground.</p> <p>This well is covered in ivy.</p> <p>No longer in use.</p>				
Author	Léa Boulay	Inventory date	27/01/2025

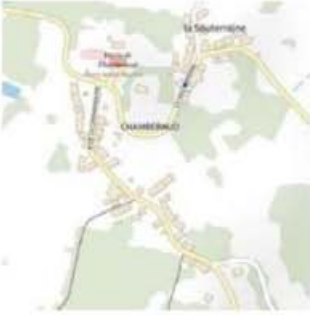
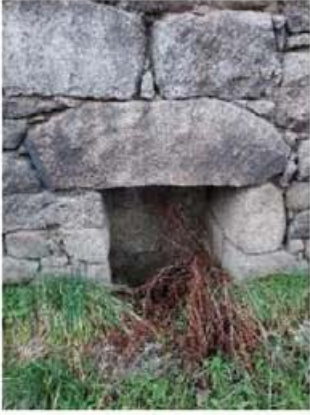
Water Heritage		Typology		Recessed well

46.049553° 2.046785°	Chamberaud	23,480	3 The Underground	
	Altitude	465.29 m	Orientation	SOUTH-EAST	
	Situation	On a plateau, below	Dimension	Nothing	
	Accessibility	<input checked="" type="checkbox"/> Easy access <input type="checkbox"/> Limit <input type="checkbox"/> Not accessible	Current state of the place	<input checked="" type="checkbox"/> Good condition <input type="checkbox"/> Average condition <input type="checkbox"/> Deteriorated <input type="checkbox"/> Abandoned

Description of materials				
	Element	Materials	Element	Materials	
	Management	Granite			
	Bottom	Granite			
	Barrier	Nothing			
Comments					
No longer in use.					
Author	Léa Boulay	Inventory date	27/01/2025

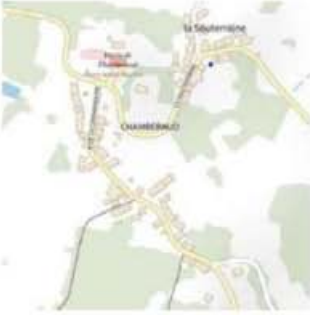
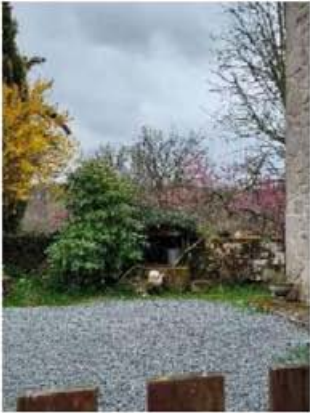
Water Heritage		Typology		Well

46.049794° 2.047213°	Chamberaud	23,480	4 La Souterraine
	Altitude	464.02 m	Orientation	NORTH
	Situation	On a plateau, below	Dimension	Nothing
	Accessibility	<input type="checkbox"/> Easy access <input type="checkbox"/> Limit <input checked="" type="checkbox"/> Not accessible	Current state of the place	<input checked="" type="checkbox"/> Good condition <input type="checkbox"/> Average condition <input type="checkbox"/> Deteriorated <input type="checkbox"/> Abandoned

Description of materials			
	Element	Materials	Element	Materials
	Awning	Nothing	Margelle	Granite
	Winch	Drink		
	Gallows	Wrought iron		
	Crank	Wrought iron		
Comments				
It is impossible to know if the canopy is still there and what material it is made of, because it is covered by ivy.				
No longer in use.				
Author	Léa Boulay	Inventory date	27/01/2025

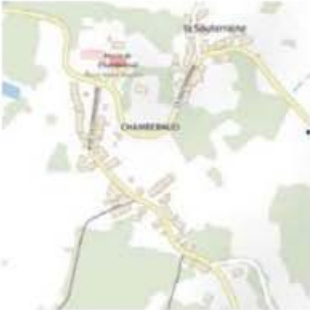
Water Heritage		Typology	Aqueduct

46.049034° 2.049501°	Chamberaud	23,480	
	Altitude	451.46 m	Orientation	North
	Situation	Below	Dimension	Nothing
	Accessibility	<input checked="" type="checkbox"/> Easy access <input type="checkbox"/> Limit <input type="checkbox"/> Not accessible	Current state of the place	<input checked="" type="checkbox"/> Good condition <input type="checkbox"/> Average condition <input type="checkbox"/> Deteriorated <input type="checkbox"/> Abandoned

Description of materials			
	Element	Materials		
	Vaulted	Granite		
	Jamb	Granite		
Comments				
It can be found by the roadside. It is small and is used for irrigating water.				
Author	Léa Boulay	Inventory date	27/01/2025

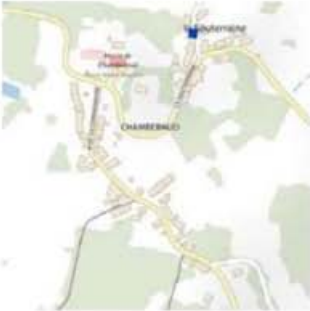
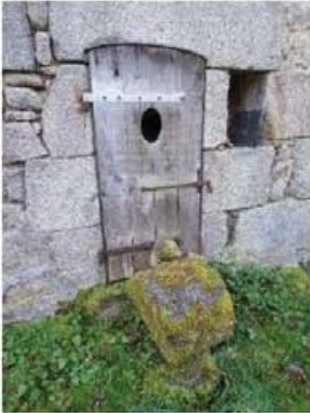
Water Heritage		Typology	Recessed well

46°05'01.2"N 2°04'69.11"E	Chamberaud	23,480	
	Altitude	462.4 m	Orientation	NORTH
	Situation	On a plateau, below	Dimension	Nothing
	Accessibility	<input checked="" type="checkbox"/> Easy access <input type="checkbox"/> Limit <input type="checkbox"/> Not accessible	Current state of place	<input checked="" type="checkbox"/> Good condition <input type="checkbox"/> Average condition <input type="checkbox"/> Deteriorated <input type="checkbox"/> Abandoned

Description of materials			
	Element	Materials		
	Management	Granite		
	Bottom	Granite		
	Door	Drink		
Comments				
<p>No longer in use.</p> <p>The door has a hole</p>				
Author	Léa Boulay	Inventory date	27/01/2025

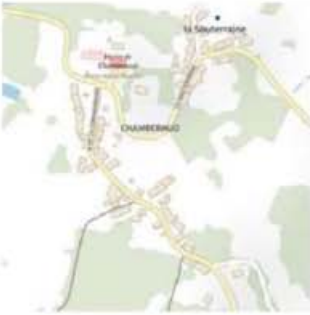
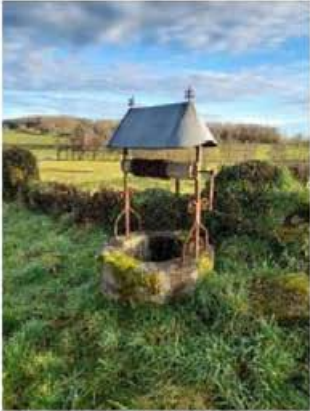
Water Heritage		Typology		Well

46.050404° 2.047447°	Chamberaud	23,480	La Souterraine
	Altitude	460.02m	Orientation	WEST
	Situation	On a plateau, below	Dimension	Nothing
	Accessibility	<input type="checkbox"/> Easy access <input type="checkbox"/> Limit <input type="checkbox"/> Not accessible	Current state of place	<input checked="" type="checkbox"/> Good condition <input type="checkbox"/> Average condition <input type="checkbox"/> Deteriorated <input type="checkbox"/> Abandoned

Description of materials			
	Element	Materials	Element	Materials
	Awning	Sheet metal	Margelle	Granite
	Winch	Drink		
	Gallows	Wrought iron		
	Crank	Wrought iron		
Comments				
<p>The parts of this well that are made of wrought iron represent a significant amount of work because it is decorated, by means of volutes present on the bracket but also at the level of the canopy.</p> <p>No longer in use</p>				
Author	Léa Boulay	Inventory date	27/01/2025

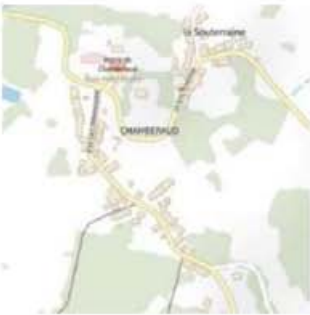
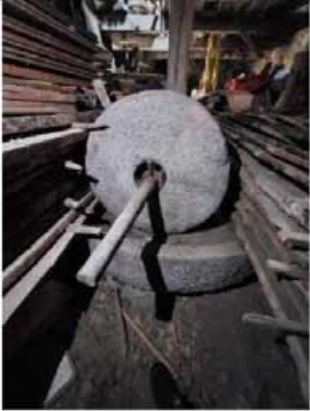
Craft heritage		Typology		Grinding wheel

46.049564° 2.046746°	Chamberaud	23,480	3 La Souterraine
	Altitude	466.35 m Orientation		NORTHEAST
	Situation	On a plateau, below	Dimension	Nothing
	Accessibility	<input type="checkbox"/> Easy access <input type="checkbox"/> Limit <input checked="" type="checkbox"/> Not accessible	Current state of place	<input checked="" type="checkbox"/> Good condition <input type="checkbox"/> Average condition <input type="checkbox"/> Deteriorated <input type="checkbox"/> Abandoned

Description of materials			
	Element	Materials		
	Grinding wheel	Granite		
	Crusher/Press	Granite		
Comments				
<p>This cider millstone was used to press apples. The wheel, driven by a donkey or a man, would turn and crush the apples placed in the press.</p>				
Author	Léa Boulay	Inventory date	06/04/2025

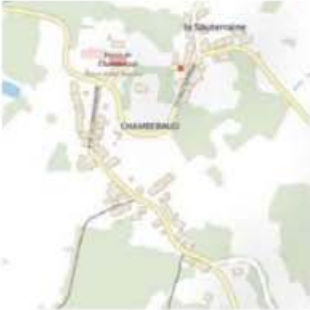
Craft heritage		Typology	Salting

46.049757° 2.046733°	Chamberaud	23,480	
	Altitude	465.3 m	Orientation	NORTH
	Situation	At height	Dimension	Nothing
	Accessibility	<input type="checkbox"/> Easy access <input type="checkbox"/> Limit <input checked="" type="checkbox"/> Not accessible	Current state of place	<input checked="" type="checkbox"/> Good condition <input type="checkbox"/> Average condition <input type="checkbox"/> Deteriorated <input type="checkbox"/> Abandoned

Description of materials			
	Granite container			
Comments				
Also called "vats", this object was used to preserve food by soaking it in salt.				
Author	Léa Boulay	Inventory date	06/04/2025

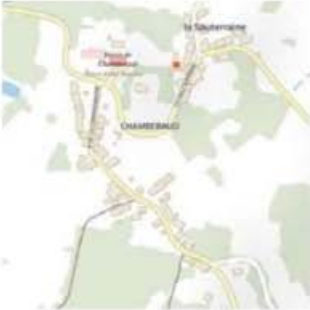
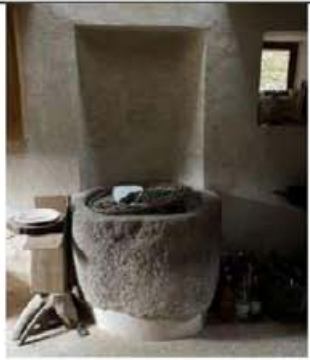
Craft heritage		Typology	Bujadier

46.049799° 2.046681°	Chamberaud	23,480	
	Altitude	465.29 m	Orientation	NORTH
	Situation	At height	Dimension	Nothing
	Accessibility	<input type="checkbox"/> Easy access <input type="checkbox"/> Limit <input checked="" type="checkbox"/> Not accessible	Current state of place	<input checked="" type="checkbox"/> Good condition <input type="checkbox"/> Average condition <input type="checkbox"/> Deteriorated <input type="checkbox"/> Abandoned

Description of materials			
	Granite container			
Comments				
It was used for doing "bugade", laundry.				
Author	Léa Boulay	Inventory date	06/04/2025

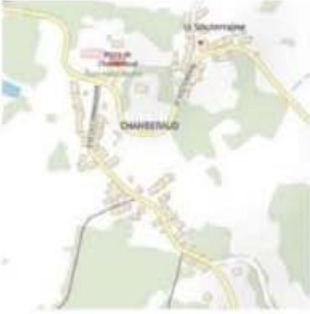
Craft heritage		Typology		Grinding wheel

46.050020° 2.047081°	Chamberaud	23,480	9 La Souveraine
	Altitude	462.25 m Orientation		NORTH
	Situation	On a plateau, below	Dimension	Nothing
	Accessibility	<input checked="" type="checkbox"/> Easy access <input type="checkbox"/> Limit <input type="checkbox"/> Not accessible	Current state of place	<input checked="" type="checkbox"/> Good condition <input type="checkbox"/> Average condition <input type="checkbox"/> Deteriorated <input type="checkbox"/> Abandoned

Description of materials			
	Element	Materials		
	Grinding wheel	Granite		
	Crusher/Press	Granite		
Comments				
Next to the circular millstone, a granite oculus was found.				
Author	Léa Boulay	Inventory date	06/04/2025

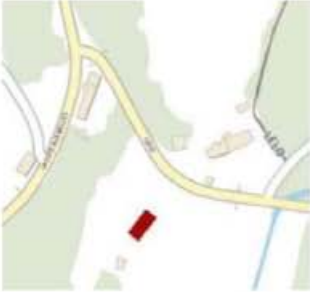
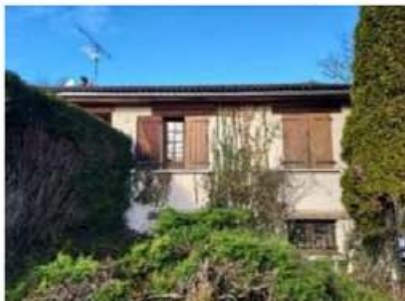
Built heritage		Typology		Home housing

46°05'03.2"N 2°04'25.3"E	Chamberaud	23,480	1 Lelo
	Altitude	476.35 m	Orientation	SOUTH-EAST
	Situation	Below	Dimension	10m x 19m
	Accessibility	<input checked="" type="checkbox"/> Accessible <input type="checkbox"/> Limit <input type="checkbox"/> Not accessible	Current state of place	<input checked="" type="checkbox"/> Good condition <input type="checkbox"/> Average condition <input type="checkbox"/> Deteriorated <input type="checkbox"/> Abandoned

Description of materials			
	Element	Materials	Element	Materials
	Management berries	Wood and concrete	Roofing	Mechanical tile in the Roman style
	Joinery	Drink	Cornices	Nothing
	Walls	Coating zip line	Chimney	Concrete
	Foundations	Nothing		
Comments				
<p>Two-sided roofed house</p> <p>From left to right, the house has 6 bays, bays 2 to 4 of which are surmounted by a covered porch:</p> <ul style="list-style-type: none"> - Bays 2 to 3 each open onto a large double-leaf bay window covered by wooden shutters. - Bay 4 appears to be a doorway - Bays 5 and 6 have two levels, the first being the basement with a bay window per bay opening on a small garage window. On the second level, by bays, there is a window that can be closed with shutters.

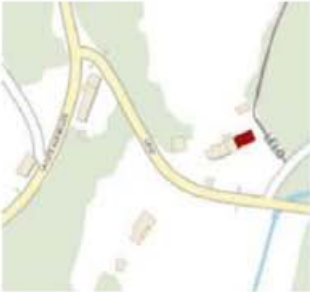
Built heritage		Typology		Home housing

46°05'08.0"N 2°04'33.3"E	Chamberaud	23,480	2 Lelo
	Altitude	471.31 m	Orientation	SOUTH
	Situation	Below	Dimension	9.3 m x 10 m
	Accessibility	<input checked="" type="checkbox"/> Accessible <input type="checkbox"/> Limit <input type="checkbox"/> Not accessible	Current state of the place	<input checked="" type="checkbox"/> Good condition <input type="checkbox"/> Average condition <input type="checkbox"/> Deteriorated <input type="checkbox"/> Abandoned

Description of materials			
	Element	Materials	Element	Materials
	Management berries	Brick, concrete, wooden lintels	Roofing	Mechanical tile
	Joinery	Wood, metal	Cornices	Nothing
	Walls	Coating Tyrolean line, granite rubble stone joined with cement. Chain corner cut granite	Chimney	Brick
	Foundations	Nothing		
Comments				
<p>Two-sided house, with a single-sided extension to its right. Adjoining a barn.</p> <p>The house has two levels of elevation:</p> <ul style="list-style-type: none"> - On the first level of elevation, on the left, there is an opening that can be closed with a dark red wooden shutter. To its right is a wooden entrance door and an opening leading to a window that can also be closed with dark red wooden shutters. These last two openings are surmounted by a canopy. - On the second level there is an opening, a window that can be closed with shutters. <p>The extension comprises two bays:</p> <ul style="list-style-type: none"> - One on the right with a double-leaf door, whose jambs are shaped like harps and saddlebags and whose wooden lintel continues to the next bay where there is a tall window that can be closed with a wooden shutter <p>Corner chain in harps and satchel.</p>

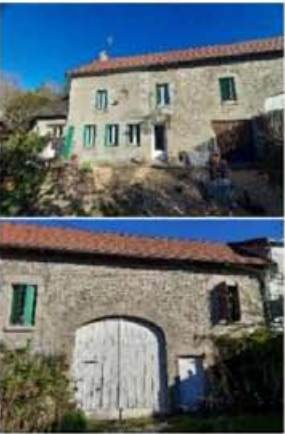
46°05'07.5"N 2°04'31.8"E	Chamberaud		23,480	4 Lelos and 2 Lelos
	Altitude	470.01 m		Orientation	SOUTH
	Situation	Below		Dimension	10m x 20m
	Accessibility	<input checked="" type="checkbox"/> Accessible <input type="checkbox"/> Limit <input type="checkbox"/> Not accessible		Current state of place	<input checked="" type="checkbox"/> Good condition <input type="checkbox"/> Average condition <input type="checkbox"/> Deteriorated <input type="checkbox"/> Abandoned

Description of materials				
	Element	Materials		Element Materials	
	Management berries	Concrete, hewn granite, monolithic lintels, and keyed lintels		Roofing	Mechanical tile
		PVC, wood, and green-painted metal joinery; molded granite cornices			
	Walls	Tyrolean plaster, granite rubble jointed with cement. Concrete corner tie beam		Chimney	Brick
Comments					
<p>Longère with two slopes. If we add to this the barn of 2 LÉLO, it is because this building seems to have been a longère, whose facade of the living part has been rendered and extends partly onto the barn part which was rehabilitated and the rest of the barn has been separated between two properties but must have been one in view of the style of construction.</p> <p><u>Residential section, two levels:</u></p> <ul style="list-style-type: none"> - Level one: three aligned openings leading to windows that can be closed with shutters green. - Level two: an opening leading to a window, which can be closed with shutters and featuring harp-shaped legs and a satchel <p><u>Former barn sections, 4 bays from left to right:</u></p> <ul style="list-style-type: none"> - Bay 1: an entrance door surmounted by a canopy and, on the second level, a window closable with shutters - Bay 2: a double-leaf barn door that appears to be an addition and has a lintel with a flat band and broken courses. On the second level, a green louvered window - Bays 3: Double-leaf barn door with a segmental arch, one with a man's door the doors and to its right. - Bays 4: on the second level a window with shutters which seems to be part of the dwelling of 2 LÉLO who must have rehabilitated his part of the barn. <p>An extension to the left of the building, with an opening leading to a bay window, appears to have been added more recently. Corner quoins and harp-shaped and bag-like jambs</p>

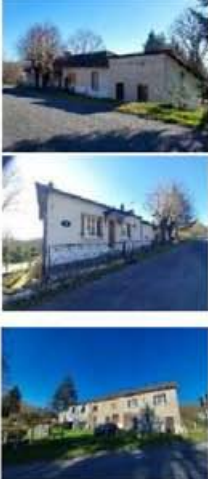
46°05'10.72"N 2°04'21.0"E	Chamberaud	23,480	1 The Coast Beautiful
	Altitude	482.99 m	Orientation	WEST
	Situation	At height	Dimension	7.5 m x 30.4 m
	Accessibility	<input checked="" type="checkbox"/> Accessible <input type="checkbox"/> Limit <input type="checkbox"/> Not accessible	Current state of the place	<input checked="" type="checkbox"/> Good condition <input type="checkbox"/> Average condition <input type="checkbox"/> Deteriorated <input type="checkbox"/> Abandoned

Description of materials			
	Element	Materials	Element	Materials
	Window frames	Concrete (supports, lintels and (legs)	Roofing	Mechanical tile
	Joinery	Metal, wood	Cornices	Nothing
	Walls	Coating zip line	Chimney	Brick, steel
	Foundations	Nothing		
Comments				
<p>The house is composed of three parts, as the original section has been gradually expanded with two extensions. Thus, the original dwelling has a single-pitched roof, while the extensions have gabled roofs, one of which has a hipped roof. The house has three chimneys: two brick and one steel.</p> <p><u>The first part, the original part:</u></p> <ul style="list-style-type: none"> - It was a guinguette at the time, or dance bar. - It comprises two bays with two openings: a door on the left and a window blocked by... wooden panels <p><u>The second section, to the left of the first, consists of 4 bays.</u></p> <ul style="list-style-type: none"> - The rightmost bay has an opening with shutters - Second bay: an opening with shutters - Third bay: an entrance door with harp and satchel-shaped frames and surmounted by a marquise. - Fourth bay: a window that can be closed with shutters and has harp-shaped jambs and satchel <p><u>The third part consists of 4 bays:</u></p> <ul style="list-style-type: none"> - A side section featuring a closable bay window with shutters - To the left of the first one, there are two bays, one small and one larger, which opens onto a window that can be covered with shutters - Third bay: a doorway surmounted by a canopy - Fourth: a window with shutters. <p>The dwelling has a second level, the ground floor of which is visible from the rear of the building. 01/04/2025</p>

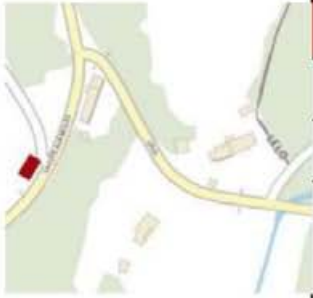
Built heritage		Typology		Home housing

46°05'06.8"N 2°04'15.8"E	Chamberaud	23,480	2 Côte aux Belles
	Altitude	488.8 m	Orientation	SOUTH-EAST
	Situation	At height	Dimension	7 m x 13.5 m
	Accessibility	<input checked="" type="checkbox"/> Accessible <input type="checkbox"/> Limit <input type="checkbox"/> Not accessible	Current state of the place	<input checked="" type="checkbox"/> Good condition <input type="checkbox"/> Average condition <input type="checkbox"/> Deteriorated <input checked="" type="checkbox"/> Abandoned
Description of materials

Element	Materials	Element	Materials
	Supervision of berries	Brick and concrete support	Roofing	Mechanical tile
	Joinery	Metal, blue-painted wood, white PVC	Cornices	Cut granite
	Walls	Concrete plaster, lime plaster, granite rubble with lime mortar joints. Granite corner chain	Chimney	Brick
	Foundations	Concrete		
Comments				
<p>Two-sided dwelling The house appears to be in three parts, the main part in the center and the right and left parts seem to have been added at different times judging by the construction methods.</p> <p>The structure is divided into 4 bays, with two elevation levels:</p> <ul style="list-style-type: none"> - The first bay consists of only one elevation level with a bay window with blue shutters. Its legs are shaped like harps and a satchel - The second bay has, on the first level, an opening with a white shutter that can serve as an entrance door. On the second level, there is a bay window with blue shutters. - The third bay has two bays, another blue convent and the one above with blue shutters - The fourth behaves at the first level of a triple-leaf garage door. Above You will find a bay window with a blue metal shutter and a concrete support. <p>Presence of a sink stone.</p>

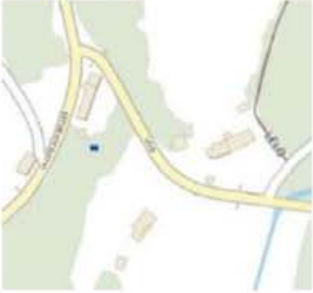
Water Heritage		Typology	Watercress farm

46.051092° 2.042119°	Chamberaud	23,480	
	Altitude	483.72 m	Orientation	SOUTHWEST
	Situation	At height	Dimension	Nothing
	Accessibility	<input checked="" type="checkbox"/> Easy access <input type="checkbox"/> Limit <input type="checkbox"/> Not accessible	Current state of the place	<input type="checkbox"/> Good condition <input checked="" type="checkbox"/> Average condition <input type="checkbox"/> Deteriorated <input type="checkbox"/> Abandoned

Description of materials			
	Element	Materials		
	Basin	Granite		
Comments				
No longer in use				
Author	Léa Boulay	Inventory date	27/01/2025

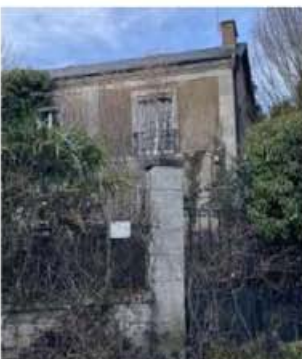
Built heritage		Typology		Manor house

46°02'53.4"N 2°02'26.3"E	Chamberaud	23,480	2 Le Puy
	Altitude	506 m	Orientation	Southeast
	Situation	On a high plateau	Dimension	12m x 9m
	Accessibility	<input type="checkbox"/> Easy access <input type="checkbox"/> Limit <input checked="" type="checkbox"/> Not accessible	Current state of place	<input type="checkbox"/> Good condition <input type="checkbox"/> Average condition <input type="checkbox"/> Deteriorated <input checked="" type="checkbox"/> Abandoned

Description of materials			
	Element	Materials	Element	Materials
	Management berries	Granite, dressed stone frame	Roofing	2 panels slate
	Joinery		Cornices	Sculpted granite
	Walls	Tyrolean plastering in a corner chain of cut stones squared	Chimney	Sculpted granite and red bricks
Foundations		Lintels	Made of stone (granite?) in continuity with bay window frame	
Comments				
<p>A large rectangular facade with a significant number of aligned and symmetrical openings and windows. Bays with black metal balustrades, detailed with a floral motif.</p> <p>A vast property consisting of exotic species, landscaped gardens with trees, and a volcanic cone. The large property is bordered by a low wall of granite stones, quite impressive in its size.</p> <p>This dwelling may have once been a manor house; today it is semi-abandoned, nature is reclaiming its rights, and the detached house is uninhabited.</p>

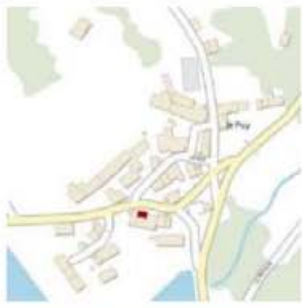
Built heritage		Typology		Home hamlet

46°02'50.5"N 2°02'21.4"E	Chamberaud	23,480	5 Le Puy
	Altitude	509m	Orientation	Northeast
	Situation	High up on a plateau	Dimension	6 x 11m
	Accessibility	<input checked="" type="checkbox"/> Easy access <input type="checkbox"/> Limit <input type="checkbox"/> Not accessible	Current state of the place	<input checked="" type="checkbox"/> Good condition <input type="checkbox"/> Average condition <input type="checkbox"/> Deteriorated <input type="checkbox"/> Abandoned

Description of materials			
	Element	Materials	Element	Materials
	Management berries	Granite and monolithic lintel	Roofing	Mechanical tiles
	Joinery	Wooden	Cornices	Sculpted granite
	Walls	Dry stone walls	Granite Fireplace	
	Granite stone foundations			
Comments				
<p>House with two slopes, granite chimney and a few skylights. Four openings, quasi-harp corner chaining and sachel. Lime-plastered facade with exposed stone, PVC windows, blue-painted wooden shutters. Small bay window on the right leading to a stone sink. On the lintel of the main door, we find a chronogram with the date 1842.</p>

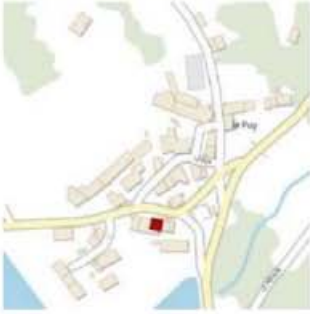
Built heritage		Typology		Long farmhouse with two stories

46°02'50.5"N 2°02'21.4"E	Chamberaud	23,480	5 Le Puy
	Altitude	510m	Orientation	Northeast
	Situation	High up on a flat area	Dimension	6 x 10m
	Accessibility	<input checked="" type="checkbox"/> Easy access <input type="checkbox"/> Limit <input type="checkbox"/> No accessible	Current state of place	<input checked="" type="checkbox"/> Good condition <input type="checkbox"/> Average condition <input type="checkbox"/> Deteriorated <input type="checkbox"/> Abandoned

Description of materials			
	Element	Materials	Element Materials	
	Management berries	Granite and lintels monolithic	Roofing	Tiles mechanics
	Joinery	Wood-colored PVC (brown)	Cornices	Carved granite stones
	Walls	Stone corner quoins	Granite fireplace	
	Stone Foundations			
Comments				
<p>Semi-detached house, gable roof</p> <p>Lime-plastered facade with exposed stonework</p> <p>Three bays including a main door, corner quoins in a harp and bag shape.</p> <p>Two oculus windows (bull's-eye shaped). The outline at the base of the chimney stack indicates a former thatched roof. On the lintel of the main door is a chronogram with a barely legible date.</p>

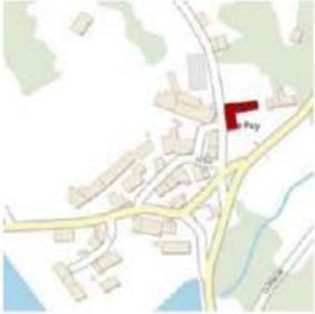
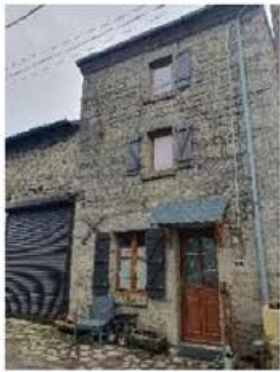
Built heritage		Typology		Long farmhouse with two stories

46°02'52.8"N 2°02'24.5"E	Chamberaud	23,480	6 Le Puy
	Altitude	511m	Orientation	WEST
	Situation	On a plateau, high up	Dimension	20m x 8m
	Accessibility	<input checked="" type="checkbox"/> Easy access <input type="checkbox"/> Limit <input type="checkbox"/> Not accessible	Current state of place	<input checked="" type="checkbox"/> Good condition <input type="checkbox"/> Average condition <input type="checkbox"/> Deteriorated <input type="checkbox"/> Abandoned

Description of materials			
	Element	Materials	Element	Materials
	Management berries	Cut granite and lintels monolithic squared	Roofing	Slate and riverbanks zinc
	Joinery	Wood and PVC	Cornices	Sculpted granite
	Walls	Cut granite	Chimney	Cut granite
	Foundations: None			
Comments				
<p>Roofs of varying heights but always with two slopes. Corner chains in harp and satchel style. <u>West facade (right side):</u> wall of dressed granite stone. Two unfinished wooden windows, one of which is missing its dark gray painted wooden shutters. On the ground floor, a half-glazed door and a window, both unfinished and made of wood, are aligned. The door is surmounted by a sheet metal canopy. A cross-shaped tie rod is present. Cornices are present only on this facade.</p> <p><u>West facade (left side):</u> former barn door converted into a PVC window; part of the wooden lintel remains. The roof has likely been raised; a line can be seen delimiting the lower part of the wall, with its grey plaster and stones of a different size, from the upper part, with wider, beige-colored joints.</p> <p><u>South gable:</u> stones waiting, sink stone, gives light at the attic level, presence of two windows aligned one above the other and closed by dark grey wooden shutters, traces of modification around the windows with a halo of plaster giving a different appearance from the rest of the gable in jointed granite rubble.</p> <p>Adjoining barn: tiled roof, wooden barn door with a man's door. A ventilation opening is present at the base of the rubble wall, decorated with corner quoins.</p>
