Année 2024 - 2025

Heritage inventory Chamberaud

Licence 3 –
Géographie et Aménagement :
Valorisation du Patrimoine et
Développement Territorial

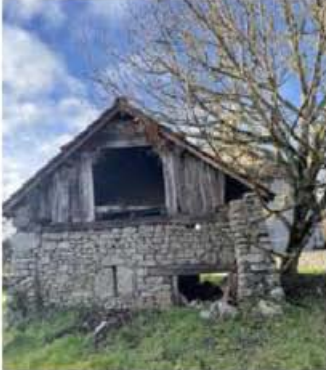
46°02'49.9"N 2°02'19.5"E	Chamberaud	23,480	11 Le Puy
	Altitude	509m	Orientation	Northeast
	Situation	High up on a flat area	Dimension	4 x 3 m
	Accessibility	<input checked="" type="checkbox"/> Easy access <input type="checkbox"/> Limit <input type="checkbox"/> Not accessible	Current state of place	<input type="checkbox"/> Good condition <input type="checkbox"/> Average condition <input checked="" type="checkbox"/> Deteriorated <input type="checkbox"/> Abandoned

Description of materials			
	Element	Materials	Element	Materials
	Window frames		Roofing	Mechanical tiles
	Joinery		Cornices	
	Walls	Dry stone walls granite	Chimney	
Granite stone foundations				
Comments				
<p>This could have been a typical rural storage shed, with a gabled roof and traditional dry stone facing. The upper section is made of wood, with a fairly large opening that could have served as storage space for hay or other items. The lower section, made of locally quarried granite, has a small opening at the bottom, which could also have served as logical and accessible storage.</p>

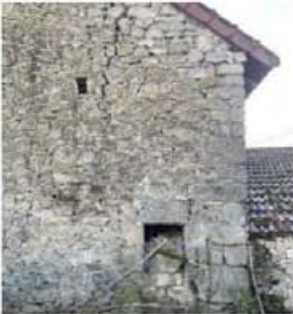
46°02'50.4"N 2°02'20.1"E	Chamberaud	23,480	11 Le Puy
	Altitude	509m	Orientation	Southwest
	Situation	High up on a flat area	Dimension	6 x 4 m
	Accessibility	<input checked="" type="checkbox"/> Easy access <input type="checkbox"/> Limit <input type="checkbox"/> Not accessible	Current state of place	<input type="checkbox"/> Good condition <input checked="" type="checkbox"/> Average condition <input type="checkbox"/> Deteriorated <input type="checkbox"/> Abandoned

Description of materials			
	Element	Materials	Element	Materials
	Window frames	Granite and monolithic lintels	Roofing	Flat tiles
	Joinery		Cornices	
	Walls	Dry granite stone without mortar	Chimney	
	Stone Foundations			
Comments Barn with gable end view, with small skylight high up and opening on the right side. Corner quoins in a harp and basket shape with dressed granite. The wall's stonework is laid without mortar, indicating a certain level of skill. Further down, more in the middle, we can see an apparent relieving arch (below), so there was certainly an opening; multiple changes are visible in the arrangement of the stones.

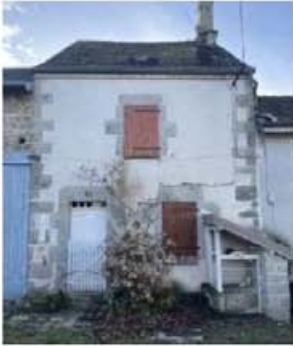
46°02'49.5"N 2°02'18.9"E	Chamberaud	23,480	13 Le Puy
	Altitude	509m	Orientation	Northeast
	Situation	High up on a flat area	Dimension	6m x 10m
	Accessibility	<input checked="" type="checkbox"/> Easy access <input type="checkbox"/> Limit <input type="checkbox"/> Not accessible	Current state of place	<input checked="" type="checkbox"/> Good condition <input type="checkbox"/> Average condition <input type="checkbox"/> Deteriorated <input type="checkbox"/> Abandoned

Description of materials			
	Element	Materials	Element	Materials
	Window frames	Granite and monolithic lintel	Roofing	Slate roofs and a few rows of interlocking tiles (3)
	Joinery	Counterwindows in drink	Cornices	Sculpted granite
	Walls	Lime plaster	Granite fireplace	
	Foundations			
Comments				
<p>Perhaps the old farmhouse.</p> <p>Semi-detached house, with two gable ends.</p> <p>Granite corner quoins in a harp shape and cut stone bag. Small roof frame.</p> <p>Lime plaster, main opening with a small barrier that can be used to block access for animals.</p> <p>Openings that are few in number and not symmetrical,</p> <p>The chimney has a lower section that could be reminiscent of an old thatched roof from bygone days.</p> <p>The house has a well below on the right.</p>

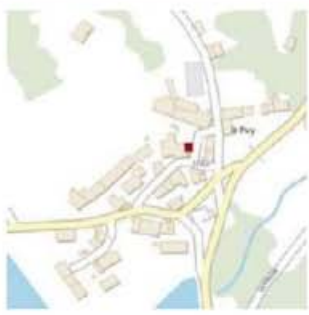
Built heritage		Typology		Annex of barn

46°02'53.0"N 2°02'23.9"E	Chamberaud	23,480	Le Puy
	Altitude	514m	Orientation	SOUTH
	Situation	On a plateau, high up	Dimension	7m x 5m
	Accessibility	<input checked="" type="checkbox"/> Easy access <input type="checkbox"/> Limit <input type="checkbox"/> Not accessible	Current state of place	<input type="checkbox"/> Good condition <input type="checkbox"/> Average condition <input checked="" type="checkbox"/> Deteriorated <input checked="" type="checkbox"/> Abandoned

Description of materials			
	Element	Materials	Element	Materials
	Management berries	Roughly cut granite	Roofing	Mechanical tiles
	Joinery	Drink	Cornices	Nothing
	Walls	Granite, some remaining lime mortar joints	Chimney	Nothing
	Foundations: None			
Comments				
<p>Gable roof, covered with mechanical tiles.</p> <p>Facade hidden by vegetation.</p> <p>Wooden barn door with man door and wooden lintel on the left.</p> <p>Basement door on the right, surmounted by a monolithic lintel and a triangular relieving arch.</p>

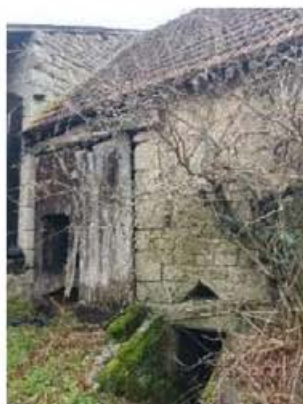
Built heritage		Typology		House of hamlet

46°02'50.2"N 2°02'19.2"E	Chamberaud	23,480	15 Le Puy
	Altitude	510m	Orientation	Southeast
	Situation	High up on a plateau	Dimension	7m x 8m
	Accessibility	<input checked="" type="checkbox"/> Easy access <input type="checkbox"/> Limit <input type="checkbox"/> Not accessible	Current state of place	<input checked="" type="checkbox"/> Good condition <input type="checkbox"/> Average condition <input type="checkbox"/> Deteriorated <input type="checkbox"/> Abandoned

Description of materials			
	Element	Materials	Element	Materials
	Window frames	Concrete lintel	Roofing	Mechanical tiles
	Joinery	PVC windows	Cornices	Made of hewn stone
	Walls	Coating zip line	Chimney	
	Concrete foundations			
Comments				
<p>Terraced house.</p> <p>Openwork shutters in the form of shutters, symmetrical openings, large two-bay façade.</p> <p>Entrance canopy, skylight.</p> <p>In the lower right corner is a stone sink with a light well above it.</p> <p>On the second bay on the upper floor there is a tie rod, a gutter on the left crosses the facade.</p>

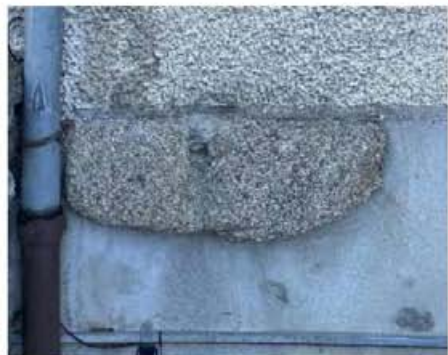
Built heritage		Typology		House of hamlet

46°02'52.2"N 2°02'24.0"E	Chamberaud	23,480	16 Le Puy
	Altitude	511m	Orientation	EAST
	Situation	On a plateau, high up	Dimension	10m x 7m
	Accessibility	<input checked="" type="checkbox"/> Easy access <input type="checkbox"/> Limit <input type="checkbox"/> No accessible	Current state of place	<input type="checkbox"/> Good condition <input checked="" type="checkbox"/> Average condition <input type="checkbox"/> Deteriorated <input type="checkbox"/> Abandoned

Description of materials			
	Element	Materials	Element	Materials
	Management berries	Granite and squared monolithic lintels	Roofing	Slate
	Joinery	Drink	Cornices	Sculpted granite
	Walls	Tyrolean plasterwork and granite corner quoins	Chimney	Granite cut stone
	Foundations	Imitation concrete jointed dressed stones		
Comments				
<p>Terraced house. Wooden shutters.</p> <p>Engraving on the wall plaster: chronogram "1900" above the door lintel, 6-leaf flower motifs between the bays of the first and second floors.</p> <p>Corner quoins in harps and squared granite bags.</p> <p>Three-sided roof.</p> <p>Snuffbox behind the chimney stack.</p> <p>Sculpted zinc ridge finials.</p> <p>Stone fireplace with an engraved last stone, with an S-shaped tie rod.</p> <p>Three bays.</p>

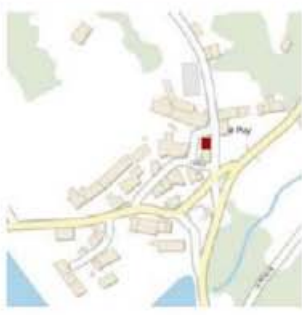
Built heritage		Typology		House of hamlet

46°02'52.5"N 2°02'24.3"E	Chamberaud	23,480	16 Le Puy
	Altitude	512m	Orientation	EAST
	Situation	On a plateau, high up	Dimension	14m x 7m
	Accessibility	<input checked="" type="checkbox"/> Easy access <input type="checkbox"/> Limit <input type="checkbox"/> Not accessible	Current state of place	<input type="checkbox"/> Good condition <input checked="" type="checkbox"/> Average condition <input type="checkbox"/> Deteriorated <input type="checkbox"/> Abandoned

Description of materials			
	Element	Materials	Element	Materials
	Window frames	Granite and monolithic lintels	Roofing	Mechanical tiles and wooden edges
	Joinery	PVC, (excluding the door on the opposite facade which is made of wood)	Cornices	Nothing
	Walls gutters	Tyrolean plasterwork and granite corner quoins	Concrete block chimneys?	
	Gable wall	Rubble-type stones		
	Foundations: None			
Comments

<p>Terraced house. PVC shutters.</p> <p>A double-pitched roof with two different heights and slopes. The upper part is covered with interlocking tiles and the lower part with slate.</p> <p>The house is equipped with two fireplaces.</p> <p>A chicken coop is attached to the building. It has only one side covered with interlocking tiles, is made of uncut granite, and is joined with concrete only at the base. It has a corner quoin in the shape of a harp and a bag.</p>				
Author	Maëlle	Inventory date	27/01/2025

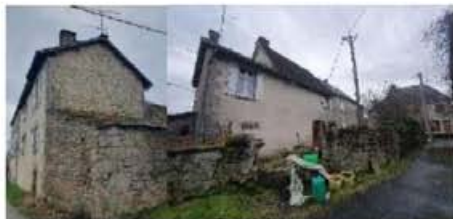
Built heritage		Typology		House of hamlet

46°02'51.6"N 2°02'23.6"E	Chamberaud	23,480	17 Le Puy
	Altitude	513m	Orientation	SOUTHWEST
	Situation	On a plateau, high up	Dimension	10m x 4m
	Accessibility	<input checked="" type="checkbox"/> Easy access <input type="checkbox"/> Limit <input type="checkbox"/> Not accessible	Current state of place	<input checked="" type="checkbox"/> Good condition <input type="checkbox"/> Average condition <input type="checkbox"/> Deteriorated <input type="checkbox"/> Abandoned

Description of materials			
	Element	Materials	Element	Materials
	Management berries	Concrete	Roofing	Slate
	Joinery	Drink	Cornices	Nothing
	Walls	Concrete and granite with exposed stone plaster	Chimney	Bricks
	Foundations			
Comments				
<p>Terraced house.</p> <p>The roof has three slopes, the adjoining house only has two, the building studied appears to be cut in two.</p> <p>The facade is asymmetrical. The base is made of granite with a lime plaster finish, exposing the stonework. The upper section is concrete. The front door is on the right, higher up than the street. It is framed in concrete. The window resembles a glass roof; it is made of wood painted white. The upstairs window is centered and has wooden shutters that appear deteriorated.</p> <p>On the gable end, there is granite with a lime plaster finish, exposing the stonework, which cascades down from the top right to the bottom of the wall on the left. The upper part of the gable on the left is concrete. The gable window is almost identical to the stained-glass window on the facade but slightly wider.</p>

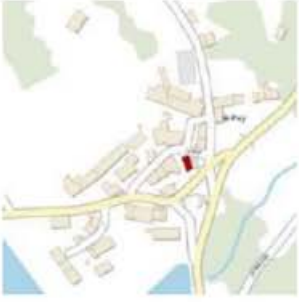
Built heritage		Typology		House of hamlet

46°02'51.7"N 2°02'23.5"E	Chamberaud	23,480	18 Le Puy
	Altitude	514m	Orientation	NORTH
	Situation	On a plateau, high up	Dimension	11m x 6m
	Accessibility	<input checked="" type="checkbox"/> Easy access <input type="checkbox"/> Limit <input type="checkbox"/> Not accessible	Current state of place	<input type="checkbox"/> Good condition <input checked="" type="checkbox"/> Average condition <input type="checkbox"/> Deteriorated <input type="checkbox"/> Abandoned

Description of materials			
	Element	Materials	Element	Materials
	Management berries	Squared granite and concrete	Roofing	Slate
	Joinery	Wood and metal	Cornices	Concrete
	Walls	Concrete and granite cut stone	Chimney	Granite and concrete joints
Foundations	Concrete imitating jointed cut stone			
Comments				
<p>Gable roof.</p> <p>The ground floor and upper floor sections are not symmetrical. The two upper-floor windows are wider and not aligned with the ground-floor windows. The window frames are regular on the upper floor and have a harp and bag-like pattern on the ground floor.</p> <p>Two broken tie rods can be seen at the top right of the building.</p> <p>The two ground floor window sills are different, the one on the left is made of molded granite while the one on the right is made of concrete.</p>

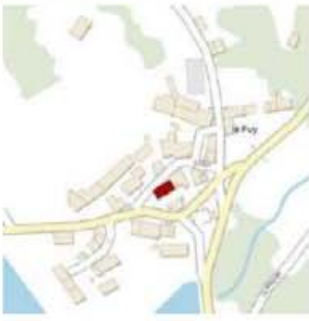
Built heritage		Typology		Limousin barn

46°02'51.4"N 2°02'22.3"E	Chamberaud	23,480	21 Le Puy
	Altitude	515m	Orientation	SOUTH-EAST
	Situation	On a plateau, high up	Dimension	15m x 8m
	Accessibility	<input checked="" type="checkbox"/> Easy access <input type="checkbox"/> Limit <input type="checkbox"/> Not accessible	Current state of place	<input type="checkbox"/> Good condition <input checked="" type="checkbox"/> Average condition <input type="checkbox"/> Deteriorated <input type="checkbox"/> Abandoned

Description of materials			
	Element	Materials	Element	Materials
	Management berries	Cut granite, wooden lintels and monolithic lintels	Roofing	Slate and riverbanks zinc
	Joinery	Drink	Cornices	Nothing
	Walls	Building blocks granite and lime mortar joints (concrete gable end)	Chimney	Nothing
	Foundations:	Granite blocks		
Comments				
<p>The corner chain is in the shape of a harp and a satchel.</p> <p>The openings are rather low compared to those of other barns.</p> <p>The door on the right is made of pieces of wood in such a way as to leave a gap between each one; this was possibly used to keep chickens inside.</p>

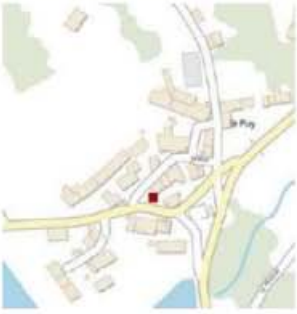
Built heritage		Typology		Barn with canopy

46°02'51.0"N 2°02'22.8"E	Chamberaud	23,480	22 Le Puy
	Altitude	509m	Orientation	Northeast
	Situation	High up on a flat area	Dimension	6 x 5m
	Accessibility	<input checked="" type="checkbox"/> Easy access <input type="checkbox"/> Limit <input type="checkbox"/> Not accessible	Current state of place	<input type="checkbox"/> Good condition <input type="checkbox"/> Average condition <input checked="" type="checkbox"/> Deteriorated <input type="checkbox"/> Abandoned

Description of materials			
	Element	Materials	Element	Materials
	Management berries	Wooden lintel and brick frame	Roofing	Sheet metal
	Joinery	Drink	Cornices	
	Walls	Granite stones, dry or with mortar	Chimney	
	Stone foundations			
Comments				
<p>This Limousin barn has a canopy, its main opening is imposing and made of wood. Two small windows are visible on the facade, above the main opening, a bay window without joinery with brick frames.</p>

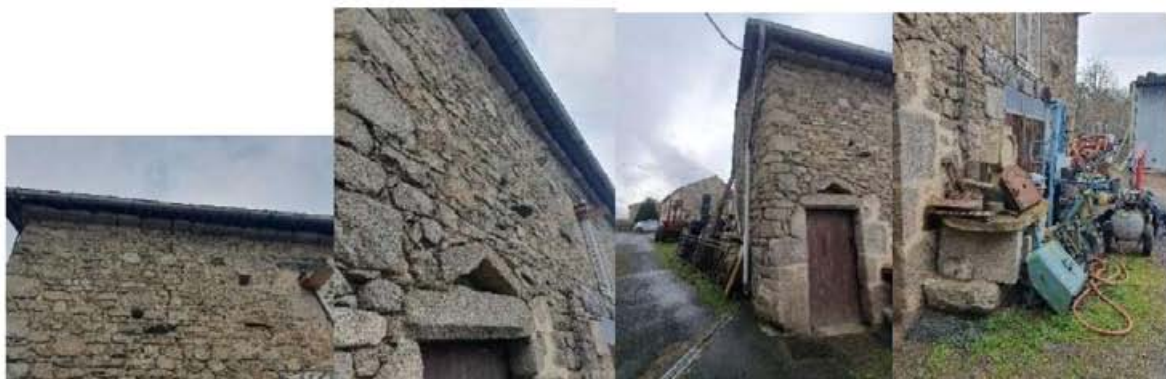
Description of materials			
	Element	Materials	Element	Materials
	Management berries	Cut granite, lintels monolithic and wooden lintels	Roofing	Jail
	Joinery	Drink	Cornices	Granite joists
	Walls	Rubble with lime joint residue	Chimney	Nothing
	Foundations	Cut granite blocks joined with lime mortar		
Comments				
<p>The corner chain is rounded.</p> <p>In its center, a barn door with a wooden lintel, above which is superimposed a small door or window closed by white wooden shutters.</p> <p>The two doors at the ends appear more or less symmetrical, they are made of wood and surmounted by monolithic lintels with a relieving arch.</p> <p>Access is limited by the mass of items stored at the foot of the building.</p>

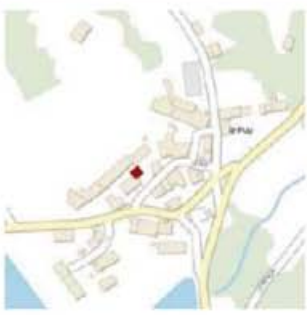
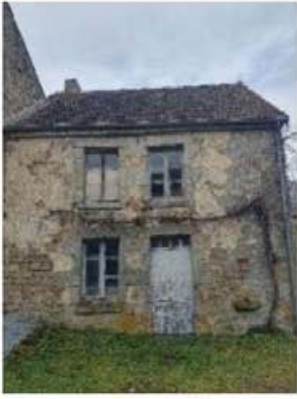
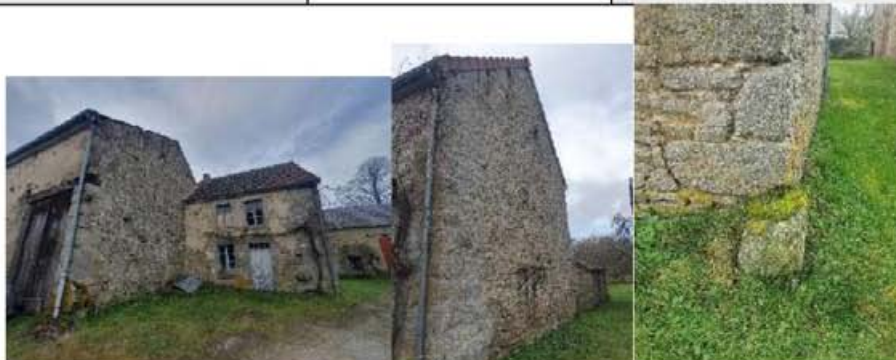
Built heritage		Typology		House of hamlet

Description of materials			
	Element	Materials	Element	Materials
	Window frames	Cut granite and lintels monolithic	Roofing	Mechanical tiles
	Joinery	Drink	Cornices	Squared granite
	Walls	Granite blocks and concrete plaster/joints	Chimney	Concrete
	Foundations: None			
Comments				
<p>The openings are arranged symmetrically, with two windows upstairs aligned with the door and window on the ground floor.</p> <p>A stone sink is present. The oculus (or opening) is framed by four granite blocks. It has been blocked by paving stones.</p> <p>Two hinge holes can be seen on the right side of the door at the level of the lower half. This is certainly the location of a barrier blocking access to animals such as chickens.</p> <p><u>The gutter wall: Left</u> bays, ground floor section: dry stone wall. Right-hand bay, upper floor section: stone wall with cement joints. Upper floor section: cement plaster residue on the stone wall.</p>

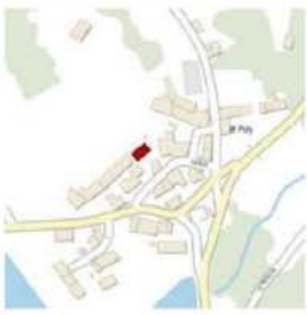
Built heritage		Typology		Limousin barn

Description of materials			
	Element	Materials	Element	Materials
	Management berries	Cut granite and wooden, monolithic lintels	Roofing	Slate and riverbanks zinc
	Joinery	Drink	Cornices	Nothing
	Walls	Granite rubble and corner quoins	Chimney	Nothing
	Foundations: None			
Comments				
<p>The barn has a gable roof.</p> <p>The lower part of the eaves wall and the gable wall appear to be made of dry stone. The upper part of the eaves wall is pointed with lime mortar. The whole structure is reinforced with a corner quoin in the shape of a harp and a basket.</p> <p>The central barn door is very recent. The two mansard doors and the second barn door are rather old. The mansard doors are topped with thick monolithic lintels, unlike the barn doors which have wooden lintels.</p> <p>We also observe some small openings, perhaps ventilation or light sources.</p>

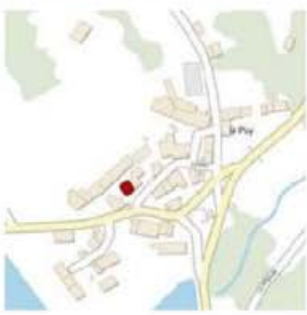
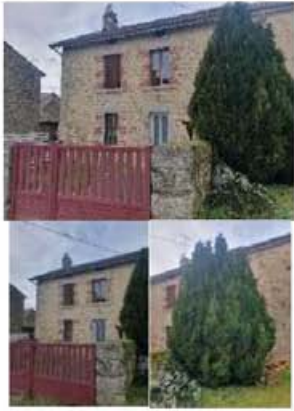
Built heritage		Typology		House of hamlet

Management berries	Cut granite and blocks, squared monolithic lintels and squared granite window sills	Roofing	Tiles and wooden friezes painted white
		Joinery	Windows and wooden shutters and door PVC	Cornices	Nothing
		Walls	Building blocks Lime-plastered granite, exposed stonework and corner quoins	Chimney	Granite

Foundations			
		Comments			
<p>Semi-detached house with a gable roof.</p> <p>There is a well on the property, near the front door.</p> <p>The facade is symmetrical. The ground-floor window and door are aligned with the first-floor windows, and the upper windows are framed with brick. The window surrounds alternate between dressed stone and stacked bricks. The door is framed entirely with dressed stone.</p> <p>The facade looks new, surely recently restored.</p>					
Author	Maëlle	Inventory date	27/01/2025

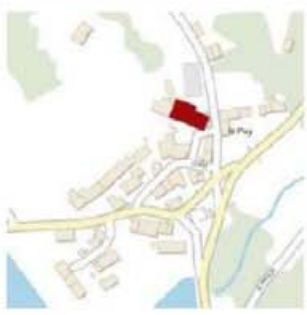
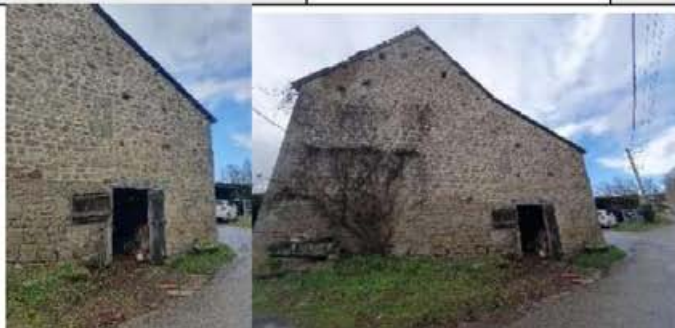
Built heritage		Typology		Limousin barn

Description of materials			
	Element	Materials	Element	Materials
	Management berries	Cut granite and wooden lintel and monolithic lintels	Roofing	Slate and tiles mechanical
	Joinery	Drink	Cornices	Nothing
	Walls	Dry stone, granite and lime mortar joints, corner quoins	Chimney	Concrete and stones
	Foundations: None			
Comments				
<p>It is a gable roof, divided in two by the materials: slate on the street side and interlocking tiles on the other. The roofs are the same height and pitch.</p> <p>The barn appears to have been enlarged. On the gable end, a demarcation of the old facade is visible (corner quoins) with the demarcation of the old roof.</p> <p>The lower part of the gable is dry-stone, up to the wooden lintel of the door. The rest of the gable is lime-pointed. The eaves wall is also lime-pointed. The whole structure is embellished with quoins in a harp and bag shape, and with projecting stones. The eaves wall is deteriorated; a section has collapsed, leaving a brick reinforcement on the right side.</p> <p>Regarding the chimneys, two can be seen; the first is made of concrete. The second is made of granite and reveals a demarcation between an old roof (certainly thatched) and the current roof of interlocking tiles.</p>

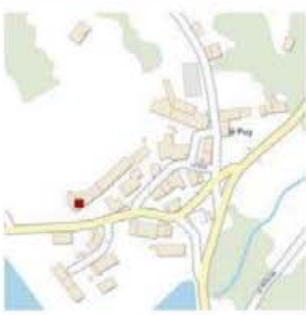
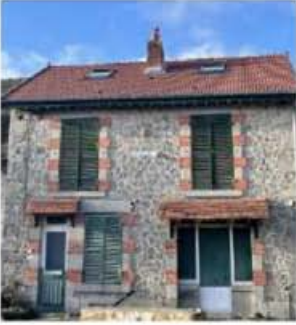
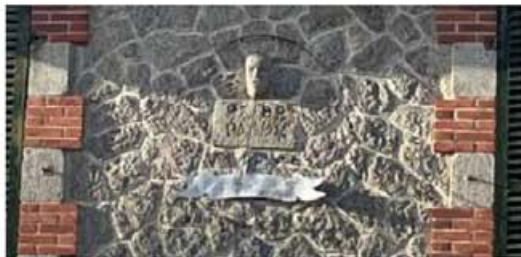
Built heritage		Typology		House of hamlet

Description of materials			
	Element	Materials	Element	Materials
	Window frames	Monolithic granite lintels	Roofing	Mechanical tiles
	Joinery	wood painted green	Cornices	Green frieze
	Walls	Lime plaster, exposed stone	Chimney	Brick reds
	Granite block foundations			
Comments				
<p>Terraced house.</p> <p>Gable roof, two ridge tiles, which is unusual for a gable roof. Two roof vents, three vent tiles. Brick chimney, with a chimney pot on the upper part.</p> <p>The façade features symmetrical openings; the first bay has granite frames alternating with brick for its windows, potentially for aesthetic purposes. A main opening with a canopy and a flat tile roof, windows with green shutters, and below it, a basement window.</p> <p>The straight bay has its main opening with two fixed windows. The corner quoins are unusual, with a half-harp and half-belt shape, rather than traditional quoins. There is a large canopy with flat tiles.</p> <p>Large facade with lime plaster and exposed stonework,</p> <p>In the middle of these two bays, a remarkable ornamentation, a face with barely visible writing, potentially reused, perhaps from the stones of the commandery.</p>

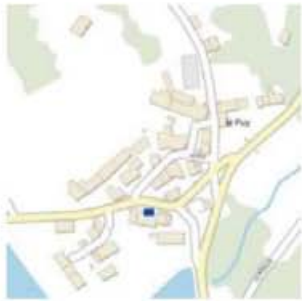
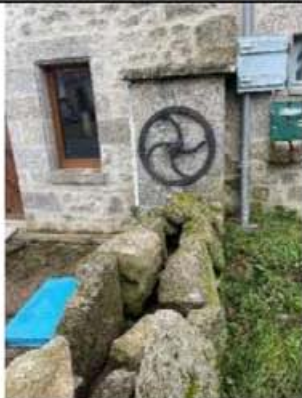
Water Heritage		Typology		Well

Description of materials			
	Element	Materials	Element	Materials
Comments				
An unusual well, in front of a house. It was used for water supply, but is now inactive.				
Author	Carine Bigot	Inventory date	27/01/2025

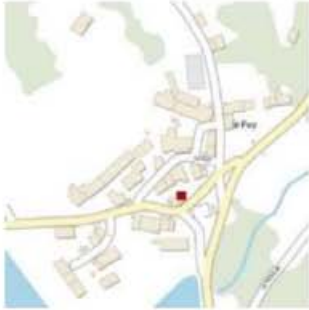
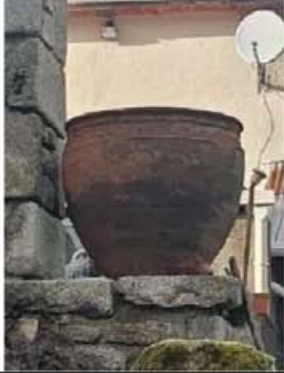
Craft heritage		Typology	Bujadier

Description of materials			
	Terracotta			
	Comments			
	<p>A terracotta laundry tub is used particularly in the context of traditional laundry techniques. Terracotta, due to its natural properties, can be used practically for washing clothes and bleaching.</p>			
Author	Carine Bigot	Inventory date	27/01/2025

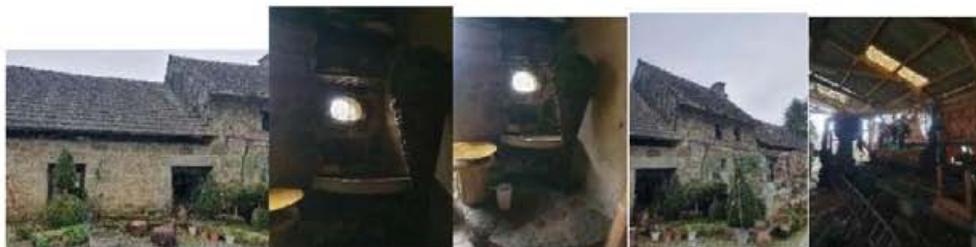
Description of materials			
	Element	Materials	Element	Materials
	Window frames	Cut granite and lintels monolithic	Roofing	Mechanical tiles
	Joinery		Cornices	Nothing
	Walls	Granite with lime plaster exposed stone, wood	Chimney	Granite
	Foundations: None			
Comments				
<p>A roof with two slopes, of different heights and the same pitch.</p> <p>The central section is the only original part of which only three walls remained standing. The other two sections were rebuilt using the stones still present on site.</p> <p>Corner chains in harp and satchel style.</p> <p>The central part is symmetrical, the openings on the ground floor and the first floor are aligned.</p> <p>Presence of a sink stone.</p> <p>On both end sections, the lintels of the openings are curbs from Ahun.</p> <p>The building has an extension on the other side of the road, in which there is a sawmill that served all the peasants.</p>

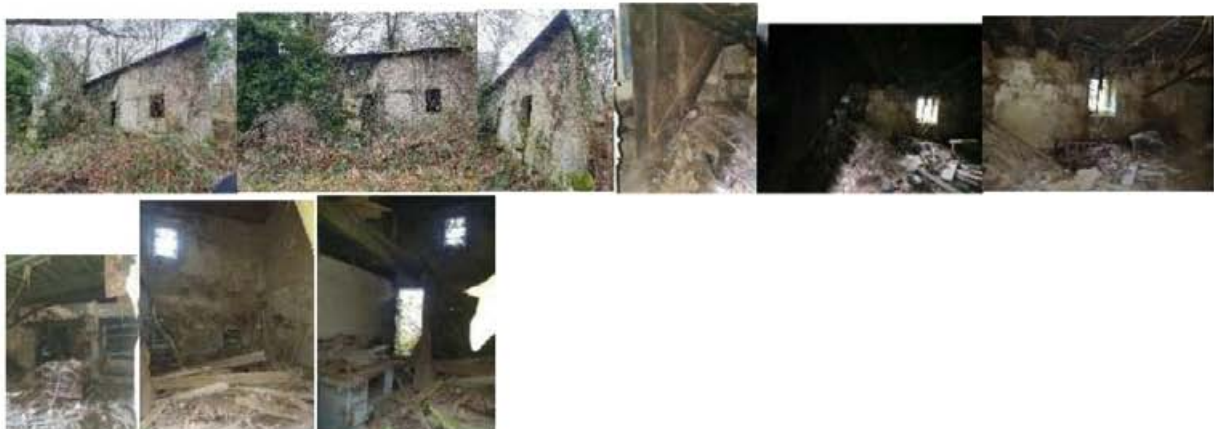
Description of materials			
	Element	Materials	Element	Materials
	Management berries	Cut granite, wooden lintel and monolithic lintels	Roofing	Tiles mechanics
	Joinery	Drink	Cornices	Nothing
	Walls	Granite with lime plaster, exposed stone	Chimney	Nothing
	Foundations: None			
Comments				
<p>We can perceive that the right-hand part is an extension, by the corner chain that crosses the building to the right of the entrance door.</p> <p>It is also noted that an opening has been blocked under the wooden lintel.</p> <p>You can also see an adjoining chicken coop.</p> <p>We were able to find newspapers dating from 1957 in the building. There is also a burnt-out car carcass at the rear of the building.</p>

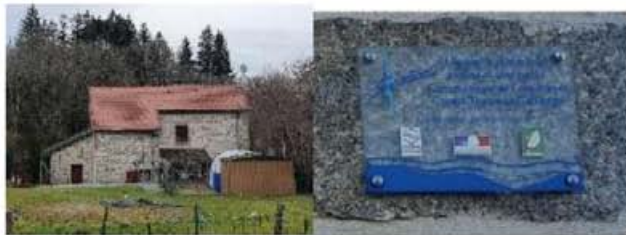
Description of materials			
	Element	Materials	Element	Materials
	Management berries	Cut granite and monolithic lintels	Roofing	Mechanical tiles
	Joinery	Painted wood red	Cornices	Squared granite
	Walls	Granite with lime plaster, exposed stone	Chimney	Nothing
	Foundations: None			
Comments				
<p>Gable roof. Corner chains in harp and satchel style. Three windows upstairs, aligned with the openings on the ground floor. Presence of stones waiting to be placed on the gable and the facade. An opening has been filled in at the top of the gable, which can be seen with the wooden lintel still present.</p>

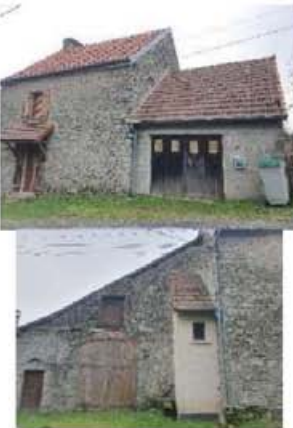
Built heritage		Typology		Home housing

Description of materials			
	Element	Materials	Element	Materials
	Window frames	Cut granite and lintels monolithic	Roofing	Mechanical tiles
	Joinery	Wood and PVC roller shutters	Cornices	Squared granite
	Walls	Granite rubble, lime mortar joints and concrete blocks	Chimney	Concrete
Foundations: None				
Comments				
<p>Gable roof. The house is composed of three elements, each with a roof of varying height. Potentially the residence in the center, a garage to the right, and a barn to the left.</p> <p>Corner chain in the shape of a harp and satchel.</p> <p>Barn and house built of granite rubble with lime mortar joints. Garage built of breeze blocks.</p> <p>The barn section has been enhanced with a very modern extension, perhaps for sanitary facilities.</p> <p>The openings of the barn: on the left a man's door surmounted by a monolithic lintel and a relieving arch, then, a barn door surmounted by a keyed brick lintel, above, a man's door.</p> <p>The openings in the living area: in the center, a door covered by a tiled canopy; on the first floor, a window aligned with the door. Both openings are fitted with PVC roller shutters and wooden blinds.</p> <p>The garage simply has a garage door.</p> <p>Blocked openings can be seen on both sides.</p>

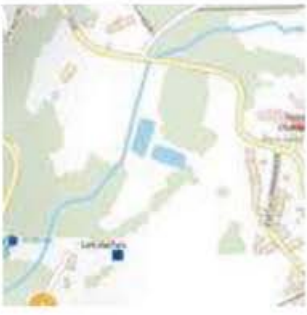
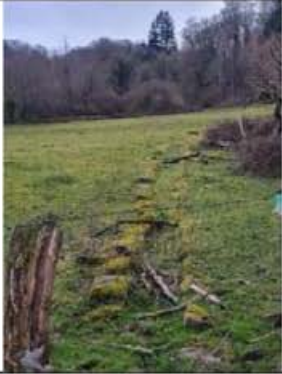
Water Heritage		Typology		Irrigation canal

Description of materials			
	Element	Materials	Element	Materials
Comments				
<p>This irrigation canal is made of arranged granite stones. Periods of drought could occur, and to anticipate or mitigate this, the cross-field irrigation canal was a useful tool. These canals can distribute water evenly on uneven terrain, preventing waterlogging.</p>				
Author	Carine Bigot	Inventory date	29/01/2025

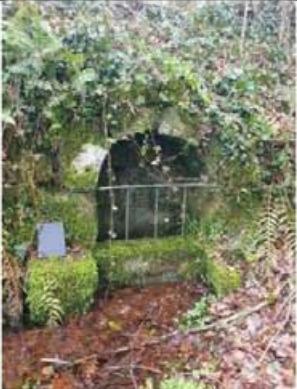
Water Heritage		Typology		Fountain

Description of materials			
	Element	Materials	Element	Materials
Comments				
<p>The fountain has a rather attractive appearance, drawing water from a spring. This spring is located in the undergrowth, beneath brambles and spontaneous vegetation. The area is becoming overgrown, but the fountain remains quite visible. Access is protected by a barrier.</p> <p>Cut granite stones. Suitable for domestic use, water supply.</p>

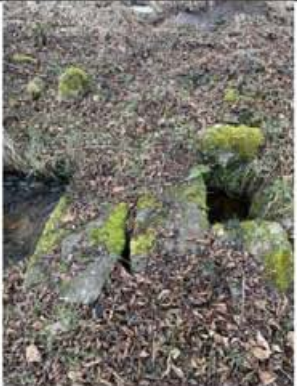
Description of materials			
	Element	Materials	Element	Materials
	Bridge	Granite		
Comments				
<p>A small structure linked to the Chamberaud stream, allowing pedestrian traffic above it. This small bridge is rustic and a good example of the omnipresence of water in the commune of Chamberaud.</p>				
Author	Carine Bigot	Inventory date	29/01/2025

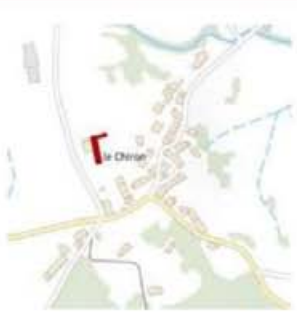
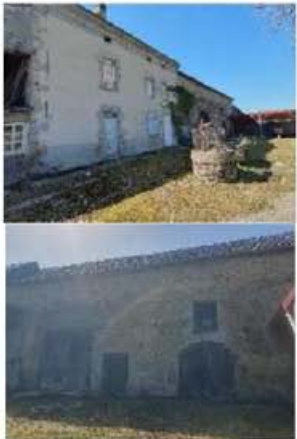
Built heritage		Typology		Long farmhouse with two stories

Description of materials			
	Element	Materials	Element	Materials
	Management berries	Squared dressed stone, monolithic lintels and wooden lintels	Roofing	Slate, interlocking tiles
	Joinery	Wood and white metal	Cornices	Cut stone sculpted
	Walls	Tyrolean plaster / rubble and lime joints	Chimney	Brick, stones
	Concrete foundations			
Comments				
<p>The building consists of a living area on the left and a barn on the right. A well, a small building (possibly a chicken coop) and a cart are on the property.</p> <p>The building has a gable roof with a different height for the living area, which is higher than the barn area.</p> <p><u>Residential section:</u></p> <p>Corner quoins with cement joints. The facade is not rendered up to the cornice, as if the roof had been raised at a later date. Three asymmetrical bays are visible. The first, wider bay features a wooden door on the ground floor and a window on the first floor. The second and third bays are narrower; the second has one window on the ground floor and another on the first floor. The third has a French door on the ground floor and a window on the first floor. All windows are fitted with metal shutters, and the first-floor openings are aligned with those on the ground floor. The gable end has exposed stonework.</p> <p><u>Barn section: The</u></p> <p>gutter wall is made of rubble stone with lime mortar joints. It has several rather haphazardly arranged openings of varying sizes. The doors are made of wood with stone jambs and monolithic lintels, except for the lintel of the largest door, which is made of wood.</p>

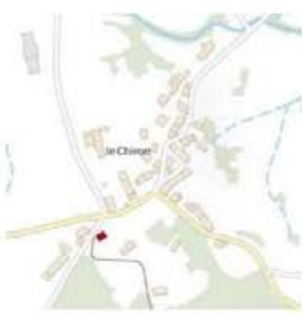
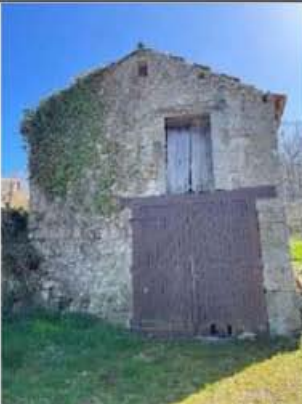
Built heritage		Typology		Limousin barn

Description of materials			
	Element	Materials	Element	Materials
	Window frames	Wood and carved granite	Roofing	Mechanical tiles
	Joinery	Brown wood	Cornices	Sculpted granite
	Walls	Granite dry stone paving	Chimney	
	Foundations	Granite blocks		
Comments				
<p>Limousin barn, gable facade, dry stone wall, granite rubble.</p> <p>Large main wooden door opening with a wooden lintel. Another opening above, with wooden shutters, also with a wooden lintel.</p> <p>A higher window on the facade. Gable roof.</p> <p>Base of a cross (presumably based on its shape), in front of this barn.</p>

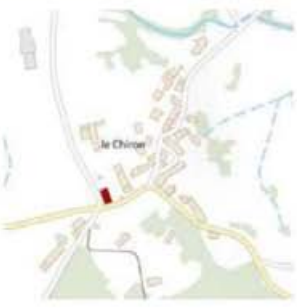
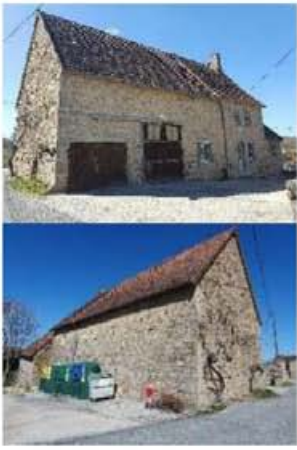
Built heritage		Typology		Long farmhouse with two stories

Description of materials			
	Element	Materials	Element	Materials
	Management berries	Cut stone (granite), monolithic lintels, reinforced concrete lintel	Roofing	Mechanical tiles
	White PVC and wood joinery		Cornices	Carved dressed stone (granite)
	Walls	Rubble and lime plasters exposed stones	Chimney	Rock
	Foundations: None			
Comments				
<p>The building consists of a residential section on the right and a barn section on the left. The building has a double-pitched roof of the same height, connected between the living area and the barn area.</p> <p><u>Living area: Corner</u> quoins. Lower and more modest extension on the right. Stone sink preserved to the left of the entrance door.</p> <p>We can observe two symmetrical bays. The first has the entrance door and a window on the first floor. The second has a window on the ground floor and another on the first floor. All the openings are PVC and the windows have PVC roller shutters. The extension on the right only has a ground floor with a single window, like the others.</p> <p><u>Barn section: The</u> eaves wall is made of rubble stone and lime-plastered with exposed stonework. It has only two openings: a wide, low one on the left with a reinforced concrete lintel, and a second, taller, sliding door on a track. Both doors are made of wood. The gable end has exposed stonework.</p>

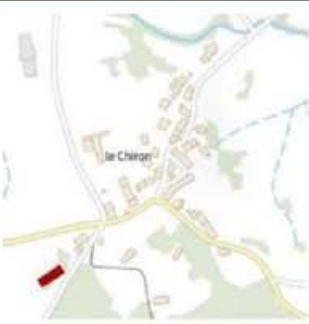
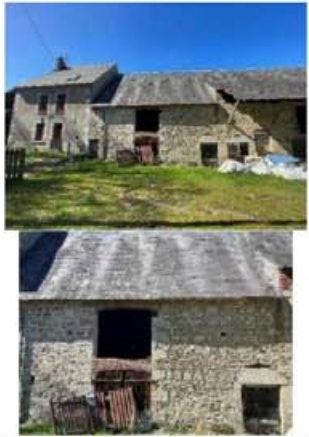
Built heritage		Typology		House at elements multiple

Description of materials			
	Element	Materials	Element	Materials
	Management berries	Granite and monolithic lintels, bricks	Roofing	Asbestos and slate barn
	Joinery	Drink	Cornices	Stones sculpted granite
	Walls	Rubble stone and Tyrolean plaster	Chimney	Sculpted granite
	Foundations	Carved granite stones		
Comments				
<p>House with multiple elements, part dwelling, hamlet house with symmetry. Asbestos roof, two slopes, a skylight, a cut granite chimney. Corner quoins in harp and bag-shaped cut granite stones, cut granite cornice, Tyrolean-style rendered facade, cut granite base, cut granite window and door frames, a stone sink with oculus, entrance door with small gate.</p> <p>Adjoining it is a Limousin-style barn with a lean-to roof and a double-pitched slate roof. There are more than eight openings, some of which have been re-stoned. The openings have monolithic lintels and granite jambs cut in a harp and bag-shaped pattern. There are relieving arches, some of which are made of red brick. Several alterations are visible.</p> <p>Lime-plastered facade with exposed stone in some places, and right side stonework with dry rubble.</p>

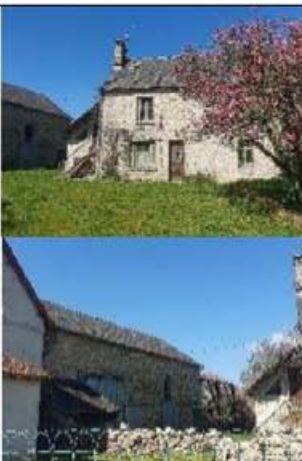
Built heritage		Typology		Multi-element house

Description of materials			
	Element	Materials	Element	Materials
	Window frames	Ashlar (granite), monolithic lintels,	Roofing	Slate
	Joinery	Wood, metal	Cornices	Squared cut stone (granite)
	Walls	Stone and lime plaster, exposed stone	Stone fireplace	
	Foundations: None			
Comments				
<p>A house with multiple dispersed sections, including separate living quarters and barn. The living quarters are attached to number 7 Le Chiron.</p> <p><u>Residential section:</u> Corner reinforcement. Four bays can be observed: the first with a window on the upper floor and one on the ground floor, both made of white/grey wood; the second with the wooden front door; the third with the outline of a former doorway, now gone; and the fourth with a window on the upper floor and one on the ground floor, both made of green wood. All the openings have metal shutters in various colors, green or brown. The chimney stack is raised, and the roof structure may have once supported a thatched roof. A modest extension is located to the left of the building.</p> <p><u>Barn section:</u> Rubble stone walls with lime mortar joints. The doors are blue metal and sliding. Monolithic lintels are surmounted by relieving arches. The main door has a wooden lintel. The jambs are made of stone.</p>

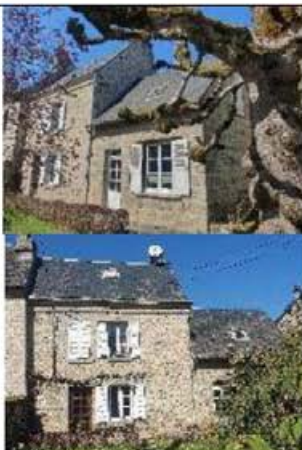
Description of materials			
	Element	Materials	Element	Materials
	Management berries	Squared granite, dressed stone, monolithic lintels, wooden lintel	Roofing	Slate
	Joinery	Drink	Cornices	Sculpted granite
	Walls	Rubble masonry and lime mortar joints	Chimney	Cut stone
	Foundations: None			
Comments				
<p>The house is semi-detached with number 5 Le Chiron. It has a gable roof with two different heights, the right side being lower. Corner quoins.</p> <p><u>Left side: Two</u> bays are visible, the first with the entrance door and a window on the upper floor. The second has two windows, one on the ground floor and one on the upper floor. The door is made of wood, and the windows are white-painted wood with white wooden shutters. The jambs are made of dressed granite, and the lintels are monolithic. A snuffbox is also visible (there is a second one in the right side).</p> <p>Remains of a stone sink to the left of the entrance door.</p> <p><u>Right side: Only</u> one floor is visible on the side facing the eaves wall; the attic appears to be converted. The eaves wall has a white wooden door on the left and a white wooden window on the right. The door jambs are made of dressed granite, with a monolithic lintel. The window is topped by a wooden lintel.</p>

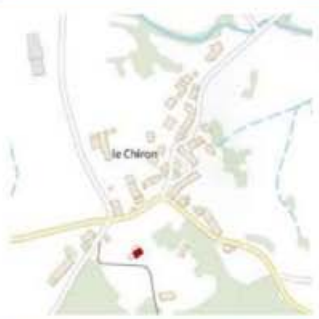
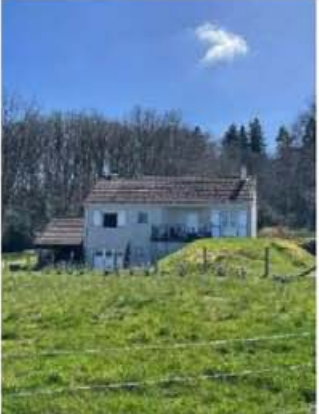
Built heritage		Typology		Modern house

Description of materials			
	Element	Materials	Element	Materials
	Management berries	Counterwinds drink	Roofing	Tiles mechanics
	Joinery		Cornices	
	Walls	Coating zip line	Chimney	
	Foundations			
Comments				
Modern house				
Author	Carine Bigot	Inventory date	31/03/2025

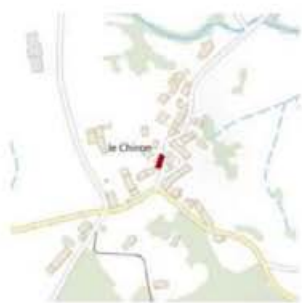
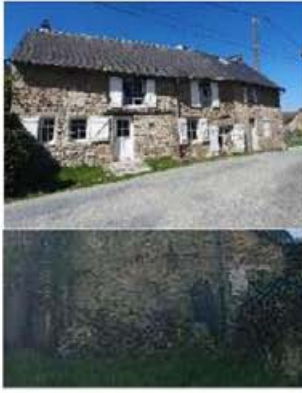
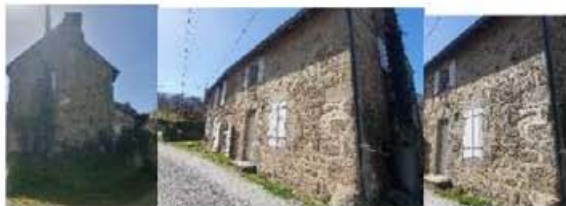
Built heritage		Typology		Long farmhouse with two stories

Description of materials			
	Element	Materials	Element	Materials
	Management berries	Ashlar (granite), monolithic lintels, wooden lintels	Roofing	Slate
	Joinery	Drink	Cornices	Nothing
	Walls	Rubble Stones	Chimney	Cut stone
	Foundations: None			
Comments				
<p>This dwelling was possibly a multi-part house, with the barn section attached to the living quarters. The wooden lintel marking the location of the former barn door is visible on the left side of the house. The right side of the house was certainly added much later, as evidenced by the roof and facade. Corner quoins are also present.</p> <p>The openings are made of white-colored wood with white-colored wooden shutters.</p> <p>The gable end contains stones waiting to be used and possibly the remains of a bread oven.</p>

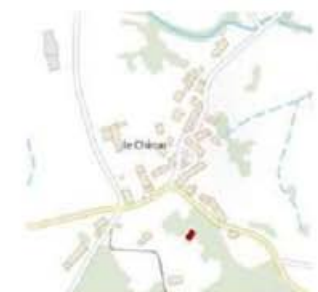
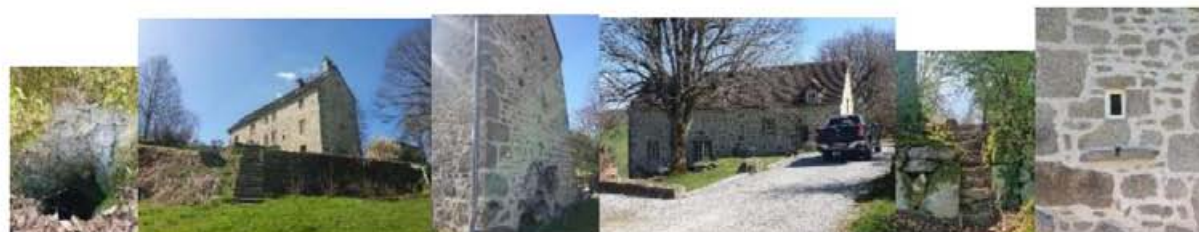
Built heritage		Typology		Long farmhouse with two floors

Description of materials			
	Element	Materials	Element	Materials
	Supervision of berries	Granite and monolithic lintels	Roofing	Flat tiles
	Joinery	Drink	Cornices	Carved granite stones
	Walls	Coating lime, exposed granite stones	Chimney	Granite cut stones
	Granite stone foundations			
Comments				
<p>Longère-style house, with two gable ends.</p> <p>Lime-plastered facade with exposed stonework. Four bays: The first bay on the left has two openings, including a main door; the second has three openings, including a window, a rather small opening, and a door; the third bay is defined by a stone sink. Further to the right is an entrance door, three windows, and a small opening. The transition to the fourth bay is clearly visible thanks to the herringbone and corbelled stonework. This design suggests that the fourth bay was the original main room, or at least existed as a separate structure.</p> <p>This fourth bay has three openings: a door and two windows. On the gable wall are remains of the old oven. The quoins are quoins with a harp-shaped profile, and the window and door frames are also harp-shaped and have monolithic lintels. The windows and doors are made of white-stained wood. The roof has two dormer windows and two chimneys. Flat tiles are used.</p>

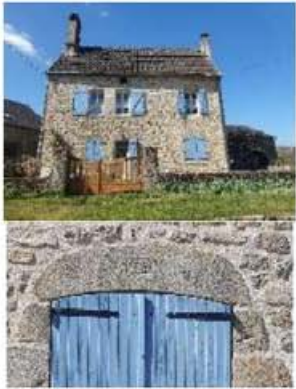
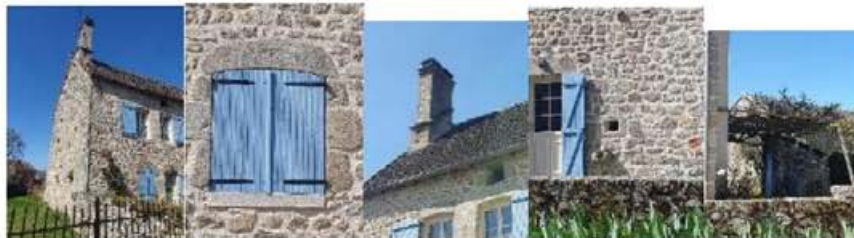
Description of materials			
	Element	Materials	Element	Materials
	Window frames	Ashlar (granite), monolithic lintels	Roofing	Mechanical tiles
	Joinery	Drink	Cornices	Nothing
	Walls	Rubble stone, lime plaster, exposed stonework	Chimney	Cut stones
	Foundations: None			
Comments				
<p>A chronogram dated 1787 is inscribed on the monolithic lintel of the ground-floor right-hand window. A stone sink is located to the right of the entrance door. The chimney stack is raised, suggesting the roof structure may have once supported a thatched roof. A modest extension stands to the left of the building.</p> <p>Three bays are visible. The first bay has two windows, one on the ground floor and one on the first floor. The second bay contains the white wooden front door with a light blue wooden shutter; above the door is a window on the first floor. The third bay has two windows, one on the ground floor and one on the first floor. The windows are white wood and the shutters are light blue wood.</p>

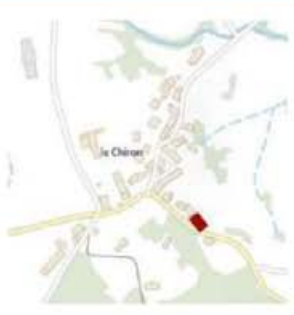
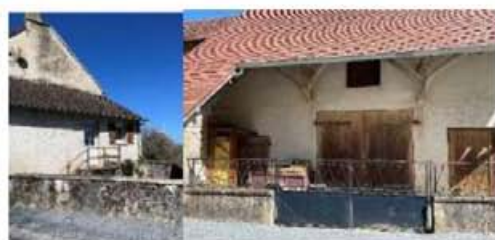
Built heritage		Typology		Long farmhouse with awning

Description of materials			
	Element	Materials	Element	Materials
	Management berries	Granite and lintels monolithic	Roofing	Flat tiles
	Joinery	White PVC and wooden shutters chestnuts	Cornices	Carved granite stones
	Walls	Coating zip line	Chimney	
	Tyrolean plaster baseboards			
Comments				
<p>Longère-style house, gable roof, a skylight, two chimneys, flat tiles. Right side with an old awning preserved, hypothesis of a former barn with an awning that has been rehabilitated.</p> <p>Tyrolean-style rendered facade. The main living area has four openings, including three windows with monolithic sculpted granite lintels, PVC frames, and brown wooden shutters. The main entrance door is white PVC with a monolithic carved granite lintel and jambs of carved granite in a harp and bag-shaped pattern. The left side features a canopy with three openings and wooden shutters.</p>

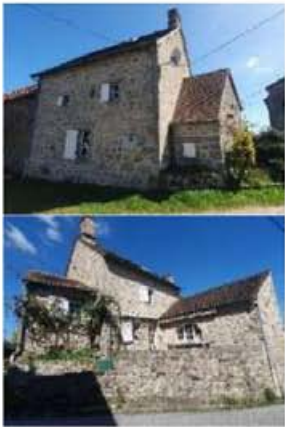
Built heritage		Typology		House of hamlet

Description of materials			
	Element	Materials	Element	Materials
	Management berries	Ashlar (granite), monolithic lintels, keyed lintel and wooden lintel	Roofing	Flat tiles
	Joinery	White wood	Cornices	Nothing
	Walls	Rubble stone, lime plaster, exposed stonework	Chimney	Cut stone
	Foundations: None			
Comments				
<p>The building has a gabled roof with three different heights, quite unusual compared to other buildings in the village. This hamlet house is attached to an abandoned house.</p>

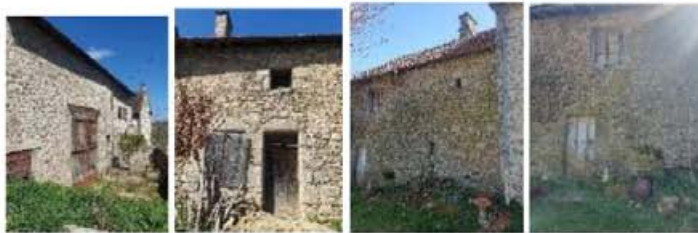
Description of materials			
	Element	Materials	Element	Materials
	Management berries	Ashlar (granite) and monolithic lintels	Roofing	Tiles mechanics
	Joinery	Drink	Cornices	Nothing
	Walls	Rubble, dry-stone blocks	Chimney	Cut stone (granite)
	Foundations: None			
Comments				
<p>This abandoned building is attached on both sides.</p> <p>It can be assumed that the roof was once raised, perhaps thatched. Indeed, the line of the old roof is still visible on the gable end of the building on the right, and the chimney also has this line.</p>

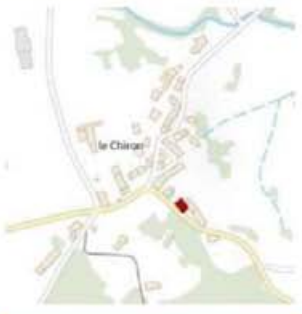
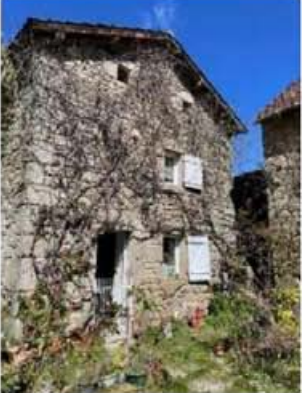
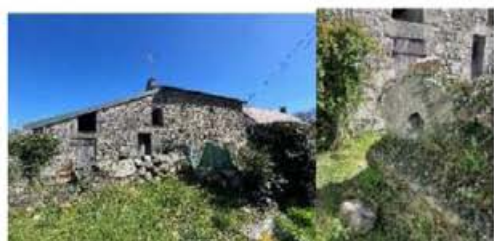
Description of materials			
	Element	Materials	Element	Materials
	Management berries	Cut granite and monolithic lintels	Roofing	Mechanical tiles
	Joinery	White wood	Cornices	Carved granite stones
	Walls	Dry stone paving	Chimney	Cut granite
	Foundations of rubble stone			
Comments				
<p>Longère-style house with a gable facade. The roof is covered with interlocking tiles. There are five openings, including a front door with white wood framing, a cut granite jamb with a harp and bag-shaped molding, and a monolithic cut granite lintel. A smaller gate stands in front of the front door. There are two white wood windows with cut granite frames, and two skylights with cut granite frames and white wood shutters.</p> <p>Dry stone facade, rustic, technical. Cornice also dry stone, exposed beams and framework.</p> <p>Corner quoins, harp and satchel in cut granite. Chiseled granite fireplace. Millstone present in the garden.</p>

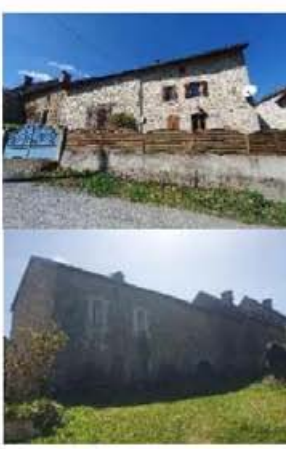
Built heritage		Typology		Long farmhouse with two stories

Description of materials			
	Element	Materials	Element	Materials
	Management berries	Cut stone (granite), monolithic lintels, concrete lintels, and wooden lintels	Roofing	Mechanical tiles
	Joinery	Wood and PVC	Cornices	Squared granite
	Walls	Rubble stone, lime plaster, exposed stone	Chimney	Cut stone
	Foundations: None			
Comments				
<p>This two-story farmhouse has a barn section still in its original state on the left and a renovated living area on the right.</p> <p>There is a difference in renovation between the front and rear of the house.</p> <p>There is a well on the property, at the rear of the building.</p>

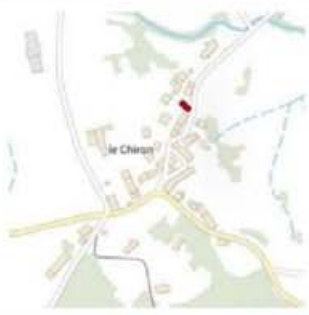
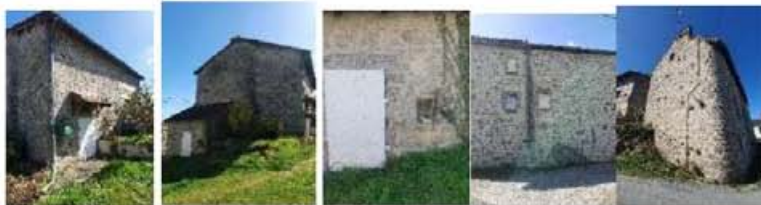
Built heritage		Typology		House of hamlet

Description of materials			
	Element	Materials	Element	Materials
	Window frames	Ashlar (granite), monolithic lintels	Roofing	Mechanical tiles
	Joinery	Wood and metal	Cornices	Nothing
	Walls	Rubble stone, exposed stone plaster	Chimney	Cut stone
	Foundations: None			
Comments				
<p>This building has a gable roof with two different heights.</p> <p>The rear door is surmounted by a canopy made of wood and mechanical tiles.</p> <p>It is noticeable that the building is partly constructed directly on the rock, which makes it a unique feature. As is its rounded corner facing the street.</p>

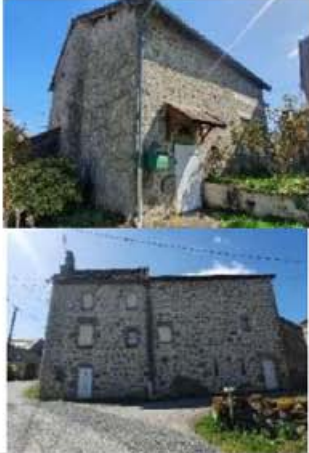
46°03'01.8"N 2°03'22.2"E	Chamberaud	23,480	17 The Chiron
	Altitude	450m	Orientation	NORTHEAST
	Situation	On a plateau, high up	Dimension	15m x 8m
	Accessibility	<input checked="" type="checkbox"/> Easy access <input type="checkbox"/> Limit <input type="checkbox"/> Not accessible	Current state of place	<input checked="" type="checkbox"/> Good condition <input type="checkbox"/> Average condition <input type="checkbox"/> Deteriorated <input type="checkbox"/> Abandoned

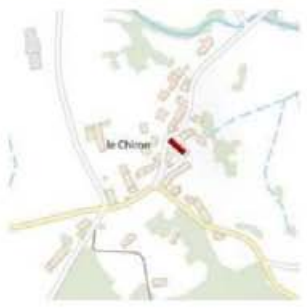
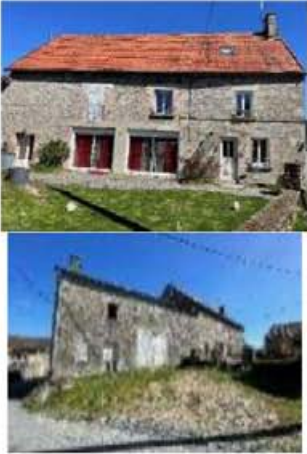
Description of materials			
	Element	Materials	Element	Materials
	Supervision of berries	Granite and monolithic lintels, reinforced concrete, bricks	Roofing	Tiles mechanics
	Joinery	PVC and wood	Cornices	Carved granite stones
	Walls	Raised joint Cement, exposed granite stones	Chimney	Cut granite
	Granite stone foundations			
Comments				
<p>Longère-style house with a gabled roof and a skylight. Three bays: the first bay has one opening, a PVC door with a monolithic lintel, and brick jambs with a harp and bag-shaped pattern. The second bay has four openings: two large French doors with reinforced concrete frames, two windows with red brick jambs, a concrete lintel, wooden shutters, and small balconies. The third bay has three openings, including a tall window with a monolithic granite frame and a small balcony. A band of dressed granite runs along the facade. The front door is PVC with a dressed granite frame and jambs, a monolithic dressed granite lintel, and a lower, straight basement window. The corner quoins are made of dressed granite with a harp and bag-shaped pattern.</p> <p>Facade with raised cement joint, protruding mortar, exposed stones.</p>

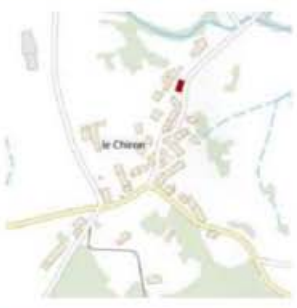
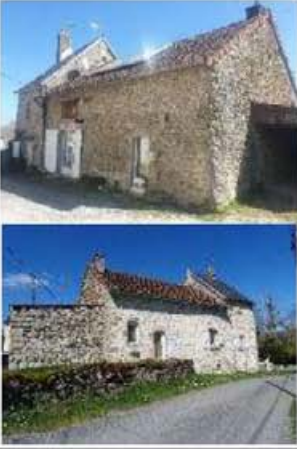
Built heritage		Typology		Long farmhouse with two stories

Description of materials			
	Element	Materials	Element	Materials
	Management berries	Ashlar (granite), monolithic lintels and wooden lintel	Roofing	Slates and tiles mechanics
	Joinery		Cornices	Nothing
	Walls	Rubble stone, plaster, exposed stonework	Chimney	Cut stone
	Foundations: None			
Comments				
<p>The owners of this two-story farmhouse most certainly had a butcher shop, judging from the building located at the rear.</p> <p>We can see that the chimney stack is raised, the framework possibly once supported a thatched roof.</p>

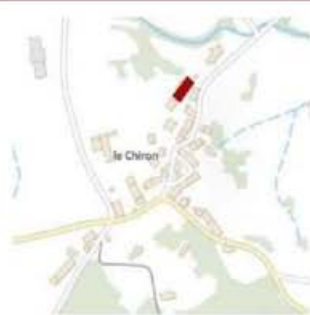
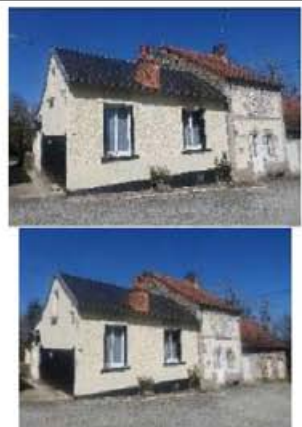
Built heritage		Typology		House of hamlet

Description of materials			
	Element	Materials	Element	Materials
	Management berries	Concrete, hewn stone, monolithic lintels	Roofing	Slate and tiles mechanical
	PVC windows and doors		Cornices	Nothing
	Walls	Tyrolean plastering	Chimney	Bricks
	Foundations	Concrete, cut stone		
Comments				
<p>The right side of the house resembles a typical migrant return home, with a certain symmetry and the band between the ground floor and the upper floor.</p> <p>We see a sink stone.</p>

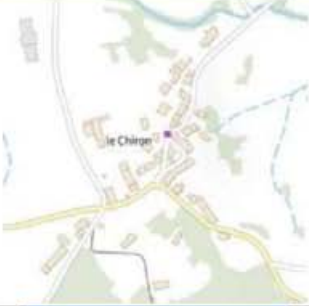
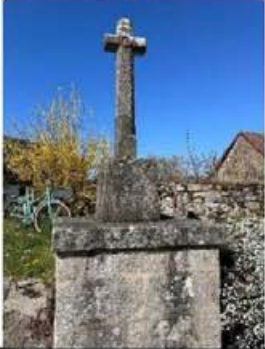
Religious heritage		Typology		Wayside cross

Description of materials			
	Element	Materials	Element	Materials
	Cross	Granite		
	Base	Granite		
	Was	Granite		
Comments				
Cross in its most elaborate form, composed of a granite base, granite shaft, and a granite potent crossbar.				
Author	Carine Bigot	Inventory date	27/01/2025

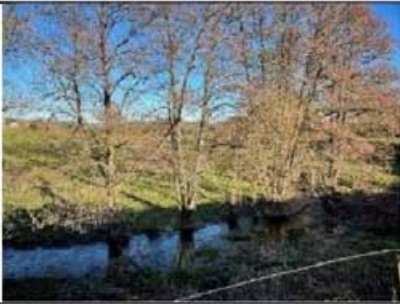
Description			
	Nature of the site		Site usage	
Comments				
<p>These riparian trees are highly resistant to flooding. Species such as ash, alder, white poplar, and birch can be found on these banks.</p> <p>Functions of these riparian trees:</p> <ul style="list-style-type: none"> • Mechanics that ensure the stability of riverbanks thanks to the root system of trees and shrubs • Plant-based filter, reduction of diffuse pollution (nitrates, phosphates and pesticides) and improvement of water quality • A function for biodiversity with a diversity of habitats for different species
