Année 2024 - 2025

Heritage inventory Chamberaud

Licence 3 –
Géographie et Aménagement :
Valorisation du Patrimoine et
Développement Territorial

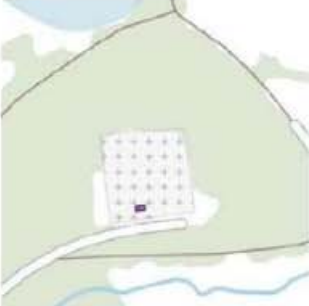
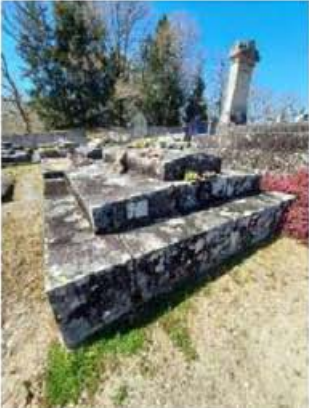
Religious and funerary heritage		Typology		Tomb common to the multiplication of tombstones

Description of materials			
	Element	Materials	Element	Materials
	Stele	Nothing	Sole	Nothing
	Base	Nothing	Barrier	Nothing
	Tomb	Granite	Family	Constantin
Base	Granite			
Comments				
<p>This burial site has two tombs</p> <p>Only one name is mentioned on this tombstone: that of Jean Constantin (1901-1953).</p>				
Author	Léa Boulay	Inventory date	03/04/2025

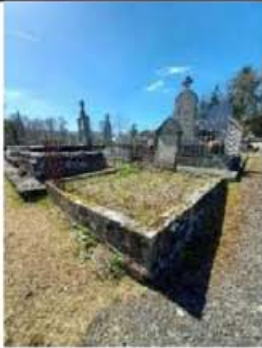
Description of materials			
	Element	Materials	Element	Materials
	Stele	Granite	Sole	Nothing
	Base	Granite	Barrier	Iron
	Tomb	Nothing	Family	Roudier
	Base	Granite		
Comments				
<p>The base of this burial is not entirely granite but appears to be filled either with earth or with gravel on which vegetation has grown.</p> <p>The plot is delimited by a barrier. However, this barrier does not completely surround the grave.</p> <p>Access to the burial site must have been more limited originally, as evidenced by the presence of a gate to the left of the headstone. This gate bears the family initial, an "R".</p> <p>The stele is an upright stone on which the epigraphy, in addition to mentioning the family name, mentions its geographical origin, which was the Puy de Chamberaud.</p> <p>A symbol is present in the triangular part of the stele; this symbol appears to be a compass and square. Thus, it is possible that this family had a connection with Freemasonry, or that they themselves were Freemasons.</p>

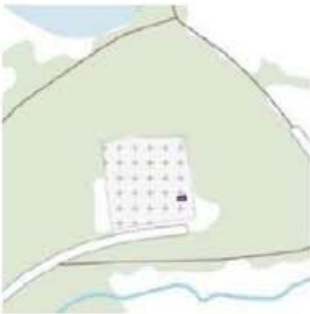
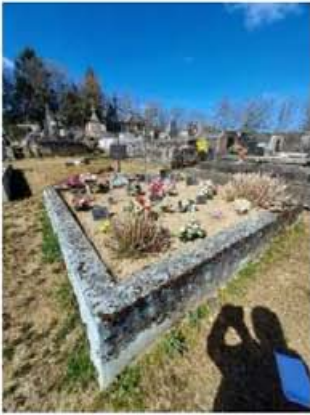
Religious and funerary heritage		Typology		Burial without a tombstone

Description of materials			
	Element	Materials	Element	Materials
	Stele	Iron	Sole	Nothing
	Base	Nothing	Barrier	Nothing
	Tomb	Nothing	Family	Dumaignaud Dido
Base	Granite			
Comments				
<p>The base of this burial site is not entirely made of granite but appears to be filled with gravel in which funerary objects are placed and real and artificial vegetation elements are planted.</p> <p>The stele is made of wrought iron on which is hung a granite funerary plaque indicating the family name.</p>

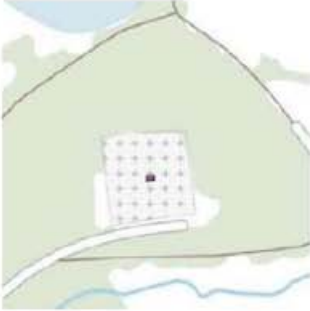
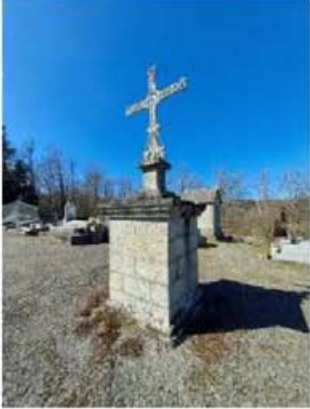
Religious and funerary heritage		Typology		Cross of graveyard

Description of materials			
	Element	Materials		
	Cross	Wrought iron		
	Was	Granite		
	Base	Granite		
	Base	Cut granite block joined with cement		
Comments				
<p>The entire cross, shaft, base and foundation have a square plan.</p> <p>The white-painted cross is decorated with scrolls at its base, on each arm of the cross there is a heart shape at the ends and in its center there is a shape that appears to be a sun.</p> <p>Located in the center of the cemetery, it serves as a central point around which the other main roads of the place radiate.</p>

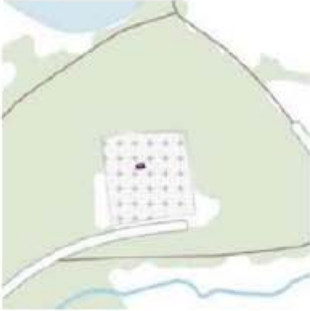
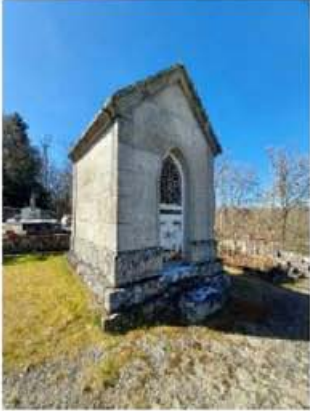
Religious and funerary heritage		Typology		Funeral chapel

Element	Materials	Element	Materials
	Management berries	Granite	Roofing	Granite
	Joinery	Wrought iron painted white	Sole	Nothing
	Walls	Cut granite	Family	Nothing
	Base	Granite		
	Comments			
<p>The door frame forms a pointed arch defined by a torus molding.</p> <p>The tomb has an opening on its facade which is a carved doorway. Various scrolls can be found on the upper part, and a heart shape is engraved on the lower part of the doorway.</p>

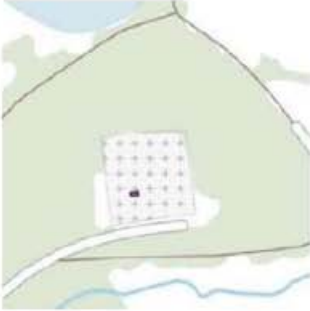
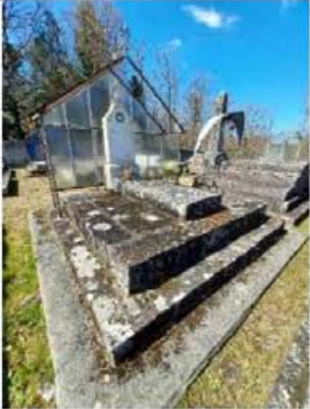
Religious and funerary heritage		Typology		Funeral chapel

Description of materials			
	Element	Materials	Element	Materials
	Stele	Granite	Sole	Granite
	Base	Granite	Barrier	Nothing
	Tomb	Granite	Family	Barthon
	Base	Granite		
Comments				
<p>The top of the tomb is surmounted by a structure intended, in our opinion, to evoke chapels. This structure is made of wrought iron and has glass walls. A heart shape is found on the ridge of this structure, and the finials are shaped like a cross.</p> <p>The stele, which is an upright stone, appears to be painted white and contains symbolic elements other than a cross:</p> <ul style="list-style-type: none"> - A wreath of everlasting flowers, sculpted and painted green, evoking eternity - Within the swirls of the stele, we can find what appear to be poppy flowers. whose capsules are colored green. This flower represents eternal sleep, but thanks to this capsule, it also represents the "promise of tomorrow".

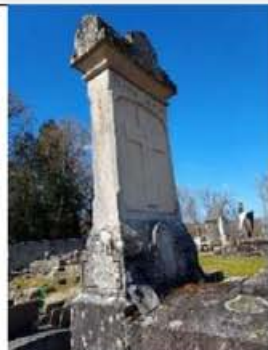
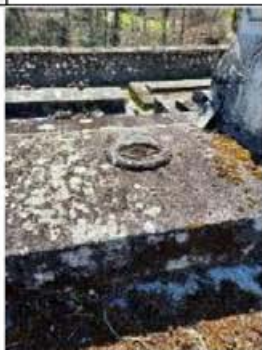
Description of materials			
	Element	Materials	Element	Materials
	Stele	Granite	Sole	Granite
	Base	Granite	Barrier	Nothing
	Tomb	Granite	Family	Danton
	Base	Granite		
Comments				
<p>When observing this burial site, one cannot miss the heather which has grown extensively at the foot of this tomb.</p> <p>Various symbols can be observed on the stele, which is an upright stone, and on the tombstone:</p> <ul style="list-style-type: none"> - On the stele, there appears to be a reference to the Templars, thanks to a Templar cross in bas-relief present on the upper part of the sides of the stele. - A bas-relief of a Christian cross can also be found on the east face of the stele. - Next, we assume that there is the presence of multiple references to the free thinker thanks to bas-reliefs in the shape of a six-pointed star on the bottom of the stele, but also on the upper part of it we find the engraving of what appears to be a flower. - Finally, on the tombstone one can see the symbol of the compass and square, a possible reference to Freemasonry or to the masons of Creuse.

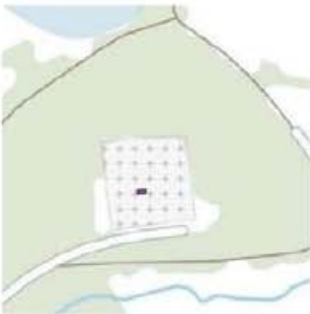
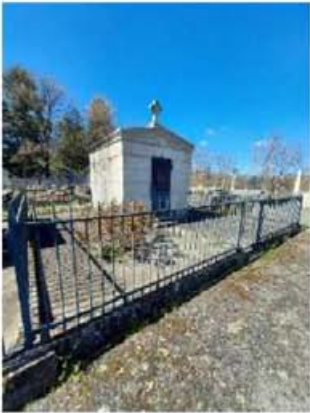
Religious and funerary heritage		Typology		Mausoleum

Description of materials			
	Element	Materials	Element	Materials
	Management berries	Nothing	Sole	Granite
	Joinery	Wrought iron painted blue	Barrier	Wrought iron
	Walls	Cut granite	Roofing	Granite
	Base	Granite	Family	Nothing
Comments				
<p>The tomb features a triangular pediment surmounted on its ridge by a granite cross.</p> <p>There is only one opening in the facade, a door on which there is a wrought-iron letter that appears to be a capital "i". Perhaps it is the initial of the family buried there.</p>

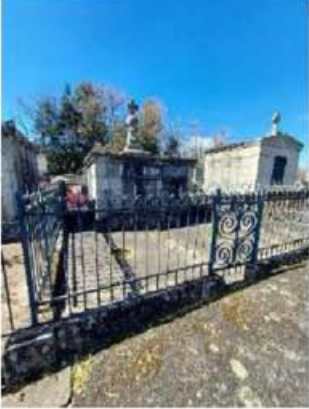
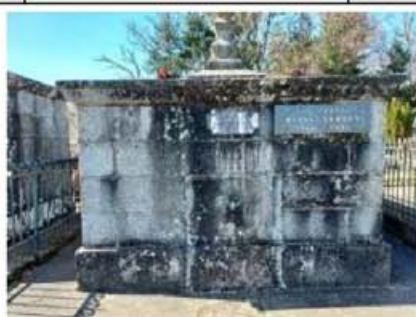
46. 051280 2.045004	Chamberaud	23,480	Mausoleum
	Altitude	475 m	Orientation	EAST
	Situation	At height	Dimension	3m x 2.5m
	Accessibility	<input checked="" type="checkbox"/> Easy access <input type="checkbox"/> Limit <input type="checkbox"/> Not accessible	Current state of place	<input checked="" type="checkbox"/> Good condition <input type="checkbox"/> Average condition Deteriorated <input type="checkbox"/> Abandoned

Description of materials			
	Element	Materials	Element	Materials
	Stele	Granite	Sole	Granite
	Base	Cut granite	Barrier	Wrought iron painted blue
	Tomb	Nothing	Family	Legrand, Neboux
	Base	Granite		
Comments				
The stele stands tall and is carved to form a circle on which is a granite cross.				
Author	Léa Boulay	Inventory date	03/04/2025

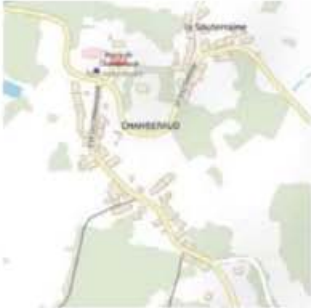
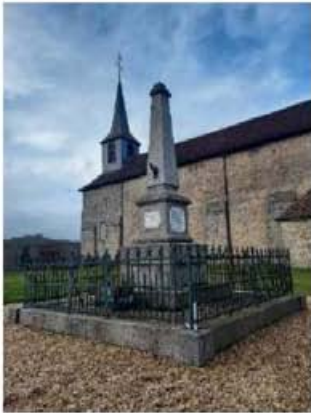
Religious and funerary heritage		Typology		War Memorial

46.049695 2.045443	Chamberaud	23,480	Mausoleum
	Altitude	482.93 m	Orientation	EAST
	Situation	At height	Dimension	Nothing
	Accessibility	<input checked="" type="checkbox"/> Easy access <input type="checkbox"/> Limit <input type="checkbox"/> Not accessible	Current state of place	<input checked="" type="checkbox"/> Good condition <input type="checkbox"/> Average condition <input type="checkbox"/> Deteriorated <input type="checkbox"/> Abandoned

Description of materials			
	Element	Materials	Element	Materials
	Stele	Granite	Fence	Wrought iron
	Base	Granite		
	Base	Granite		
	Base	Granite		
Comments				
<p>The war memorial in Chamberaud is located near the church and the town hall. The town hall has commemorative plaques on its base bearing the names of soldiers who died for France during the First World War from 1914 to 1918.</p> <p>The whole is based on a square plan and the stele, which is a square column, contains iron objects on which it is assumed that wreaths of flowers can be placed during commemoration.</p> <p>This monument, surrounded by gravel, contains a sacred space delimited by a fence.</p>
