MD Mold- Complete Mold Inspection Example Report

Thank you for choosing **MD Mold** to assist with your indoor air quality concerns. Below is a summary of findings, laboratory results, and my professional observations and recommendations.

A complete mold inspection was performed. This included an exterior inspection, interior inspection, thermal imaging and moisture mapping. Air, surface and dust sampling was conducted in several areas of the home.

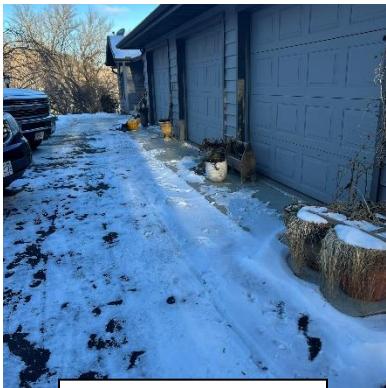
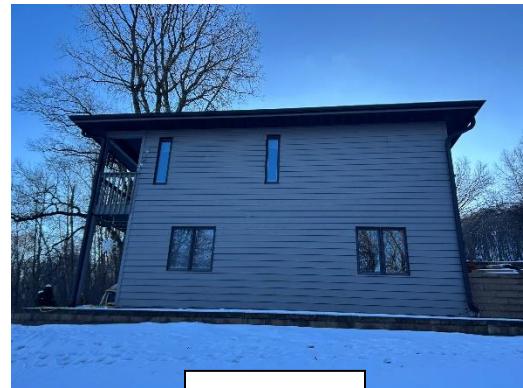
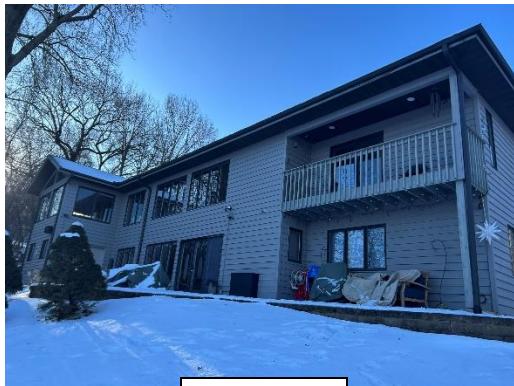
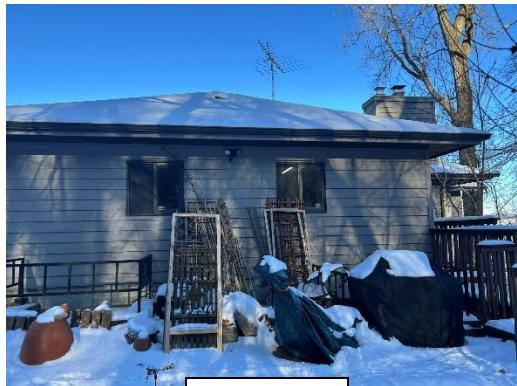
- Grading from foundation was appropriate.
- No negative grading noted. Egress window wells do not have cover, though this is optional it can help direct water away from foundation.

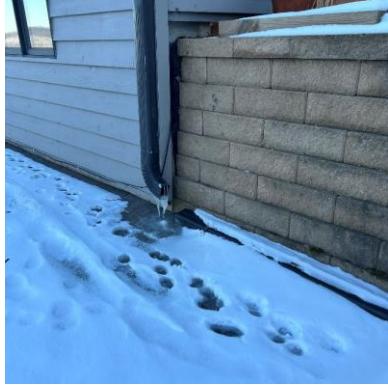
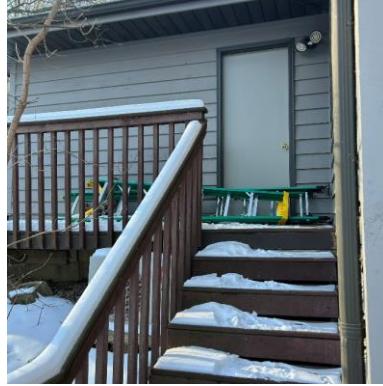
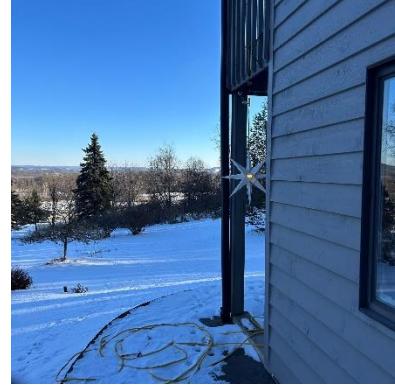
2. Drainage

- **Gutter Integrity:** Gutter system appears intact. Leaf guard installed.
- **Downspout Extensions:** All but one extension, on the westside of the house, are intact.

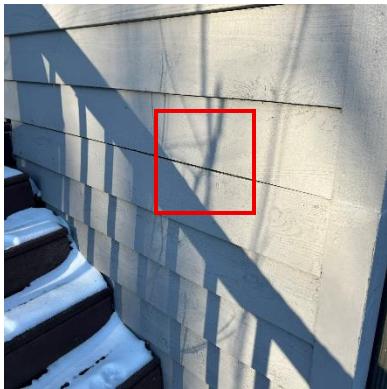
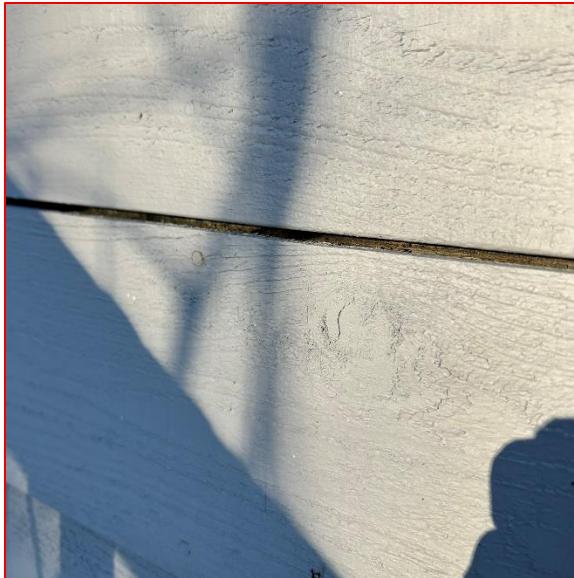
3. Building Envelope and Siding

- **Findings:** Siding condition is ok. One deficiency was noted on the eastside wall of a gap of 1/3 inch between siding rows. Cracking in sealant is minimal throughout exterior.

Recommendation: Use of a polyurethane based sealant for siding gap and fill spaces of current sealant cracks.

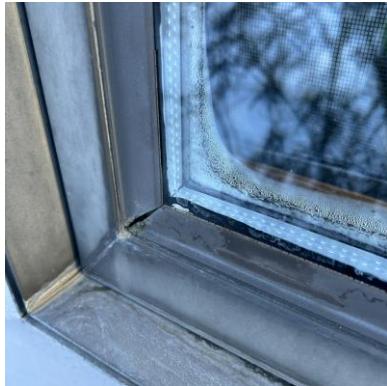
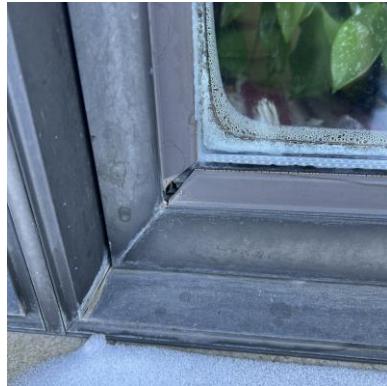
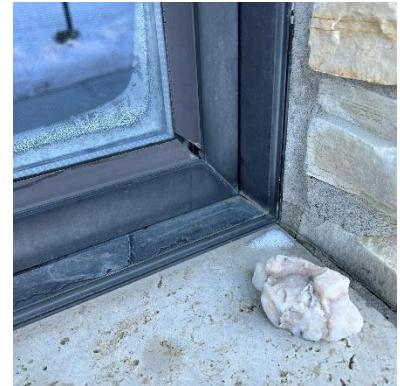
- **Windows and Doors:**

Findings: Many windows seals are degraded and have exposed gaps. This allows extra air intrusion and wind driven rain to enter this area contributing to the increased level of condensation on the interior window frames and sills.

Recommendation: These types of windows that have aluminum cladding with a wood frame are very prone to condensation. The aluminum window cladding transfers cold more easily into the warmer wooden frame, taken into consideration with the gaps and failing seals these windows may need replacement to avoid further condensation issues.

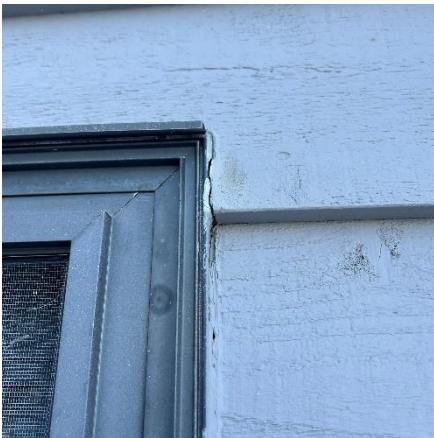
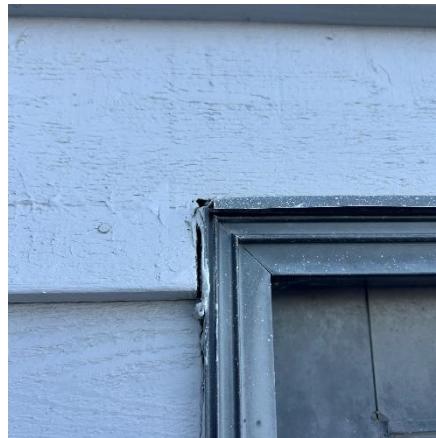
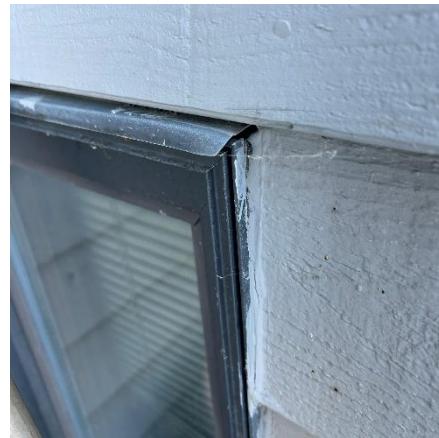
Window Flashing

Findings: Window flashing above some portion of the windows are lacking proper flashing clearance and have cracking sealant. This could lead to water intrusion through the cracked sealant and into the wall.

Recommendation: Due to the likelihood of window replacement, proper flashing should be installed at that time.

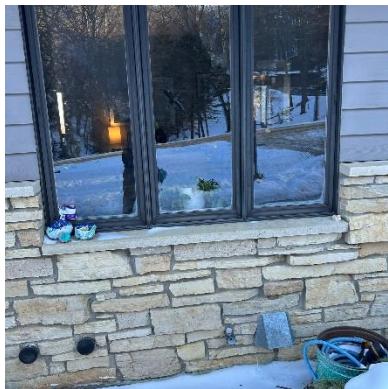
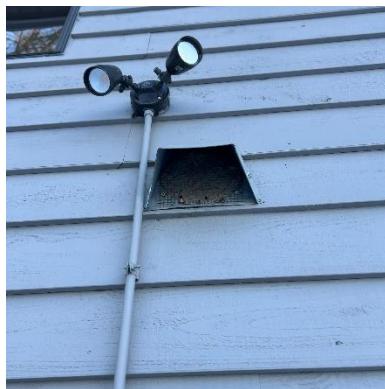
4. Penetrations and Vents

Findings: All penetrations at ground level had proper sealant.

Recommendations: One vent on the northside of the house appears to be clogged with debris and should be cleaned.

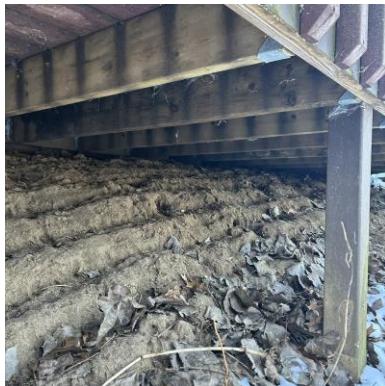
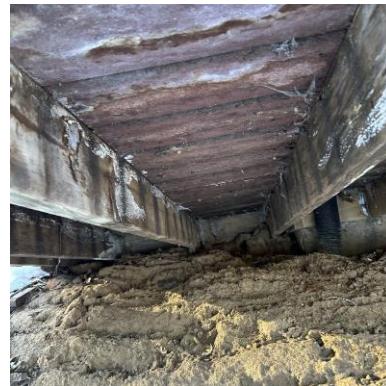
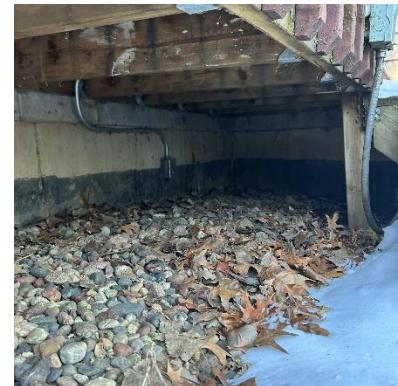
5. Decking

Findings: Wooden structural components under composite decking show signs of fungal growth. Area covers portions of many of the deck joists.

Recommendation: Observed fungal growth beneath the deck assembly is located outdoors and subject to normal environmental moisture conditions. Due to the proximity of operable windows, exterior fungal particulates may enter the structure under certain conditions, such as when windows are open. No corrective action is required at this time beyond routine exterior maintenance and moisture management. Monitoring of interior conditions is recommended.

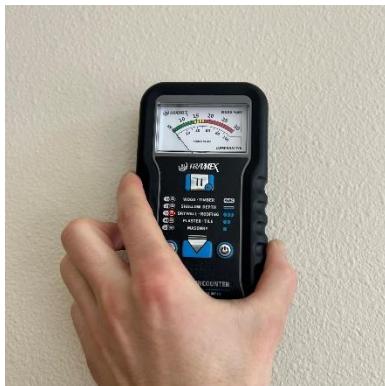
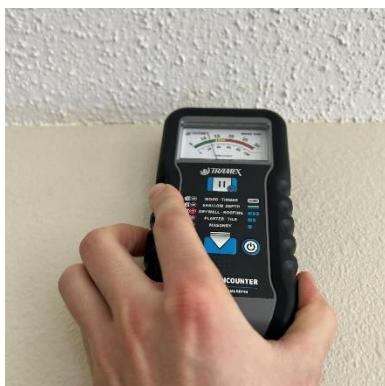
Living Areas, Bedrooms

Multiple cooler (blue) thermal anomalies were observed in ceiling areas throughout the structure. Where accessible, these areas were evaluated using a non-invasive moisture meter to assess relative moisture content (representative images to the left). Moisture measurements did not reveal elevated moisture levels when compared to surrounding reference materials. The absence of elevated moisture readings suggests that the observed thermal anomalies are consistent with insulation-related deficiencies, variations in thermal mass, or thermal bridging between framing members rather than active moisture intrusion. Framing elements, including rafter ties, appear to contribute to localized temperature differentials by encapsulating cooler air within adjacent cavities, as demonstrated through infrared imaging.

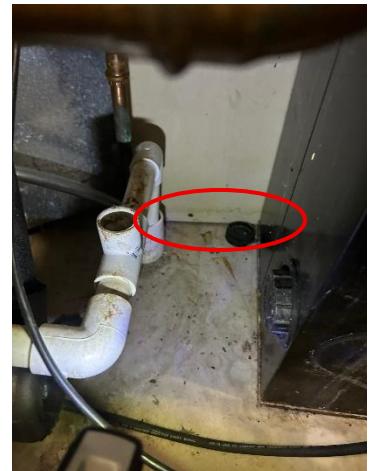
It was also noted that the utility room showed signs of moisture wicking on the lower drywall edge adjacent to the floor. Area was inspected for signs of microbial growth but none was noted. Moisture readings were taken and did not indicate higher moisture content in that portion of the drywall.

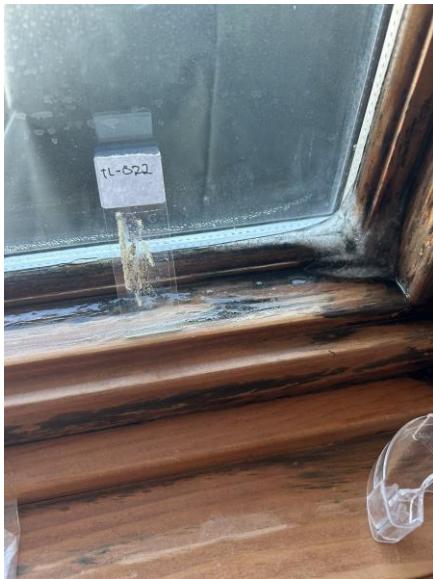
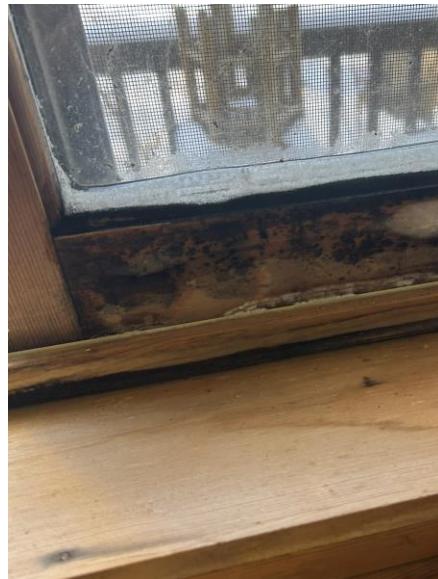
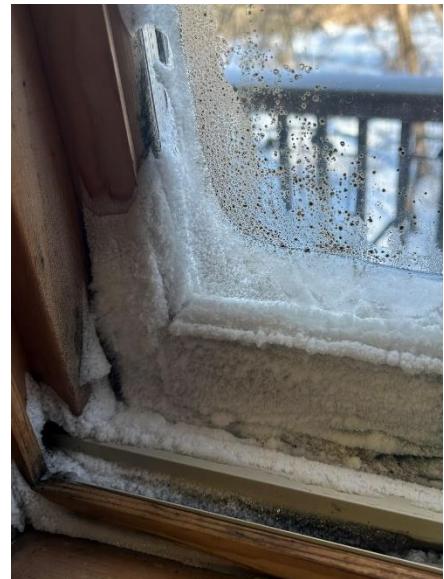
The lower operable windows were assessed and found to have large areas of frozen condensation with some areas >10cm thick. The lower operable windows are aluminum-clad units with interior wood frames. Aluminum components exhibit high thermal conductivity and readily transmit exterior cold temperatures to interior surfaces, increasing the potential for interior surface temperatures to fall below the indoor air dew point. Several gaps were observed at the interior window frame assemblies, which may allow cold air infiltration and further depress interior surface temperatures.

Many windows in the house had a DeltaT (ΔT) that was greater than **30°F** indicating a loss of insulating capacity of the windows. This can be due to improperly sealed windows, old or failing windows. This would explain the massive condensation with the low RH of 43%.

- Replacement: The client's plan to replace the windows within the next two years is the correct long-term solution. In the short term windows should be cleaned and kept as dry as possible.
- Material Selection: I strongly advise against aluminum-cladded units, as they are prone to thermal bridging and condensation. Instead, opt for composite or fiberglass frames. These materials offer superior thermal resistance and durability, significantly reducing the likelihood of future mold growth.

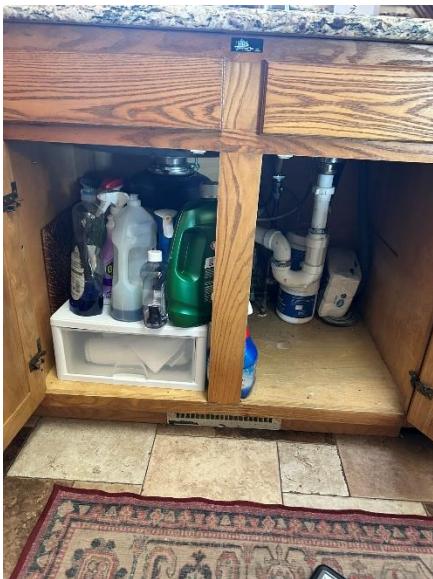
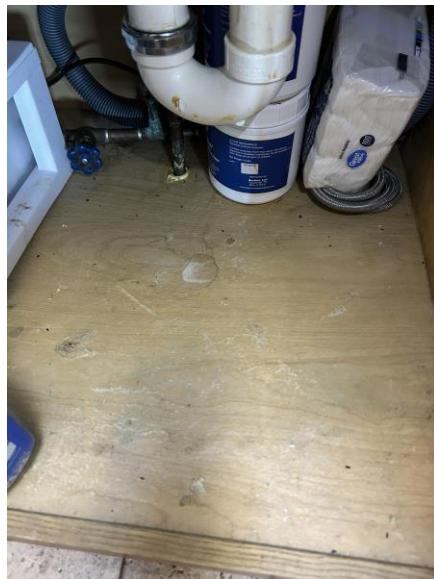
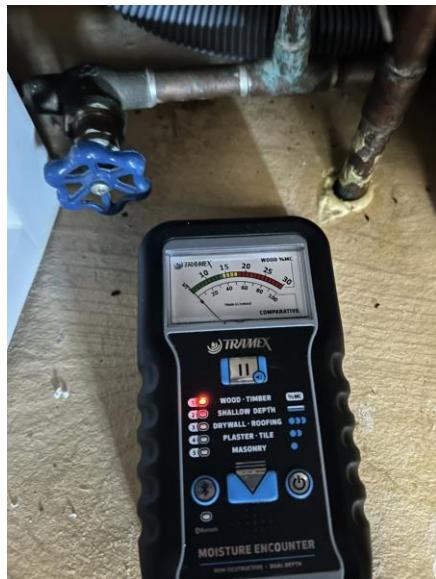
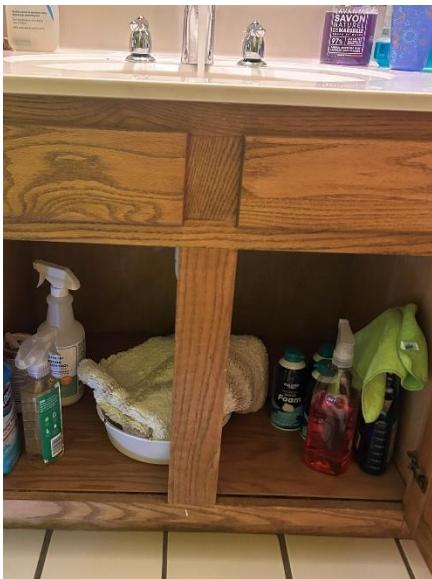
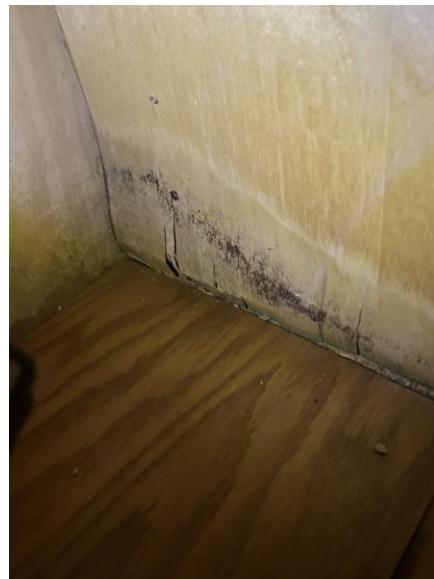
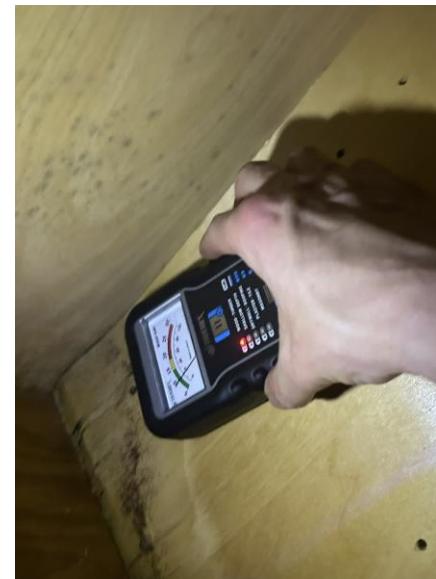
Internal Water Sources (kitchens, bathrooms, sinks)

Sink cabinet areas and associated building materials at the kitchen sink, bathroom sinks, laundry room sink, and basement bar sink were evaluated due to reported or observable evidence of prior water intrusion.

Visible indicators of historical water intrusion were present at select locations; however, moisture measurements did not indicate elevated moisture content at the time of inspection. No wet materials were identified.

Apparent microbial growth observed in the basement bathroom area was dry and desiccated in appearance and did not exhibit characteristics typically associated with active microbial growth at the time of inspection.

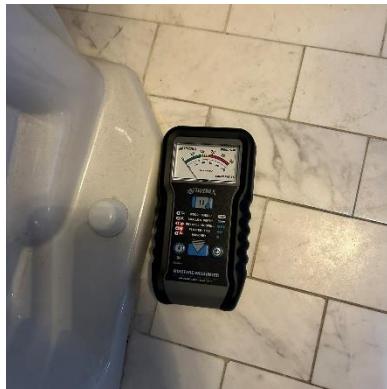
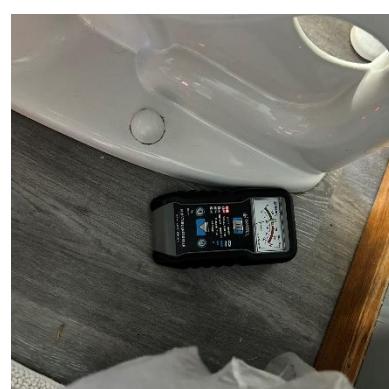
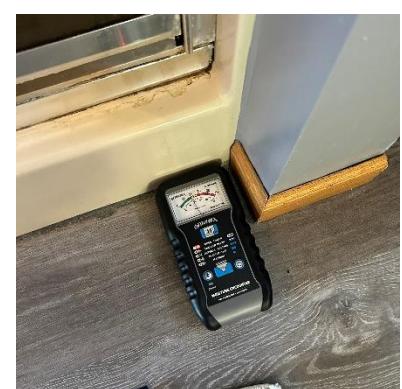
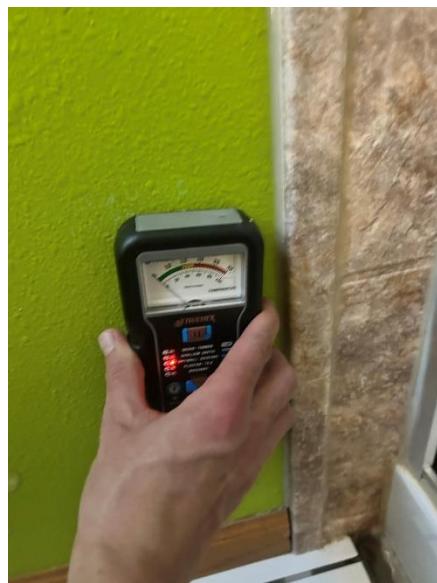
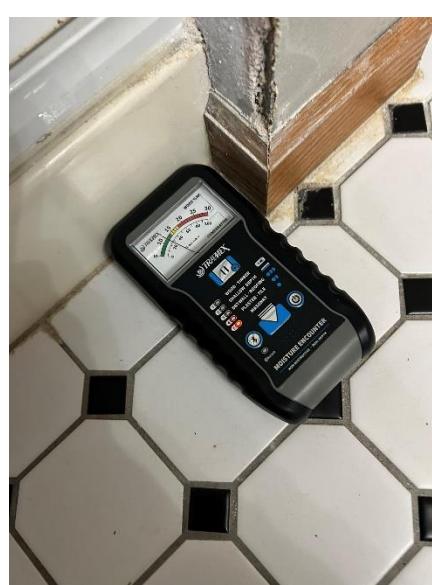
No areas were measured with increased moisture content during this inspection. Even areas with previous water intrusion, such as the basement shower wall, did not show current moisture saturation. This assessment helps confirm that the inspected areas are currently dry and not exhibiting conditions conducive to mold growth.

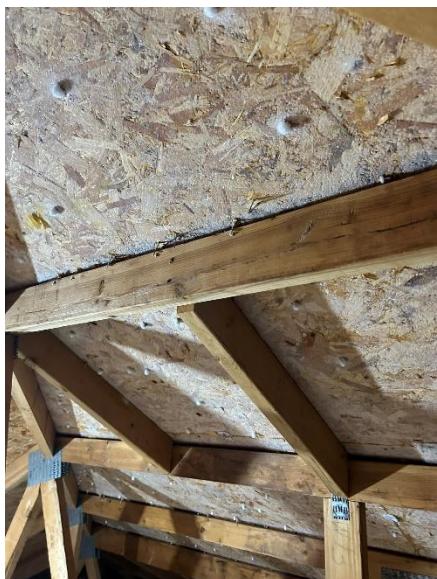
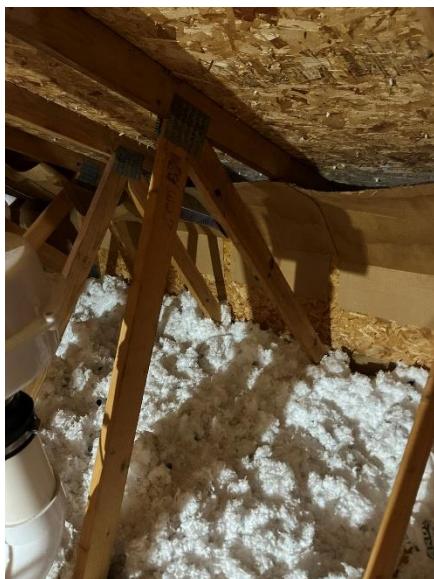
The photo on the left shows frost accumulation in the attic space along with some apparent microbial growth on the roof sheathing. Current outdoor conditions are highly conducive to condensation forming within this space. It is common for attics inspected during prolonged cold periods to exhibit some degree of condensation. These conditions can increase the potential for moisture-related issues if not monitored or mitigated.

- **Insulation & Rodent Activity:** Evidence of rodent issues was noted. I recommend a pest controller to assess the extent of the activity and the integrity of the insulation.
- **Roofing & Attic Components:**
 - **Saturated Board:** A saturated board was identified in the attic; this must be addressed concurrently with the upcoming roof replacement.
 - **Cardboard Baffles:** The current cardboard baffles are susceptible to degradation and mold. It is highly recommended to replace these with more durable materials (such as plastic or foam) when the roof is serviced to ensure proper ventilation and prevent future microbial growth.
