# How Dr. Heater<sup>®</sup> Reveals Design Flaw

## Case #1- Serious Erosion in VDU Heater

### Introduction

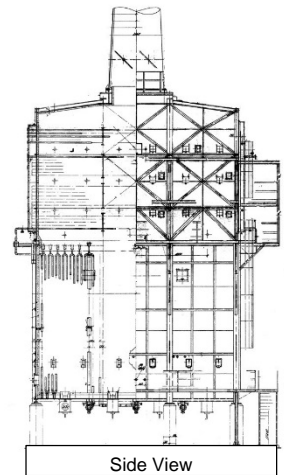
Side View

A VDU heater experienced repeated tube failures due to severe erosion near the outlet, despite normal tube wall temperatures and no operational alarms. Traditional analysis couldn't explain the root cause until we applied **Dr. Heater<sup>®</sup>**, the FHinfinity's built-in diagnostic tool.

- **Firebox Type:** Box-shaped, Up-fired, Natural Draft
- **Number of Cell / Pass:** Four / Six
- **Number of Services:** Three (LPS, MPS, VDU Feed)
- **Tube Location:** Refractory-Backed / Central
- **Tube Diameter:** Varies across radiant section (4 different sizes)
