## RESIDENTIAL PROPERTY INSPECTION

1234 Main Street  
Edwardsville, IL 620\*\*

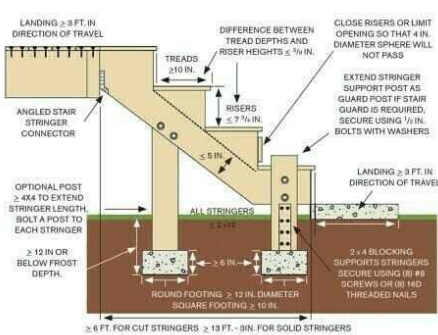
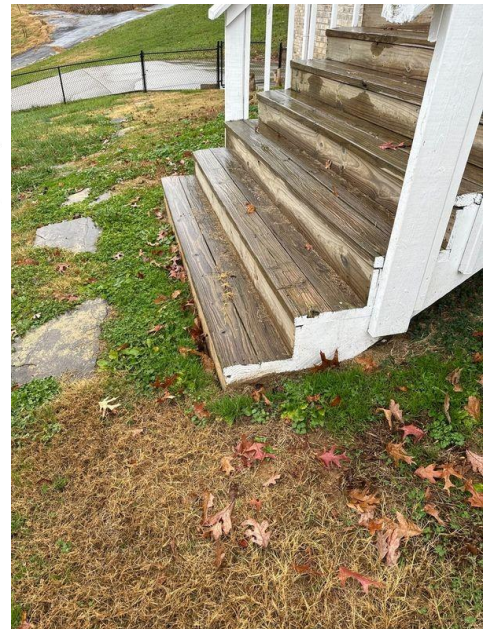
3.5.2 Stairs & Steps

## STRINGER(S) - LENGTH EXCEEDED (UNSUPPORTED)

### FRONT OF STRUCTURE

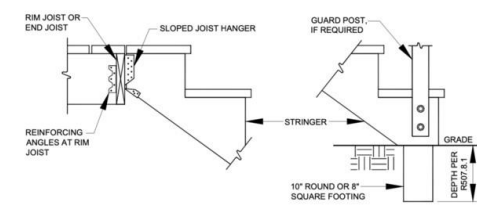
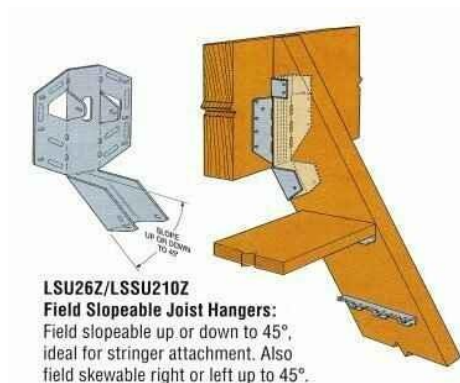
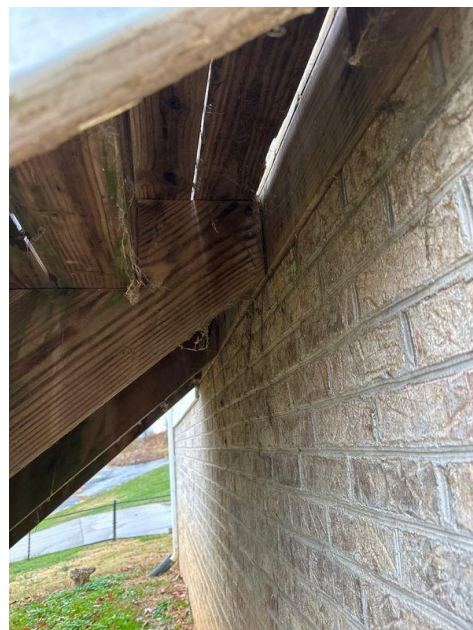
## 3.5.3 Stairs &amp; Steps

**STRINGER(S) - MISSING HANGERS**

Contact a Qualified deck contractor.

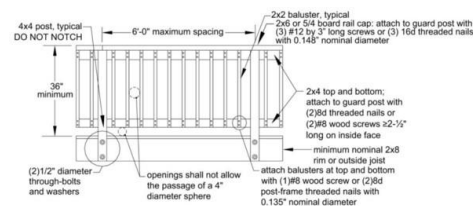
**BALUSTER(S) - IMPROPER ATTACHMENT**

FRONT OF STRUCTURE

attached/secured. Safety standards require for balusters to be attached at the top and bottom with either (1) #8 wood screw, or (2) 8d nails. Repairs to properly secure the balusters is recommended to be conducted by a Qualified contractor.

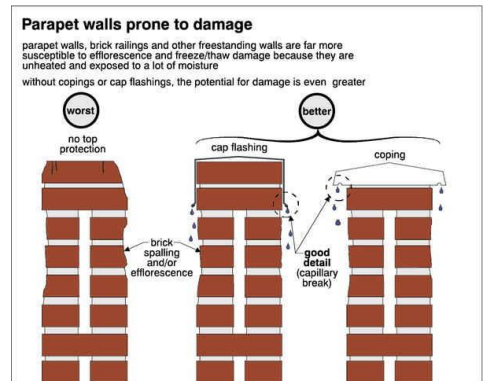
Coping flashing was not present on the top of the retaining wall. This can allow water infiltration into the masonry and related damage due to this moisture freezing and expanding in freezing temperatures. The installation of coping or cap flashing is recommended to be performed as desired by a mason or other qualified person.

Marginal Defect

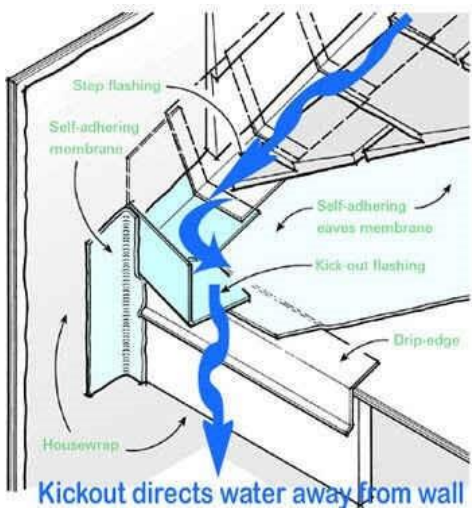
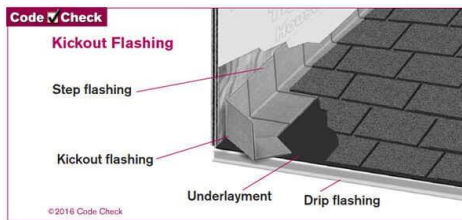
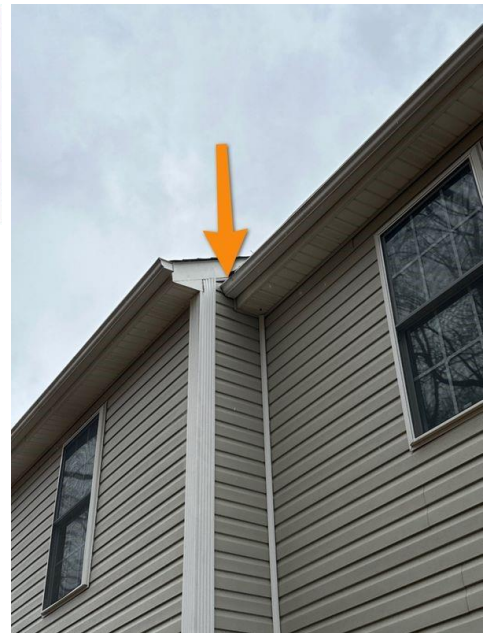
4.6.1 Roof Flashings

Marginal Defect

Contact a Qualified Roofing professional.

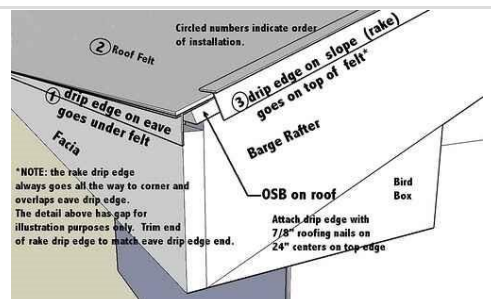
4.6.2 Roof Flashings

Marginal Defect

Contact a Qualified Roofing professional.

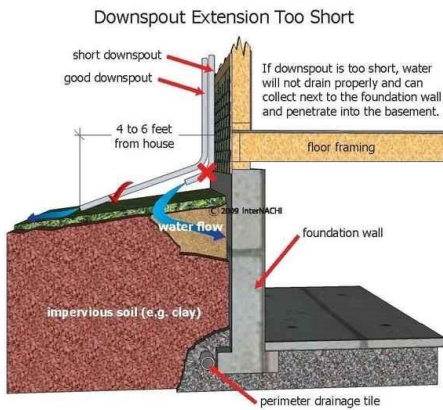
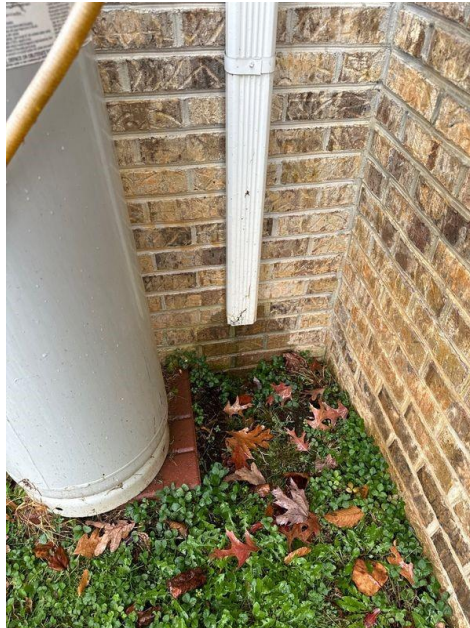
4.7.1 Gutters/Downspouts

Marginal Defect

Contact a Qualified gutter contractor

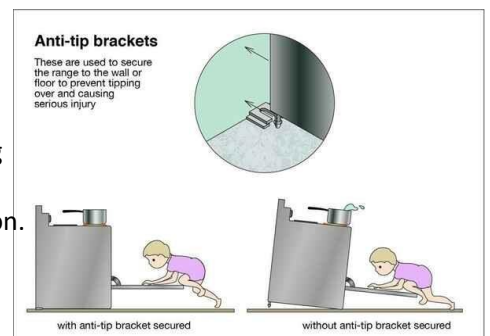
### 6.6.1 Oven/Range

#### SAFETY - ANTI-TIP BRACKET MISSING

**SFTY** - An anti-tip bracket was not installed for the range (and, if present, did not prevent the range from tipping). An anti-tip bracket prevents the range from tipping over if weight is applied to an open oven door, such as a child stepping or sitting on the door. Ranges contain a warning label inside the oven door with more information. This bracket can be purchased at home improvement stores for approximately ten dollars. The installation of an anti-tip bracket is recommended to be conducted by a Qualified person for safety. <http://www.sears.com/search=anti%20tip%20bracket%20for%20oven>

Contact a Qualified professional.

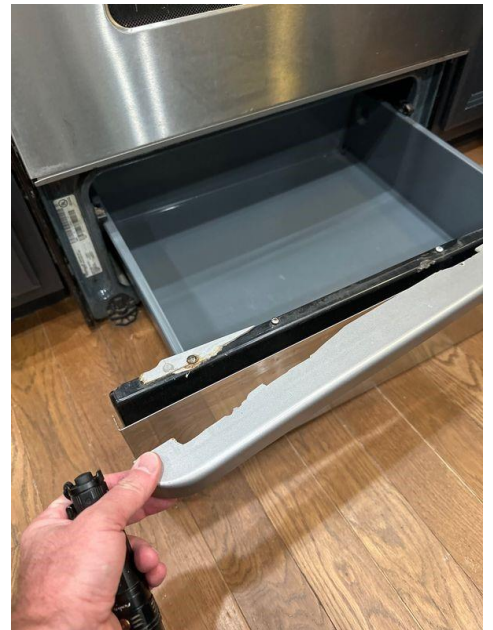
6.6.2 Oven/Range

**BOTTOM DRAWER - DAMAGED**

The range's bottom drawer contained some degree of damage. Repairs or replacement of components made as needed is recommended to be performed by a qualified professional.

Contact a qualified professional.

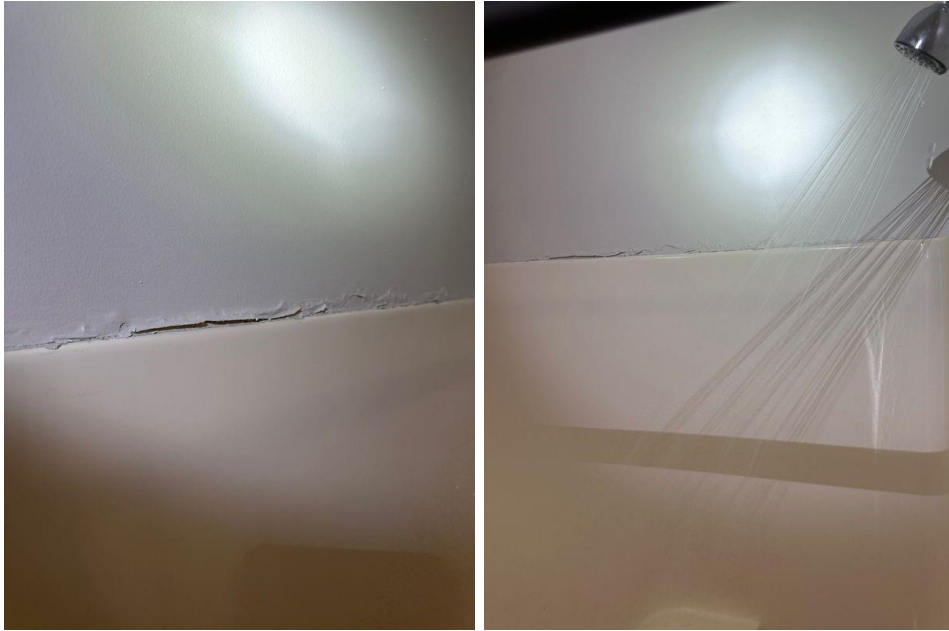
#### DRYWALL - WATER DAMAGE (ABOVE SHOWER)

Some degree of damage was present to the drywall, where the shower walls meet the drywall in the referenced bathroom(s). Repairs are recommended to be performed to the damage as needed by a drywall contractor or other Qualified person.

Contact a Qualified drywall contractor.

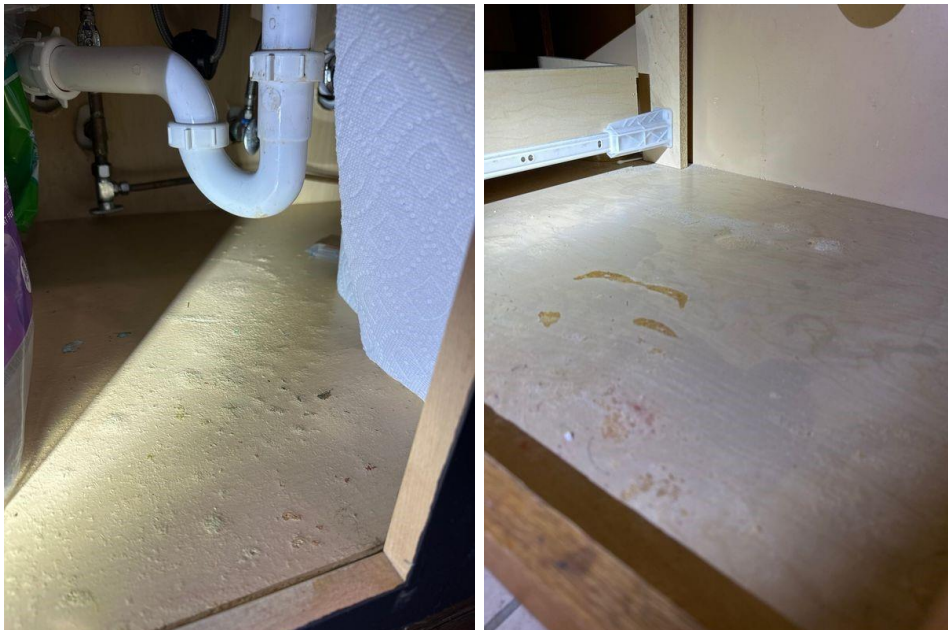
Marginal Defect**MOISTURE DAMAGE - MINOR TO MODERATE**

Minor to moderate moisture damage was present on the cabinet floor below the referenced sink(s). Repairs are recommended to be conducted to any damage present by a Qualified person.

Contact a Qualified handyman.

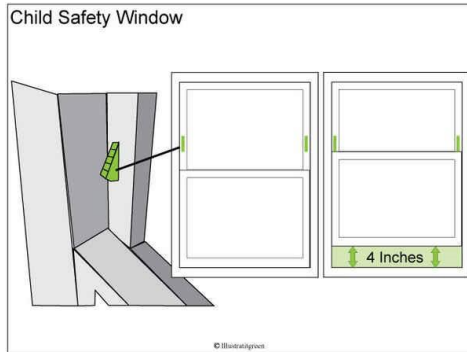
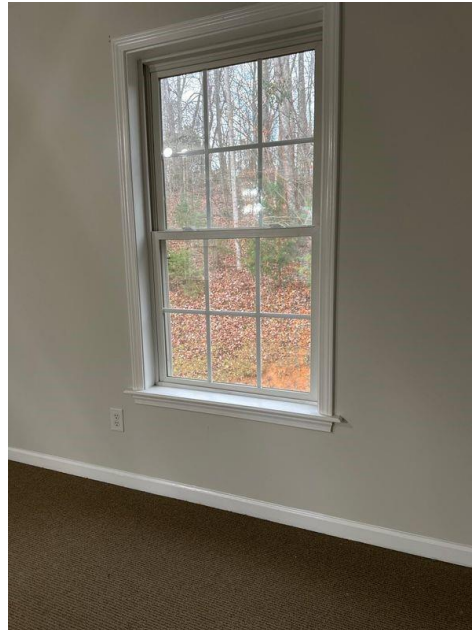
## SAFETY - FALL PROTECTION MISSING

**SFTY** - There were windows present that were within 24 inches of the oor and higher than 72 inches from nished grade outside. Fall protection is recommended to be installed on these windows for child safety by a Qualified person. More info can be found at the link below. [https://pubstore.aamanet.org/docs/TB\\_03-12\\_8-13-12.pdf](https://pubstore.aamanet.org/docs/TB_03-12_8-13-12.pdf)

Contact a Qualified professional.

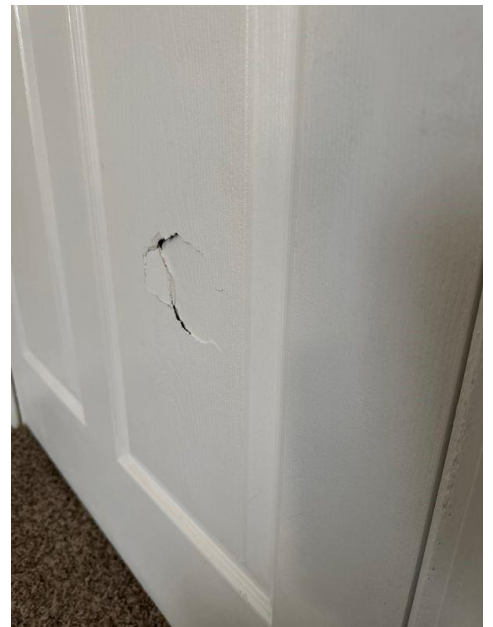
### 8.5.1 Interior Doors

## GENERAL - DAMAGED

The referenced door(s) contained some degree of damage. Repairs or replacement of the doors as needed is recommended to be conducted by a qualified person.

Contact a qualified handyman.

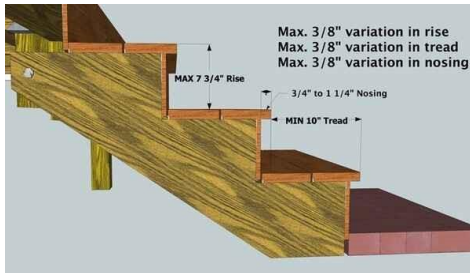
### 8.6.1 Stairs, Handrails, & Guardrails

## STAIRS - RISER, TREAD, AND/OR NOSING DESIGN DEFICIENCIES

**SFTY** - The stairway contained one or more of the following deficiencies :

- 
- There were tread depths present that were less than 10" in depth (measured from nosing to nosing). *10" is the minimum recommended tread depth.*
- The stair tread nosing projected more than 1 1/4" or less than 3/4". *Current standards call for a 1 1/4" maximum and 3/4" minimum tread nosing.*
- There were non-uniform risers, treads, and/or nosings present. *There shouldn't be more than a 3/8" variance between the individual riser heights, stair tread depths, or nosings.*

Any variances from these numbers can result in a potential trip hazard. I recommend consulting a contractor who specializes in stairs to discuss possible modifications or repair options as needed for safety.

Contact a Qualified professional.

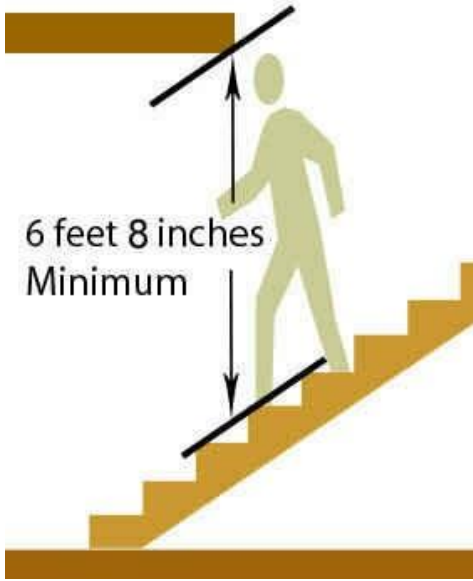
## 8.6.2 Stairs, Handrails, & Guardrails

### STAIRS - INADEQUATE HEIGHT CLEARANCE

**SFTY** - The stairway had inadequate height/head clearance in areas. 6'8" of clearance is recommended for safety. I recommend consulting with a Qualified contractor regarding any improvements that could be made.

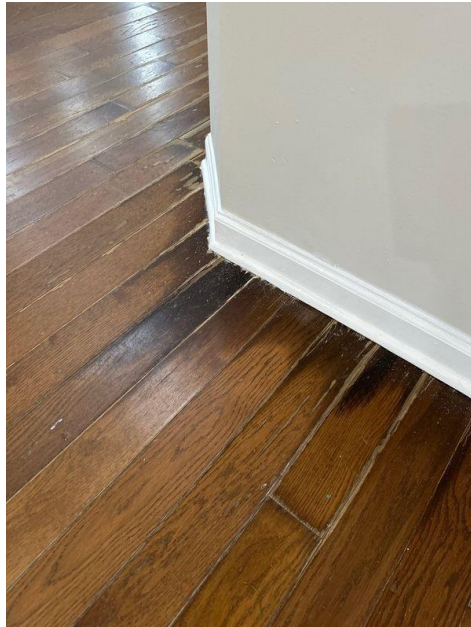
8.8.1 Floor Condition

**HARDWOOD - DAMAGE**

There was some degree of damage present to the hardwood flooring in the referenced area(s). An evaluation of the flooring with repairs made as needed is recommended to be performed by a flooring contractor.

Contact a Qualified flooring contractor

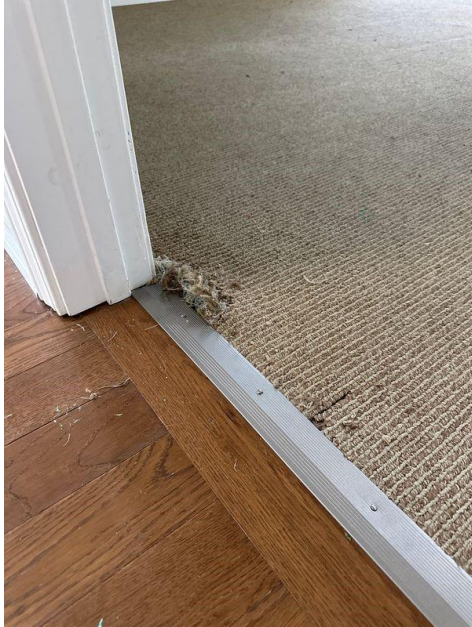
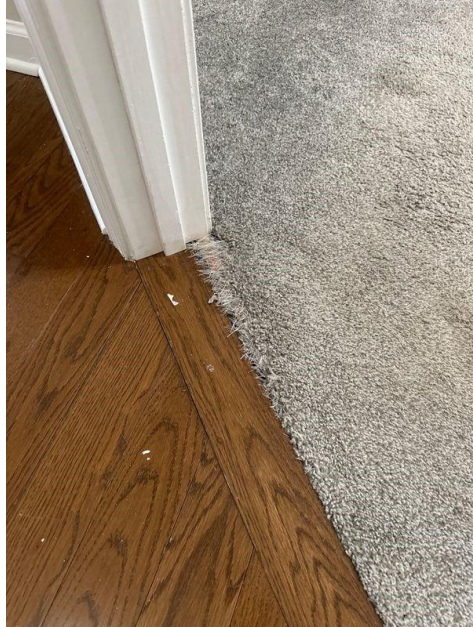
8.8.2 Floor Condition

Marginal Defect**CARPET - DAMAGE PRESENT**

Contact a Qualified flooring contractor

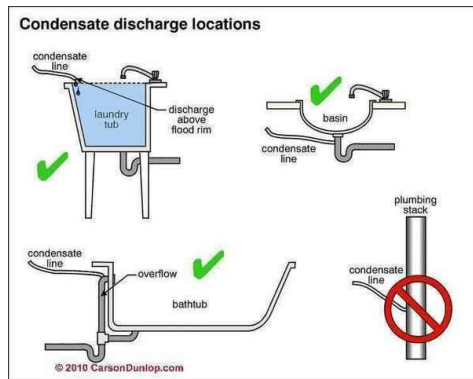
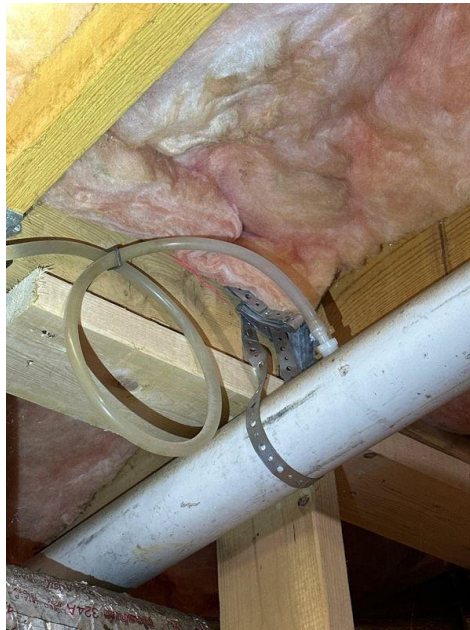
The vinyl condensate drain line from the condensate pump was discharging into a DWV (drain, waste, and vent) pipe. Standards state that condensate can only discharge indirectly to a DWV pipe. An indirect connection would be a connection that is not connected directly with the drainage system, but that discharges into the drainage system through an air break or air gap into a trap, fixture, receptor or interceptor. This connection is also prohibited as DWV pipes can not be drilled or tapped into. Proper routing and termination of the condensate drain pipe is recommended to be conducted by an HVAC contractor, with plugging or repairs made to the DWV pipe made as needed by a licensed plumber.

Contact a Qualified HVAC professional.

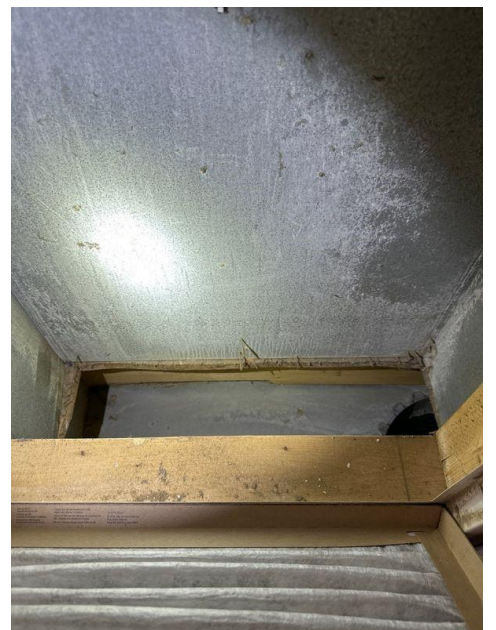
### 10.10.1 Air Filter/Return Plenum

### RETURN PLENUM - WALL/FLOOR CAVITY USED (UPGRADE) DINING ROOM

The HVAC system used a wall or floor cavity to "return" air to the system. This is not recommended due to being an "unsealed" design, which can allow for dust and/or debris to enter the system. I recommend consulting with an HVAC contractor to discuss upgrade/repair options to include a full sheet metal return.

Contact a qualified heating and cooling contractor

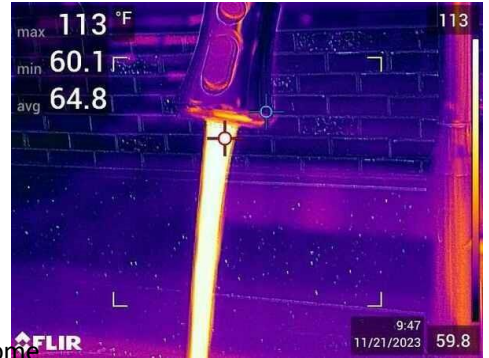
While the maximum recommended water temperature produced at faucets in the home is 120 degrees due to the possibility of scalding at temperatures above this, tank temperatures are recommended to be kept between 135-140 degrees to prevent the formation of Legionellae bacteria in the water heater.

A tempering valve can allow for this combination, keeping water at faucets in the home at safe levels (120 or lower) while keeping tank temperatures high enough to kill harmful bacteria. I recommend consulting with a licensed plumber to install a tempering valve.

Contact a handyman or DIY project

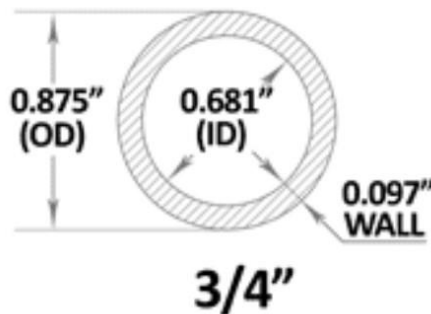
11.3.1

3/4" Aquapex was used for the TPR valve discharge tube, which has an inner diameter of .681. Discharge tubes can not be sized smaller than the TPR valve outlet which is .75 (3/4"). Replacement of the discharge tube with 7/8" o.d aquapex or another approved material with at least a .75" inner diameter is recommended to be conducted by a licensed plumber.

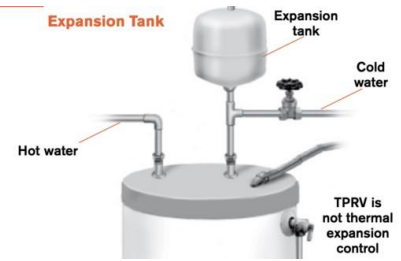
11.4.1 Water Pipes

**EXPANSION TANK - NOT PRESENT**

An expansion tank was not installed for the water heater. Current standards and manufacturers instructions recommend that expansion tanks be installed during water heater installations on closed loop systems. The presence of a pressure regulator where the water pipe enters the home, prevents back ow, and makes this a closed loop system. When water is heated, it expands, and can put pressure on the water heater or plumbing components, the expansion tank provides an area for this "expanded" water to enter. The installation of an expansion tank is recommended to be conducted by a licensed plumber. More info can be found here:

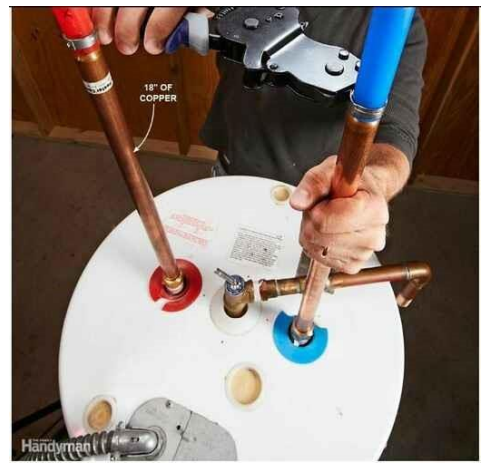
**WATER PIPES AQUAPEX PIPES WITHIN 18" OF UNIT**

Aquapex water pipes were installed within the rst 18 inches of the water heater unit. Current standards do not allow aquapex pipes to be installed within 18 inches of the water heater. Replacement of the pipes with an approved material is recommended to be conducted by a licensed plumber. This deficiency will be labeled in Blue when installed on an electric water heater and Orange when installed on a gas water heater. I know of no repercussions with installing PEX directly to electric units. Though, the heat from a ue on a gas water heater could allow for damage to PEX water pipes.

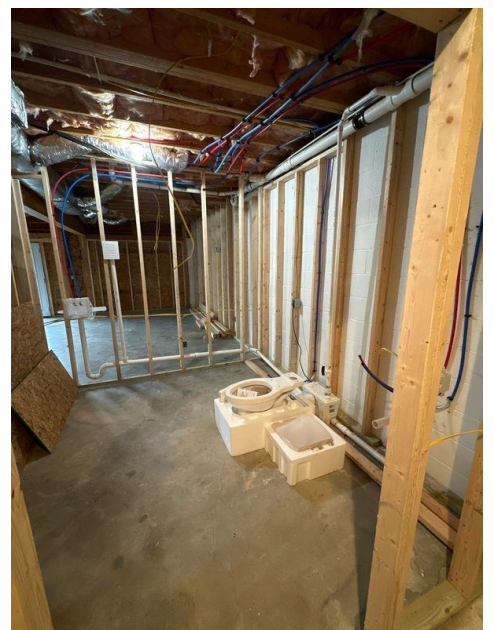
**LMT** - There were incomplete plumbing installations located at the referenced area(s). Incomplete installations are not inspected for their condition or functionality. An evaluation of the installations is recommended to be performed by a licensed plumbing contractor to ascertain " nishing" costs.

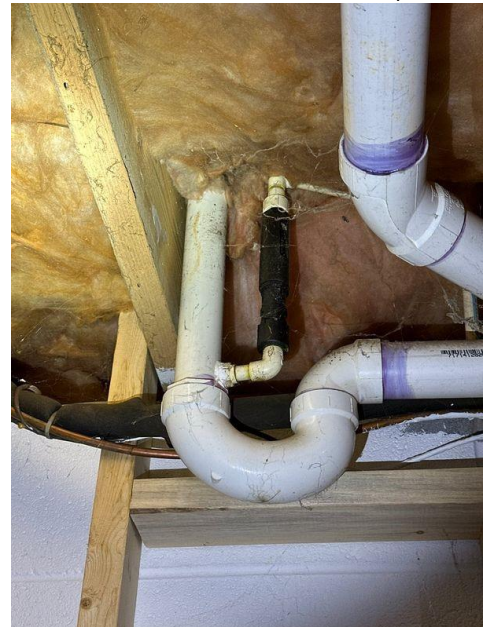
12.6.1 Drain, Waste, and Vent Pipes (DWV)

Waste and/or drain pipe(s) were present that have been tapped and/or drilled into. This is a prohibited connection as the depth of the tapped connection can not be verified and could potentially catch solids in the pipe. Removing the tapped connection and re-routing as needed along with subsequent repairs to the pipe is recommended to be performed by a licensed plumber.

Contact a qualified plumbing contractor.

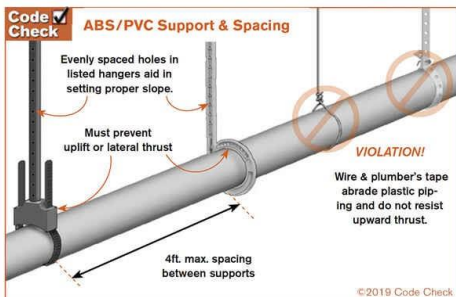
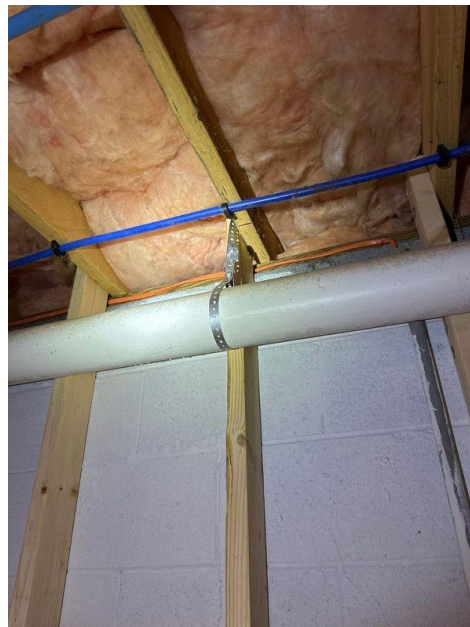
12.6.2 Drain, Waste, and Vent Pipes (DWV)

PVC/ABS - IMPROPER HANGERS

There were improper supports and/or hangers used to secure the drain and waste pipes. Improper supports can allow for abrasion of the pipes due to movement and thermal expansion as well as not preventing uplift. Repairs to incorporate proper materials as needed to properly support the pipes is recommended to be conducted by a licensed plumbing contractor.

Contact a Qualified plumbing contractor.

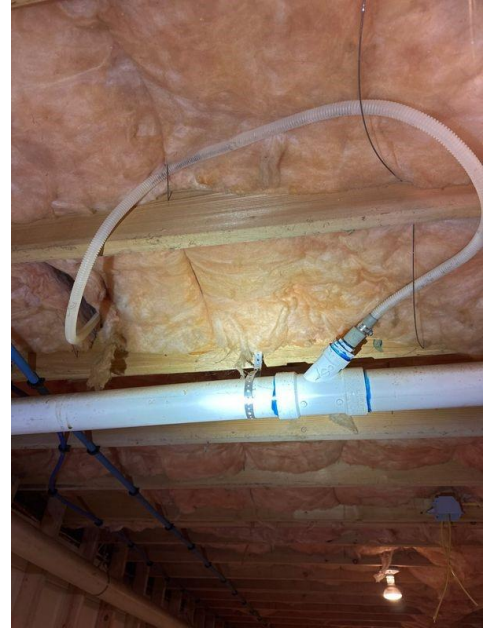
12.6.3 Drain, Waste, and Vent Pipes (DWV)

### TRAP(S) - REFERENCED CONNECTION NOT TRAPPED

The referenced connection to the waste/drain pipes was not trapped. This can allow for sewer gases to enter living areas. The installation of a proper trap is recommended to be conducted by a licensed plumbing contractor.

Contact a Qualified plumbing contractor.

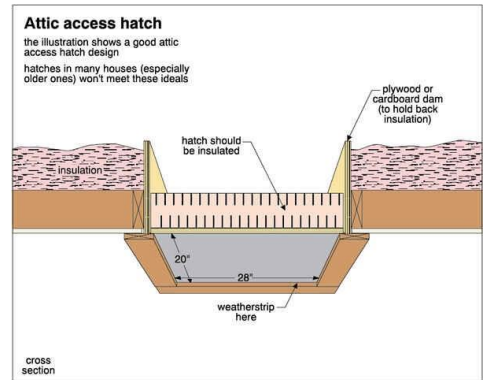
The access opening cover was not insulated and/or weatherstripped around the opening. This can affect energy efficiency. I recommend placing weatherstripping around the attic opening and adhering a batt of R-30 insulation or foamboard to the backside of the cover for energy savings.

Contact a handyman or DIY project

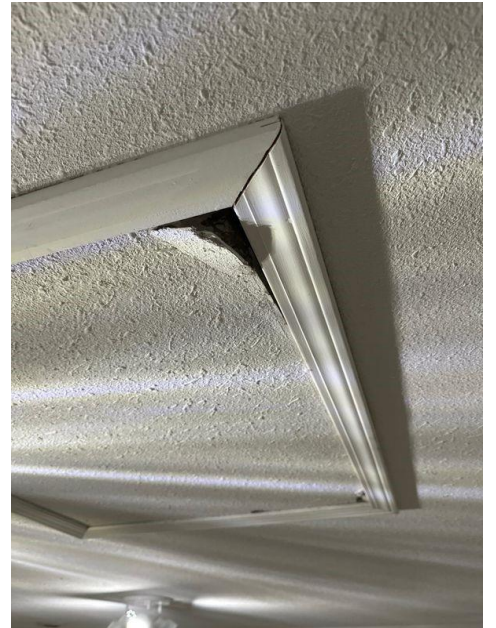
14.2.2 Attic Access

**SCUTTLE PANEL - DAMAGED**

The drywall scuttle panel was damaged. Replacement of the panel is recommended to be performed by a qualified professional.

Contact a qualified professional.

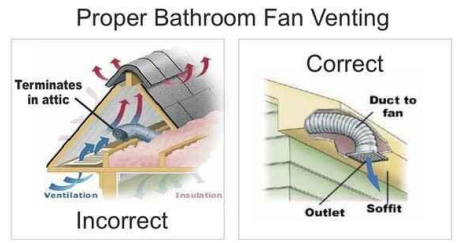
14.7.1 Exhaust Fan(s)

There were exhaust fan(s) present that were terminating in the attic. Exhaust fans should be vented to the exterior of the home to limit condensation and moisture in the attic. Repairs to properly terminate the exhaust fan(s) is recommended to be performed by a Qualified professional.

Contact a Qualified professional.

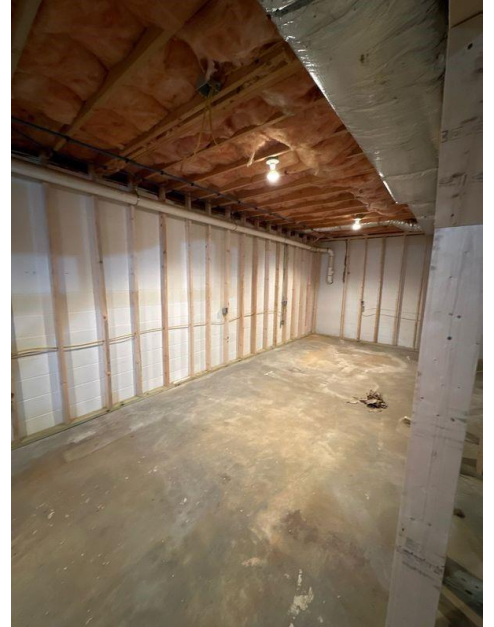
#### **FOUNDATION WALLS - PAINTED WITH MASONRY SEALANT PAINT**

**LMT** - The foundation walls (or portions of them) have been painted with masonry sealant paint. This is typically done to try and lower humidity in the basement area and to prevent moisture infiltration. Addressing the source of the moisture on the exterior is much preferred, as masonry sealers will only mask the problems. Due to this "paint," indications of moisture infiltration and cracking on the foundation walls may be visually concealed and are excluded from this inspection. It is recommended to consult with the sellers as to why the walls were painted.

Contact the seller for more info

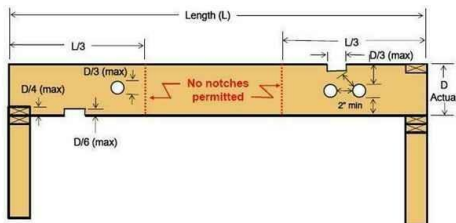
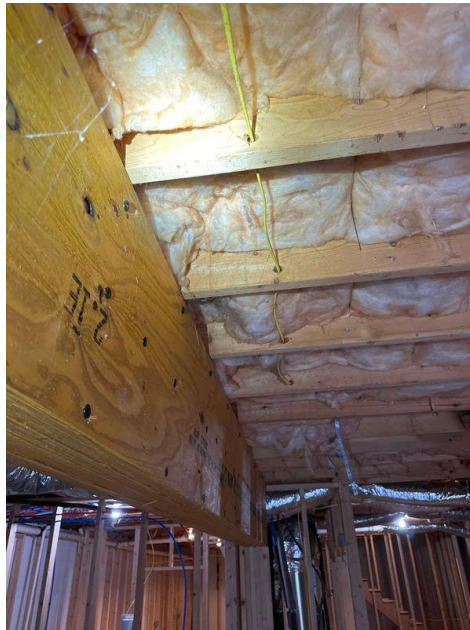
**JOISTS - IMPROPER BORING OF HOLES**

Contact a Qualified general contractor.

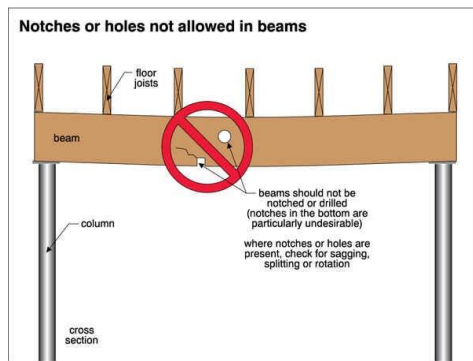
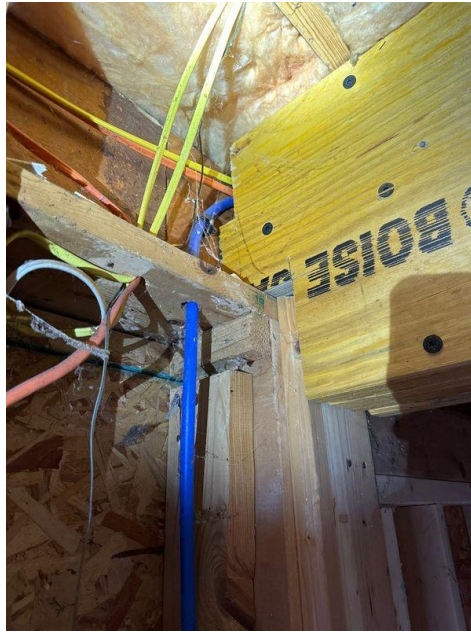
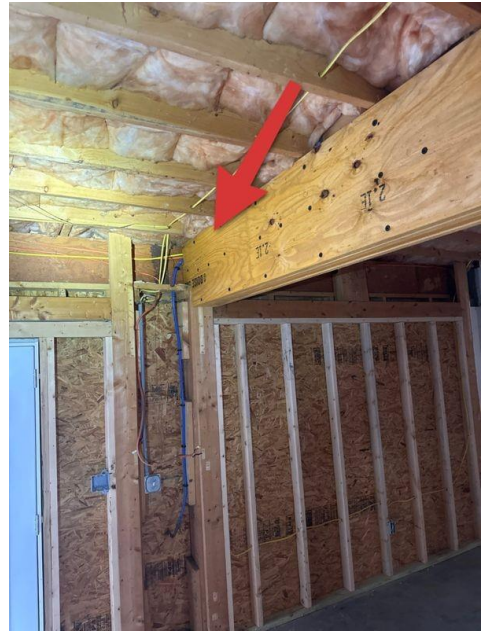
## 15.4.2 Framing/Floor Structure

Significant Defect**BEAM/GIRDER - LVL ALTERED**

Contact a Qualified professional.

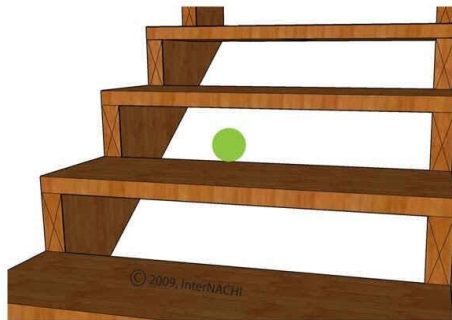
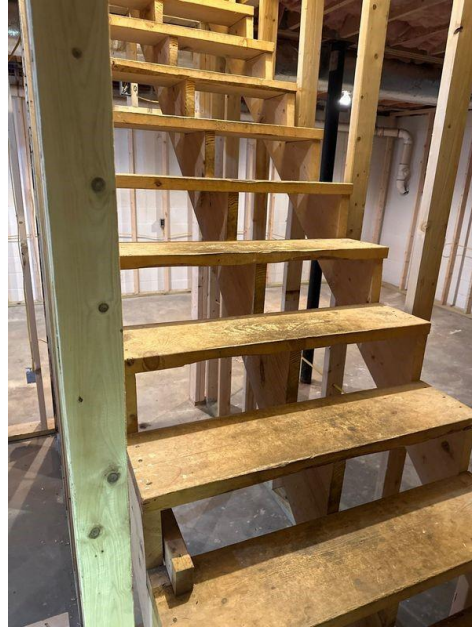
## 15.9.2 Stairs

**STAIRS - OPEN RISERS**

Contact a Qualified professional.

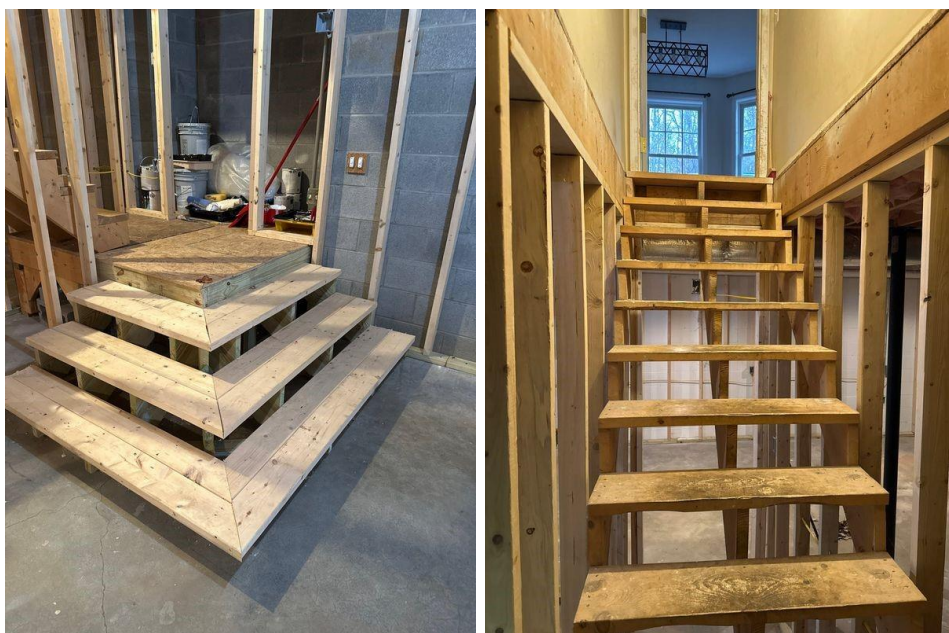
## 15.9.3 Stairs

**HANDRAIL - MISSING**

Contact a Qualified professional.
